Re: Final Report; Interim Defueling Completion Inspection

***Interim* Defueling Completion Inspection Report**

March 5-8, 2024

Red Hill Bulk Fuel Storage Facility
Joint Base Pearl Harbor-Hickam
Oahu, Hawai'i

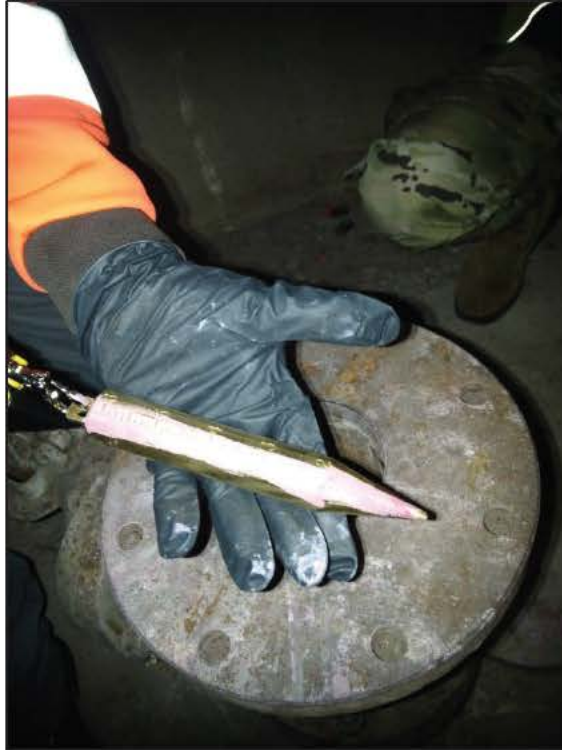
On March 5, 2024, at approximately 10:30 AM HST, EPA inspectors witnessed FLC personnel perform manual gauging of Tank 20. Gauging occurred from the access port at the top of the tank, accessed from the Upper Access Tunnel. FLC personnel coated a plumb bob with fuel gauging paste and descended the bob on gauging tape until it struck the bottom of the tank. The depth to tank bottom was recorded at (b) (3) (A). Upon retrieval, the fuel paste indicated fuel at a depth of less than (b) (3) (A) approximated at (b) (3) (A).

Figure 26 - Plumb bob after retrieval in gauging Tank 20. Fuel paste that changes color in contact with fuel indicated that (b) (3) (A) of fuel present at location where bob struck tank bottom (EPA Inspection Photo Log).

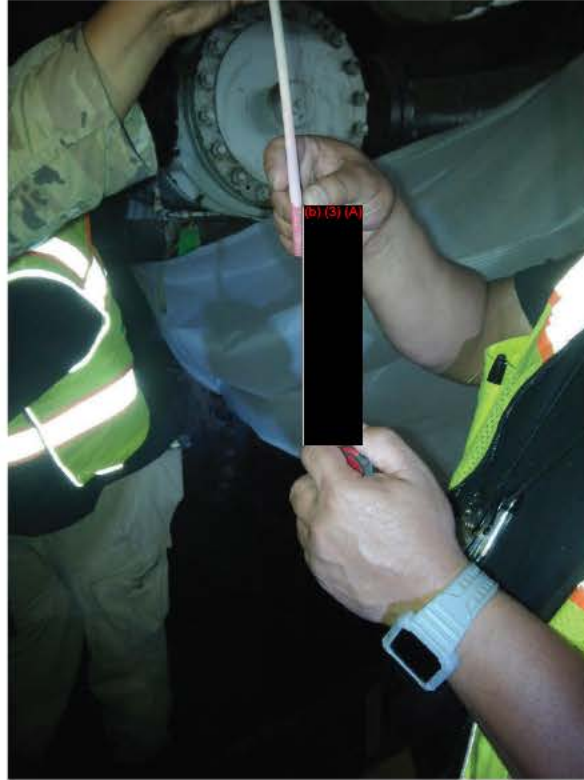
Figure 29 - Example of Navy personnel reading the probe coated in fuel paste at the HPV on the JP-5 pipeline near (b) (3) (A). Results indicate approximately (b) (3) (A) of fuel present (EPA Inspection Photo Log).
