MATTAPOISETT BOGS WETLAND RESTORATION PROJECT

Sara N. da Silva Quintal Restoration Ecologist quintal@savebuzzardsbay.org Photo by Halsey Fulton

Goal: Restore natural wetlands on former farmed cranberry bog

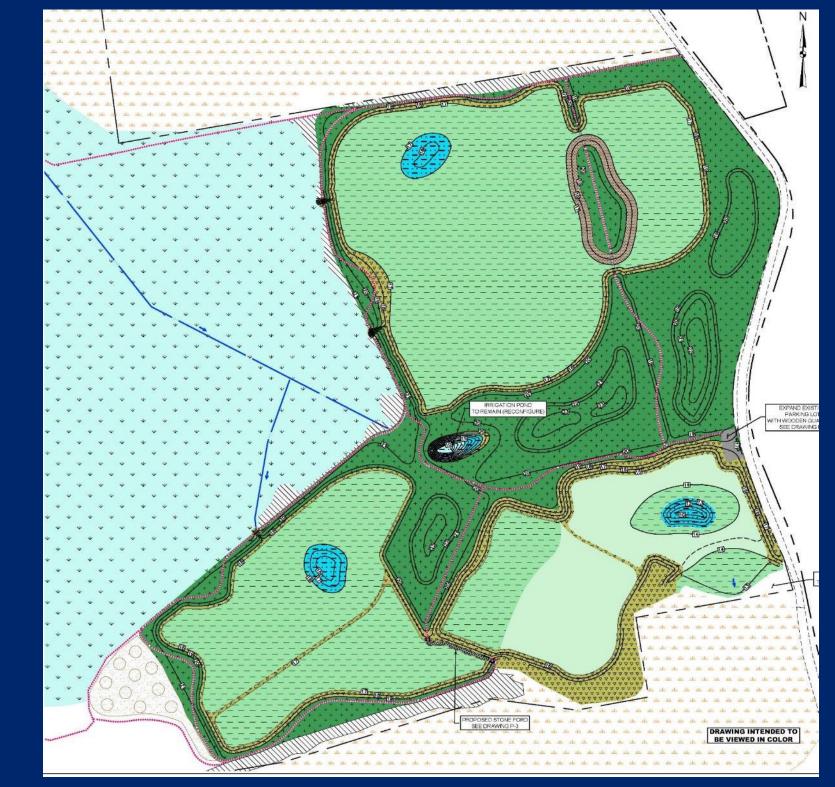
Proposed Plan

- Remove dikes, culverts, pipes
- Scrape sand to expose buried wetland soils
- Replace water diversion structure with natural stream channel
- Install bridges and boardwalks over restored water ways
- Use excavated sand on site to:
 - Fill ditches
 - Naturalize topography
 - Create sandplain grassland
 - Maintain open vistas

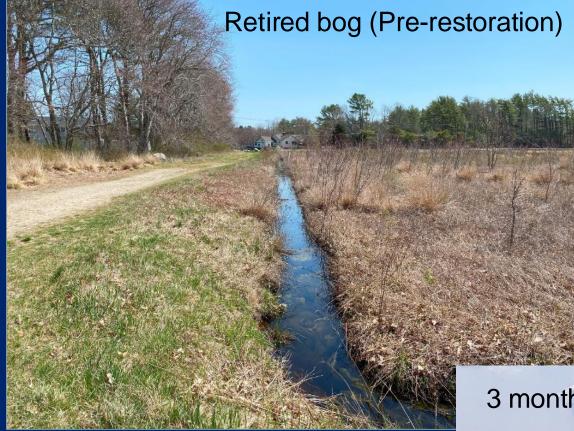
3 months after restoration

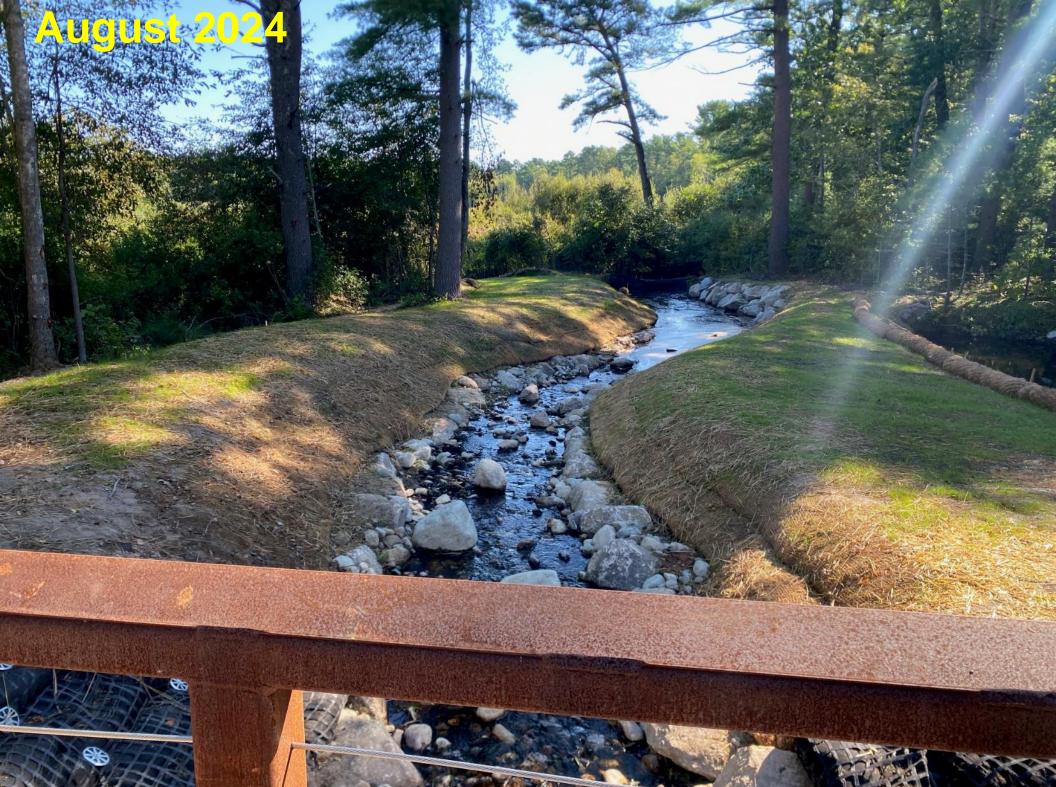
Pre-restoration

Irrigation Canal

Tripps Mill Brook

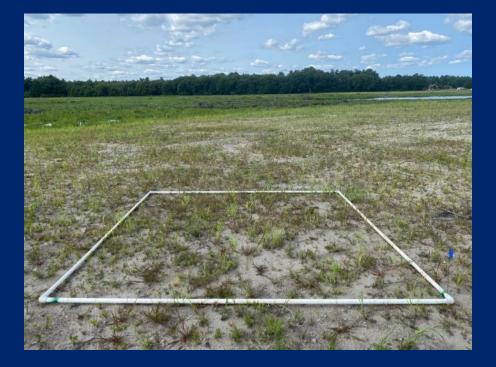
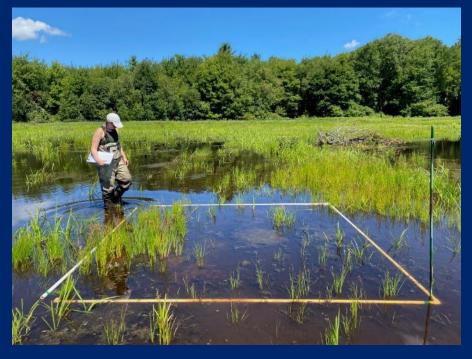
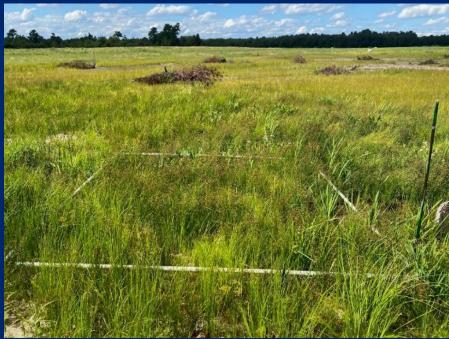
Vegetation Monitoring (40 plots)

Habitat Sampled, 2024 (3 months post- completion)	Mean Native Cover	Mean Wetland Cover	Mean Upland Cover
Wetland	65%	60%	5%
Grassland	57%	28%	31%

Total Richness: Pre-restoration = 111; Post-restoration = 114

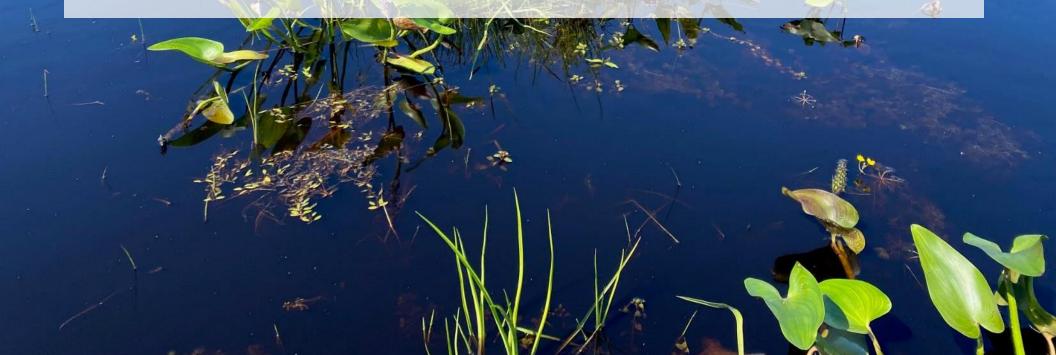
Bogs: Sand scraping (scratched down to surface of original peat)

- + / 6" microtopography creates variability and interconnected pools
- Ponds 2+ feet deep
- No seeding necessary on bog surfaces, and possibly lower slopes
- Ditches maintain rootstock; revegetate quickest
- Revegetation evident within 2 months July (completion by early May; areas completed in early winter revegetated quickest)
- Bogs: Surface roughening
 - Removal of irrigation tubing, selective grubbing, tracked surface
- Confidence in accuracy of bog surfaces critical
