# Long-Term Stewardship Assessment Report

## Constellium Rolled Products

EPA ID #: WVD009233297

Assessment Date: **September 16, 2024**

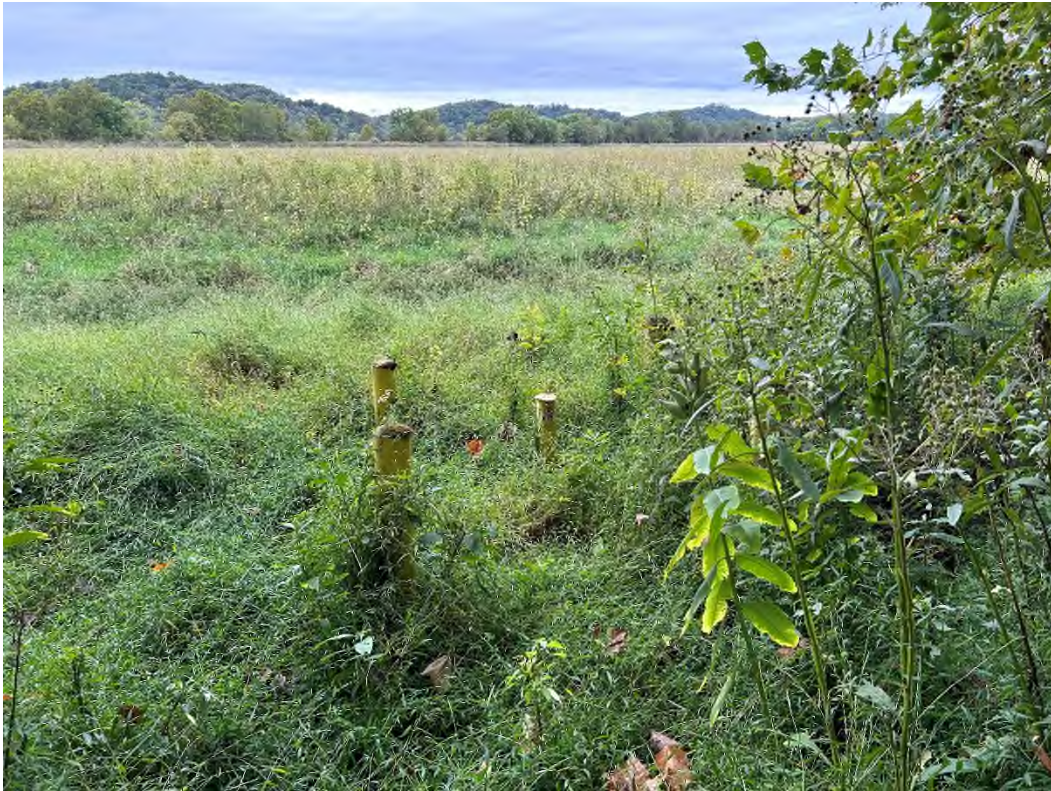
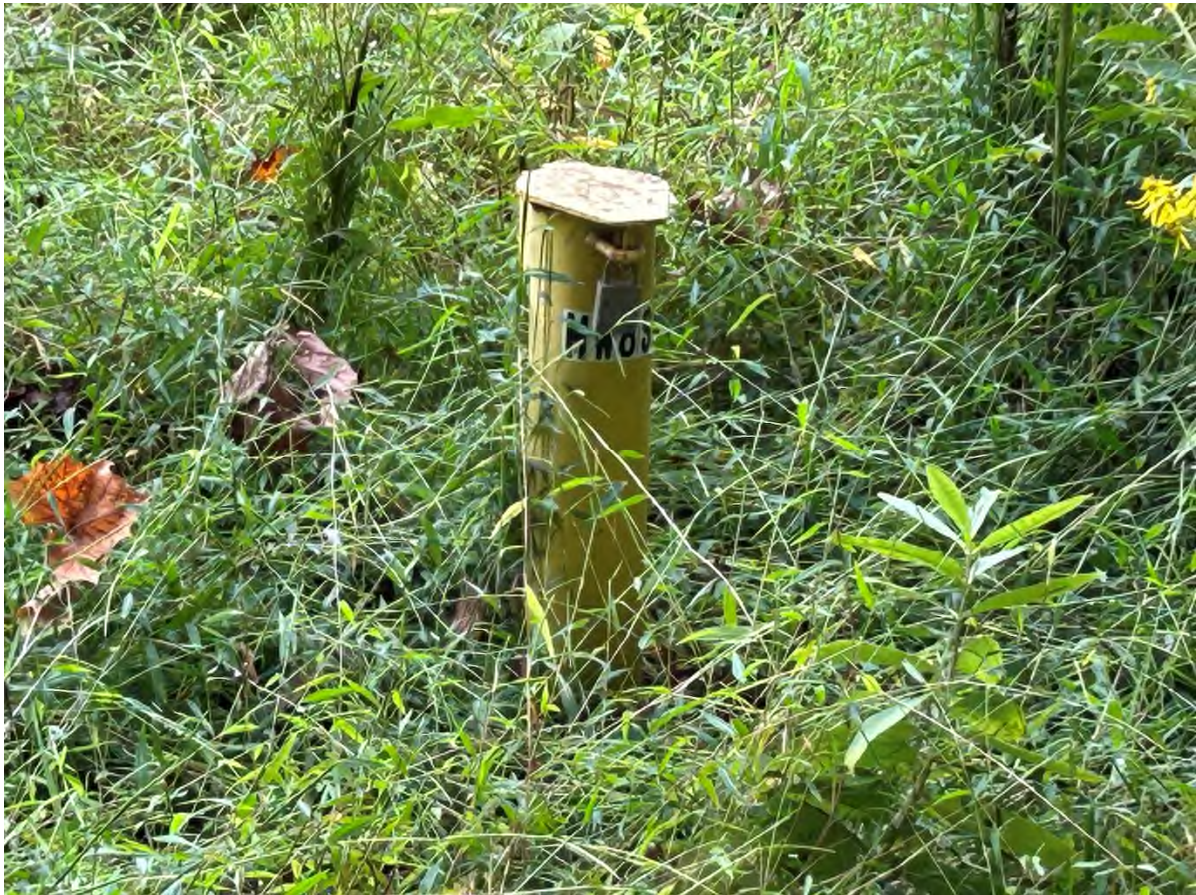
standards are met, Constellium will conduct annual monitoring of the natural attenuation of arsenic in groundwater at wells MW-8s and MW-11. During this visit, WVDEP observed wells MW-8s and MW-11 on location. The Facility, through their contractor Pace Analytical, Inc., has been sampling these wells and providing analytical results, included in Annual MNA Reports since 2017. The 2023 Annual MNA report was submitted in May 2024.

**Images 1 & 2:** Two images from the Monitoring well MW-8s and its vicinity.

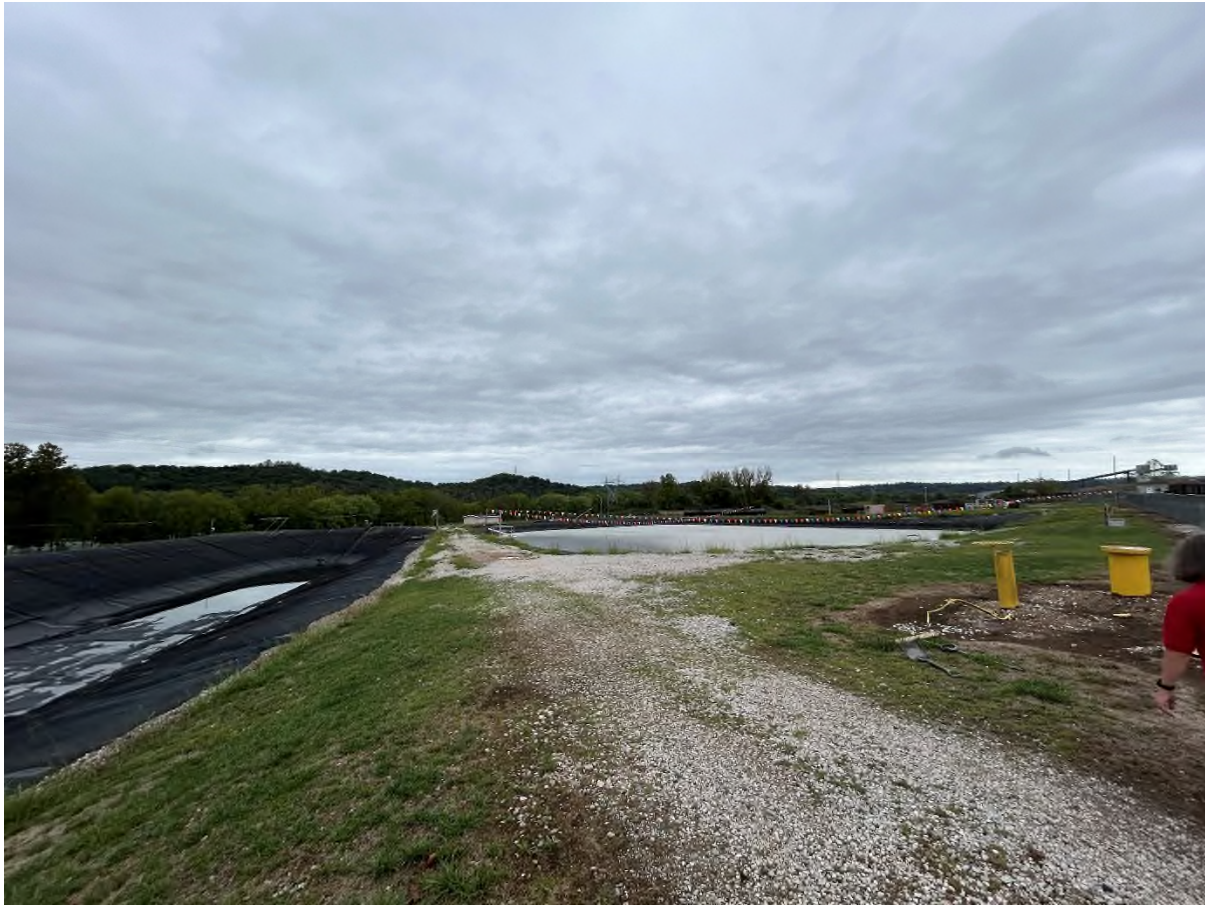
**Image 5:** An image of the oil ponds looking west/northwest with Pond 1 to the right and Pond 2 to the left.

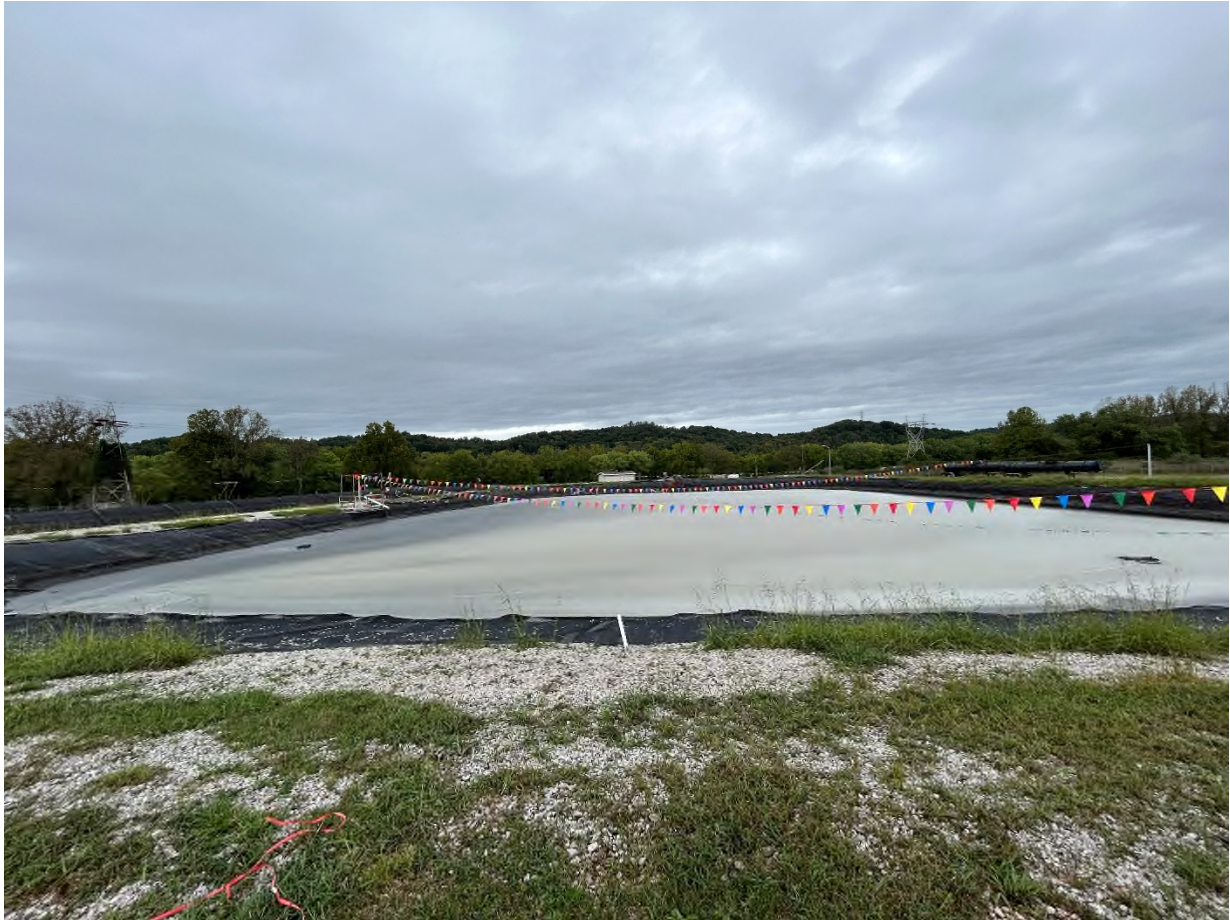
**Image 6:** An image of Pond 1 in the foreground looking west/northwest.

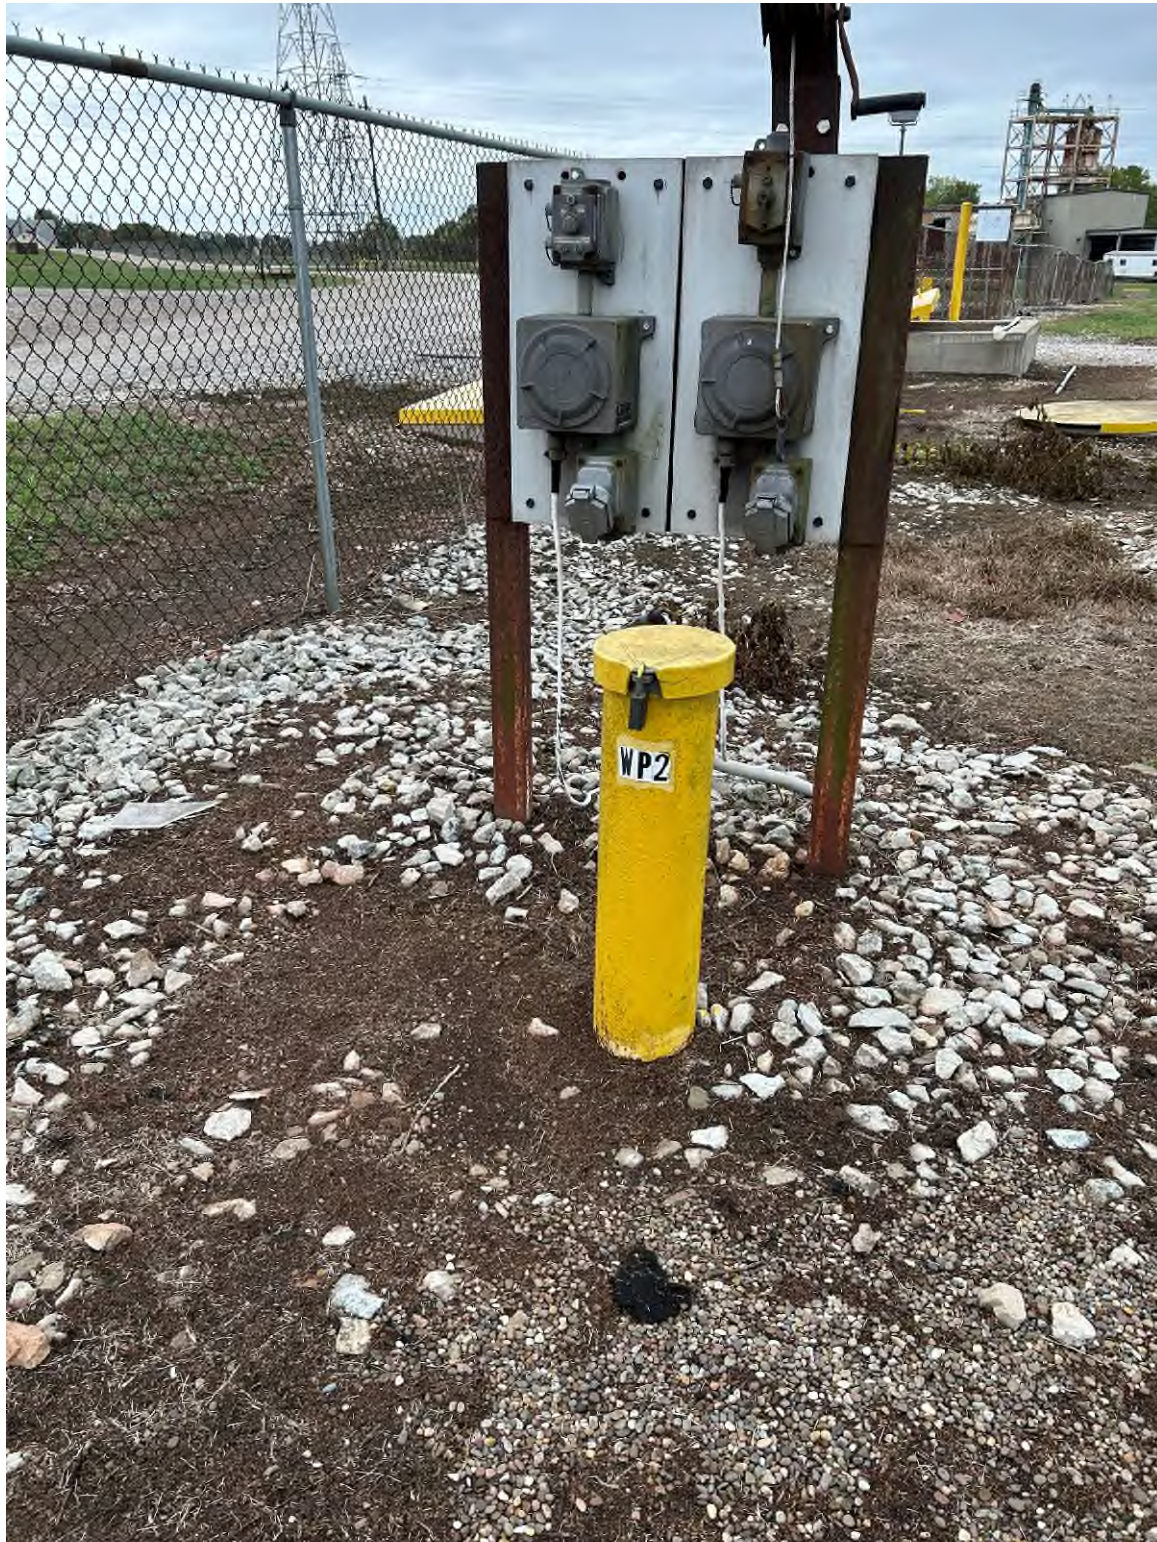
**Image 7:** The image of WP-2, one of ten (10) free product (oil) recovery wells in the vicinity of the oil ponds area.

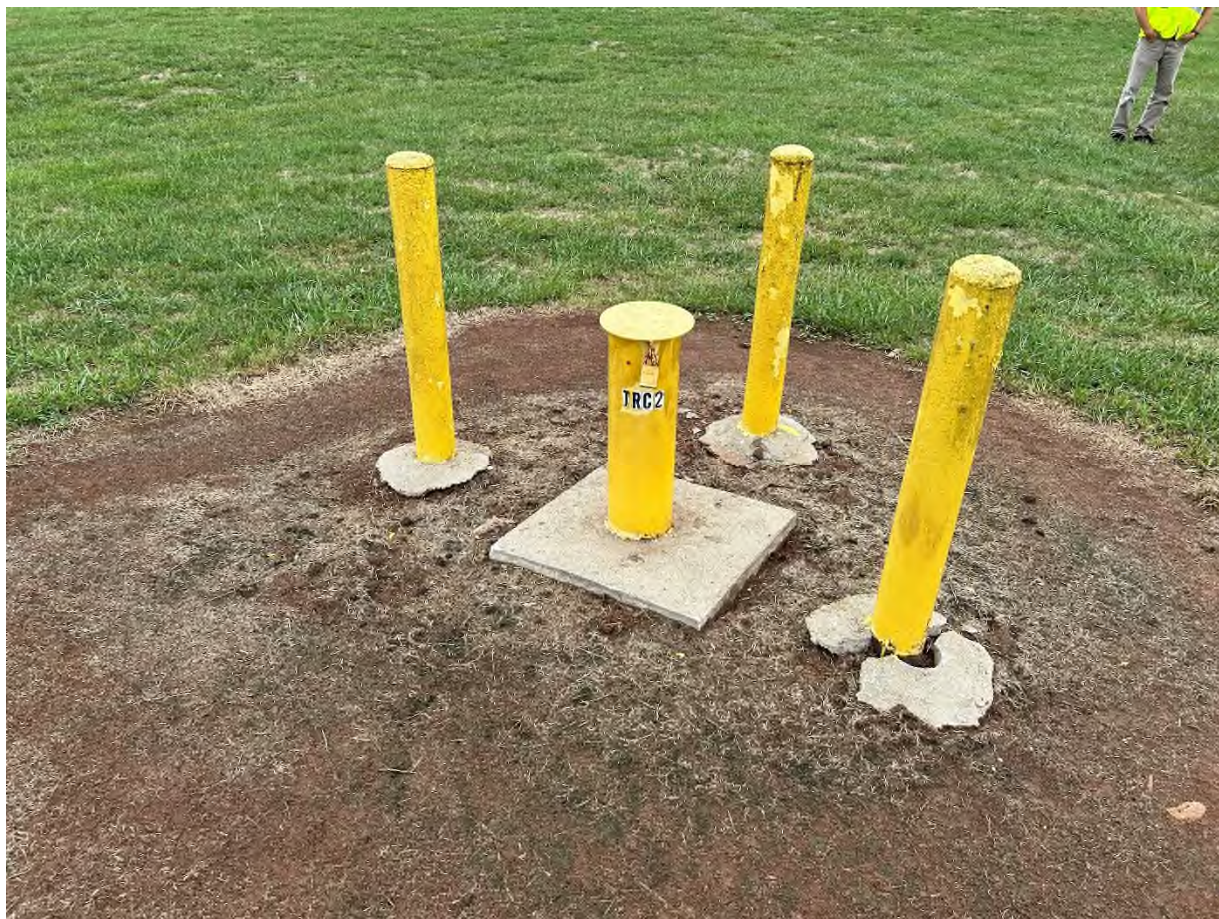
**Image 8:** The image of TRC-2, one of the 4 groundwater wells monitored for total lead in the vicinity of oil ponds area.
