## Long-Term Stewardship Assessment Report

### TRC Spent Cathode Storage Pile

EPA ID #: WVD988766127

Assessment Date: **September 26, 2024**

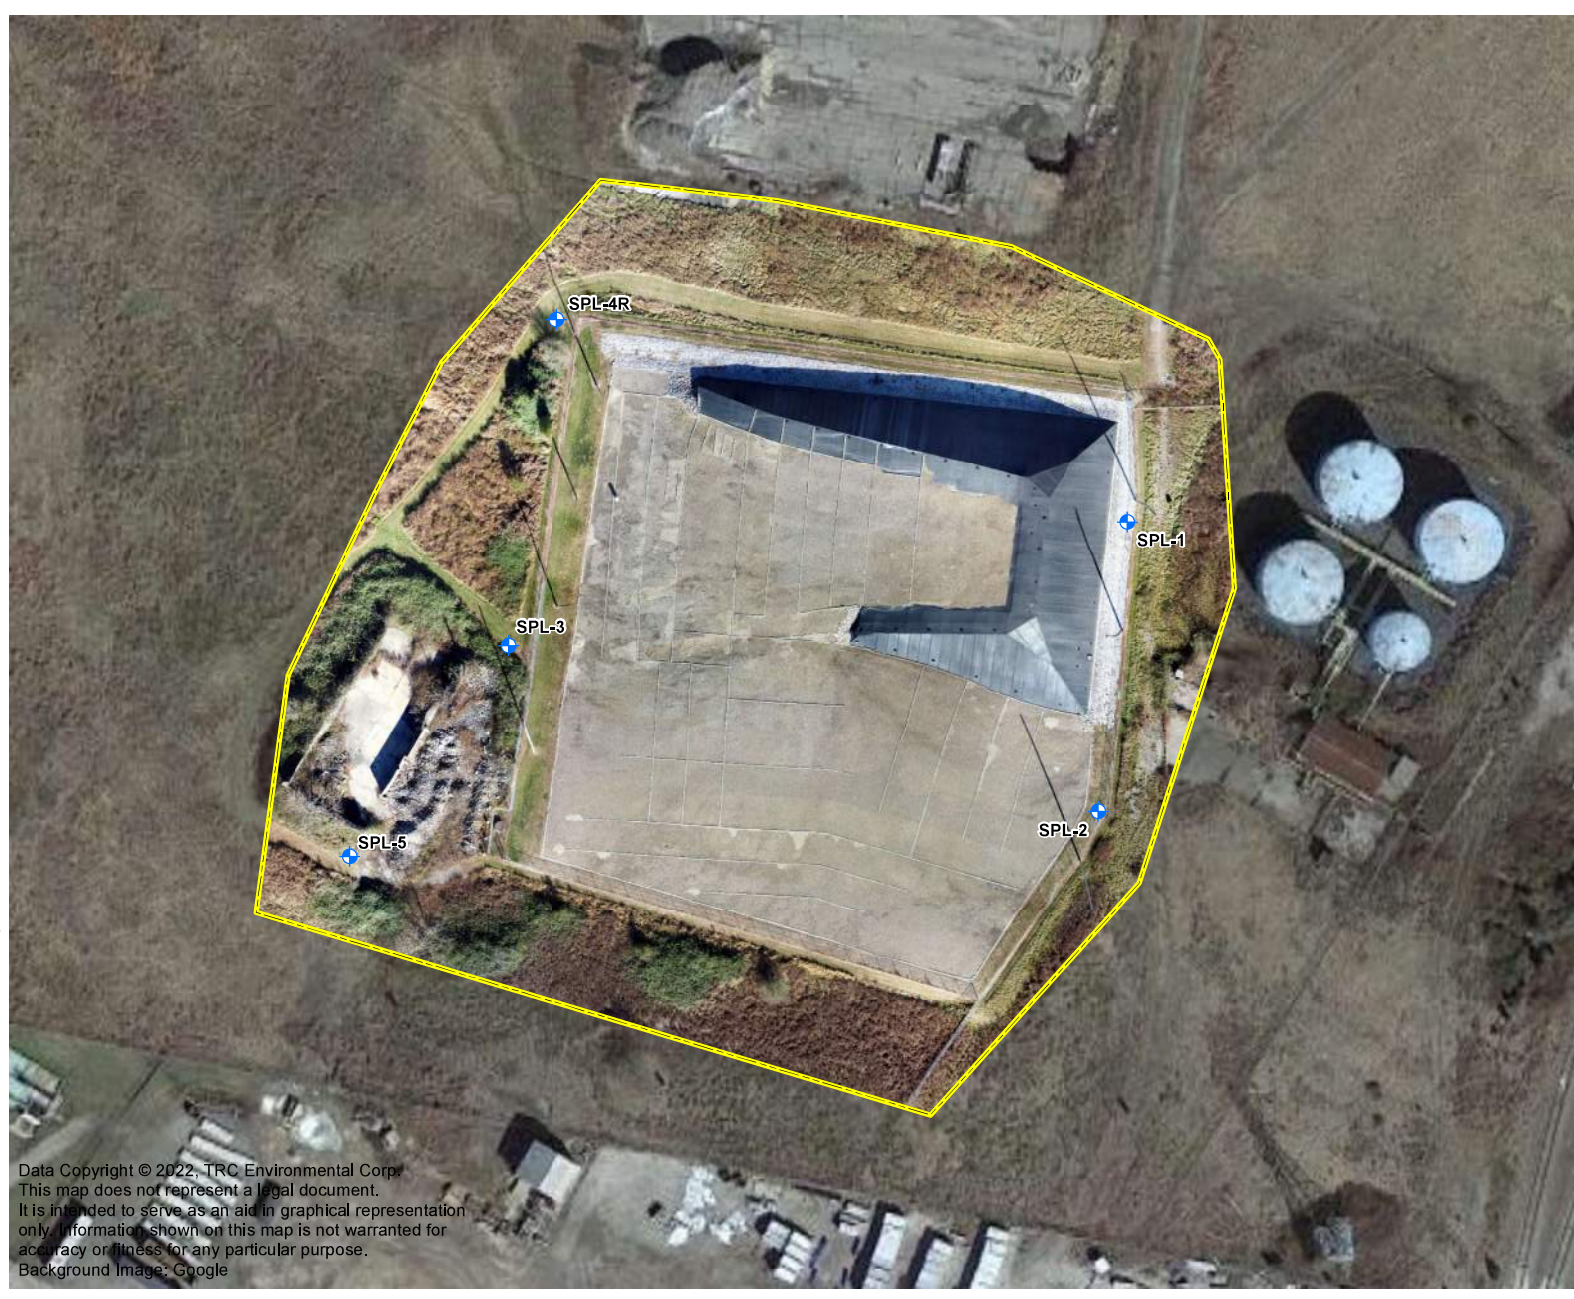
**Mapping:** The EPA Facility website are accurate and include a geospatial PDF showing the use restriction boundaries of the SPL Pile and the adjacent Discolored Puddle Area. This map was field-verified and no issues were noted. A relatively recent drone image of the SPL Pile showing the location of the five monitoring wells is attached as Figure 1 in this report.

**Figure 1:** Aerial/drone image of SPL Pile, showing locations of the five (5) monitoring wells.

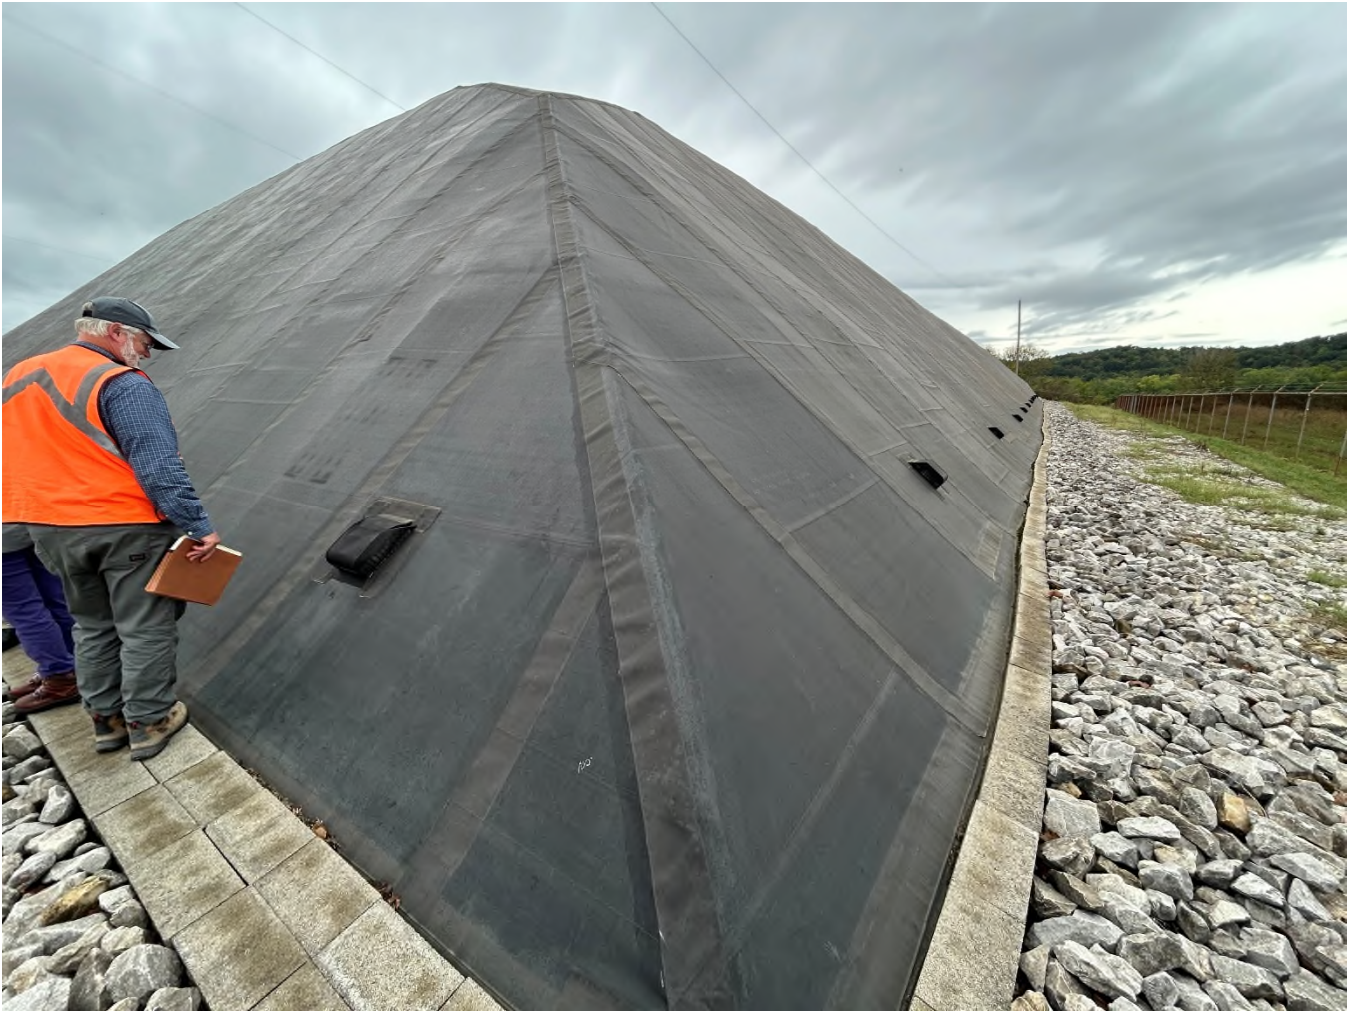
**Image 1:** A close look at the EPDM cover; looking southeast from the northeast corner of the SPL Pile shown in Figure 1.

**Image 1:** A close look at the EPDM cover; looking east from the west corner from the SPL Pile.

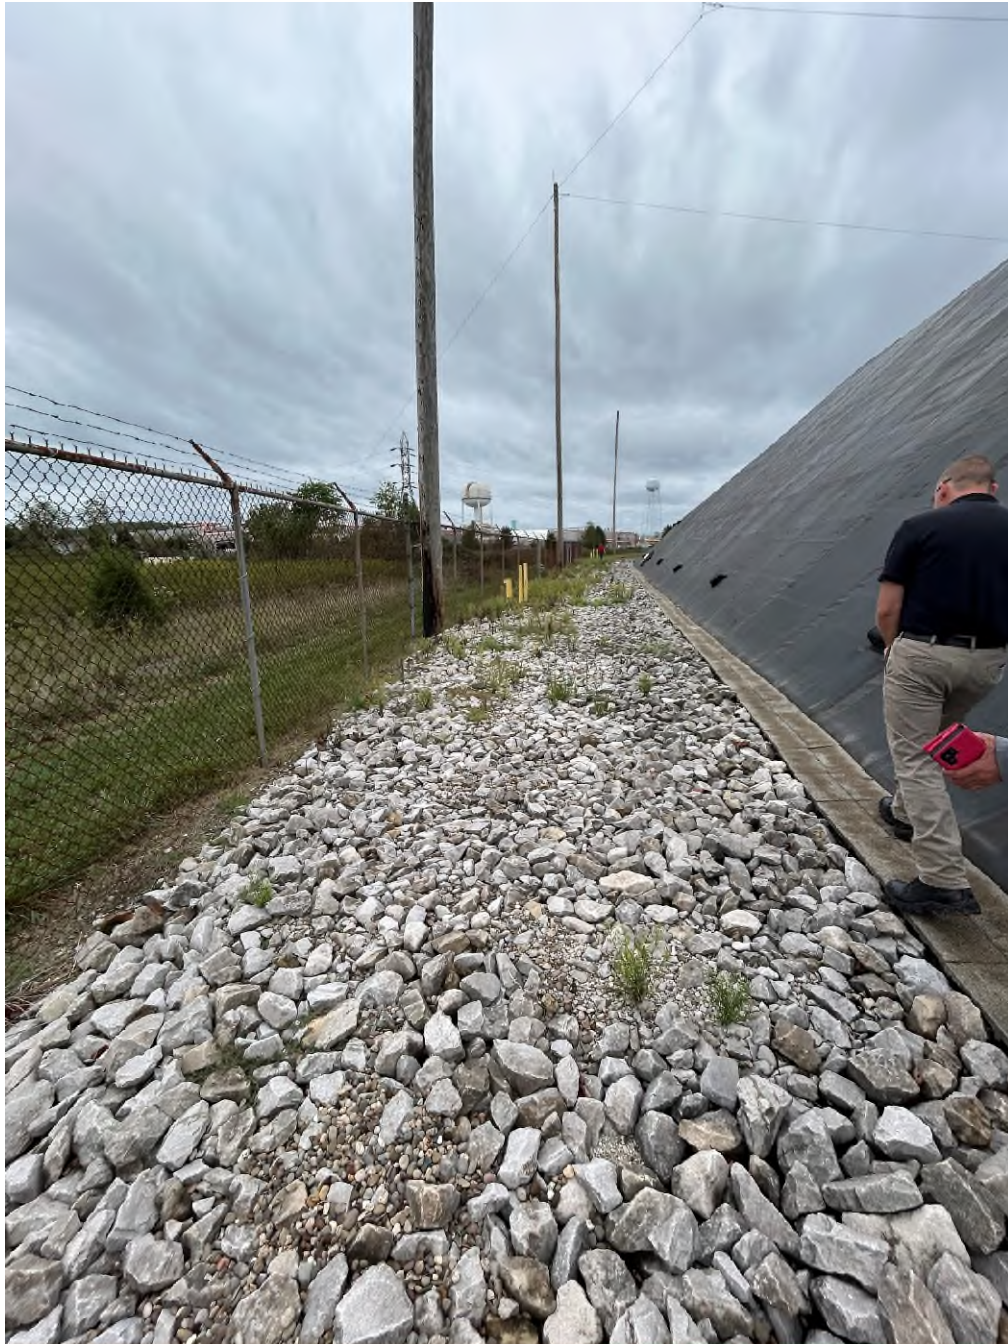
**Image 2:** Walking south along the east, steep edge of the SPL Pile. Monitoring well SPL-1 is visible in the distant foreground.

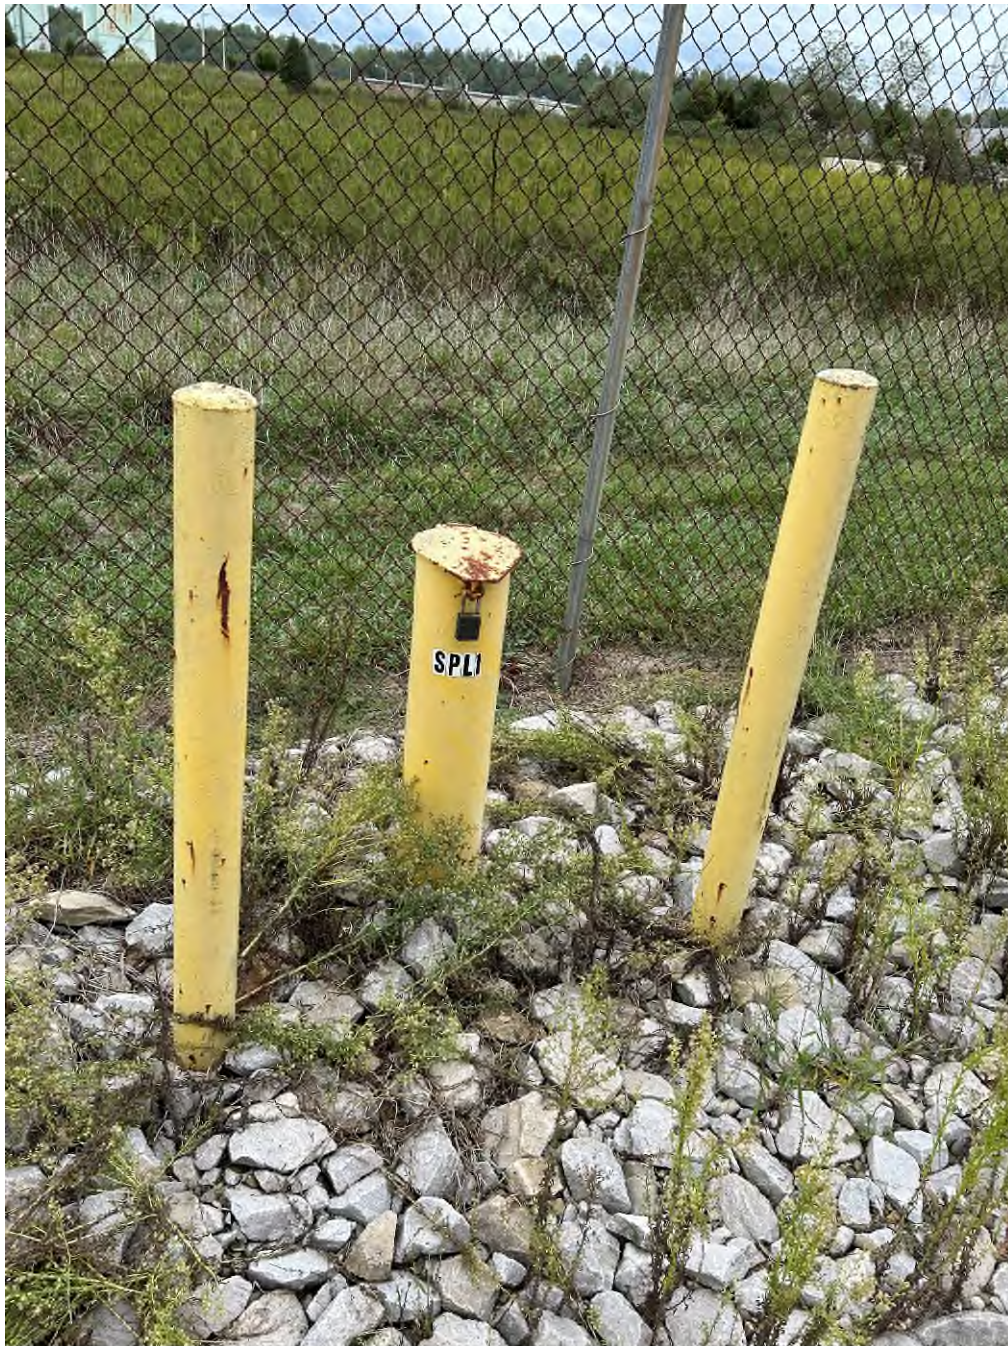
During this assessment visit, WVDEP observed and verified that the engineering controls selected for the Facility are implemented and remain intact and undamaged. Monitoring wells were verified to be in good condition (see attached images). Furthermore, no IC deficiencies have been identified at the Facility.

**Image 3:** A close up view of monitoring well SPL-1.

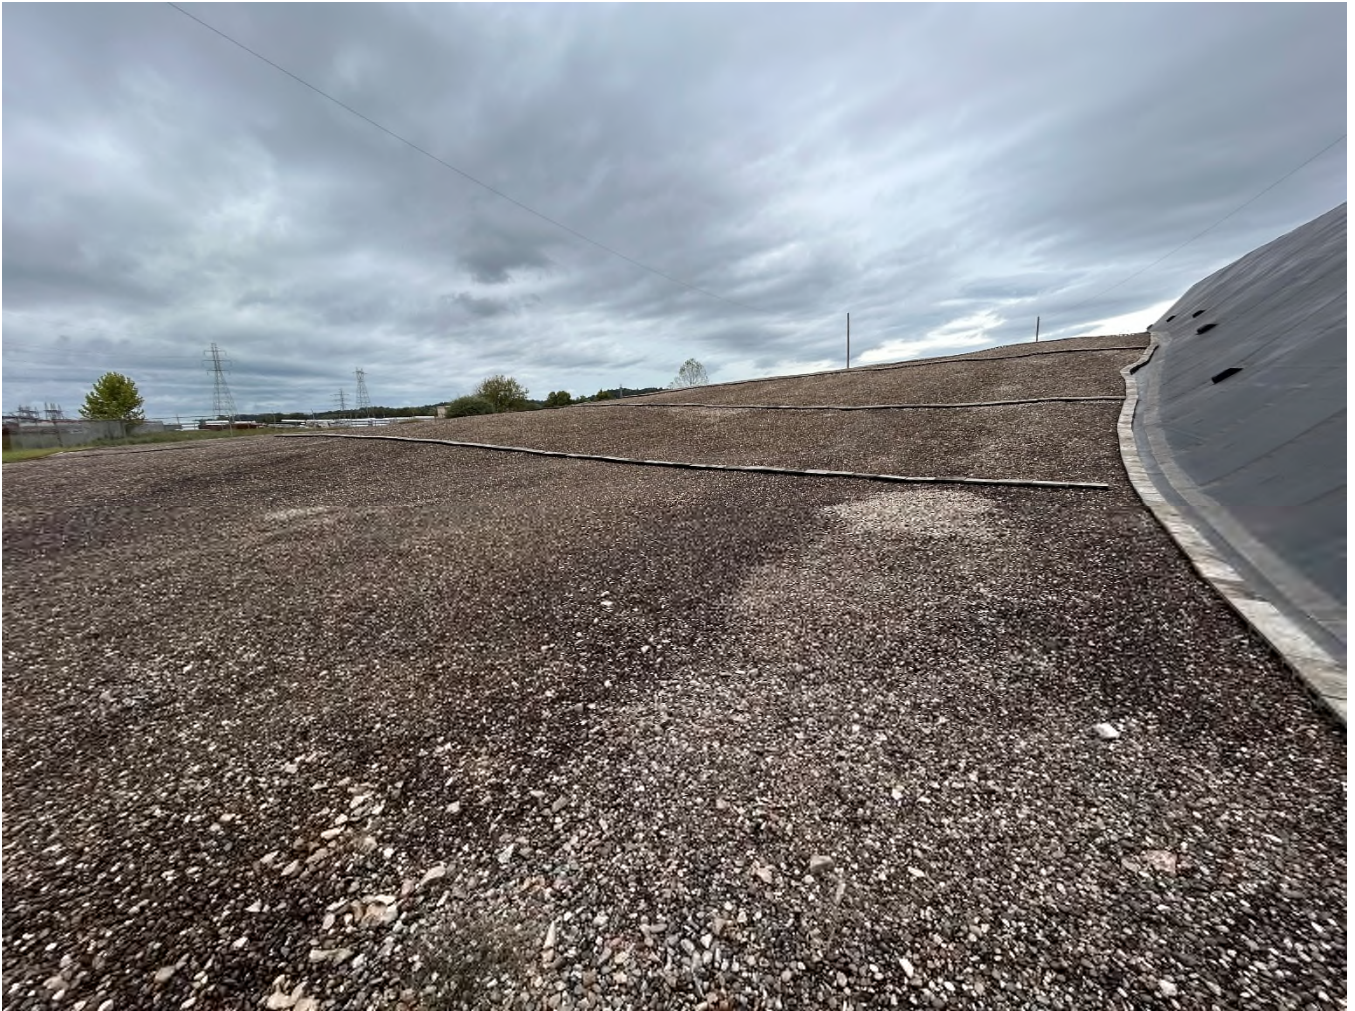
**Image 4:** Looking west near the mid-point of the eastern edge of the SPL Pile, where a steeply sloping EPDM cover goes under the gravel covering the less steep southern part of the pile. Linear features over the gravel are wooden walk boards to conduct inspections, and, if needed repair work.

**Image 4:** Looking west near the mid-point of the eastern edge of the SPL Pile, where a steeply sloping EPDM cover goes under the gravel covering the less steep southern part of the pile. Linear features over the gravel are cinder blocks to walk and conduct inspections, and, if needed repair work.

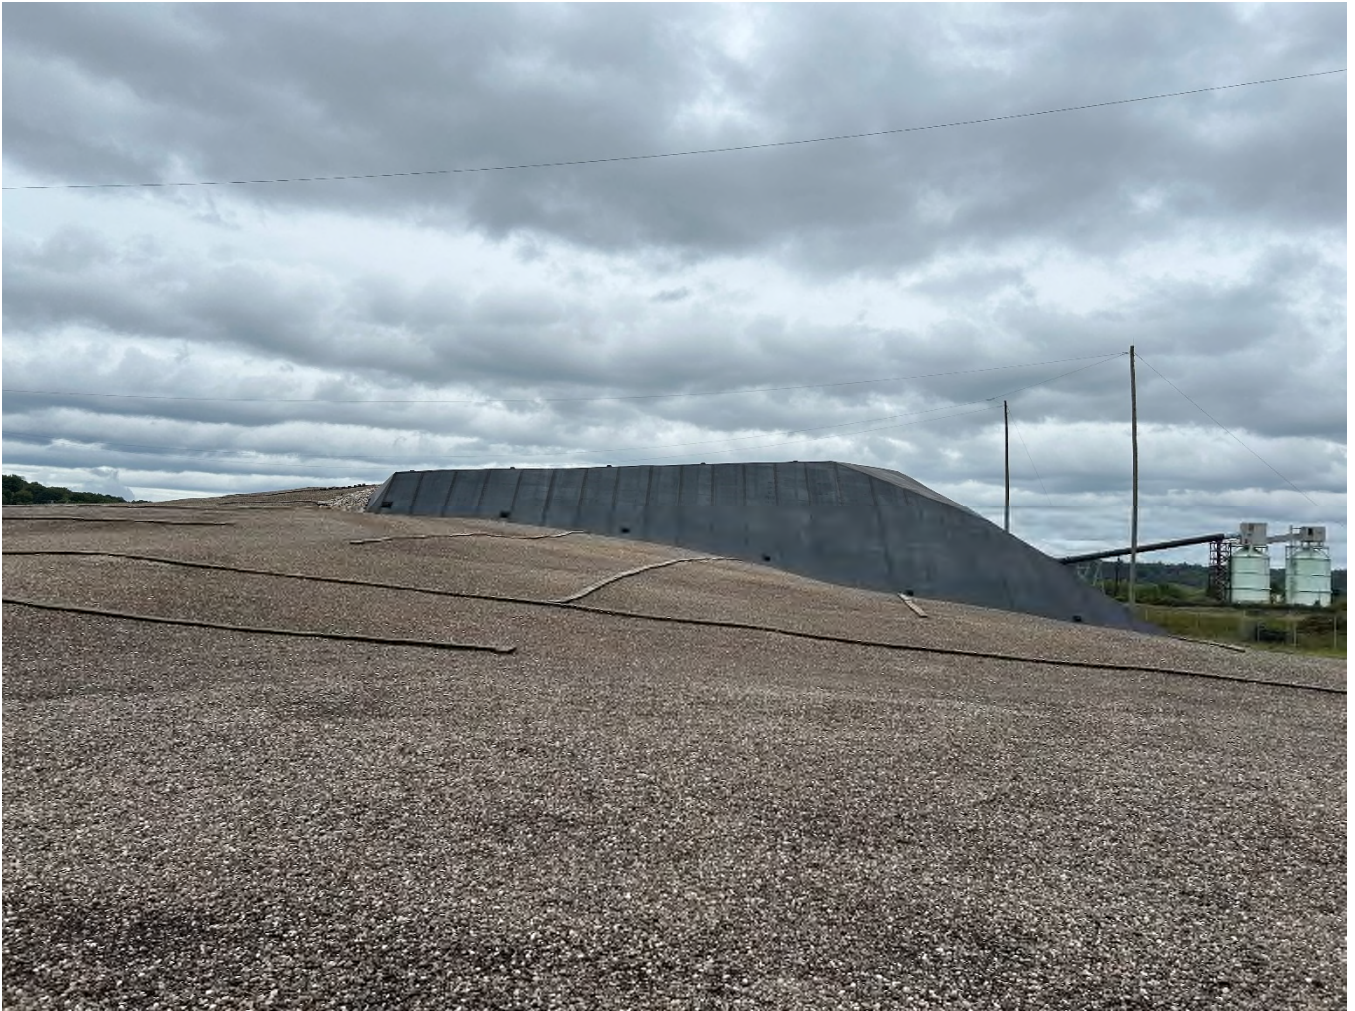
**Image 5:** Looking north near the southeastern corner of the SPL Pile; visible here the gravel covered gently sloping southeastern part and the southern half of the EPDM covered portion of the pile.

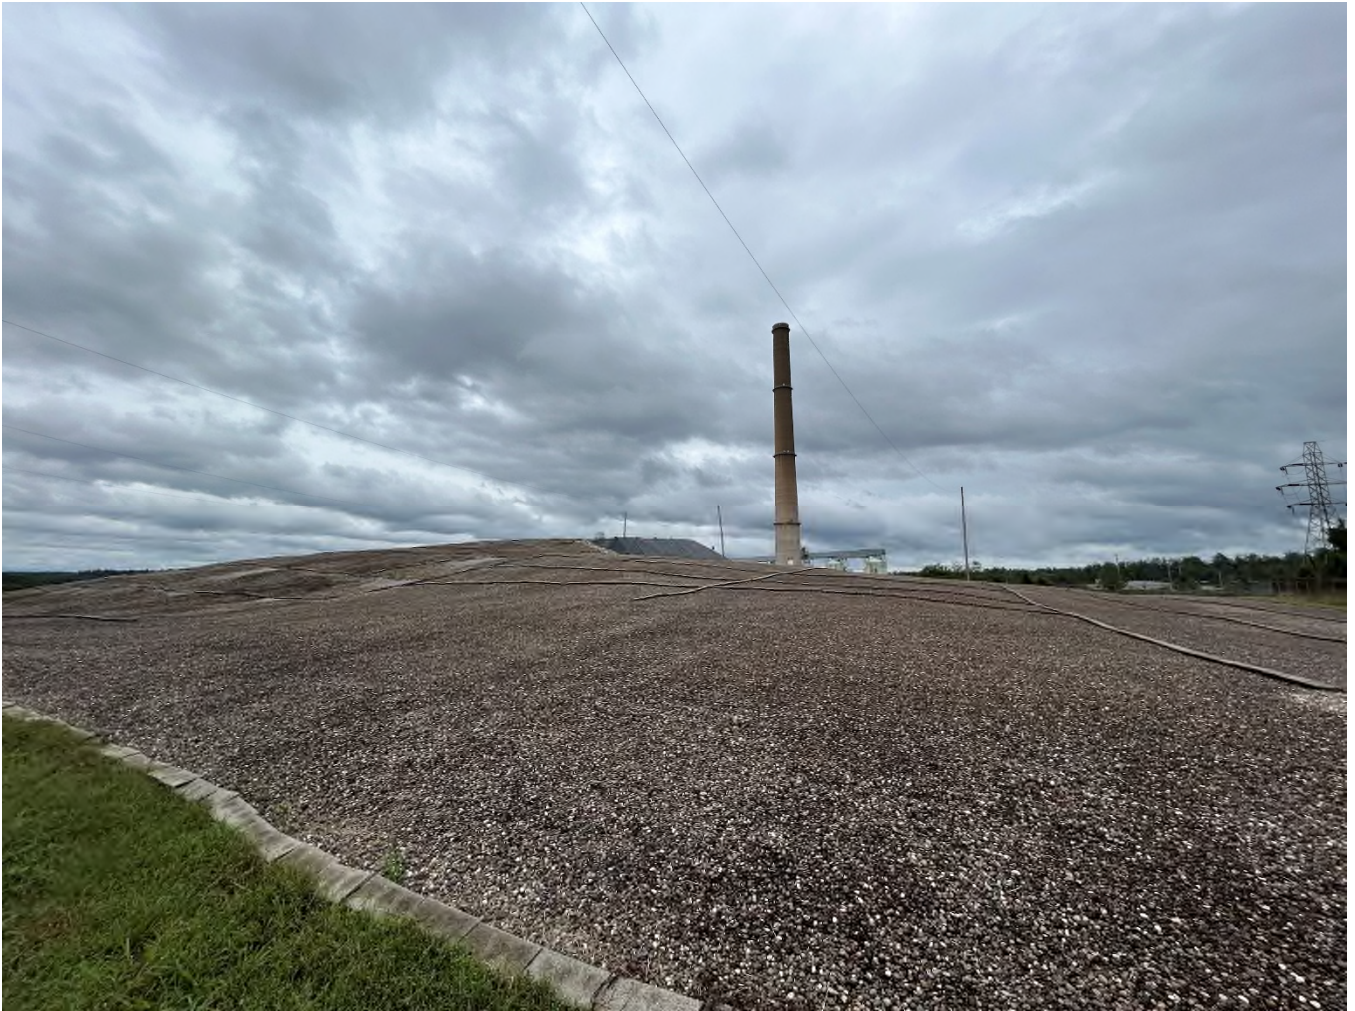
**Image 6:** Looking east over the gravel covered southern half of the of the SPL Pile.

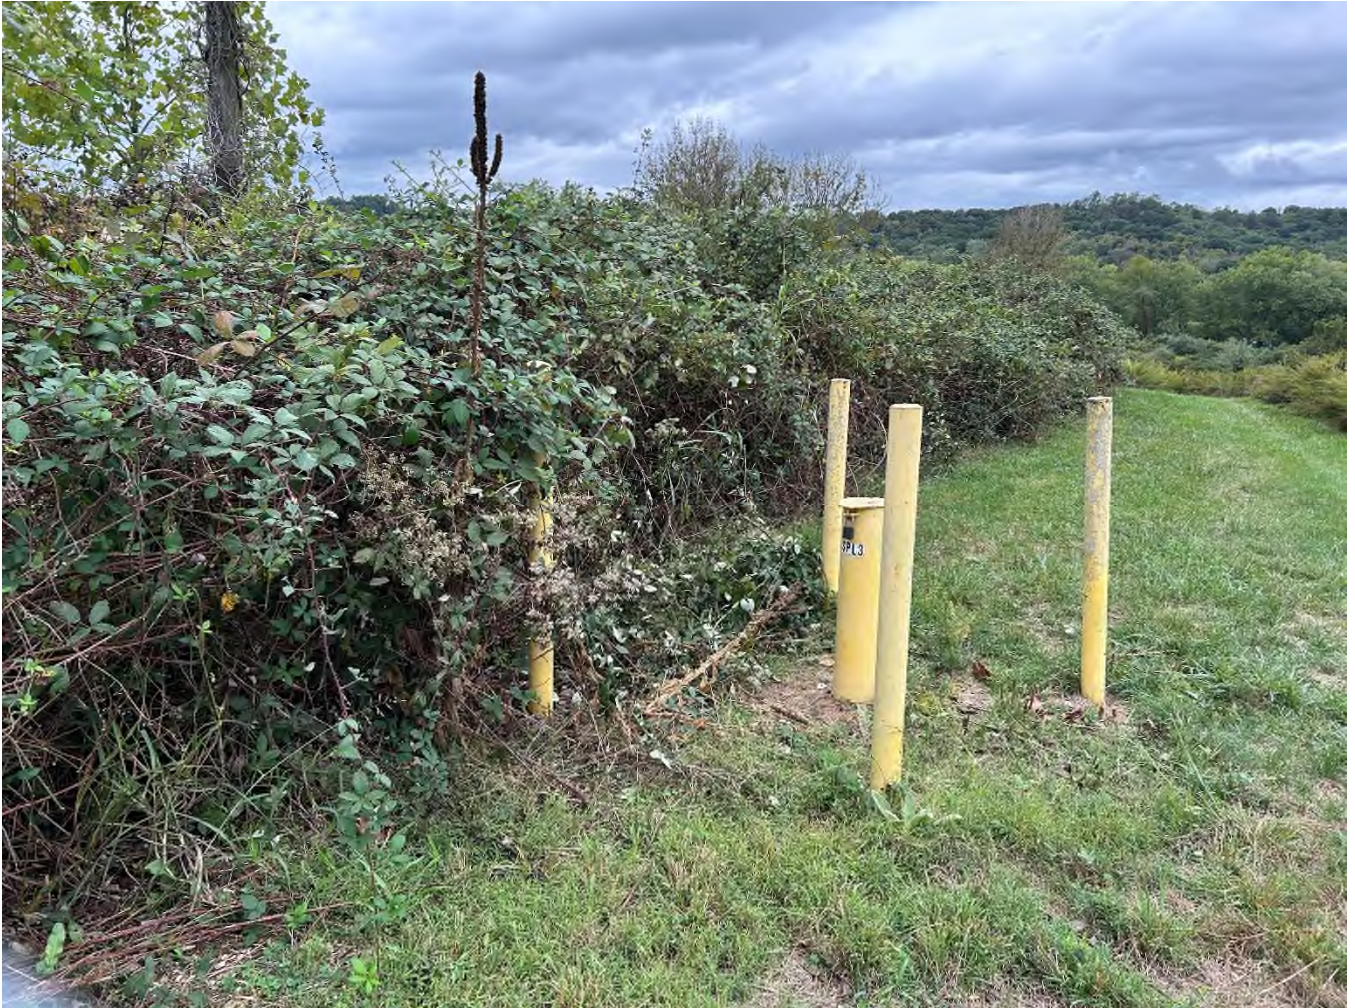
**Image 7:** Monitoring well SPL-3 and its vicinity.

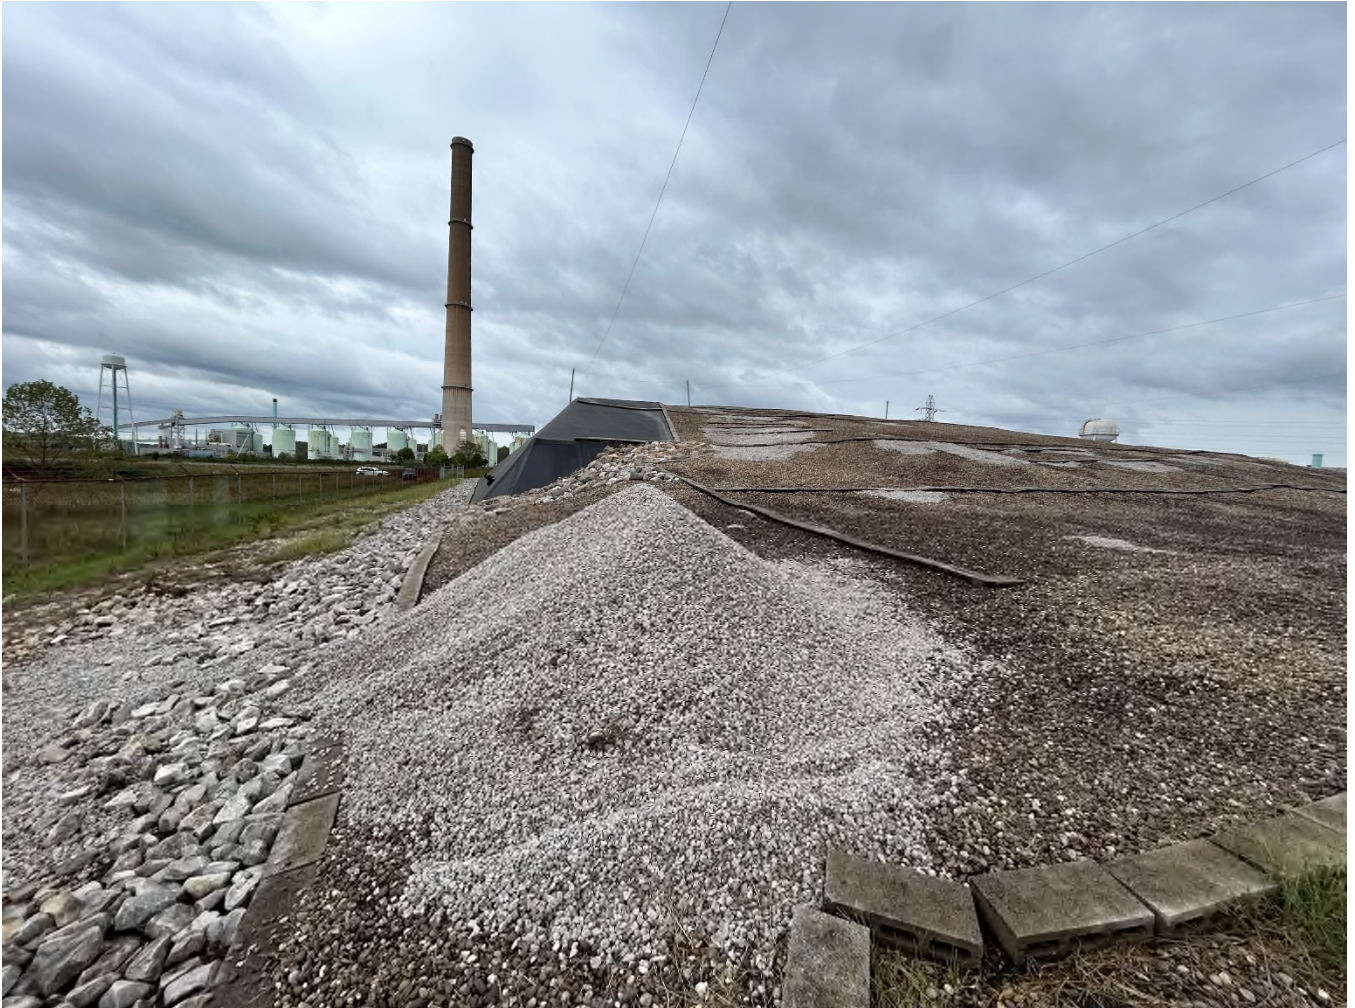
**Image 8:** Looking east near the northwest corner of the pile; river rock/gravel to use as fill between the washed out areas of the 4-6 inch rip rap rock at the foot of the SPL Pile. The 4-6 inch rip rap is used for water velocity reduction/water dissipation.

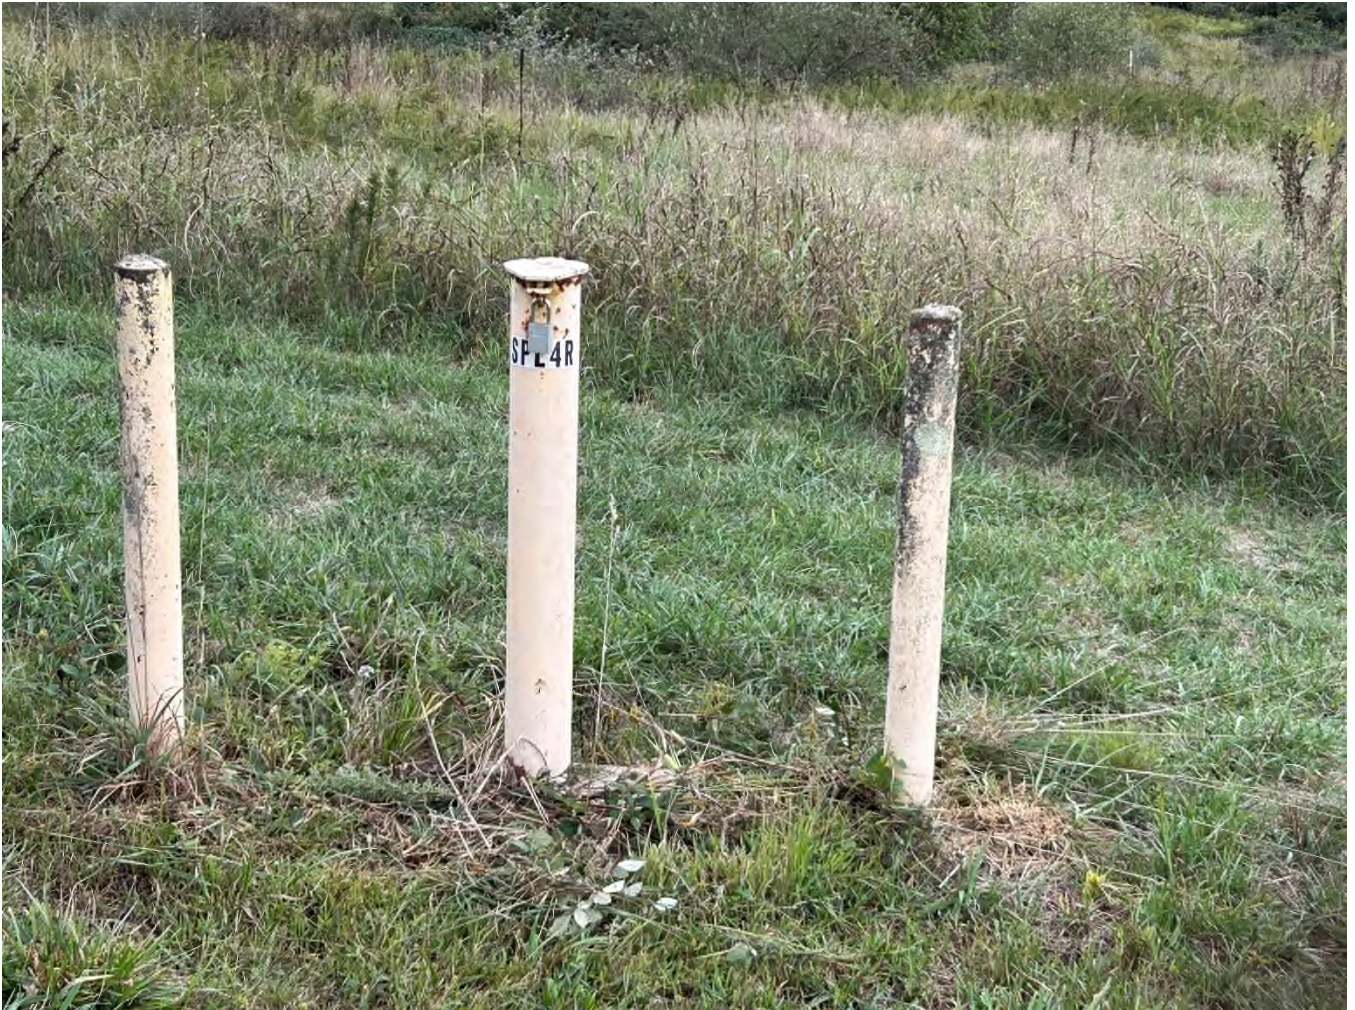
**Image 9:** Monitoring well SPL-4R and its vicinity, looking west.

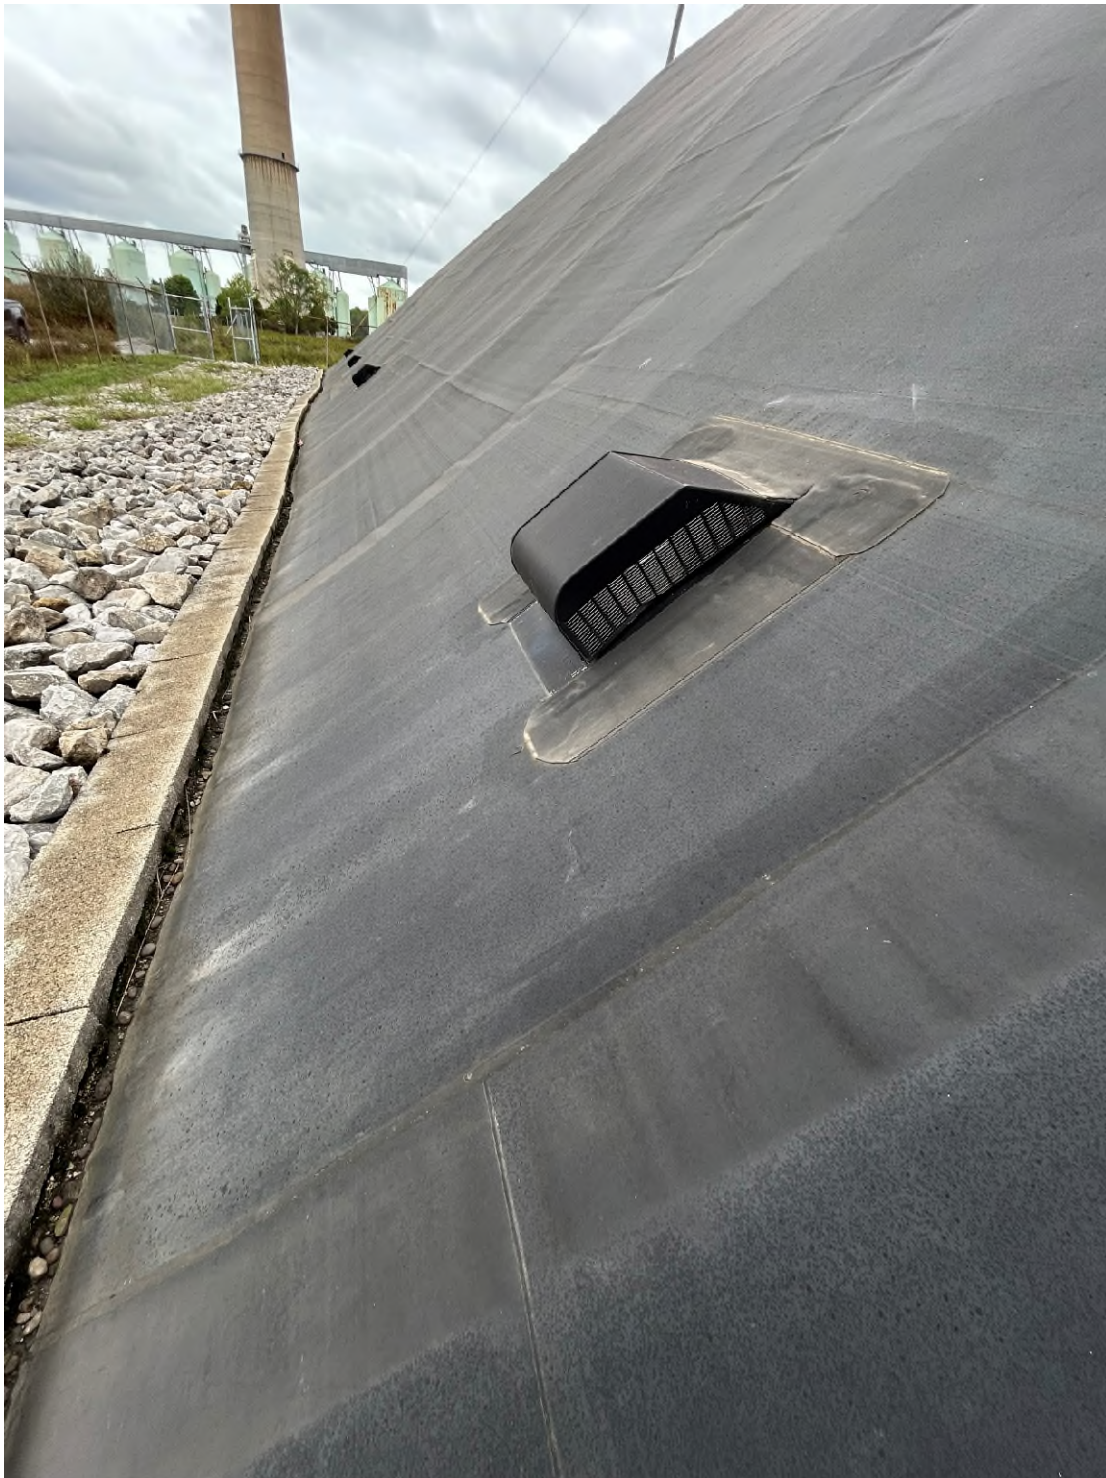
**Image 10:** Looking west along northern edge of the SPL Pile where the air vents are visible. Air vents were installed around the top and bottom perimeter of the wood substructure supporting the EPDM Cover. Also visible is the small rock/rip rap along the steep pile wall for water dissipation.
