Final Massachusetts Statewide Total Maximum Daily Load for Pathogen-Impaired Waterbodies

## **Appendix D: Deerfield River Basin**

December 2024

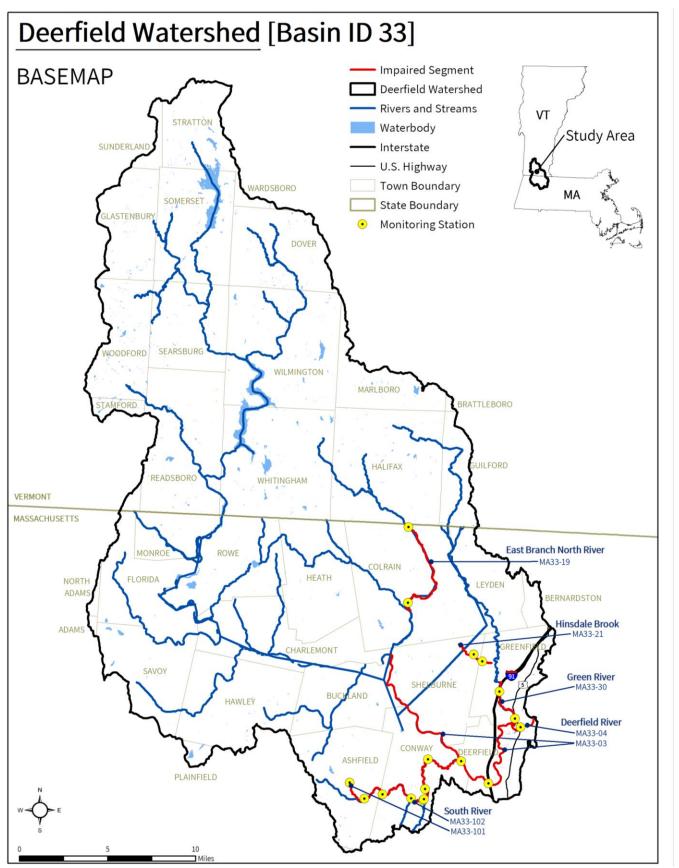
**Figure 2-1:** Map of all pathogen-impaired river segments, water quality monitoring stations, municipal borders, waterbodies, and roads in the Deerfield River watershed.

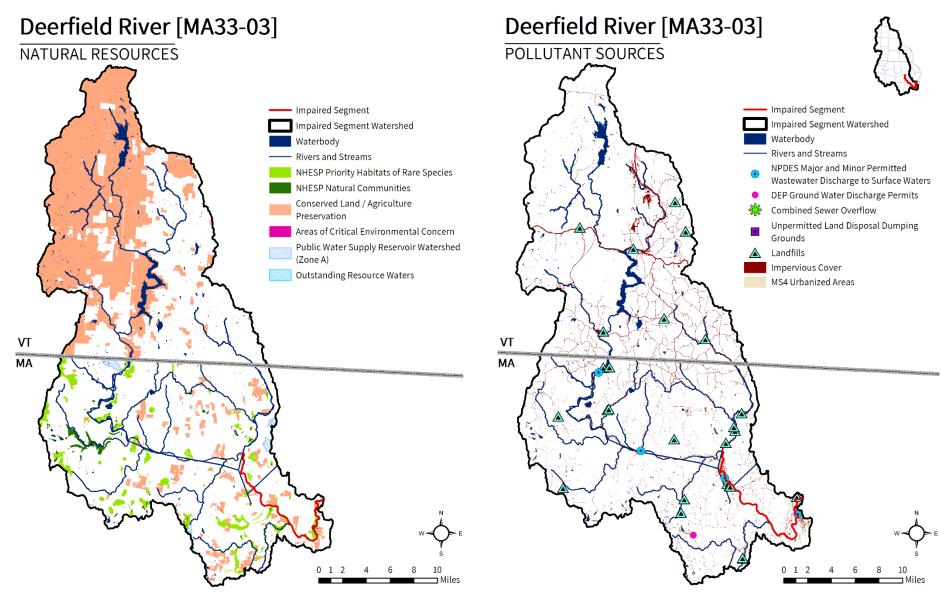
**Figure 3-1**. Natural resources and potential pollution sources draining to the Deerfield River segment MA33-03. The map on the left shows critical habitat, water features, and conserved land. The map on the right indicates potential and known pollution sources, including impervious cover, MS4 areas, and permitted facilities.

The watershed is partially<sup>1</sup> served by public sewer and <1% of the watershed is subject to stormwater regulations under the NPDES General MS4 Stormwater Permit (USEPA, 2020). There are four NPDES permits on file governing point source discharges of pollutants to surface waters within the MA portion of the watershed (Table 3-1), as well as one MassDEP discharge to groundwater permit for on-site wastewater discharge within the MA portion of the watershed but not the immediate drainage area. There are also no combined sewer overflows within the MA portion of the watershed, 26 landfills (19 landfills within MA), and no unpermitted land disposal dumping grounds within the MA portion of the watershed. See Figure 3-1.

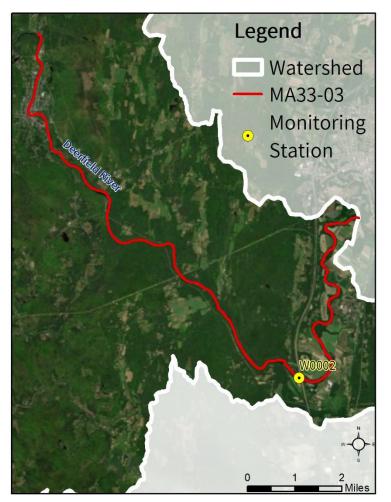
**Figure 3-2.** Location of monitoring station(s) along the impaired river segment.

In 2005, five samples were collected at W0002, resulting in three days when the 30day rolling geomean exceeded the criterion. Since there were no stations and years with more than 10 samples, the STV criterion was applied to single sample results. Out of five samples, three exceeded the STV criterion during both wet and dry weather.

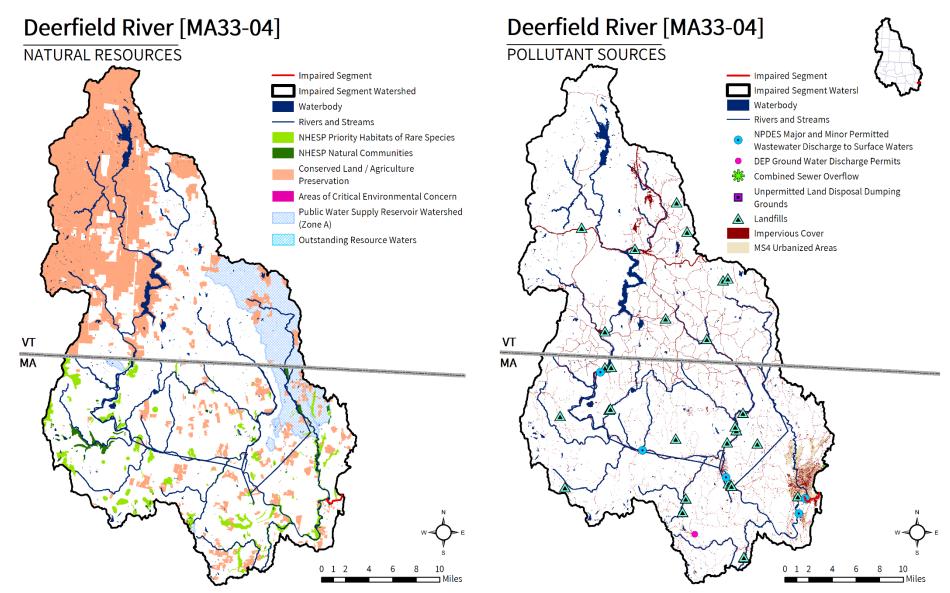
**Figure 4-1**. Natural resources and potential pollution sources draining to the Deerfield River segment MA33-04. The map on the left shows critical habitat, water features, and conserved land. The map on the right indicates potential and known pollution sources, including impervious cover, MS4 areas, and permitted facilities.

file governing point source discharges of pollutants to surface waters within the immediate MA drainage area and four additional NPDES permits within the entire watershed (Table 4-1). There is one MassDEP discharge to groundwater permit for on-site wastewater discharge within the watershed, though not within the immediate drainage area. There are no combined sewer overflows within the MA portion of the watershed, 29 landfills (20 landfills within MA), and no unpermitted land disposal dumping grounds within the MA portion of the watershed. See Figure 4-1.

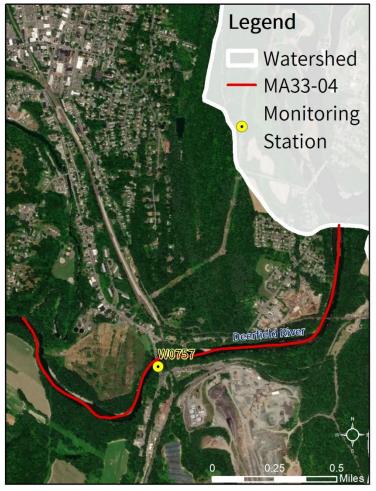
**Figure 4-2.** Location of monitoring station(s) along the impaired river segment.

In 2005, five samples were collected at W0757, resulting in four days when the 30day rolling geomean exceeded the criterion. Since there were no stations and years with more than 10 samples, the STV criterion was applied to single sample results. Out of five samples, two exceeded the STV criterion during dry weather.

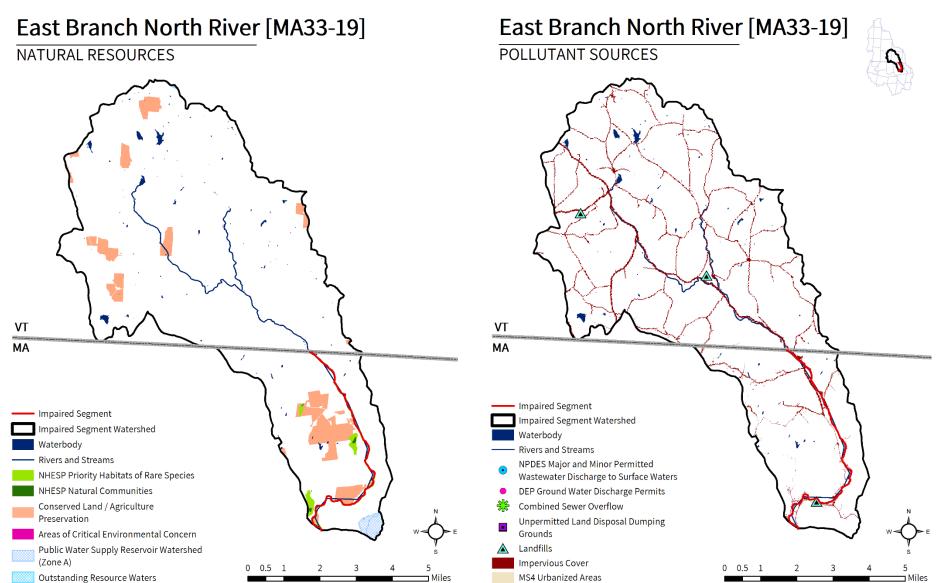
**Figure 5-1**. Natural resources and potential pollution sources draining to the East Branch North River segment MA33-19. The map on the left shows critical habitat, water features, and conserved land. The map on the right indicates potential and known pollution sources, including impervious cover, MS4 areas, and permitted facilities.

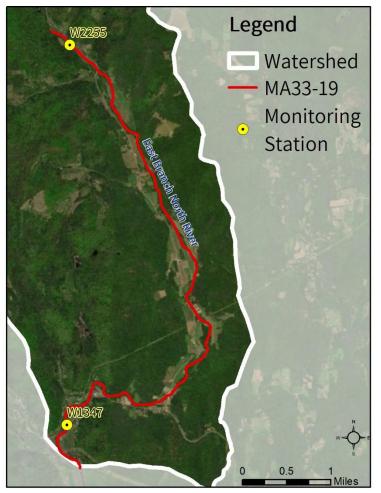
**Figure 5-2.** Location of monitoring station(s) along the impaired river segment.

- In 2005, six samples were collected at NOR-004, resulting in no days when the 90-day rolling geomean exceeded the criterion. Since there were no stations and years with more than 10 samples, the STV criterion was applied to single sample results. Out of six samples, one exceeded the STV criterion during dry weather.
- From 2005-2007, 18 samples were collected at NOR-005, resulting in 13 days when the 90-day rolling geomean exceeded the criterion. Since there were no stations

and years with more than 10 samples, the STV criterion was applied to single sample results. Out of 18 samples, five exceeded the STV criterion during dry weather.

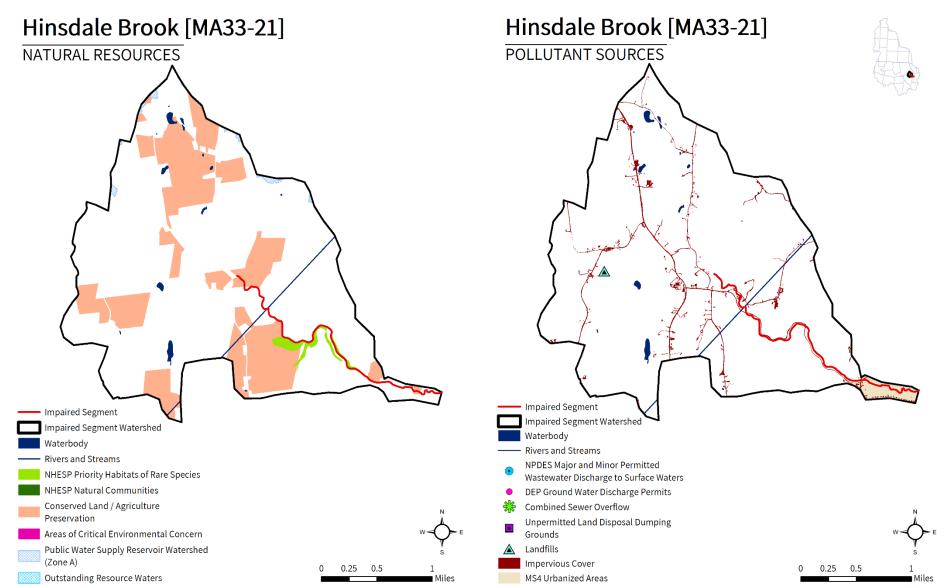
**Figure 6-1**. Natural resources and potential pollution sources draining to the Hinsdale Brook segment MA33-21. The map on the left shows critical habitat, water features, and conserved land. The map on the right indicates potential and known pollution sources, including impervious cover, MS4 areas, and permitted facilities.

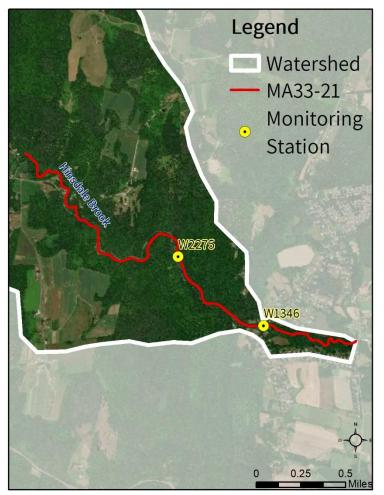
**Figure 6-2.** Location of monitoring station(s) along the impaired river segment.

- In 2005, five samples were collected at W1346, resulting in three days when the 90day rolling geomean exceeded the criterion. Since there were no stations and years with more than 10 samples, the STV criterion was applied to single sample results. Out of five samples, one exceeded the STV criterion during dry weather.
- In 2012, six samples were collected at W2275, resulting in no days when the 90day rolling geomean exceeded the criterion. Since there were no stations and years with more than 10 samples, the STV criterion was applied to single sample results. Out of six samples, none exceeded the STV criterion.

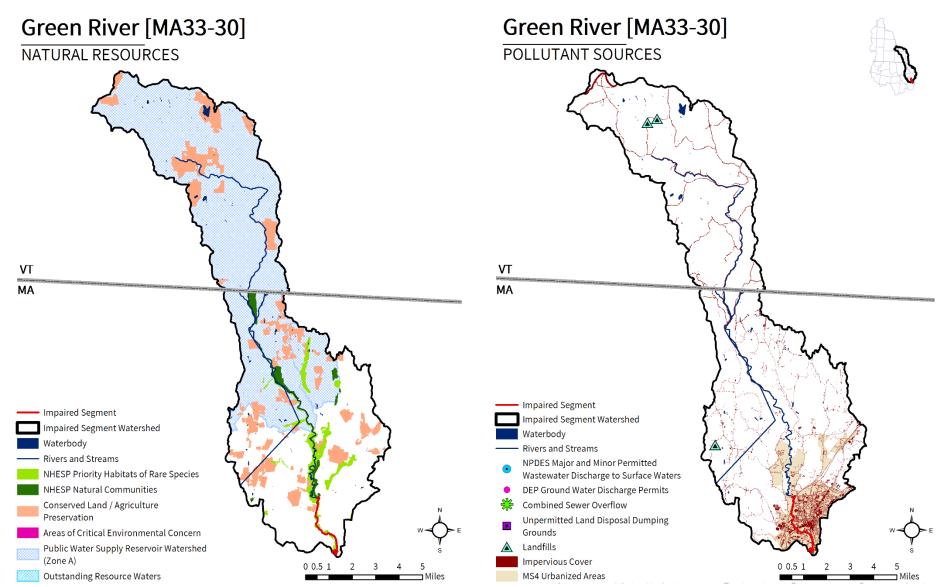
**Figure 7-1**. Natural resources and potential pollution sources draining to the Green River segment MA33-30. The map on the left shows critical habitat, water features, and conserved land. The map on the right indicates potential and known pollution sources, including impervious cover, MS4 areas, and permitted facilities.

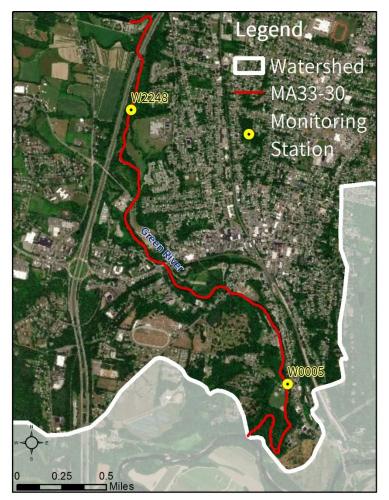
**Figure 7-2.** Location of monitoring station(s) along the impaired river segment.

- In 2005, five samples were collected at W0005, resulting in four days when the 90day rolling geomean exceeded the criterion. Since there were no stations and years with more than 10 samples, the STV criterion was applied to single sample results. Out of five samples, four exceeded the STV criterion during wet and dry weather.
- In 2012, six samples were collected at W2248, resulting in four days when the 90day rolling geomean exceeded the criterion. Since there were no stations and years with more than 10 samples, the STV criterion was applied to single sample results. Out of six samples, two exceeded the STV criterion during wet and dry weather.

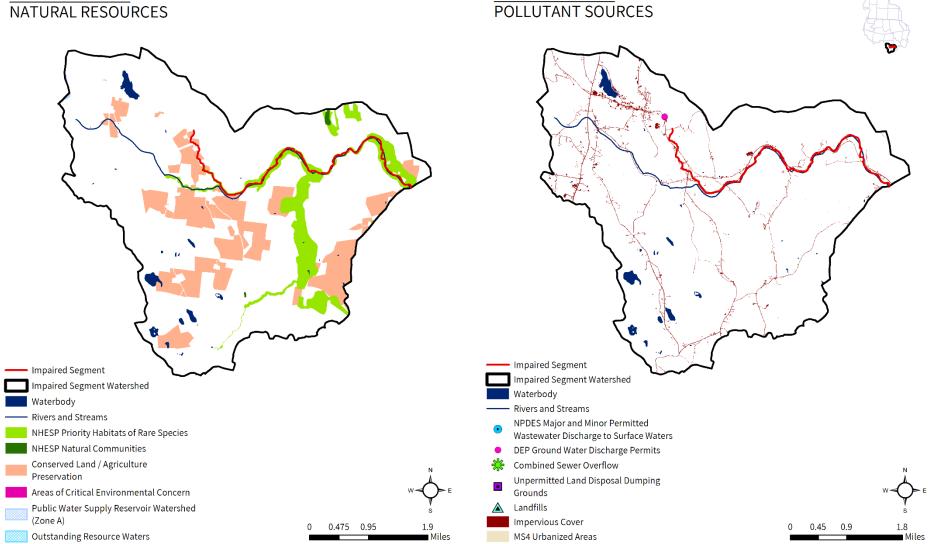
South River [MA33-101]

Figure 8-1. Natural resources and potential pollution sources draining to the South River segment MA33-101. The map on the left shows critical habitat, water features, and conserved land. The map on the right indicates potential and known pollution sources, including impervious cover, MS4 areas, and permitted facilities.

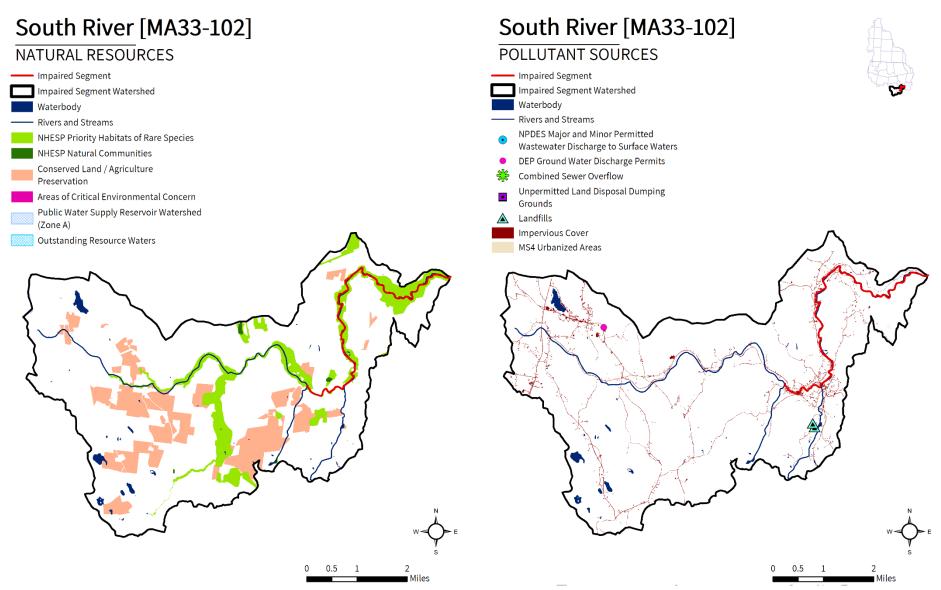
**Figure 9-1**. Natural resources and potential pollution sources draining to the South River segment MA33-102. The map on the left shows critical habitat, water features, and conserved land. The map on the right indicates potential and known pollution sources, including impervious cover, MS4 areas, and permitted facilities.

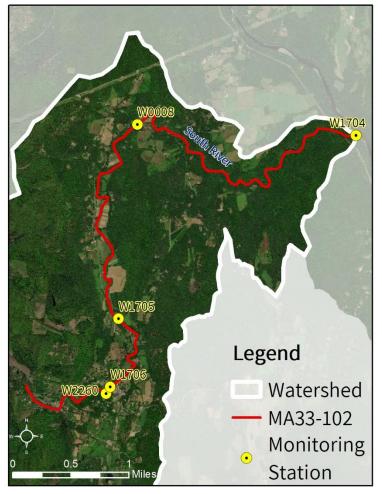
**Figure 9-2.** Location of monitoring station(s) along the impaired river segment.

- In 2005, six samples were collected at SOR-001, resulting in three days when the 90-day rolling geomean exceeded the criterion. Since there were no stations and years with more than 10 samples, the STV criterion was applied to single sample results. Out of six samples, one exceeded the STV criterion during dry weather.
- In 2005, six samples were collected at SOR-002, resulting in five days when the 90-day rolling geomean exceeded the criterion. Since there were no stations and years with more than 10 samples, the STV criterion was applied to single sample results. Out of six samples, three exceeded the STV criterion during dry weather.

- In 2006, seven samples were collected at SOR-002A, resulting in five days when the 90-day rolling geomean exceeded the criterion. Since there were no stations and years with more than 10 samples, the STV criterion was applied to single sample results. Out of seven samples, one exceeded the STV criterion during wet weather.
