Date: January 17, 2023
Our Ref: 30123419
Subject: Temporary Consolidation Waste Pile Regrading Completion Report 2022
Location: Haystack Mines Site; McKinley County, New Mexico

Attachment 1 – Photograph Log
Temporary Consolidation Waste Pile Regrading Completion Report 2022
Haystack Mines Site
Baca/Prewitt Chapter, Navajo Nation
McKinley County, New Mexico

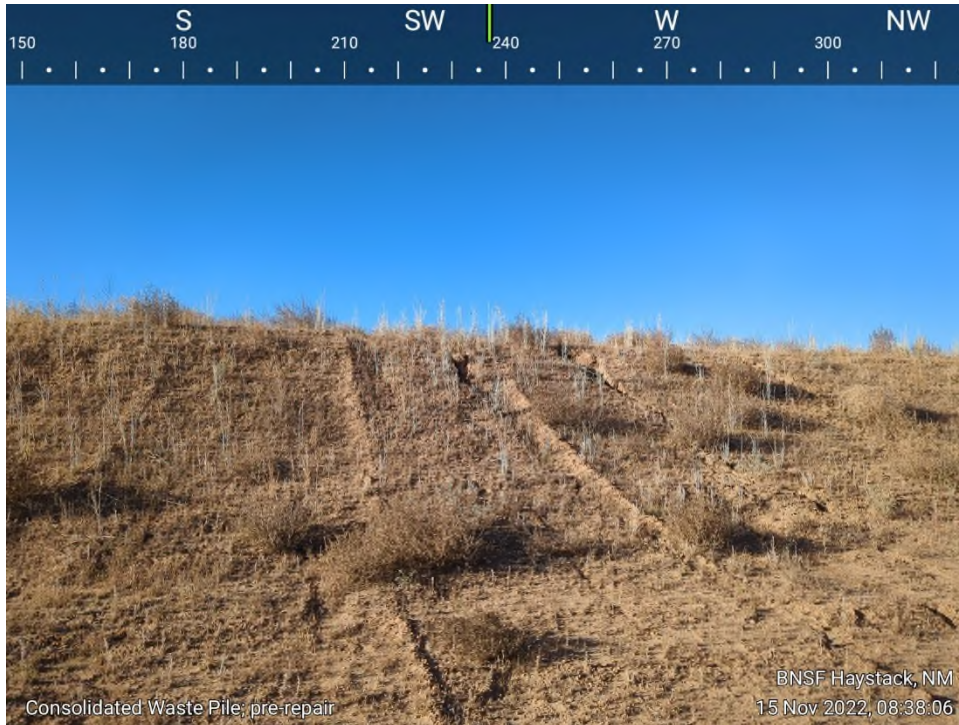
Photograph: 1

Description:
Pre-repair work

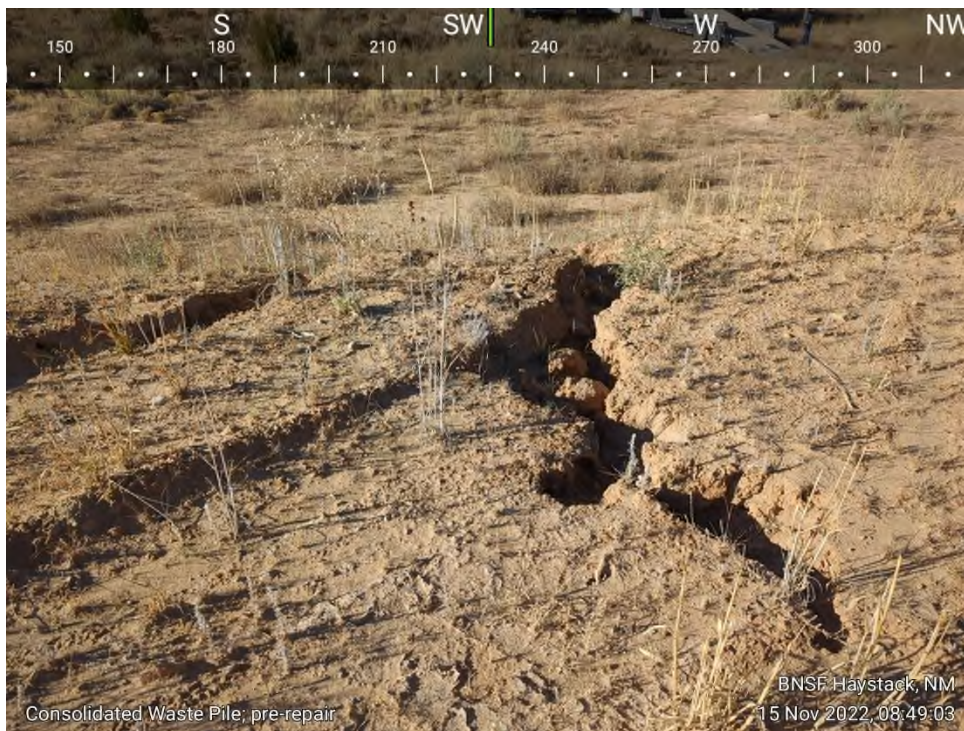
Photograph: 2

Description:
Pre-repair work

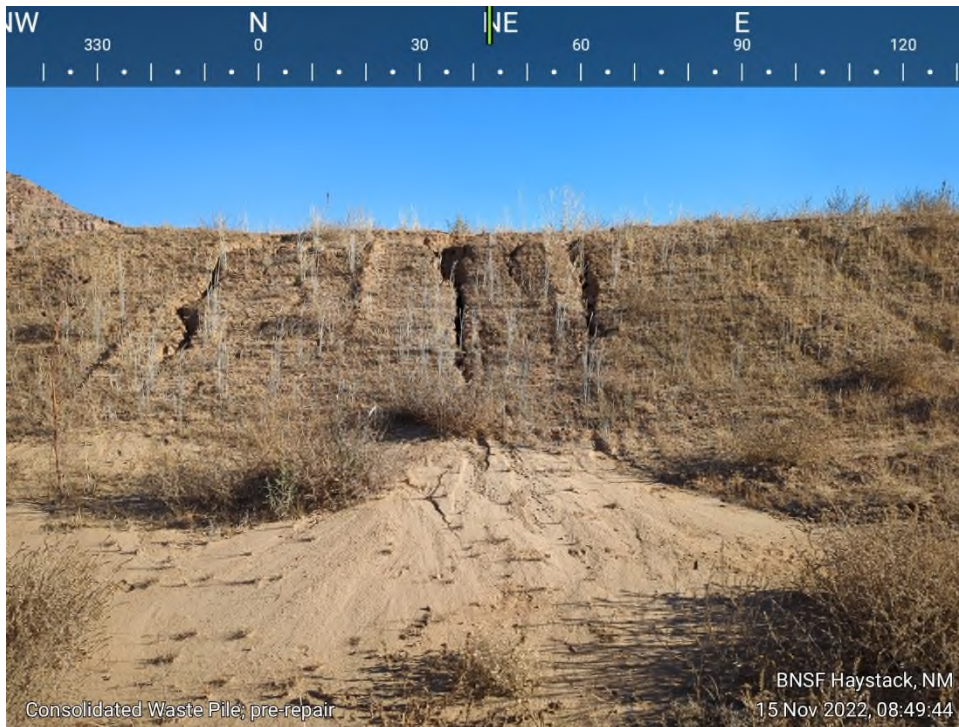
Photograph: 3

Description:
Pre-repair work

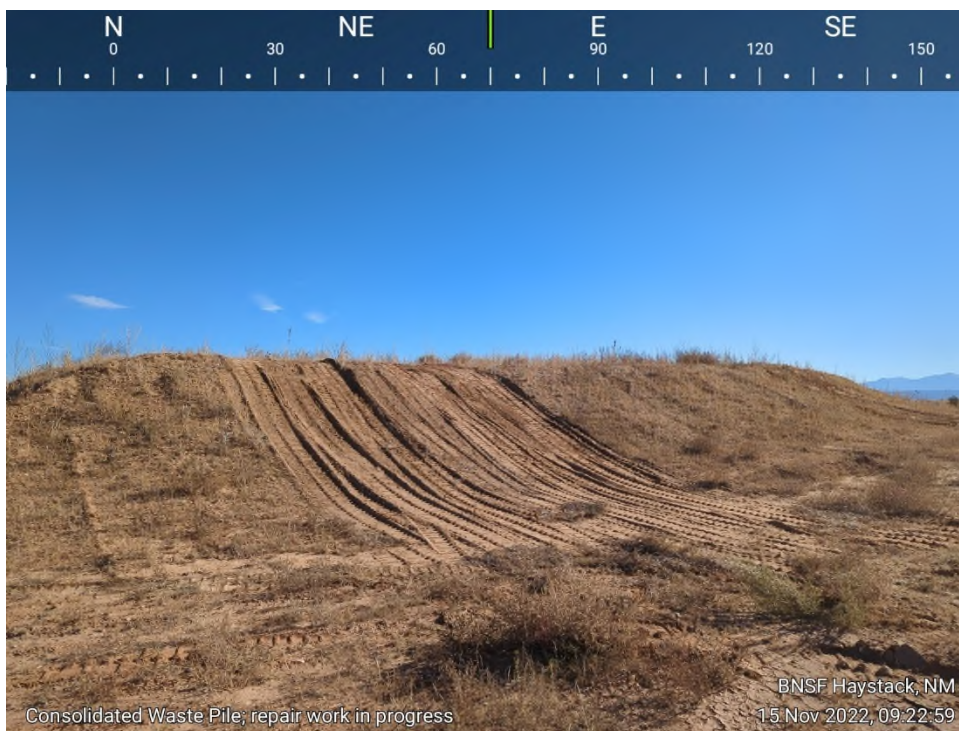
Photograph: 4

Description:
Erosional rills repaired

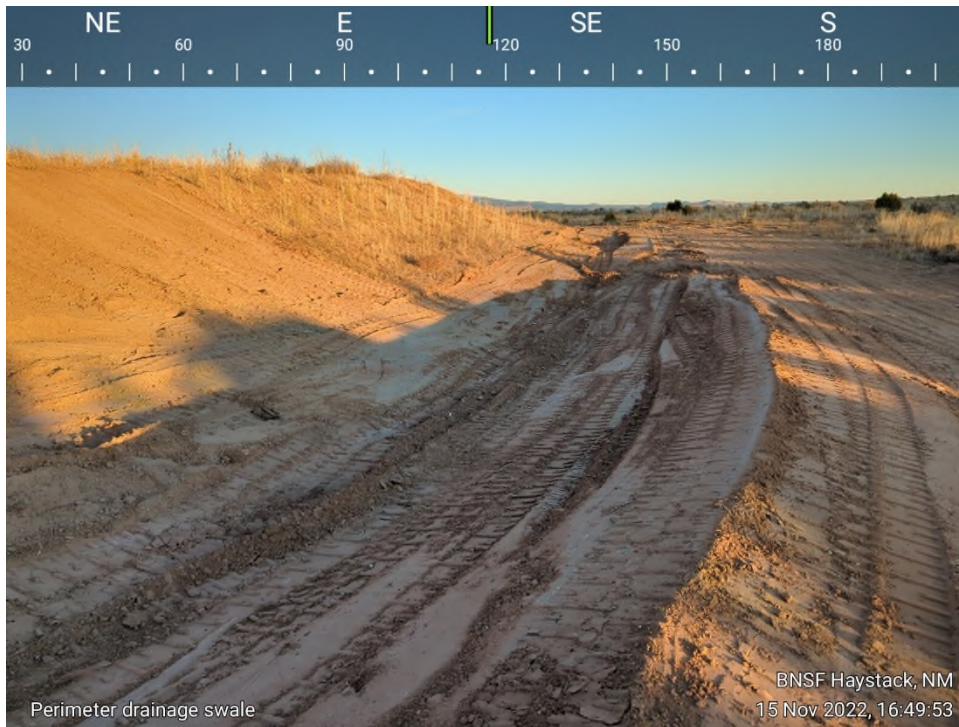
Photograph: 5

Description:
Perimeter drainage
swale

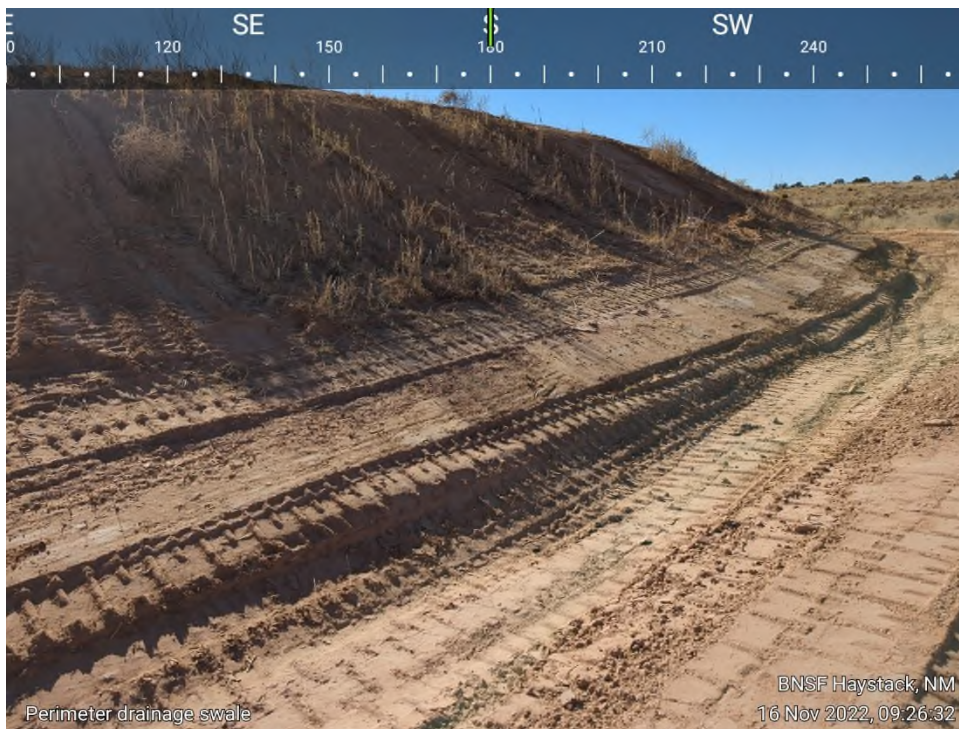
Photograph: 6

Description:
Perimeter drainage
swale

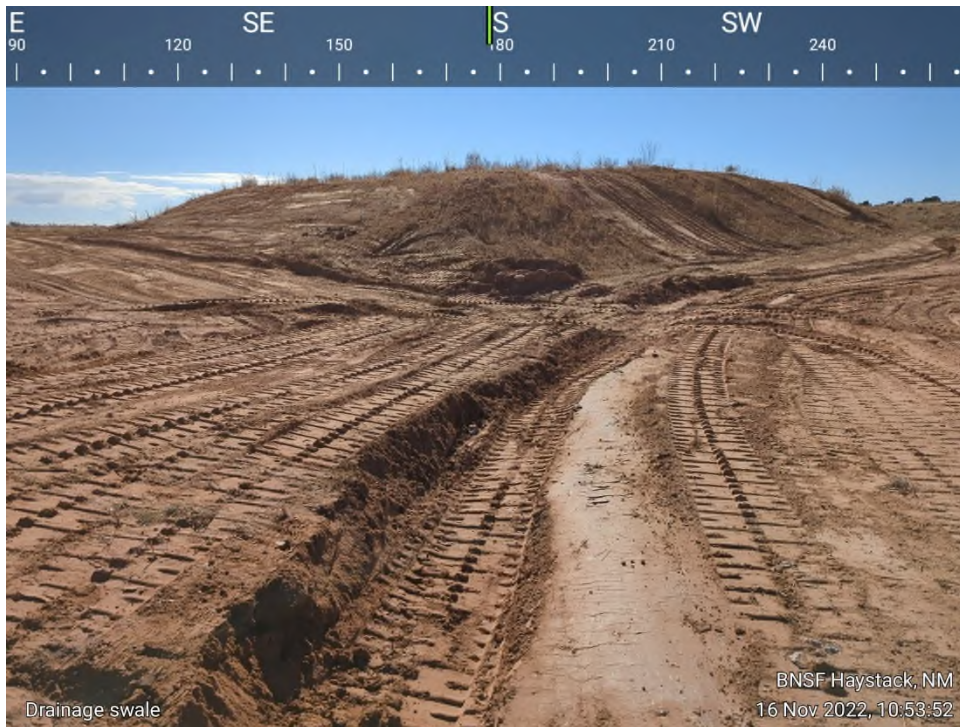
Photograph: 7

Drainage swale from
Temporary
Consolidated Waste
Pile to sediment basin

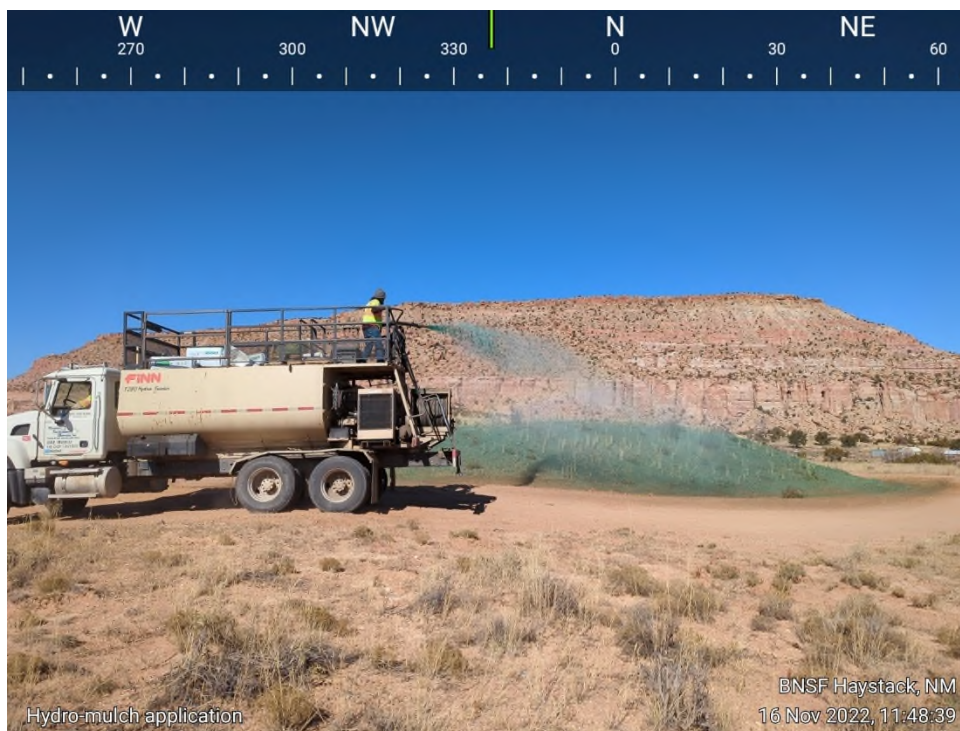
Photograph: 8

Hydro-mulch
application

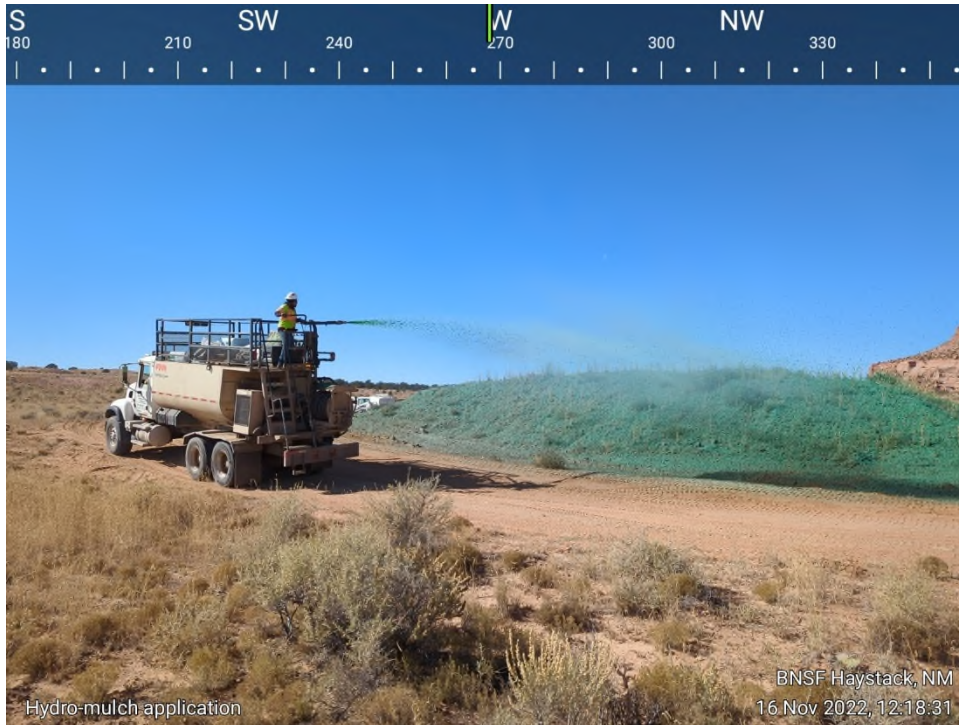
Photograph: 9

Description:
Hydro-mulch
application

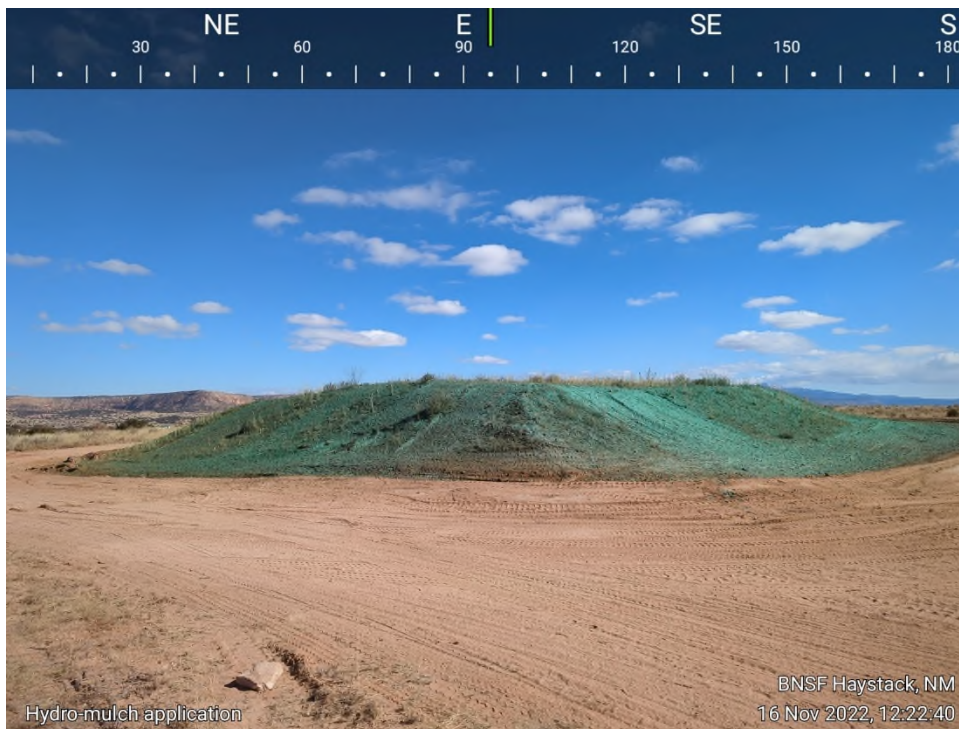
Photograph: 10

Description:
Hydro-mulch
application

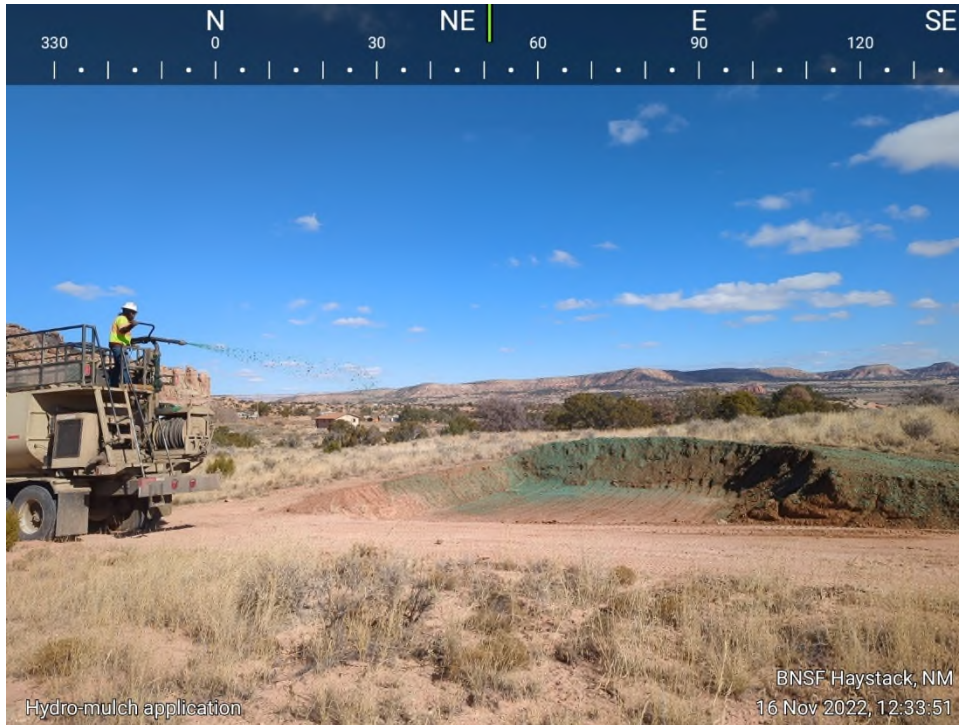
Photograph: 11

Description:
Hydro-mulch
application at sediment
basin

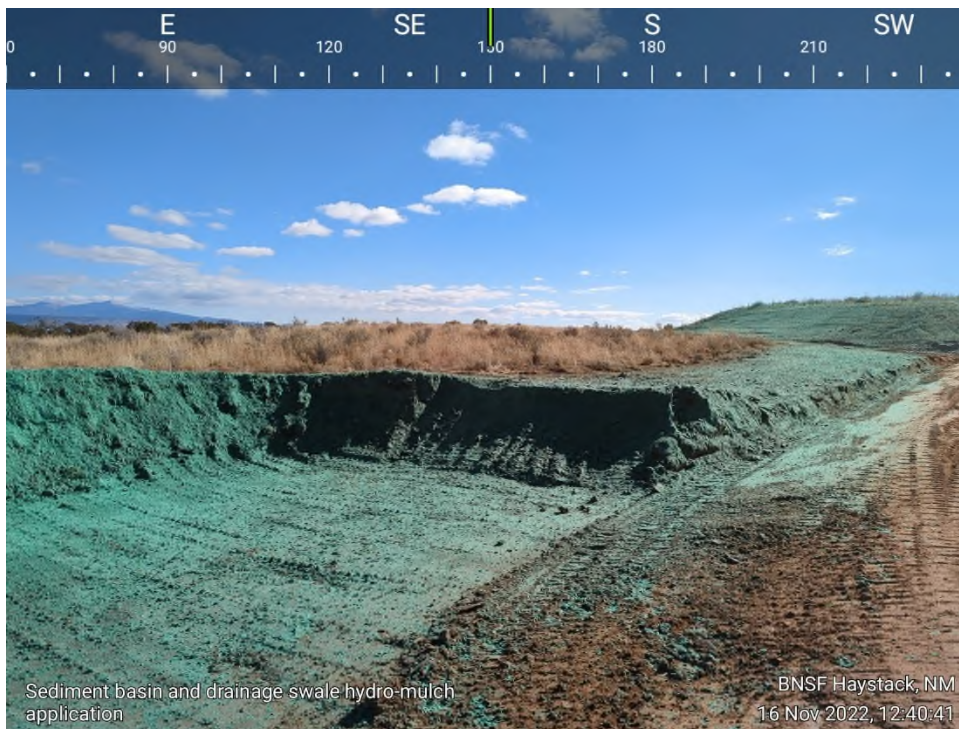
Photograph: 12

Description:
Hydro-mulch
application at sediment
basin

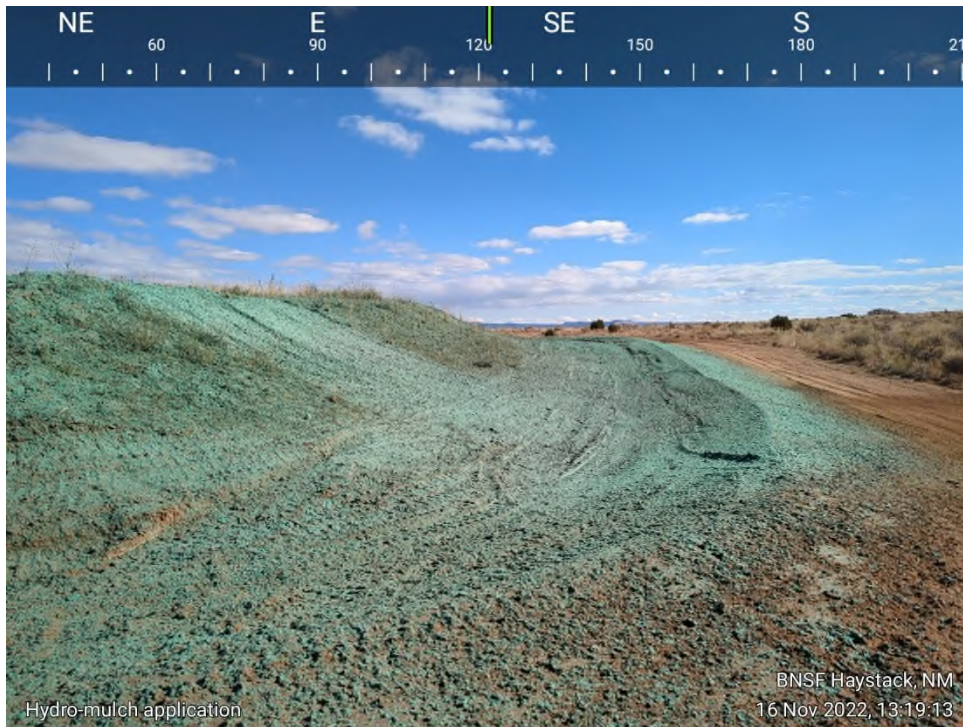
Photograph: 13

Description:
Hydro-mulch
application at perimeter
drainage swale

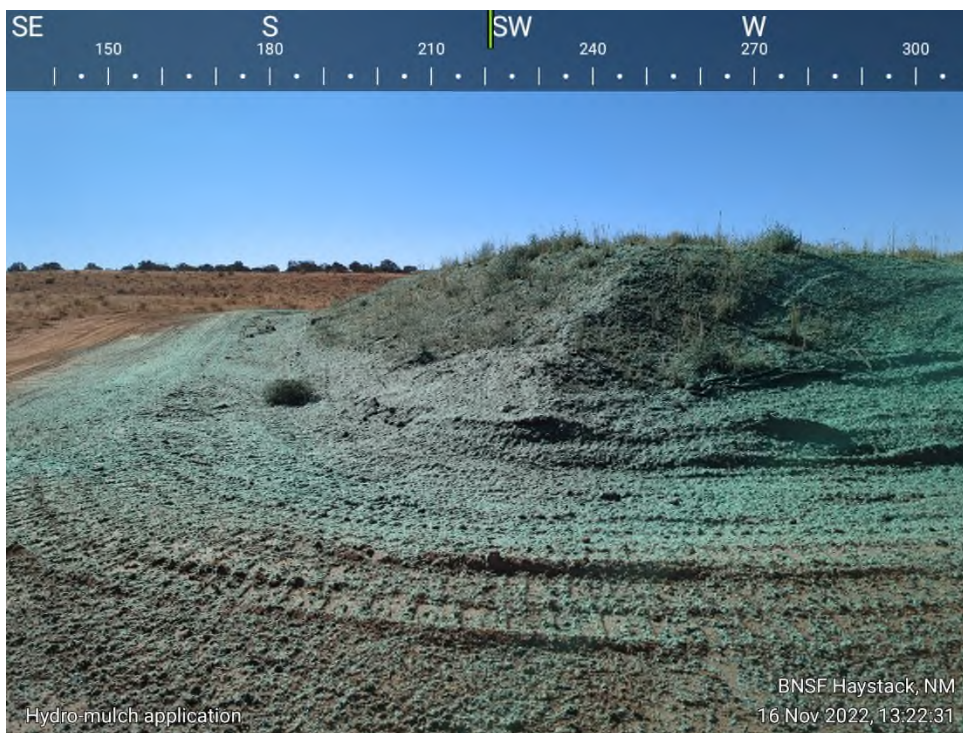
Photograph: 14

Description:
Hydro-mulch
application at perimeter
drainage swale

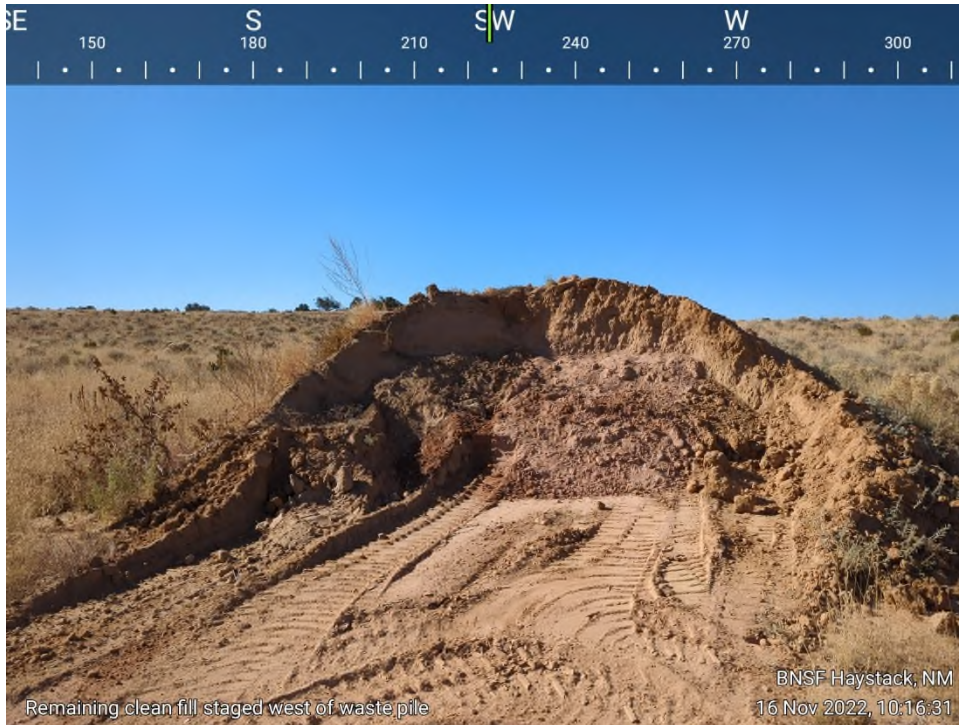
Photograph: 15

Leftover clean fill soil
staged west of
Temporary
Consolidated Waste
Pile
