**REMOVAL ASSESSMENT REPORT**  
**ABANDONED URANIUM MINE SITES**  
**HAYSTACK NO.1, SECTION 24, AND BIBO TRESPASS**

**Navajo Nation, Baca/Haystack Chapter, McKinley County, New Mexico**

**June 2015**

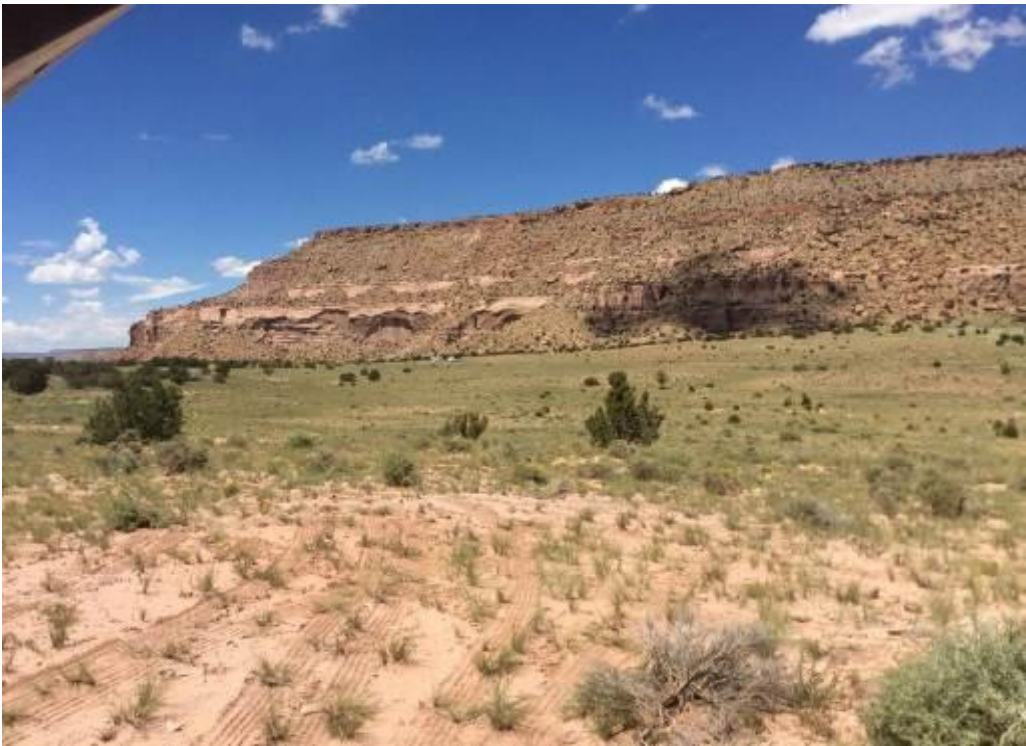
| <b>Photo No.</b><br><b>1</b> | <b>Date:</b><br>8/16/2014 | | |

| <b>Description:</b><br><br>Haystack No. 1 Abandoned Uranium Mine (AUM), site overview | | | |

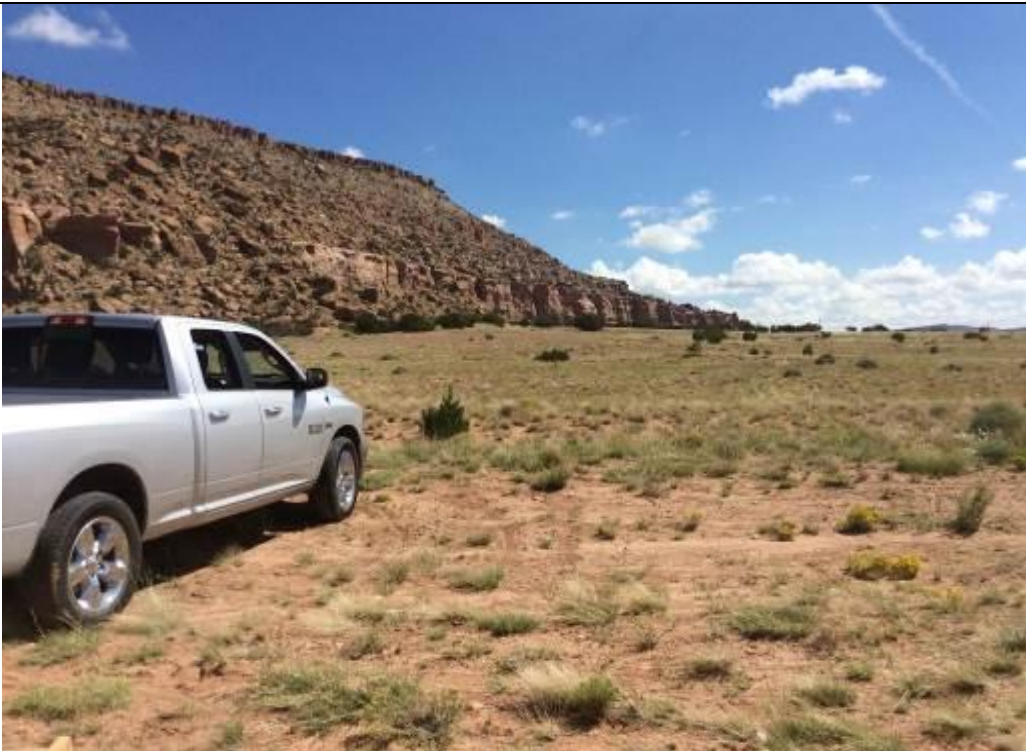
| <b>Photo No.</b><br><b>2</b> | <b>Date:</b><br>8/12/2014 | |

- Bibo Trespass AUM: A historical pit was located in the southeast corner of the AUM, and elevated gamma activity levels were found highest along the dirt road transecting the site, more than five times the naturally-occurring background levels;

| <b>Description:</b><br><br>Bibo Trespass AUM, site overview | | |

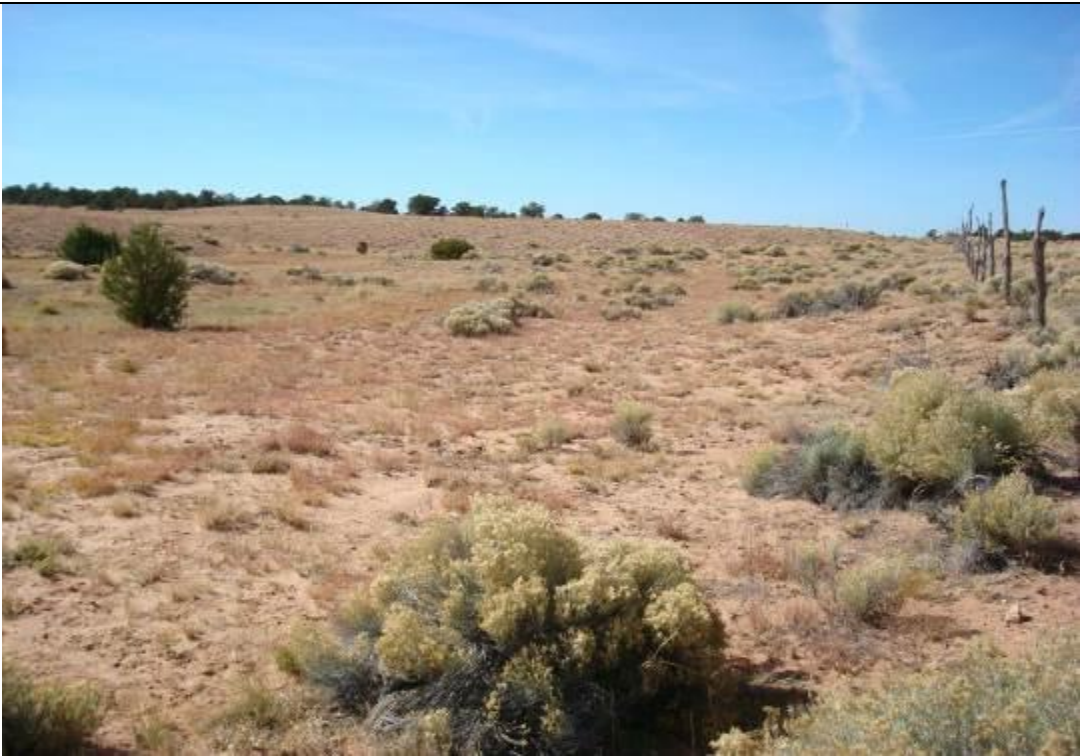
| <b>Photo No.</b><br><b>3</b> | <b>Date:</b><br>8/12/2014 | |

- Section 24 AUM: Historical workings were found in the northeast portion of the AUM, and elevated gamma activity and graded soil was found across the site, including levels measured at more than 25 times the naturally-occurring background levels. A fence runs the entire length of the northern and eastern boundaries, and radiological hazard signs are posted throughout the site;

| <b>Description:</b><br><br>Section 24 AUM, site overview | | |

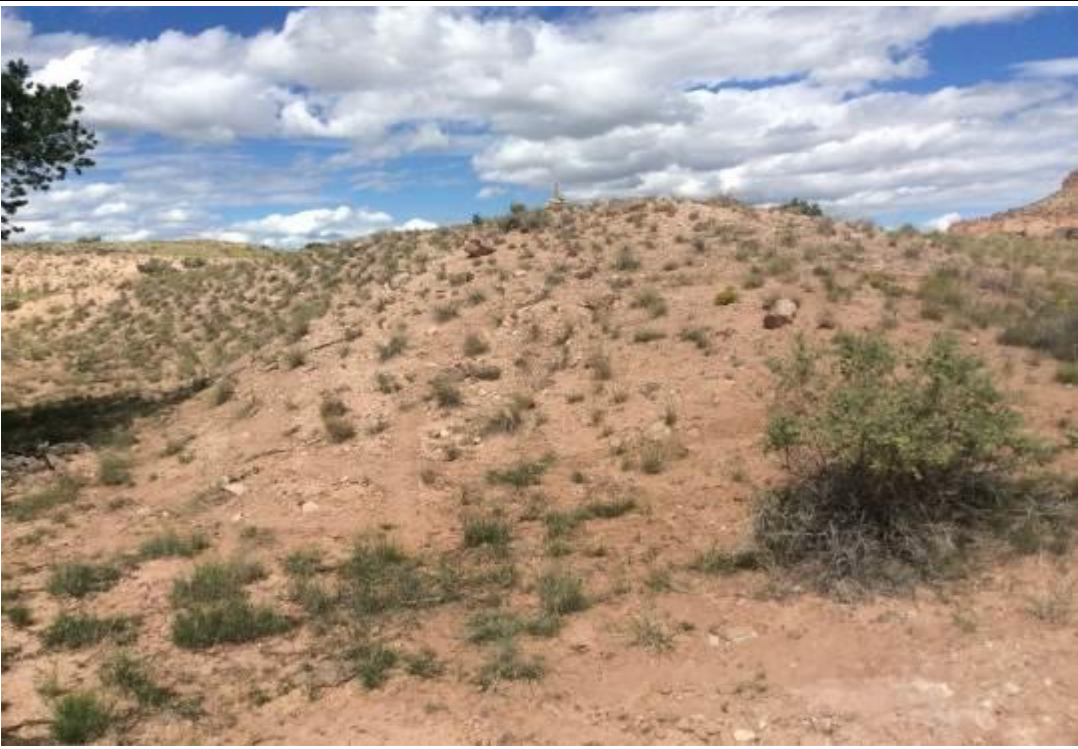
| <b>Photo No.</b><br><b>12</b> | <b>Date:</b><br>8/17/2014 | |

| <b>Description:</b><br><br>Haystack No. 1 AUM,<br>subsurface boring location,<br>waste rock pile | | |

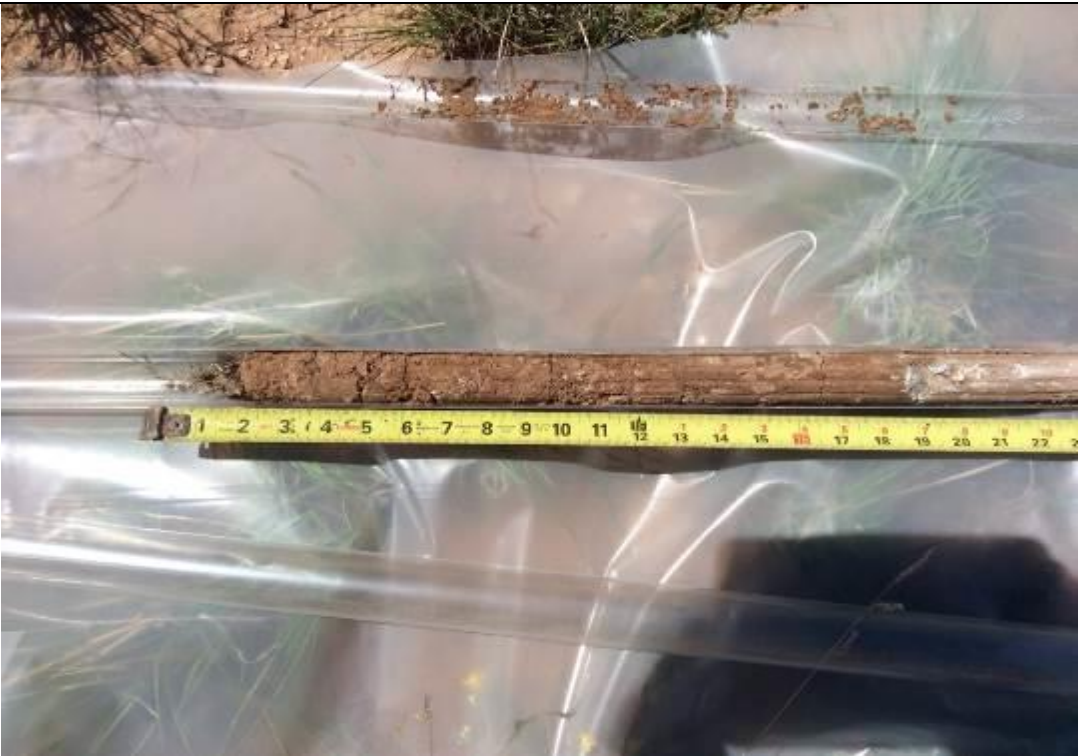
| <b>Photo No.</b><br><b>15</b> | <b>Date:</b><br>8/17/2014 | |

| <b>Description:</b><br><br>Haystack No. 1 AUM, SS-07<br>soil core, surface depth | | |

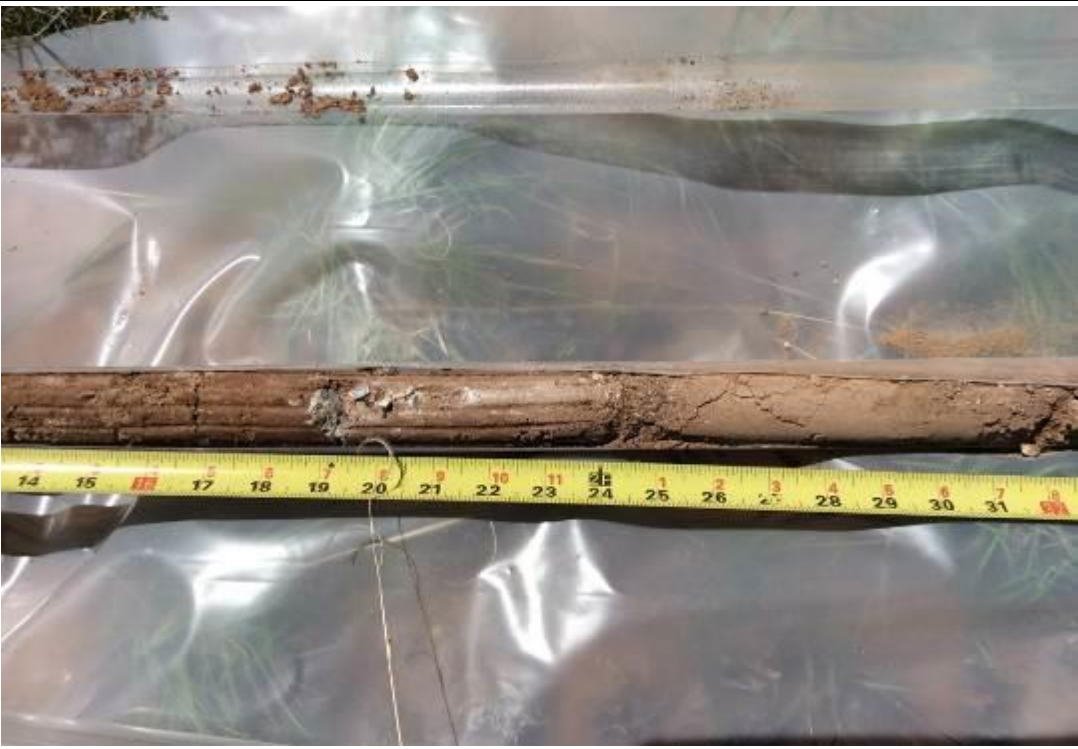
| <b>Photo No.</b><br><b>16</b> | <b>Date:</b><br>8/17/2014 | |

| <b>Description:</b><br><br>Haystack No. 1 AUM, SS-07<br>soil core, subsurface depth | | |

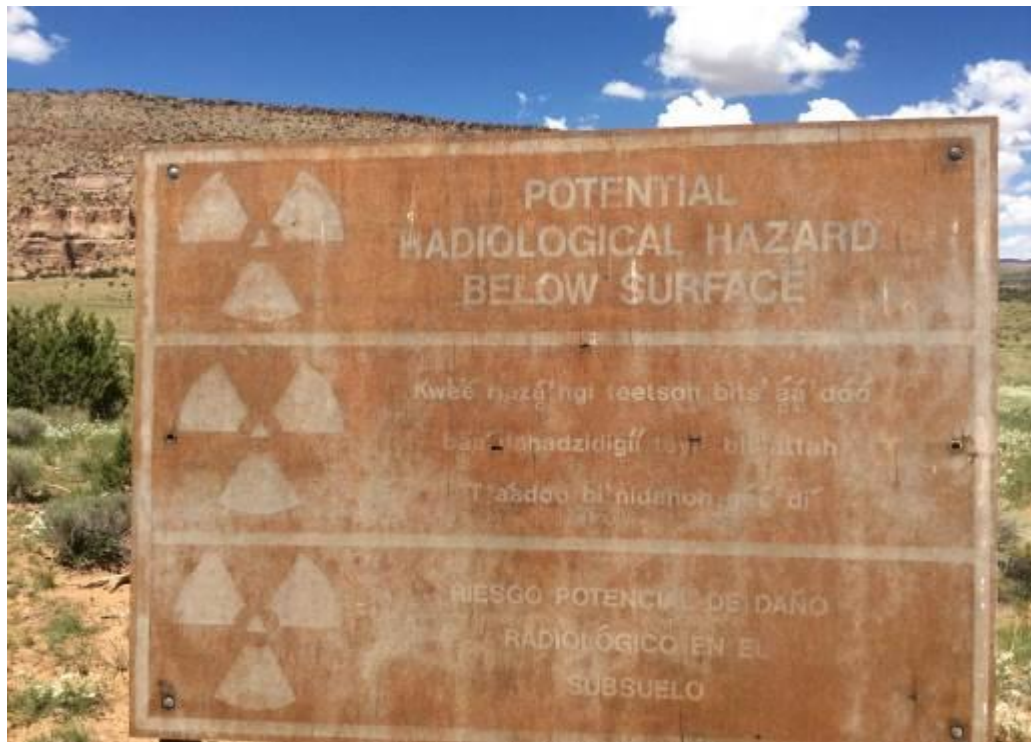
| <b>Description:</b><br><br>Worn sign reads,<br>“POTENTIAL<br>RADIOLOGICAL HAZARD<br>BELOW SURFACE” in<br>English, Navajo, and<br>Spanish | |

A photograph of a weathered, rusted metal sign in a desert landscape. The sign features a radiation warning symbol (three triangles) on the left side. The text on the sign is in three languages: English at the top, Navajo in the middle, and Spanish at the bottom. The background shows a dry, grassy field with some yellow wildflowers and a wooden signpost. The sky is blue with white clouds.

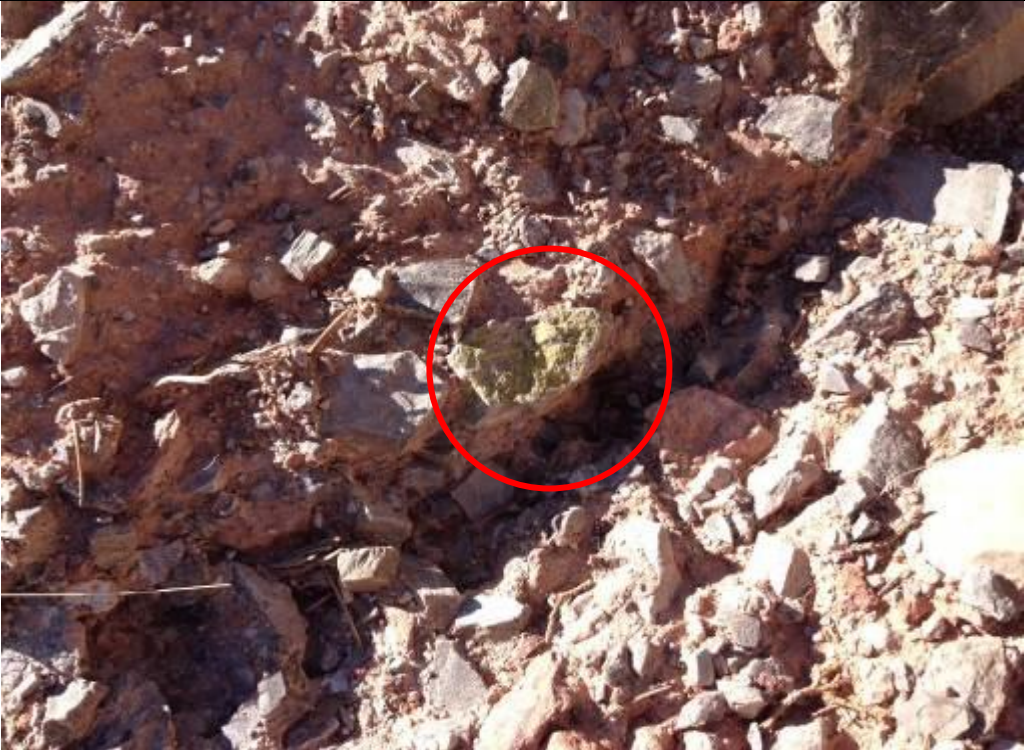
| <b>Photo No.</b><br><b>39</b> | <b>Date:</b><br>8/20/2014 | |

| <b>Description:</b><br><br>Yellow uranium ore in one of the offsite drainages, representative of rock found onsite | | |

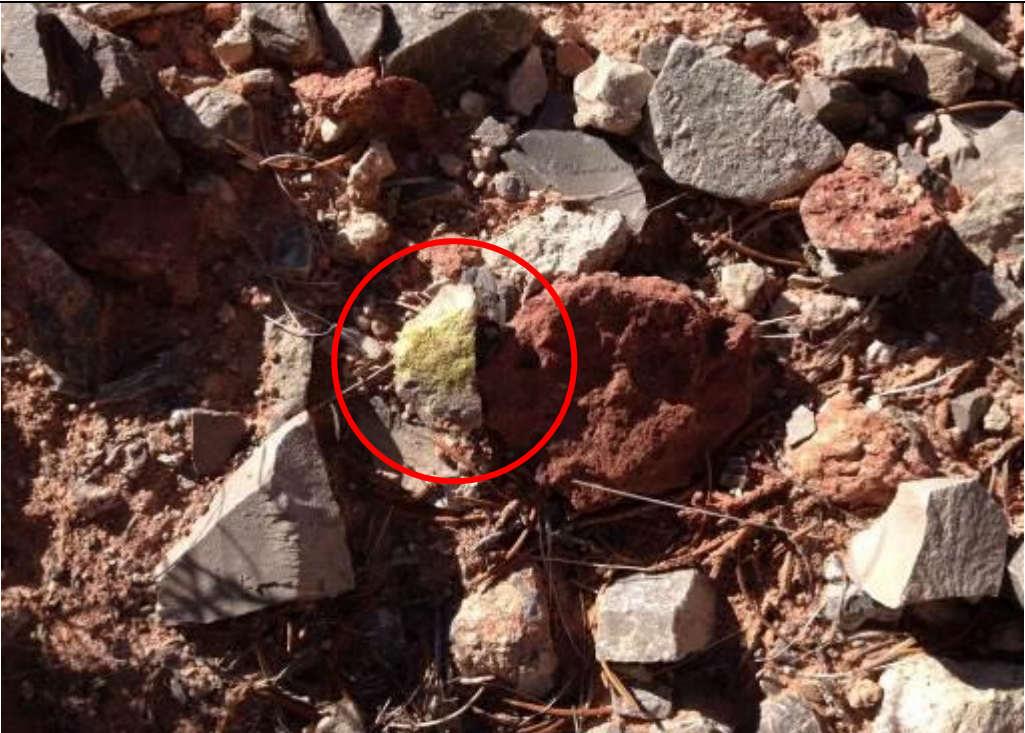
| <b>Photo No.</b><br><b>40</b> | <b>Date:</b><br>8/20/2014 | |

| <b>Description:</b><br><br>Yellow uranium ore in one of the offsite drainages, representative of rock found onsite | | |
