**Region 9 Enforcement and Compliance Assurance Division**  
**TSCA PCB INSPECTION REPORT**

<b>Inspection Date(s):</b>	06/24/2024	<b>Inspection Announced:</b> No	
<b>Time:</b>	<b>Entry:</b> 09:00 am	<b>Exit:</b> 1:25 pm	
<b>Media:</b>	TSCA		
<b>Regulatory Program(s)</b>	Polychlorinated Biphenyls (PCBs) Program		
<b>Company Name:</b>	Emerald Transformer, LLC		
<b>Facility or Site Name:</b>	Emerald Transformer Los Angeles, LLC		
<b>Facility Location(s):</b>	5756 Alba Street		
<b>(city, state, zip code)</b>	Los Angeles, CA 90058		
<b>Geographic Coordinates:</b>	33.989507 / -118.238826		
<b>County:</b>	Los Angeles County		
<b>Facility/Site Contact:</b>	Yolanda Ramirez	Operations Manager	
	<a href="mailto:yramirez@emeraldtransformer.com">yramirez@emeraldtransformer.com</a>

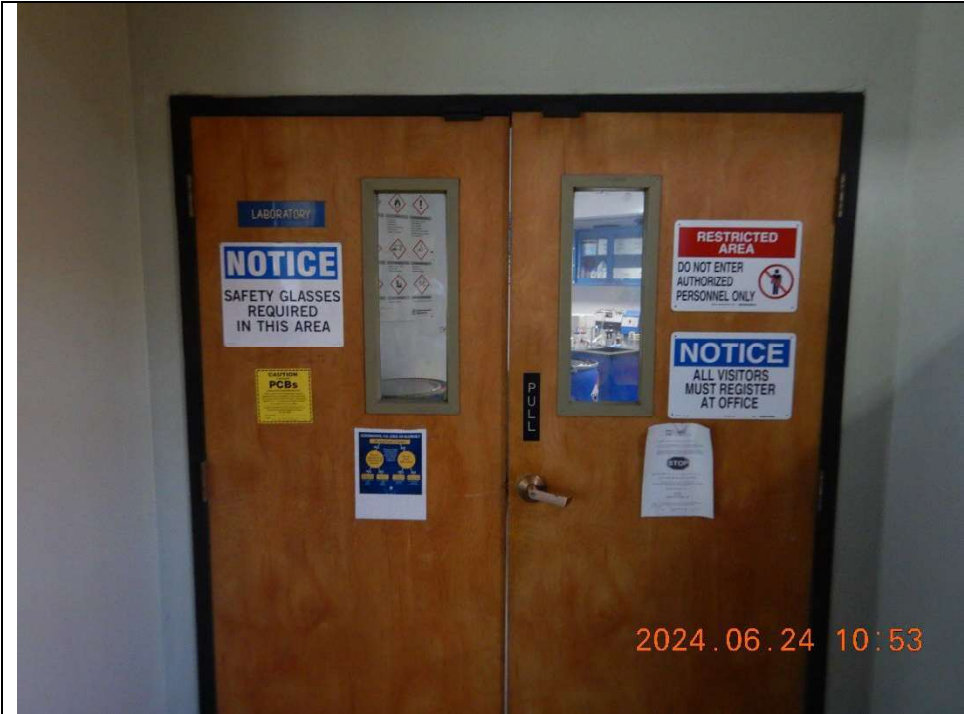
**Photograph 1.**  
Entrance to the laboratory with a PCB M<sub>L</sub> mark.

EPA observed the facility's laboratory, where the facility performs PCB waste sampling analysis. The laboratory had a PCB M<sub>L</sub> mark on the door (Photograph 1). EPA spoke with the laboratory manager, Mike McCauley, who described the facility's PCB analysis procedure using EPA Method 8082A. He indicated that the laboratory runs their own calibration set before testing, with the wipe sampling level of detection set to 10 µg/100cm<sup>2</sup>.

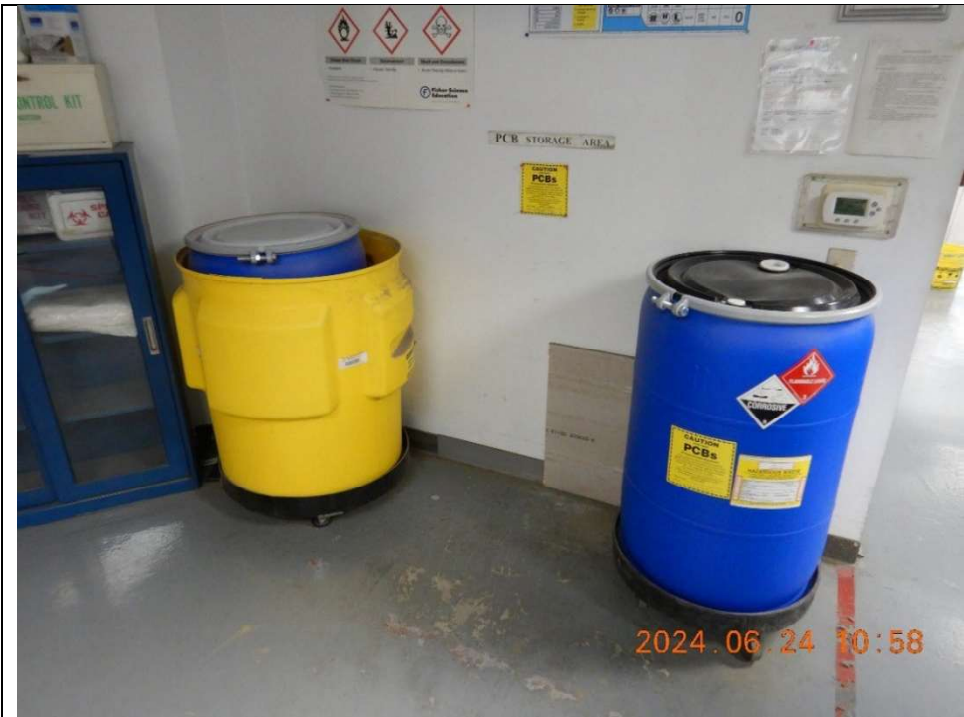
**Photograph 6.** PCB waste accumulation drums for laboratory waste that may contain PCBs.

Laboratory waste is accumulated in drums for up to three months, at which time they are shipped as PCB waste to Emerald Transformer Coffeyville, KS or Clean Harbors Aragonite, UT for disposal. EPA observed that there was a PCB M<sub>L</sub> mark on the wall near the drums and on the one blue drum currently being used to accumulate lab waste (Photograph 6). This drum had an accumulation start date of 5/10/2024 (Photograph 7 and Photograph 8).

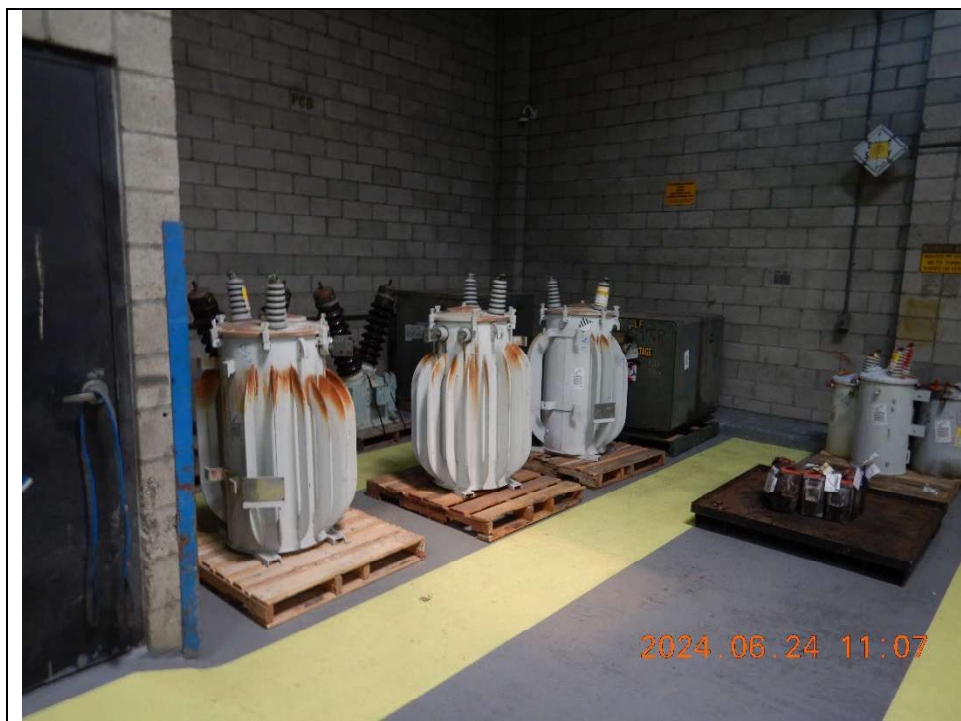
**Photograph 15.**

EPA observed two floor drains in the corners of the PCB storage area, which Mr. Peterson explained are collection pits that do not have any connections (Photograph 15 and Photograph 16). Mr. Peterson explained that the facility would pump any accumulated liquid out of the drains and transfer it to a drum or tote for off-site disposal as PCB waste. EPA also observed the storage area had a room where equipment used to handle PCB waste is stored (Photograph 17).

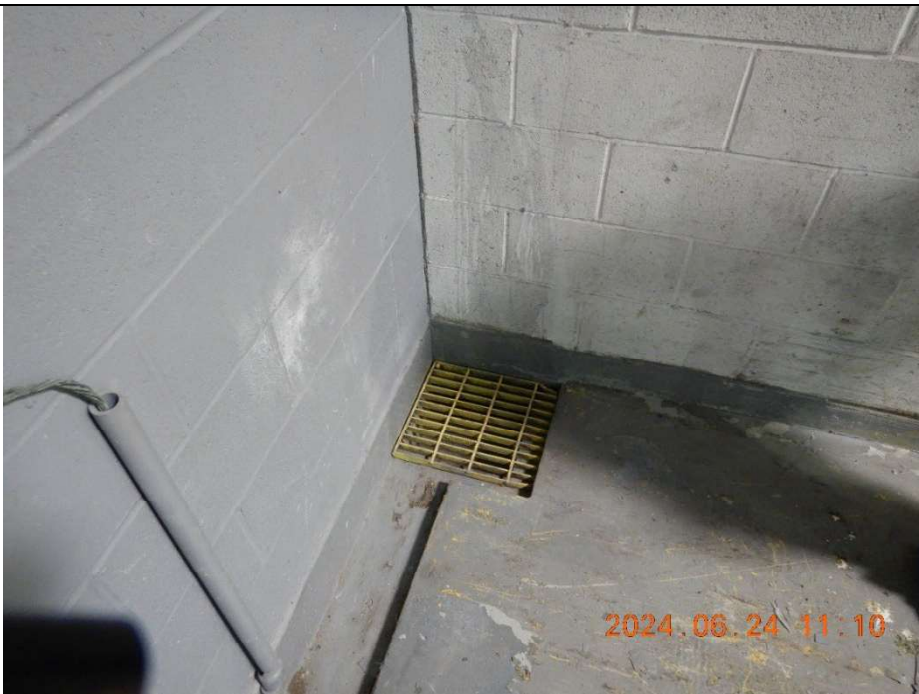
Floor drain located in the corner of the PCB storage area.

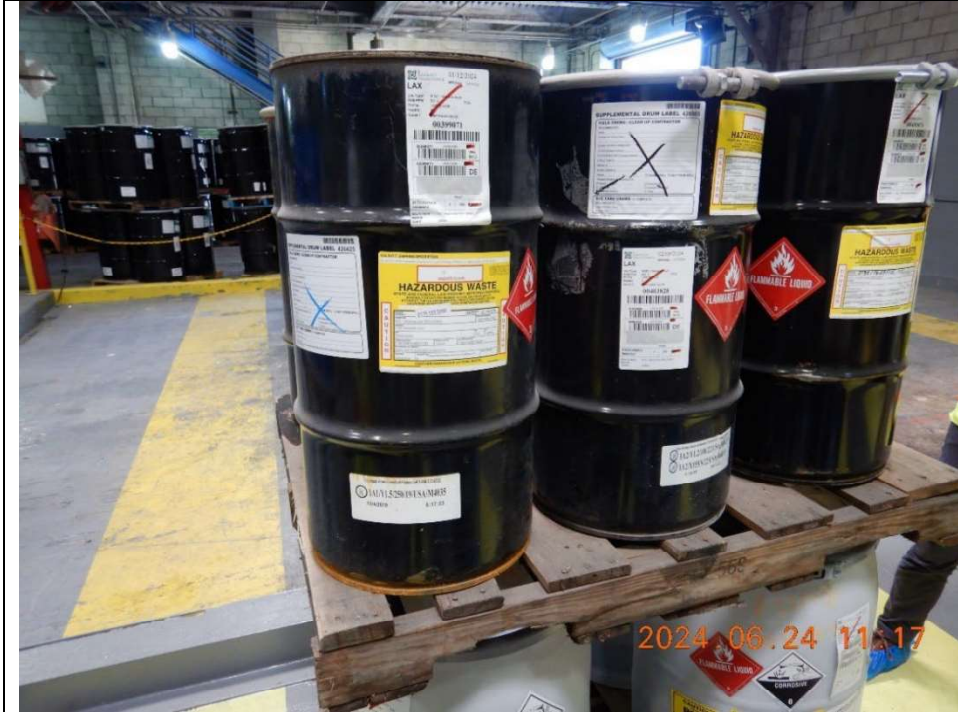
**Photograph 18.**

EPA observed approximately 16 PCB items in the PCB storage area that did not have a PCB M<sub>L</sub> sticker affixed to them. When EPA pointed out the missing stickers, Emerald Transformer representatives proceeded to add the PCB M<sub>L</sub> stickers during the inspection (Photograph 18 through Photograph 28). *Area of Concern 4.*

Six drums (two rows of three drums) in the PCB storage area without PCB M<sub>L</sub> stickers.

EPA observed several items of PCB waste without a PCB M<sub>L</sub> sticker in the PCB storage area. When EPA pointed out the missing stickers, Emerald Transformer representatives proceeded to add the PCB M<sub>L</sub> stickers during the inspection (Photograph 18 through Photograph 28). The facility also provided photographic evidence after the inspection that PCB M<sub>L</sub> stickers were added to the waste that was not present on the PCB inventory at the time of the inspection (see Facility Photograph 3).

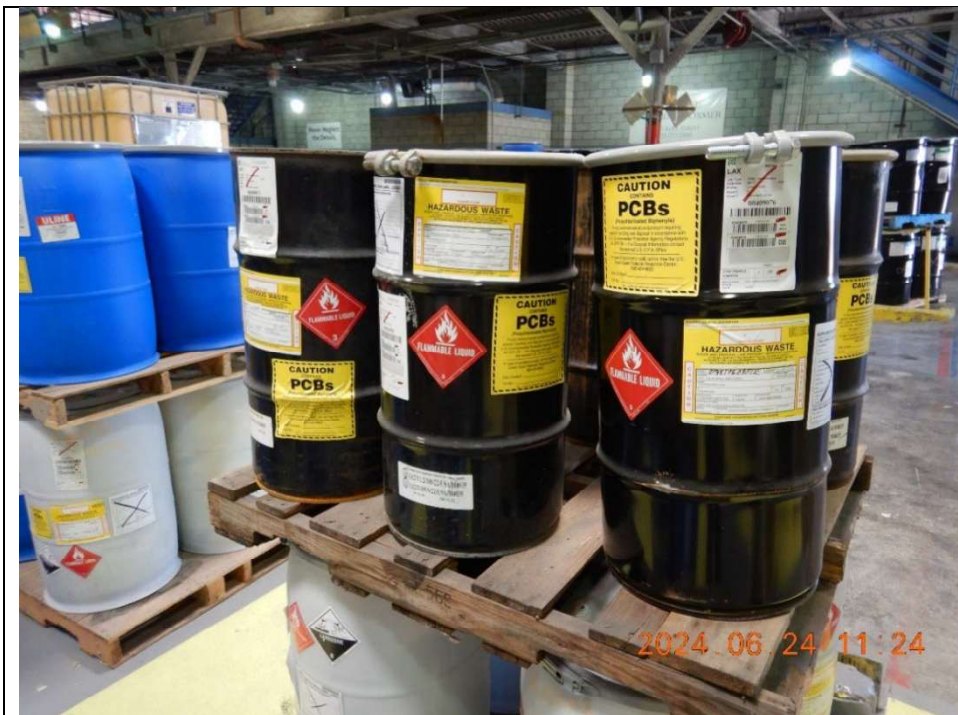
**Photograph 19.**

The three drums from the front row of the previous photograph, once the facility affixed PCB M<sub>L</sub> stickers during the inspection.

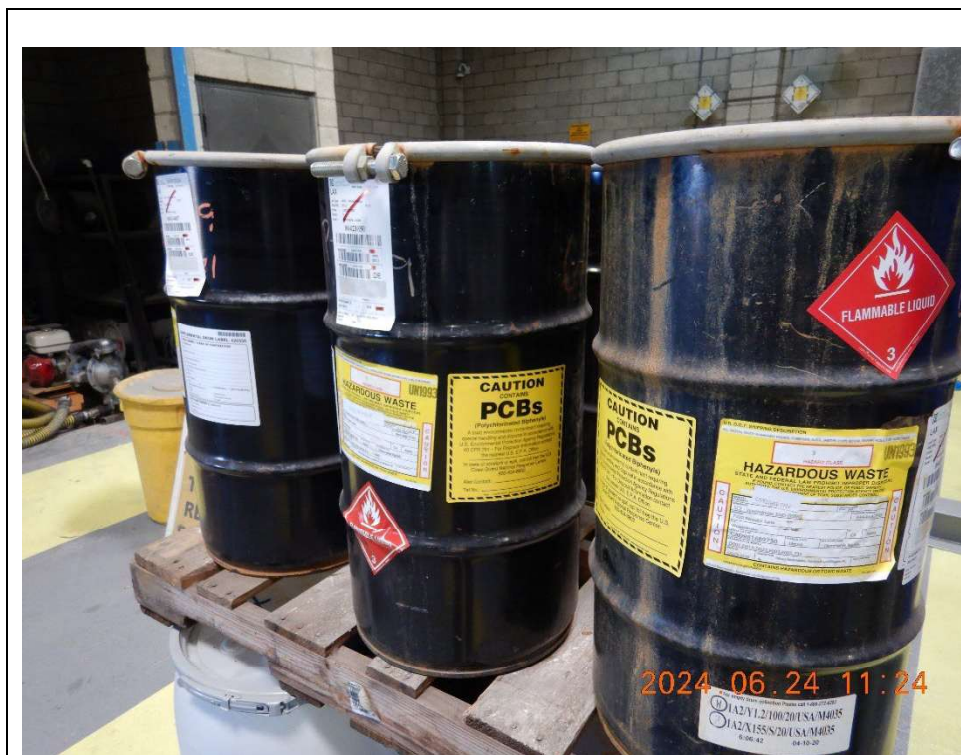
**Photograph 20.**

The three drums from the back row of the previous photograph, once the facility affixed PCB M<sub>L</sub> stickers

during the  
inspection.

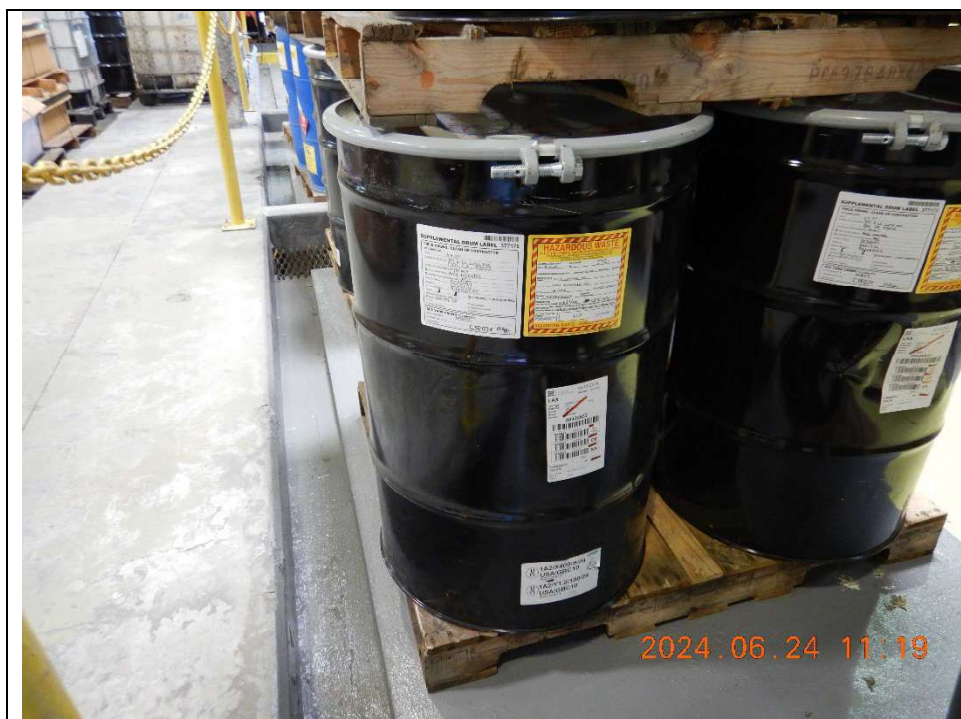
**Photograph 21.**  
Two drums in the  
PCB storage area  
without PCB M<sub>L</sub>  
stickers.

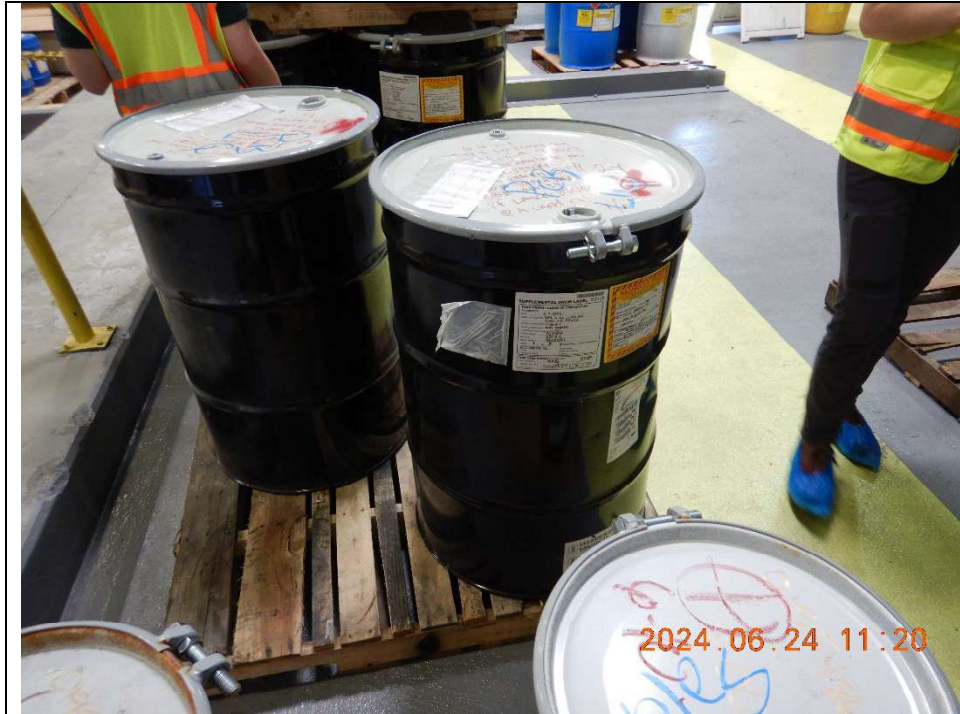
**Photograph 22.**

Two additional drums in the PCB storage area without PCB M<sub>L</sub> stickers.

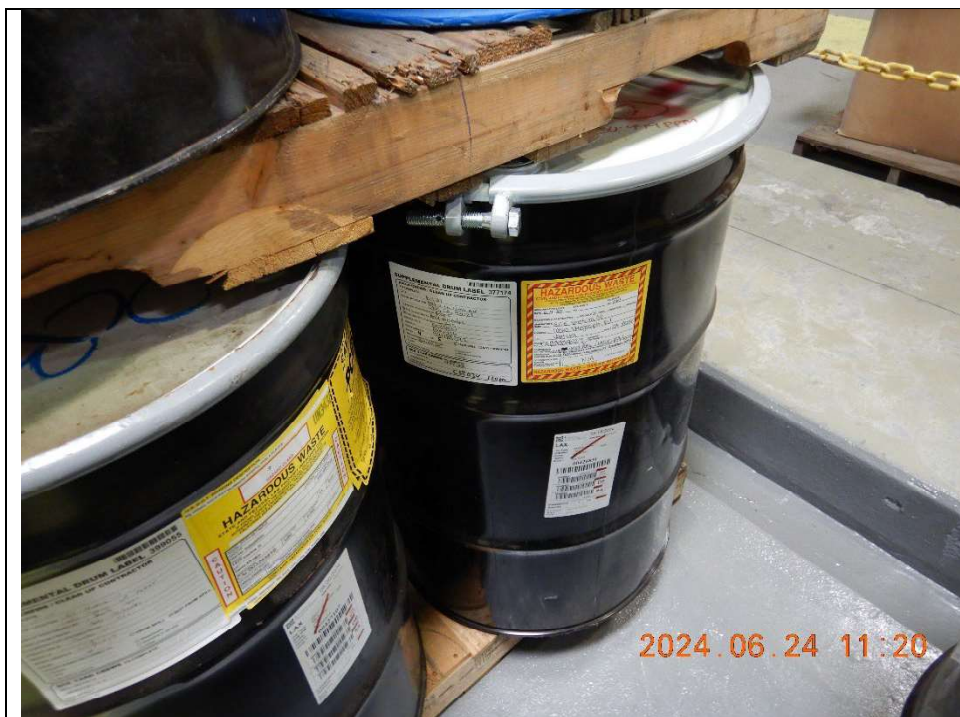
**Photograph 23.**

Two additional drums in the PCB storage area without PCB M<sub>L</sub> stickers.

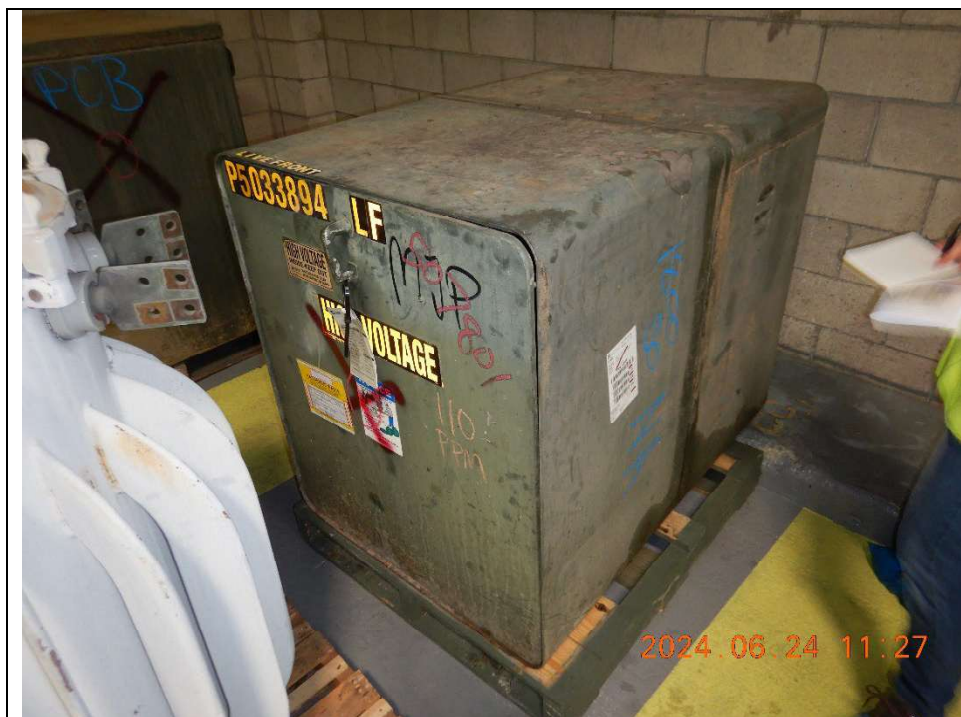
**Photograph 24.**

EPA took wipe samples of the ground of the PCB storage area (sample IDs 24264400, 24264402, and 24264404) and of the transformer pictured in Photograph 24 (sample ID 24264401). The results were non-detect for all PCB Aroclors. The facility's split sample results indicated all wipe samples had <10 µg/100 cm<sup>2</sup> (Attachment 14). See the "Sampling and Analytical Results" section for more information.

A transformer in the PCB storage area without a PCB M<sub>L</sub> sticker.

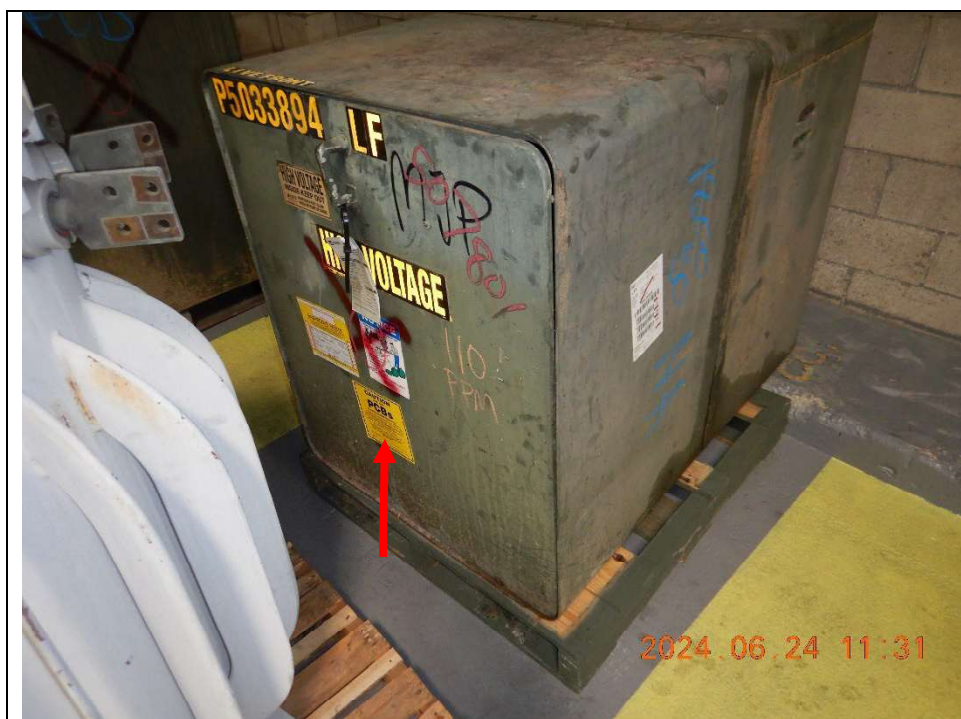
**Photograph 25.**

The transformer from the previous photograph, once the facility added a PCB M<sub>L</sub> sticker during the inspection (denoted by red arrow).

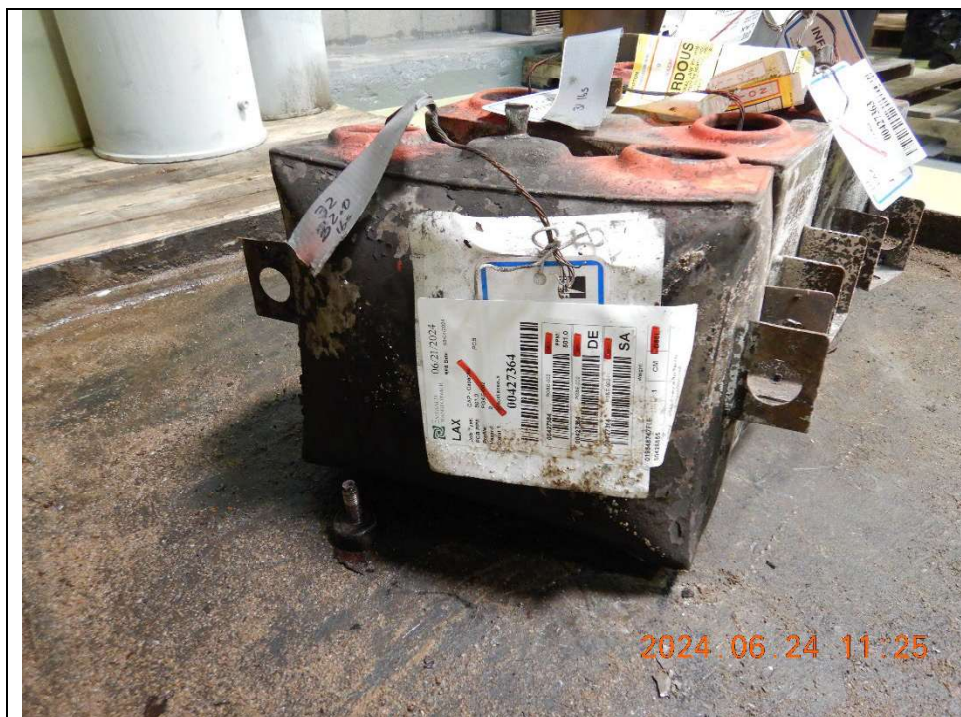
**Photograph 26.**

Three capacitors in the PCB storage area without a PCB M<sub>L</sub> sticker.

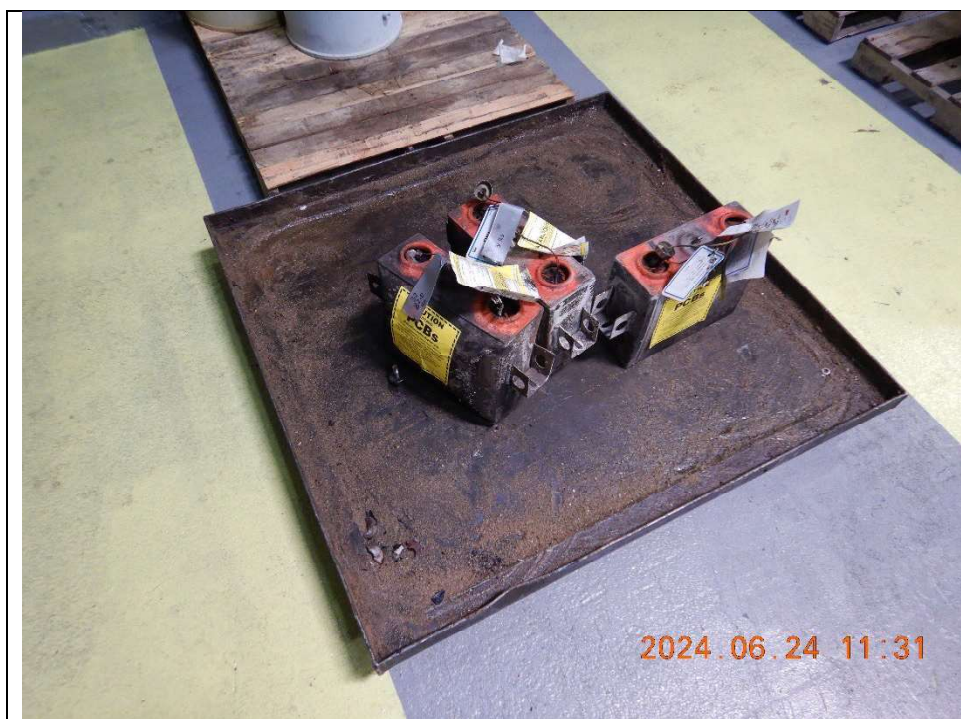
**Photograph 27.**

The three capacitors from the previous photograph, once the facility added PCB M<sub>L</sub> stickers.

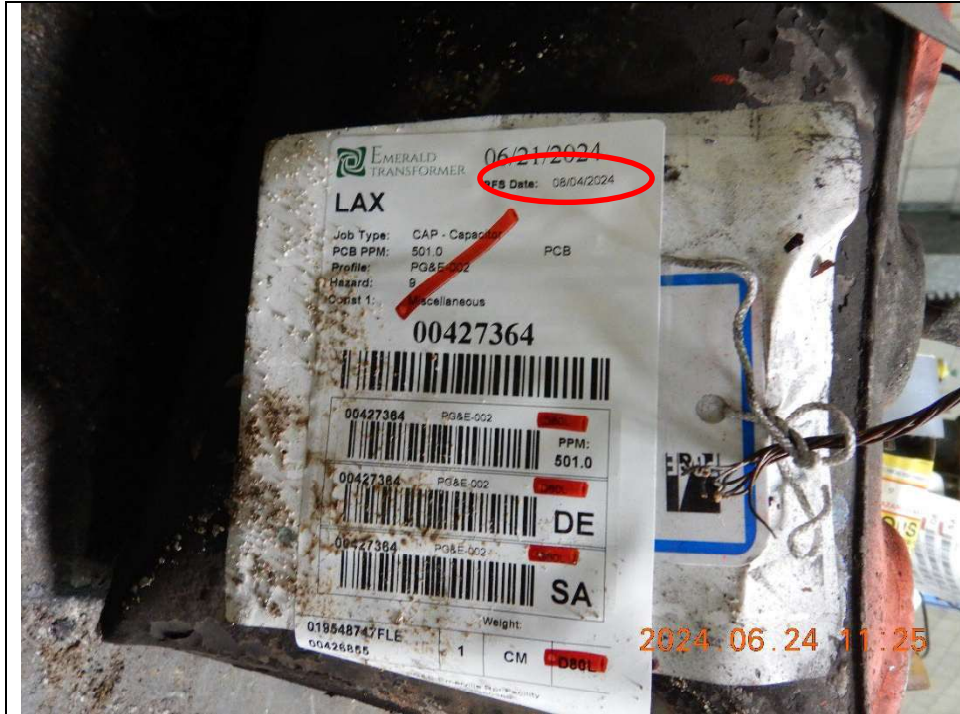
**Photograph 28.**

Close-up view of a label on the three capacitors from the previous photograph, with a removed from service date listed as 8/4/2024 (circled in red).

EPA observed several capacitors with a removed from service date in the future (8/4/24). Ms. Ramirez provided the manifest for these capacitors, which indicates the correct removed-from-service date is 8/4/2022 (Attachment 4). After the inspection, Ms. Ramirez provided photographic evidence with the corrected removed from service date (see Facility Photograph 3).

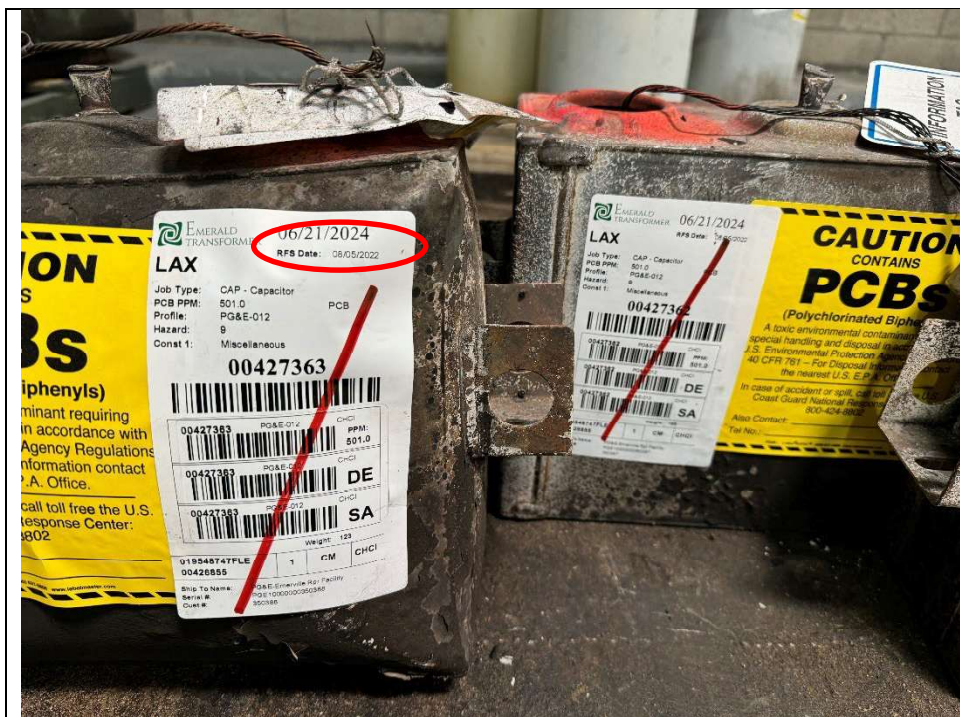
**Facility Photograph 3.**

Follow up photographic evidence of the corrected removed from service date of 8/5/2022 (circled in red).

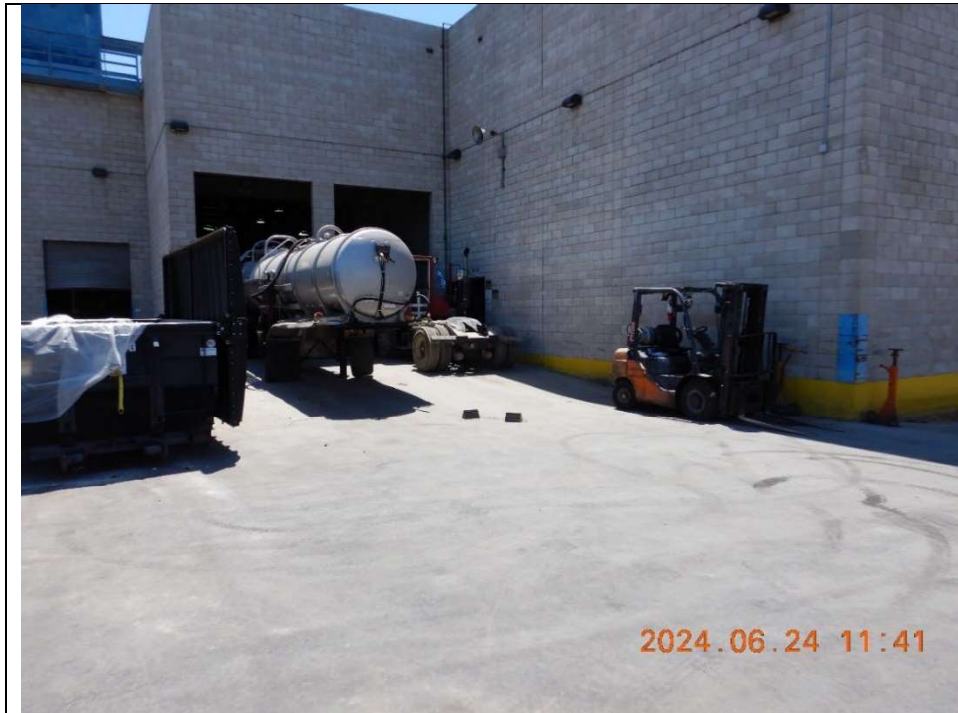
**Photograph 29.**

EPA next observed the facility's two outdoor 10-day storage areas where the facility temporarily stores trailer trucks of incoming waste before unloading them (Photograph 29 and Photograph 30). The 10-day storage areas are located adjacent to the storage warehouse and are also used for loading of trucks for PCB waste shipment to disposal facilities. Steve Peterson

10-day storage area, along the north wall of the storage warehouse.

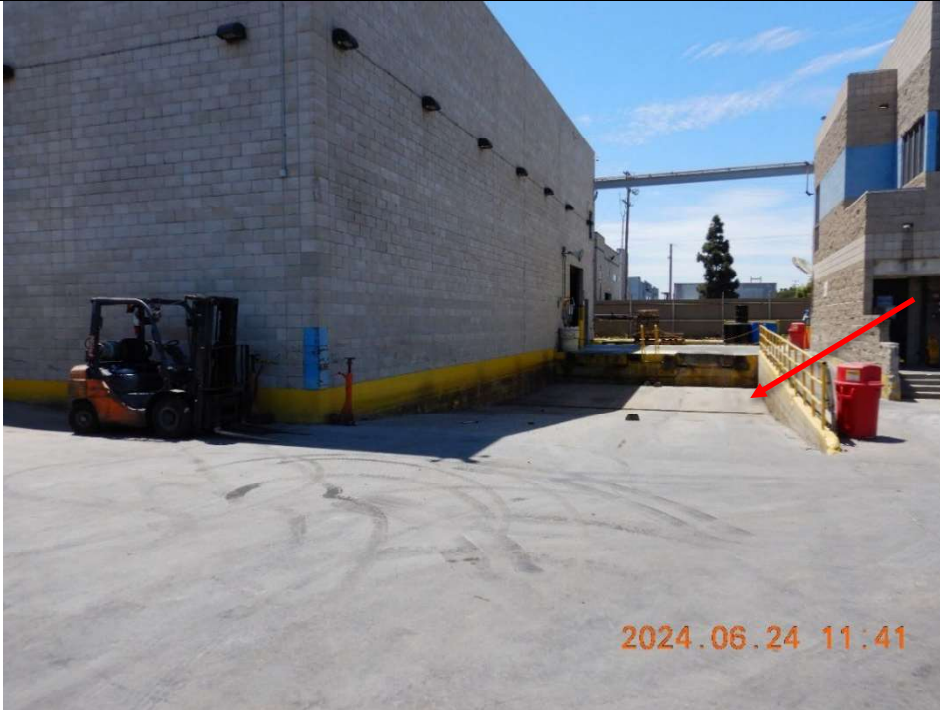
**Photograph 30.**

10-day storage area, along the west wall of the storage warehouse. Stormwater collection trench drain indicated by red arrow.

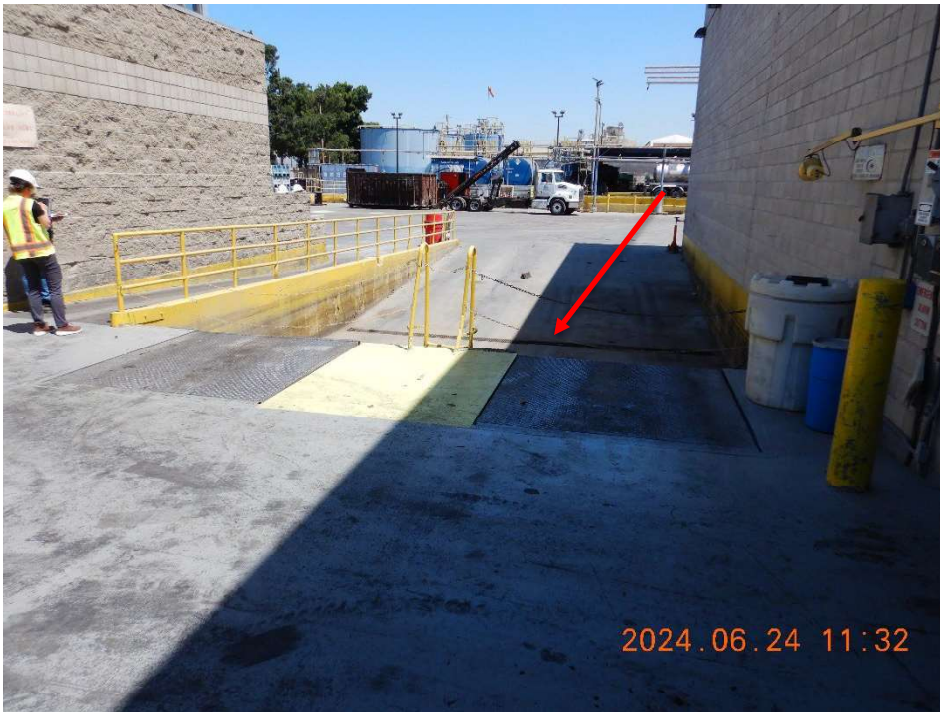
**Photograph 31.**

Alternate view of the 10-day storage area along the west wall of the storage warehouse, with the stormwater trench drain denoted with a red arrow.

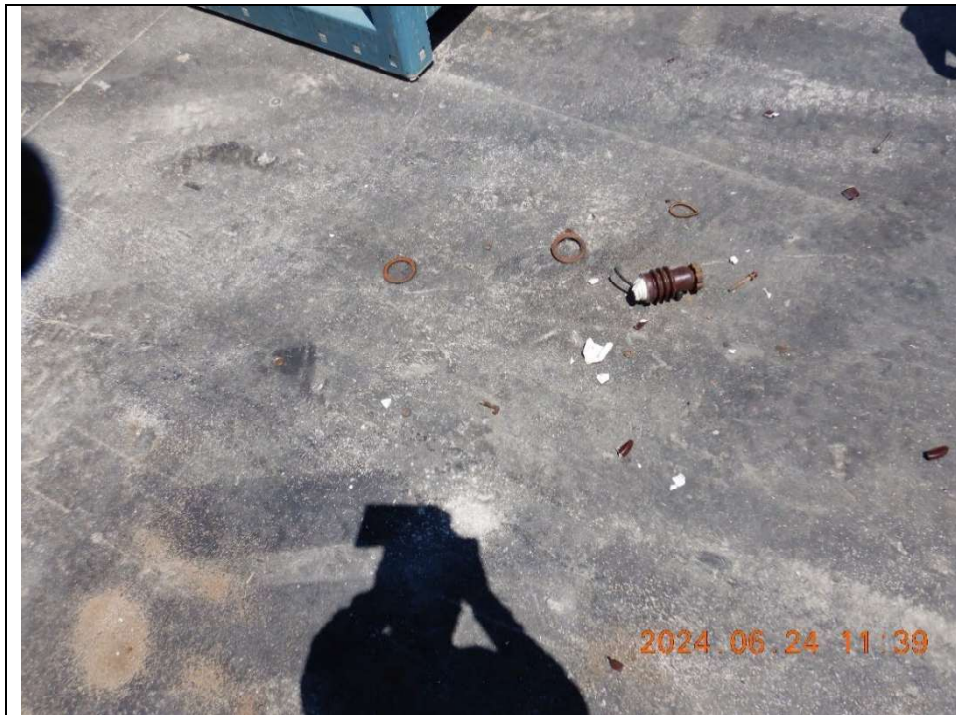
While walking through the waste receiving area, EPA observed a cracked and broken bushing (Photograph 32). EPA also observed at least three oil spots and some small plastic debris in the receiving area (Photograph 33 through Photograph 35). Mr. Diaz indicated that cleanup materials from the waste receiving area, including absorbent used on oil spots, are not considered PCB waste nor would be tested to confirm. EPA took a wipe sample of the interior of the bushing and one wipe sample of an oil spot in the waste receiving area (sample ID 24264403 and 24264405 respectively). Emerald Transformer had cleaned the oil spots with absorbent before the end of the inspection but was waiting for sample results before disposing of the bushing. The results were non-detect for all PCB Aroclors. The facility's split sample results showed  $<10 \mu\text{g}/100 \text{ cm}^2$  for both samples (Attachment 14). See the "Sampling and Analytical Results" section for more information. See *Area of Concern 8*.

**Photograph 32.**  
Broken bushing  
observed in waste  
receiving area.

EPA observed that there was a broken bushing located on the ground in the waste receiving area (Photograph 32). EPA also observed at least three oil spots in the same area (Photograph 33 through Photograph 35). Mr. Diaz indicated that cleanup materials from the waste receiving area, including absorbent used on oil spots, are not considered PCB waste nor would be tested to confirm. However, Emerald Transformer offloads and handles PCB waste in this area, so the facility should consider whether waste material and oil spills in this area may contain PCBs when cleaning them up. TSCA is a strict liability statute. Emerald Transformer should treat all equipment appropriately based on the actual PCB concentration of the equipment or wastes. EPA reminds Emerald Transformer that the assumptions for use do not apply to disposal of PCB waste.

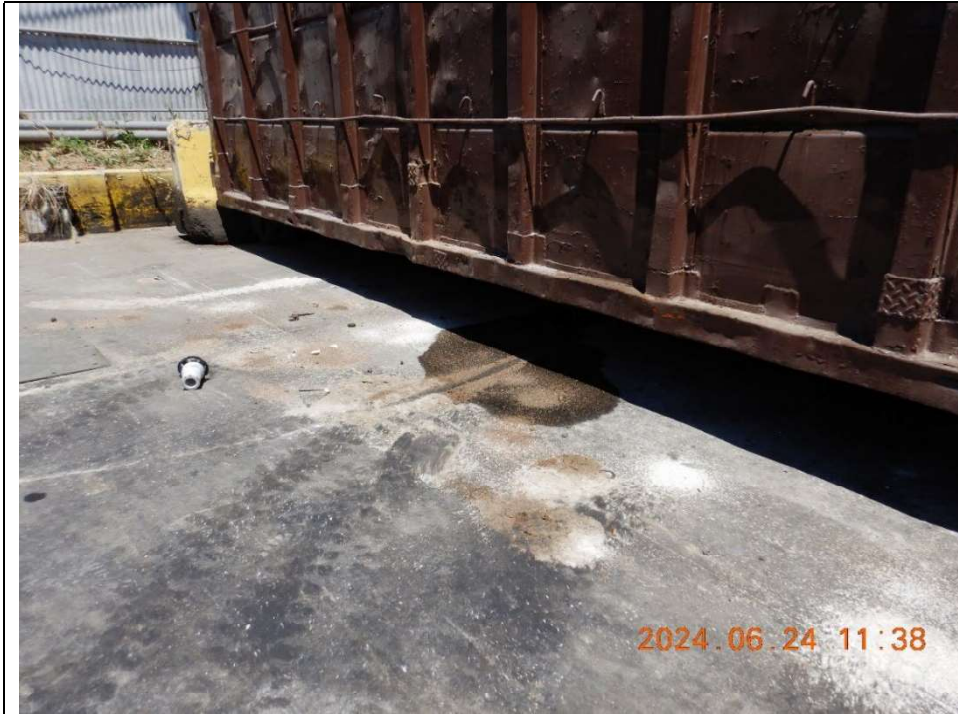
**Photograph 33.**

Oil spot and plastic debris in the waste receiving area, near a metal bin.

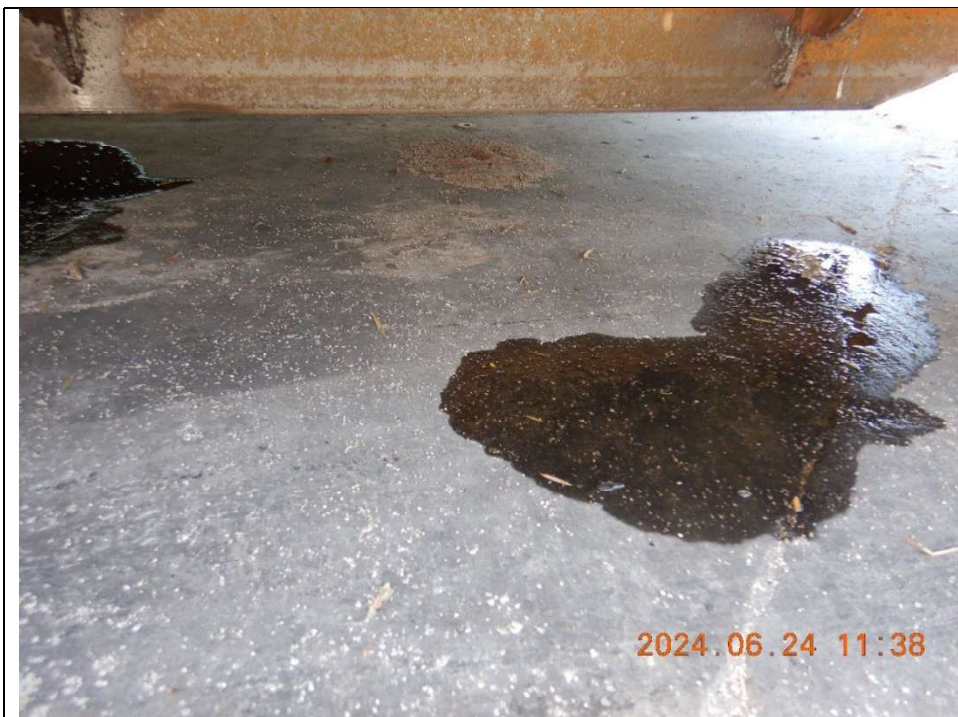
**Photograph 34.**

Additional oil spot in the waste receiving area, underneath a truck trailer.

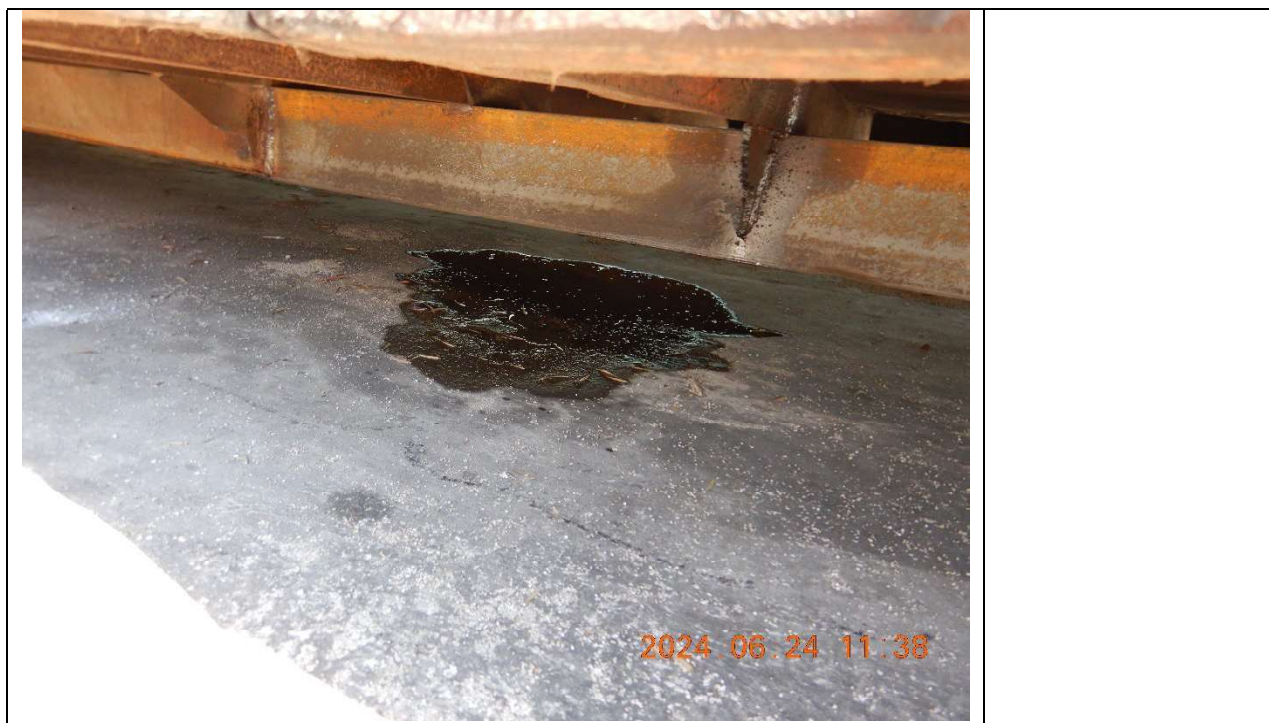
**Photograph 35.**

Second oil spot in the waste receiving area, underneath a truck trailer.

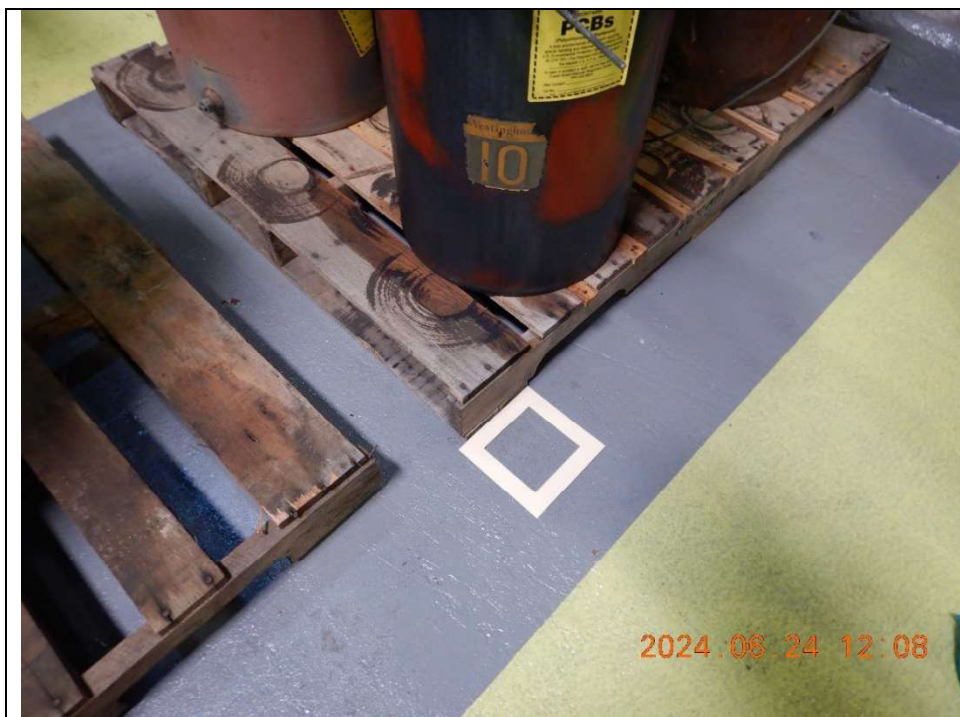
**Photograph 37.**

Sample location for  
wipe sample  
24264400, on inside  
of bermed area of  
PCB storage.

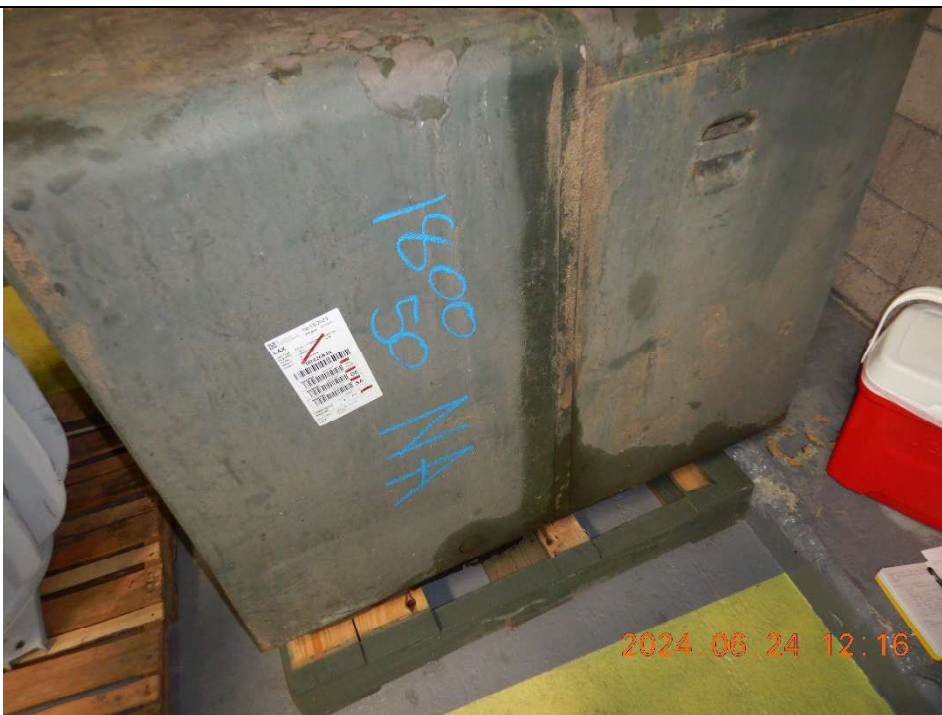
**Photograph 39.**

Transformer  
00426848 that was  
sampled for wipe  
sample 24264401.

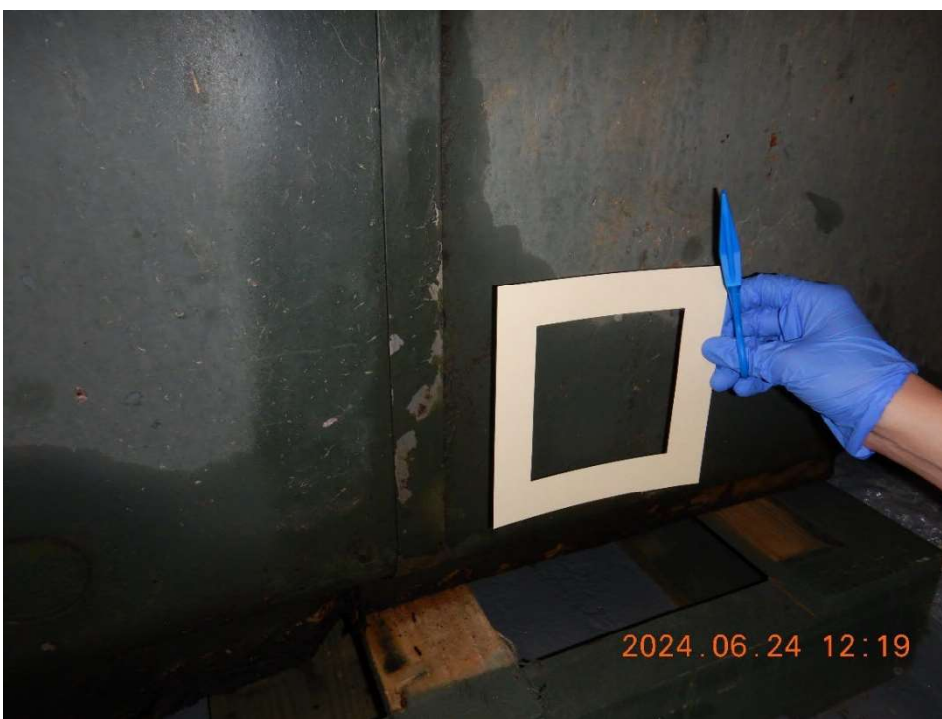
Surface wipe  
templated used to  
sample transformer  
00426848 for  
sample 24264401.

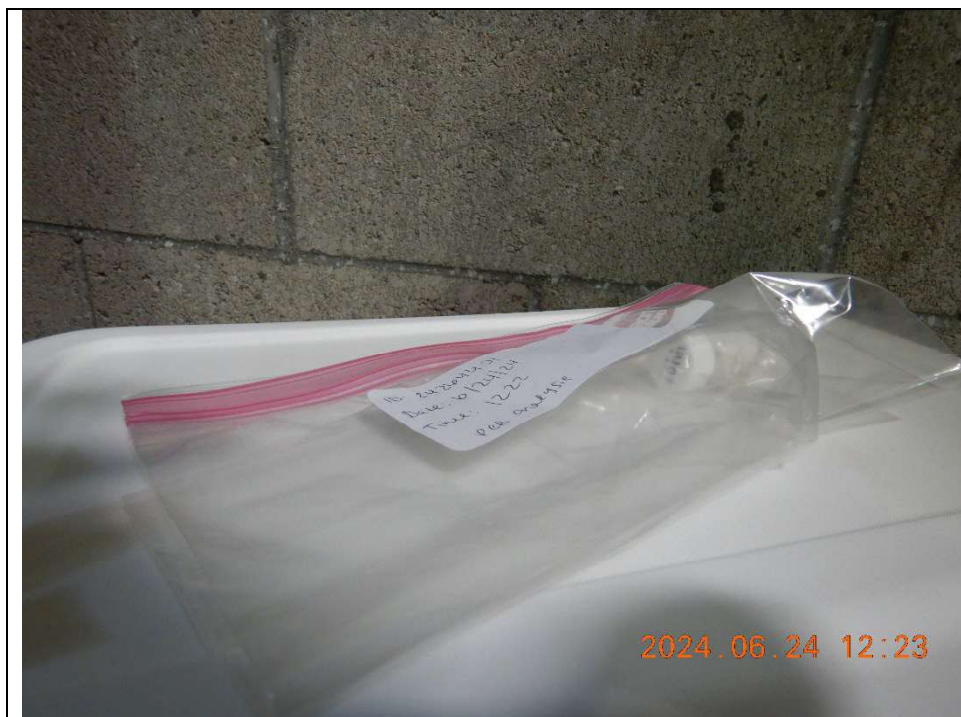
**Photograph 41.**  
Filled sample bottle  
for 24264401.

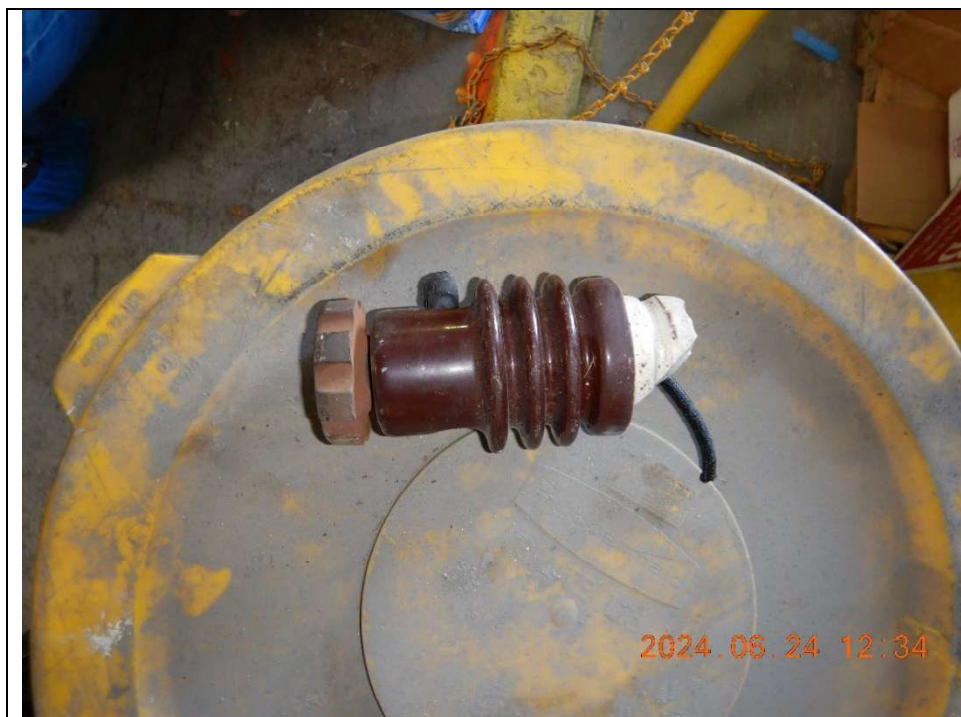
**Photograph 43.**  
Sample location for  
wipe sample  
24264403, which  
was taken from the  
inside of the broken  
bushing found in the  
waste receiving  
area.

EPA took a wipe sample of the interior of the bushing and one wipe sample of an oil spot in the waste receiving area. Emerald Transformer had cleaned the observed oil spots with absorbent before the end of the inspection. However, the facility indicated they would hold the bushing until the wipe sample results were available. The results were non-detect for all PCB Aroclors. The facility's split sample results showed <10 µg/100 cm<sup>2</sup> for both samples (Attachment 14).

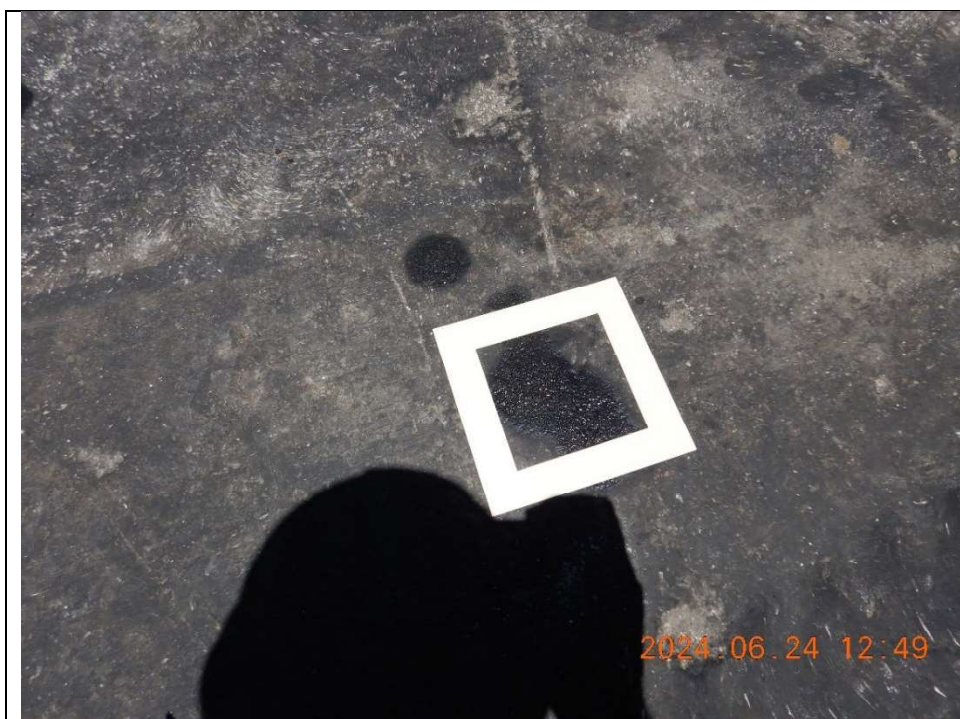
**Photograph 48.**  
Sample location for  
wipe sample  
24264405, taken on  
an oil spot in the  
waste receiving  
area.
