**Region 9 Enforcement and Compliance Assurance Division**  
**TSCA PCB INSPECTION REPORT**

<b>Inspection Date(s):</b>	06/24/2024	<b>Inspection Announced:</b> No	
<b>Time:</b>	<b>Entry:</b> 09:00 am	<b>Exit:</b> 1:25 pm	
<b>Media:</b>	TSCA		
<b>Regulatory Program(s)</b>	Polychlorinated Biphenyls (PCBs) Program		
<b>Company Name:</b>	Emerald Transformer, LLC		
<b>Facility or Site Name:</b>	Emerald Transformer Los Angeles, LLC		
<b>Facility Location(s):</b>	5756 Alba Street		
<b>(city, state, zip code)</b>	Los Angeles, CA 90058		
<b>Geographic Coordinates:</b>	33.989507 / -118.238826		
<b>County:</b>	Los Angeles County		
<b>Facility/Site Contact:</b>	Yolanda Ramirez	Operations Manager	
	<a href="mailto:yramirez@emeraldtransformer.com">yramirez@emeraldtransformer.com</a>

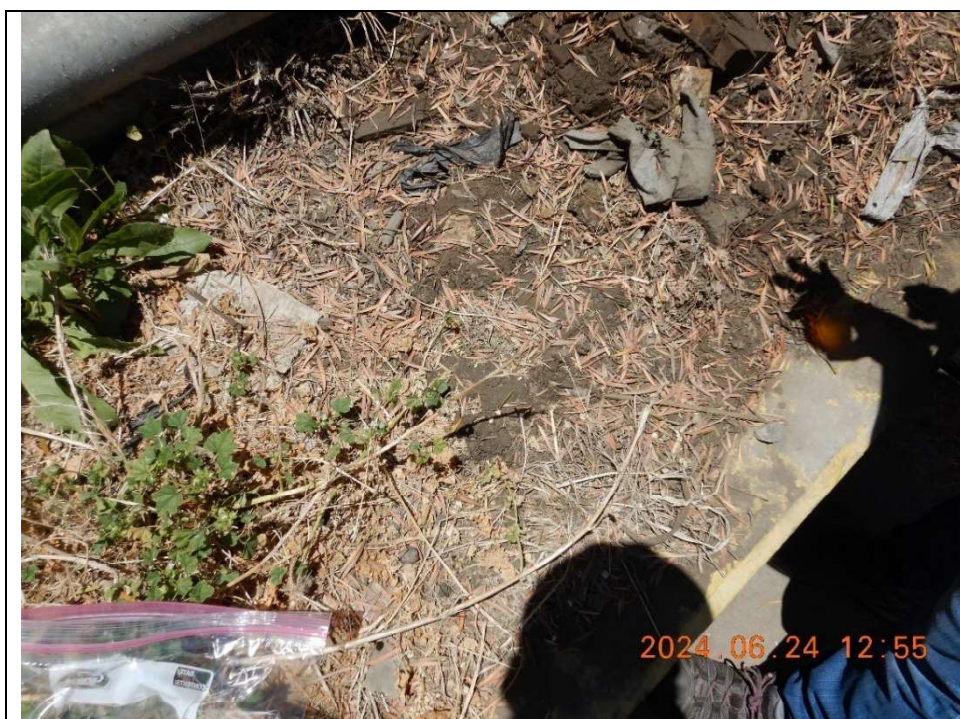
**Photograph 50.**  
Sample location for  
surface soil samples  
24264406 and  
24264407  
(duplicate), taken  
near the sump pump  
in the grassy area  
along the west of  
the waste receiving  
area.
