2023-2025 San Juan County Beaver Habitat and Mine Remediation Study

Summary Report

January 2025

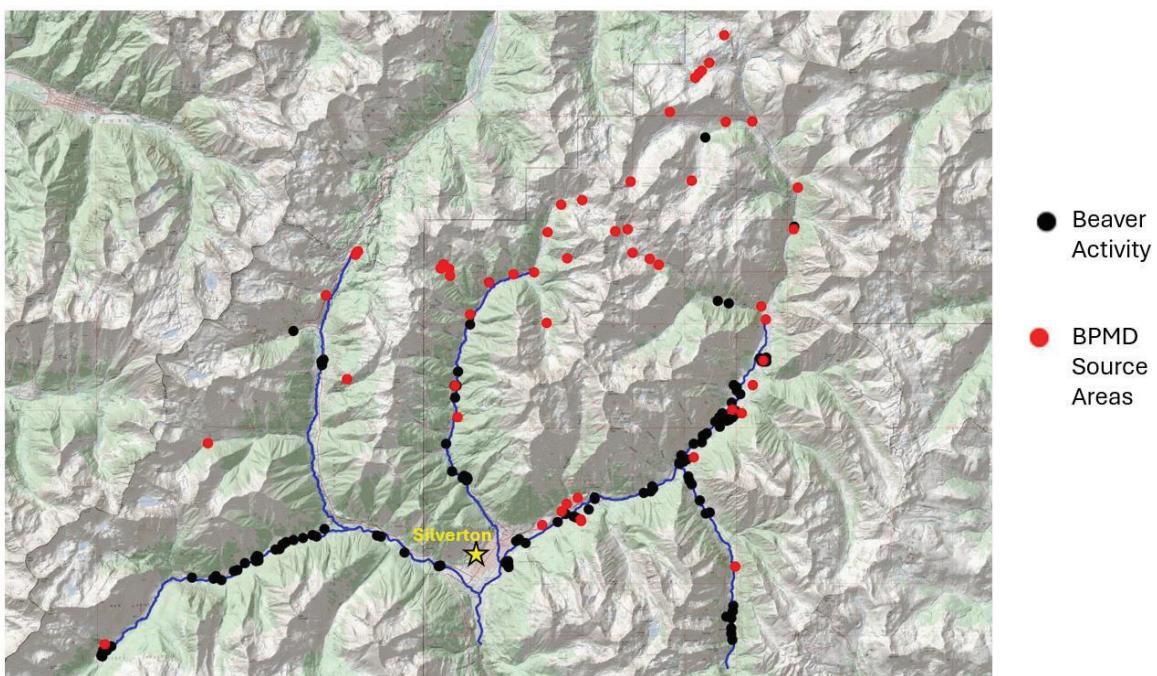
Figure 1-3. Proximity of documented beaver habitat to BPMD Source areas in San Juan County.

Beavers were found to be currently living in all three major drainages to the Animas River (Mineral Creek, Cement Creek, and the Upper Animas River), in addition to the sub tributaries of South Mineral Creek and Cunningham Creek. These sites are often adjacent to or directly in mine impacted waters (MIW). After each major tributary was characterized, existing SJC beaver habitat was overlayed with locations of abandoned mine sites. When compared geospatially, many of the 48 BPMD sites as well as unlisted abandoned mines were found to be located near historic or current beaver activity (see figure below), and all sites had existing beaver activity and habitat downstream.

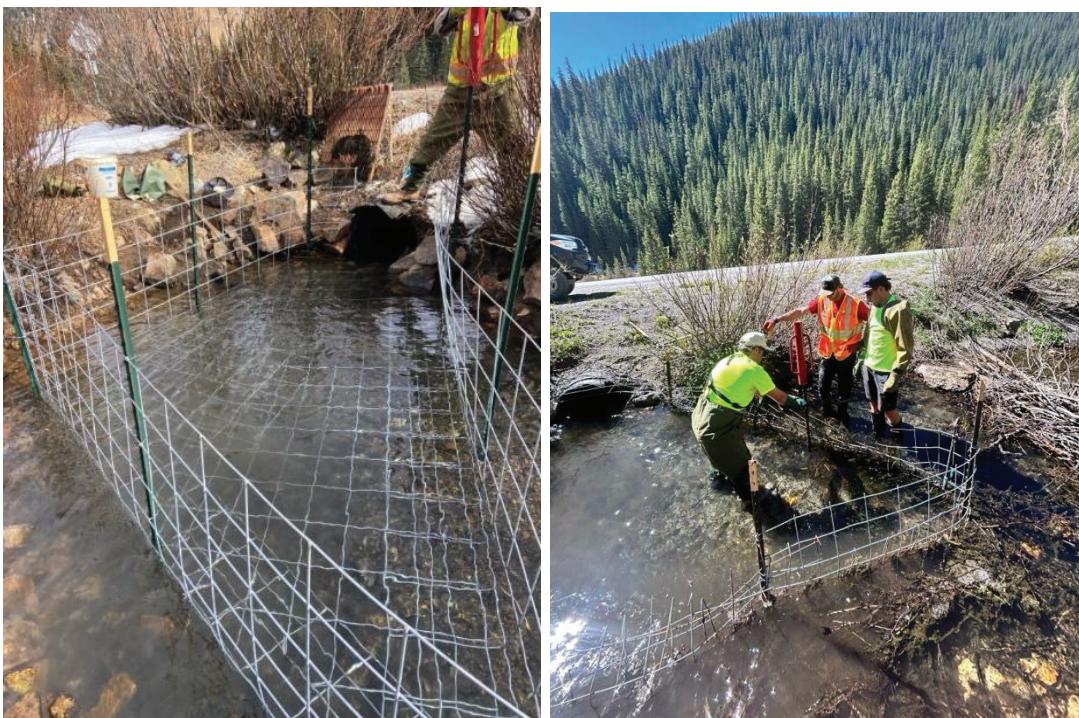
Figure 2-4: Highway 550 culvert beaver exclusion fence construction in 2020 (left), and repair work in 2024 (right).

Under this project the site was inspected in 2024 to assess the condition of the fence and the long-term maintenance requirements. The exclusion fence was still functioning after 4 years with no sign of culvert plugging by the area beavers. Due to the location of this fence infrastructure directly in a major highway avalanche path there is often extensive snow on top of the fence. After four winters the fence structure had become compromised and bent by the heavy snow loads each winter. In 2024 the AWR team performed stabilization of the existing posts and have made recommendations to CDOT on how to increase the long-term stability of this fence structure by using heavy duty post materials and more robust fence paneling. AWR intends to support long term monitoring and maintenance of this fence through future funding sources. The key takeaway from this project is that site specific characteristics, such as avalanches and snow loads, need to be taken into consideration when designing the low-tech defense structures.

As a second component to this project, AWR also constructed a BDA immediately upstream of the exclusion fence in 2023. The BDA was successful because in 2024 it was observed that beavers had taken over maintenance of the BDA and appeared to have put their focus on impounding water with the constructed dam and were no longer interested in damming at the culvert or around the exclusion fence (see BDA structure upstream of the fence in the right photo figure 2-4). This action demonstrated that while the exclusion fence prevented culvert clogging, the BDA also reduced beaver activity/damming along the exclusion fence which will ultimately reduce risks to the

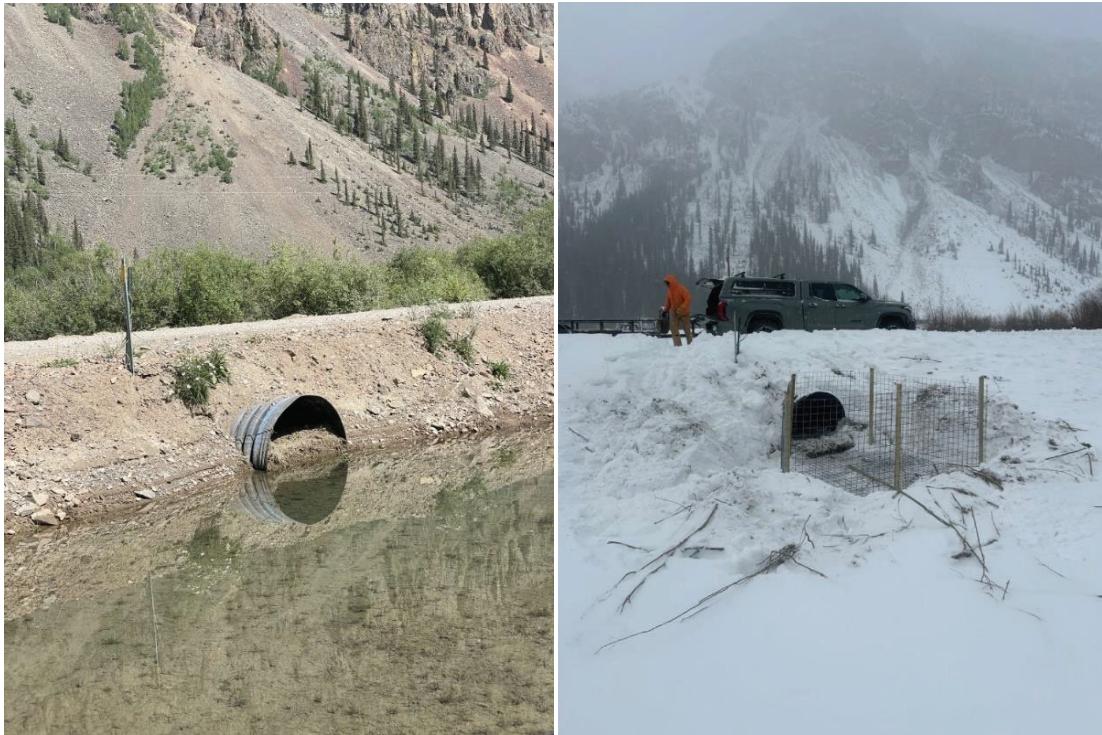
Figure 2-5. Country Road 2 culvert beaver damming in summer 2024 (left) and construction of a trapezoidal beaver exclusion fence in December 2024 (right).

San Juan County Road 2 culvert located near the Forest Queen Mine was being regularly plugged by beavers (left photo), requiring repeated maintenance to remove debris and prevent road damage. AWR received approval from the county to install a trapezoidal beaver exclusion fence (right photo). The fence excludes beaver access to the culvert and prevents flooding. The shape of the fence has been proven to discourage the beavers from damming along the entire fence due to the counter-intuitive flow direction of water across the fence walls. If beaver damming does occur an additional pipe and fence design can be extended off of the exclusion fence to permanently set a maximum water level of the ponded water and reduce risk to adjacent infrastructure and road.

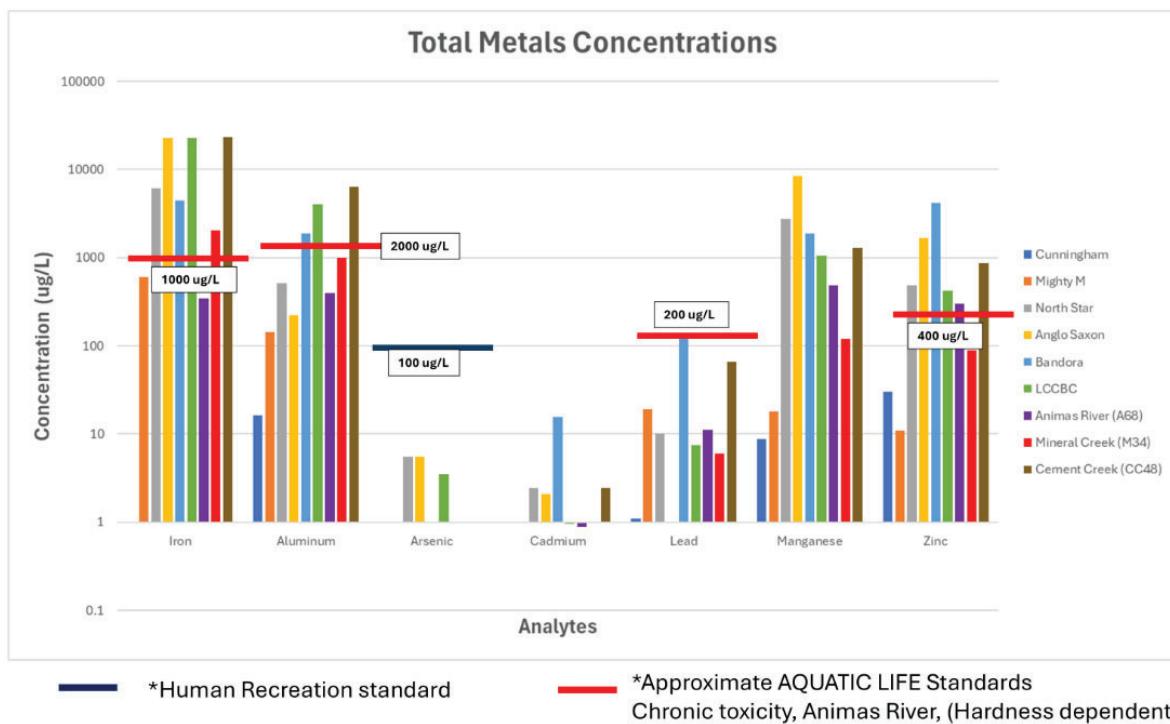
Figure 3-1. Graph of total metals concentrations at beaver habitat focus areas in relation to approximate Aquatic Life Water Quality standards for chronic toxicity in Animas River Watershed.

Due to the wide variety of beaver habitat focus areas in relation to various draining mines and diverse background of geochemistry found in the different drainages in the Upper Animas River watershed there was a wide range of metals concentrations found in the surface waters. To summarize, healthy beaver populations in areas where

beavers have been active for many decades were documented across a wide range of metals concentrations that were often in exceedance of chronic standards for aquatic life (figure 3-1). Aluminum, Iron, and Zinc concentrations measured in beaver habitat were frequently above the aquatic life standards for the Animas River. The quantitative results provide a baseline database that begins to demonstrate the ability of beavers to live in degraded water quality.

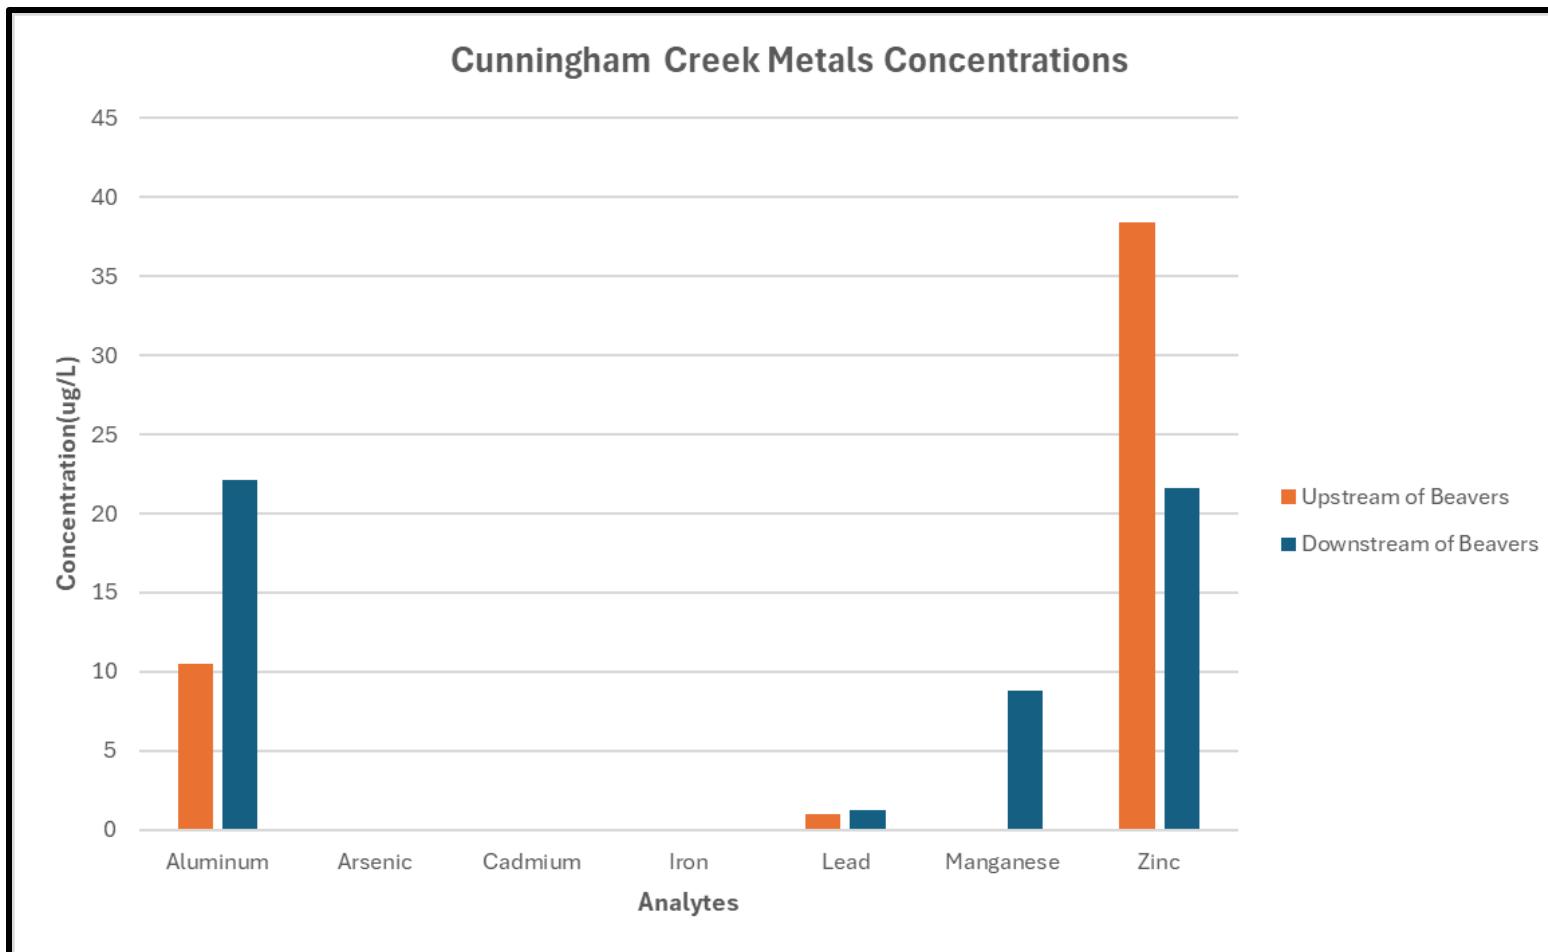
Cunningham Creek Water Quality Upstream and Downstream of Beaver Activity and Mine Water inflows

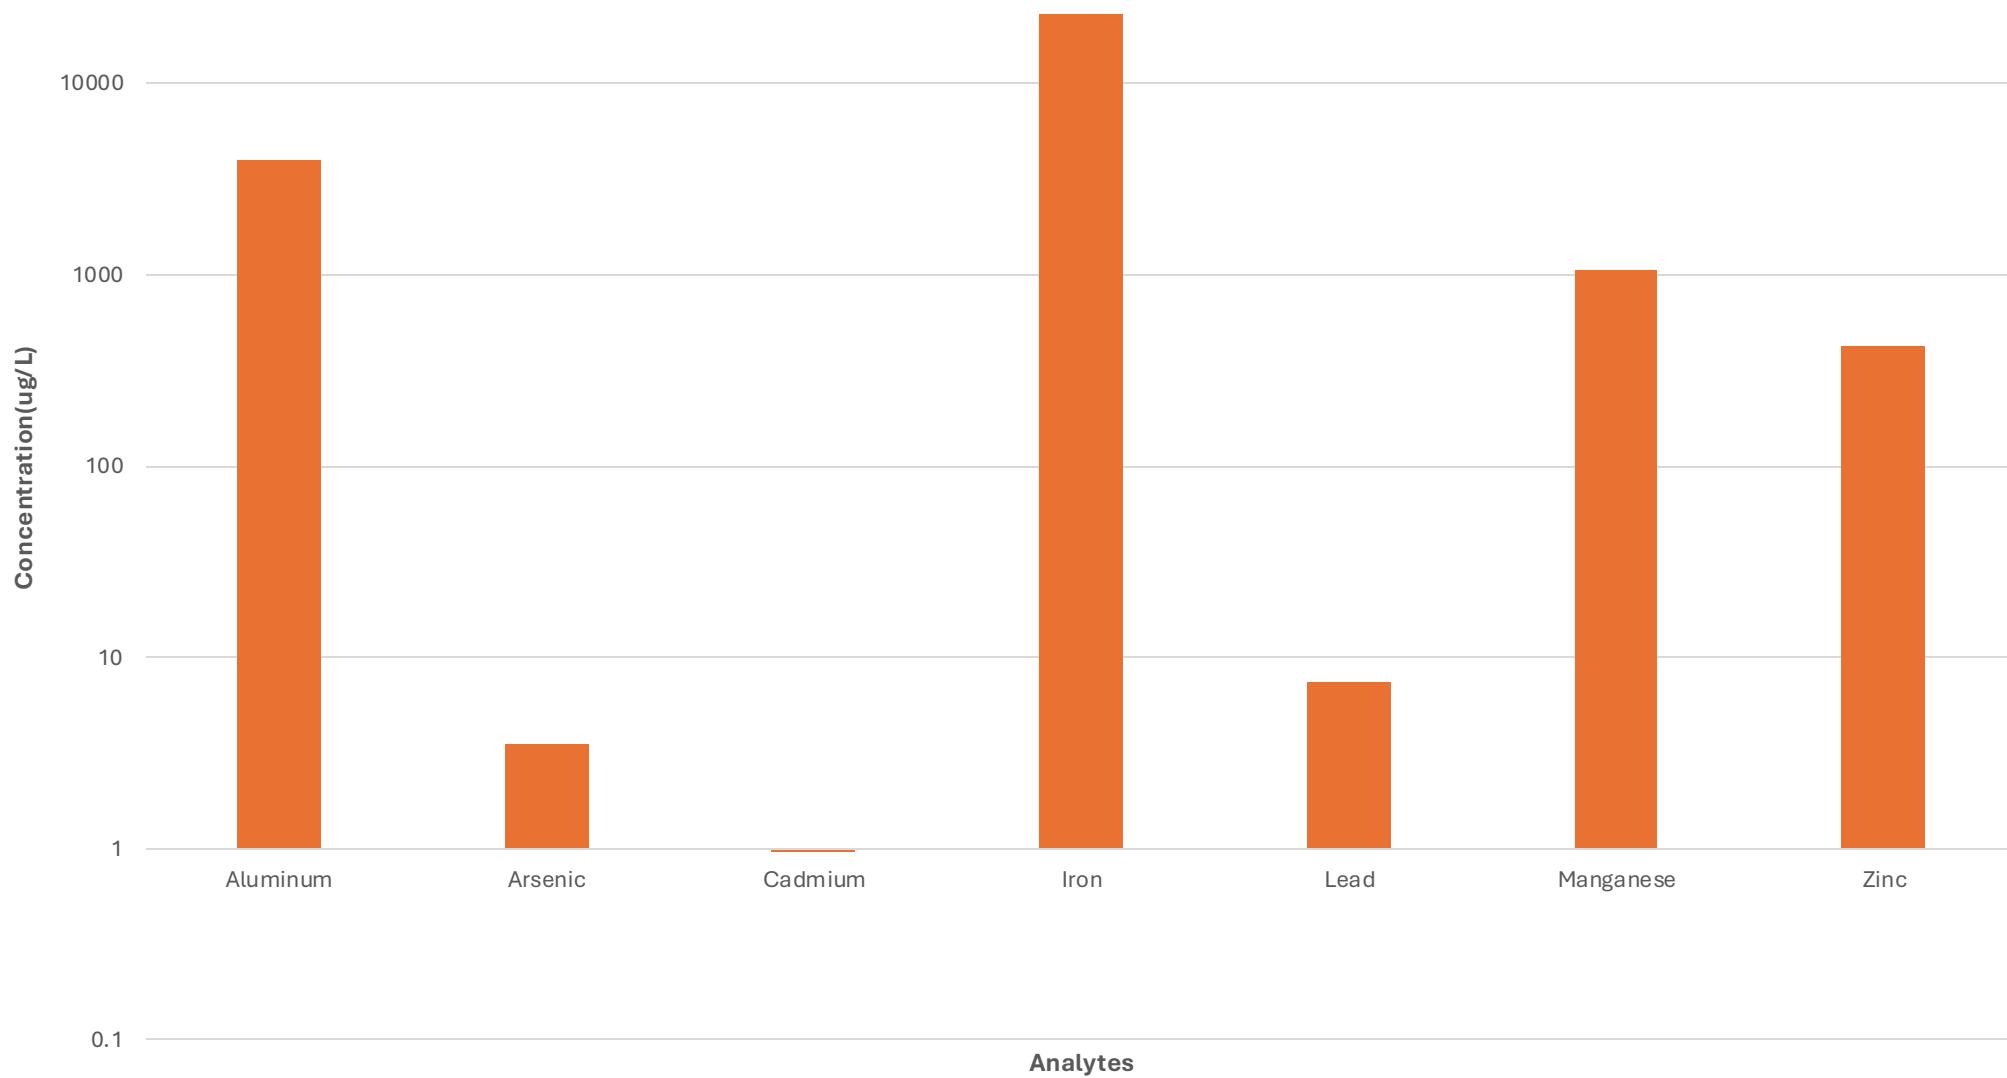
LCCBC (Lower Cement Creek Beaver Complex) Total Metals Concentrations

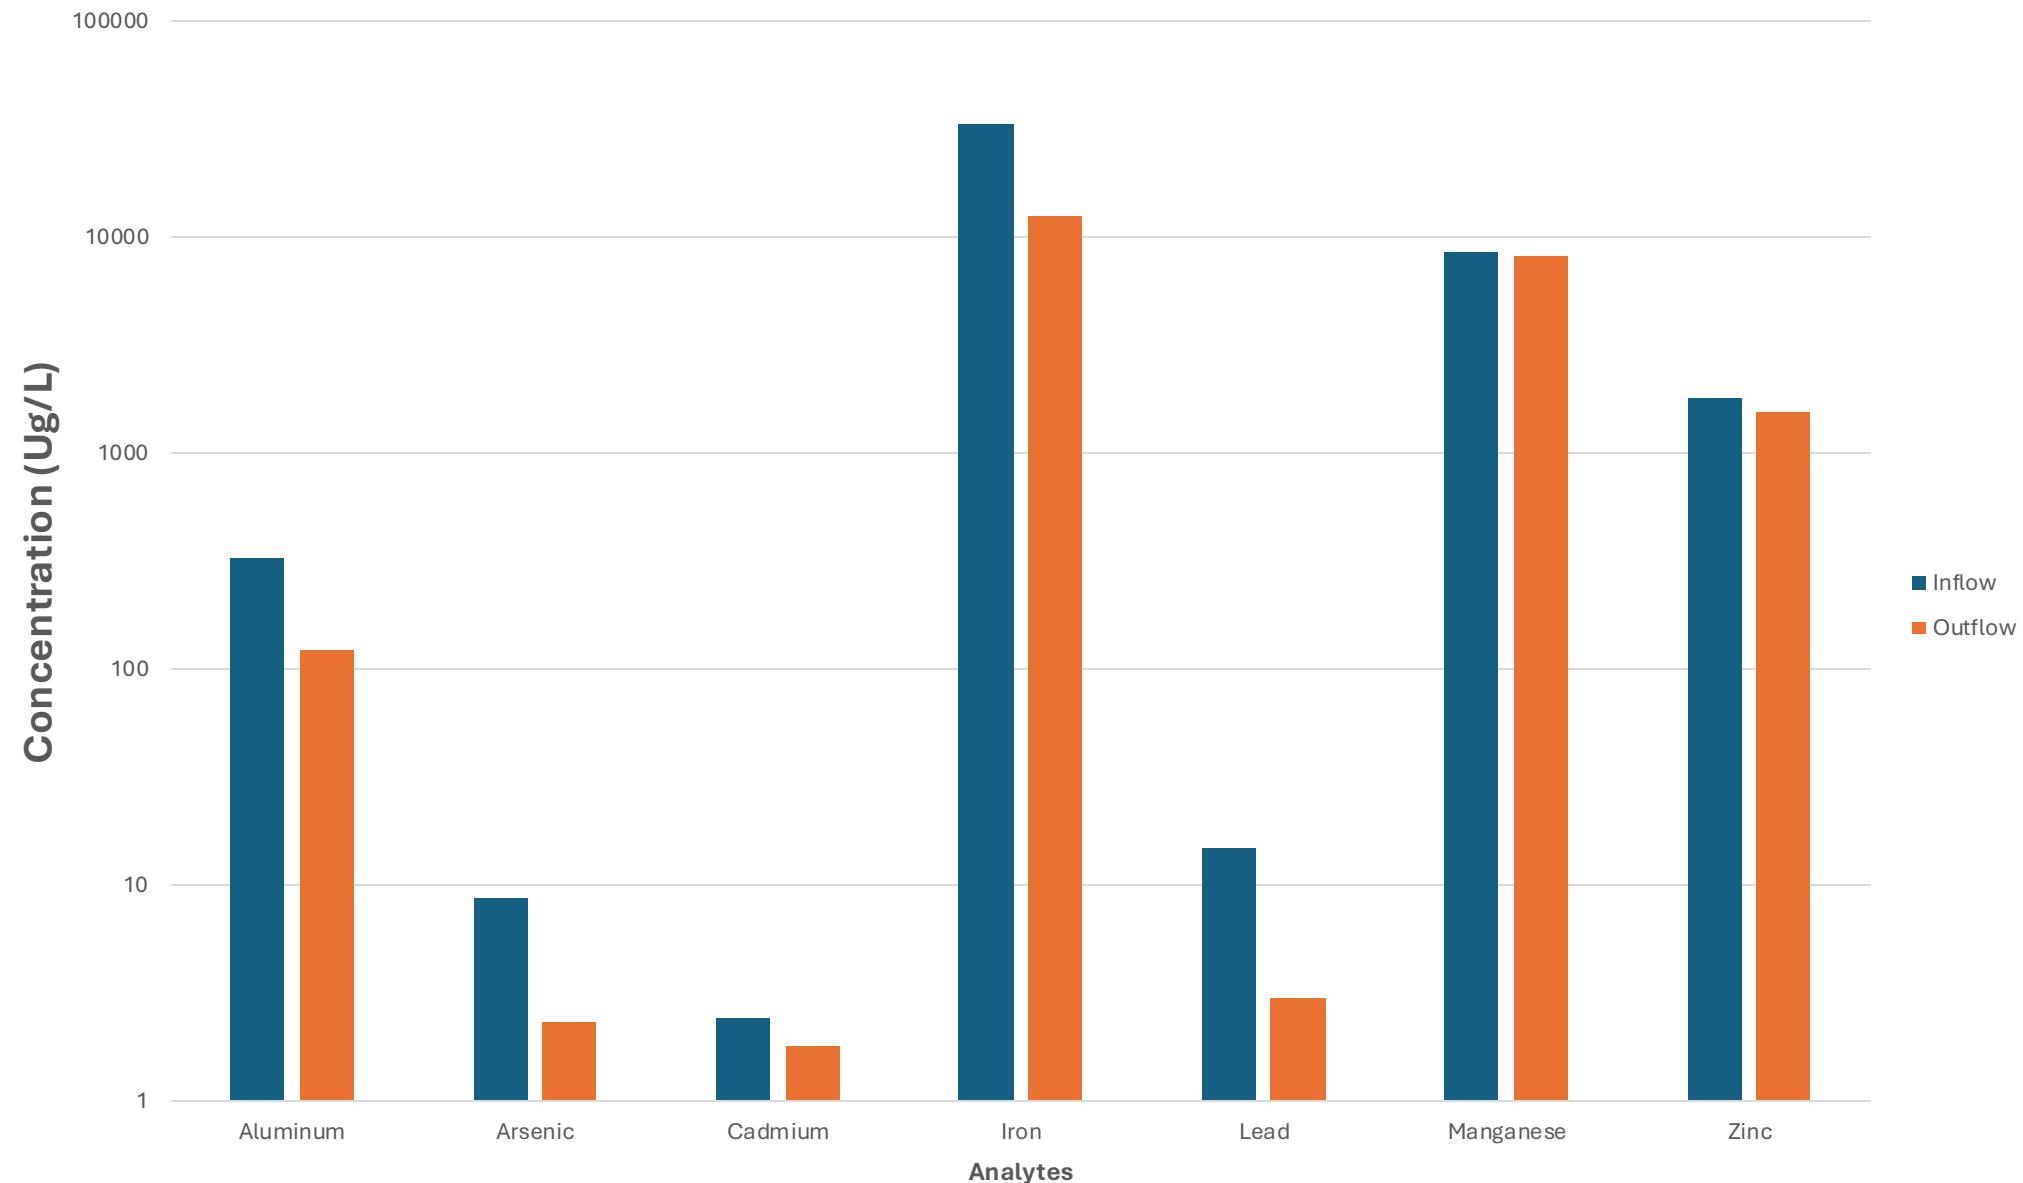
Anglo Saxon Mine Metals Concentrations

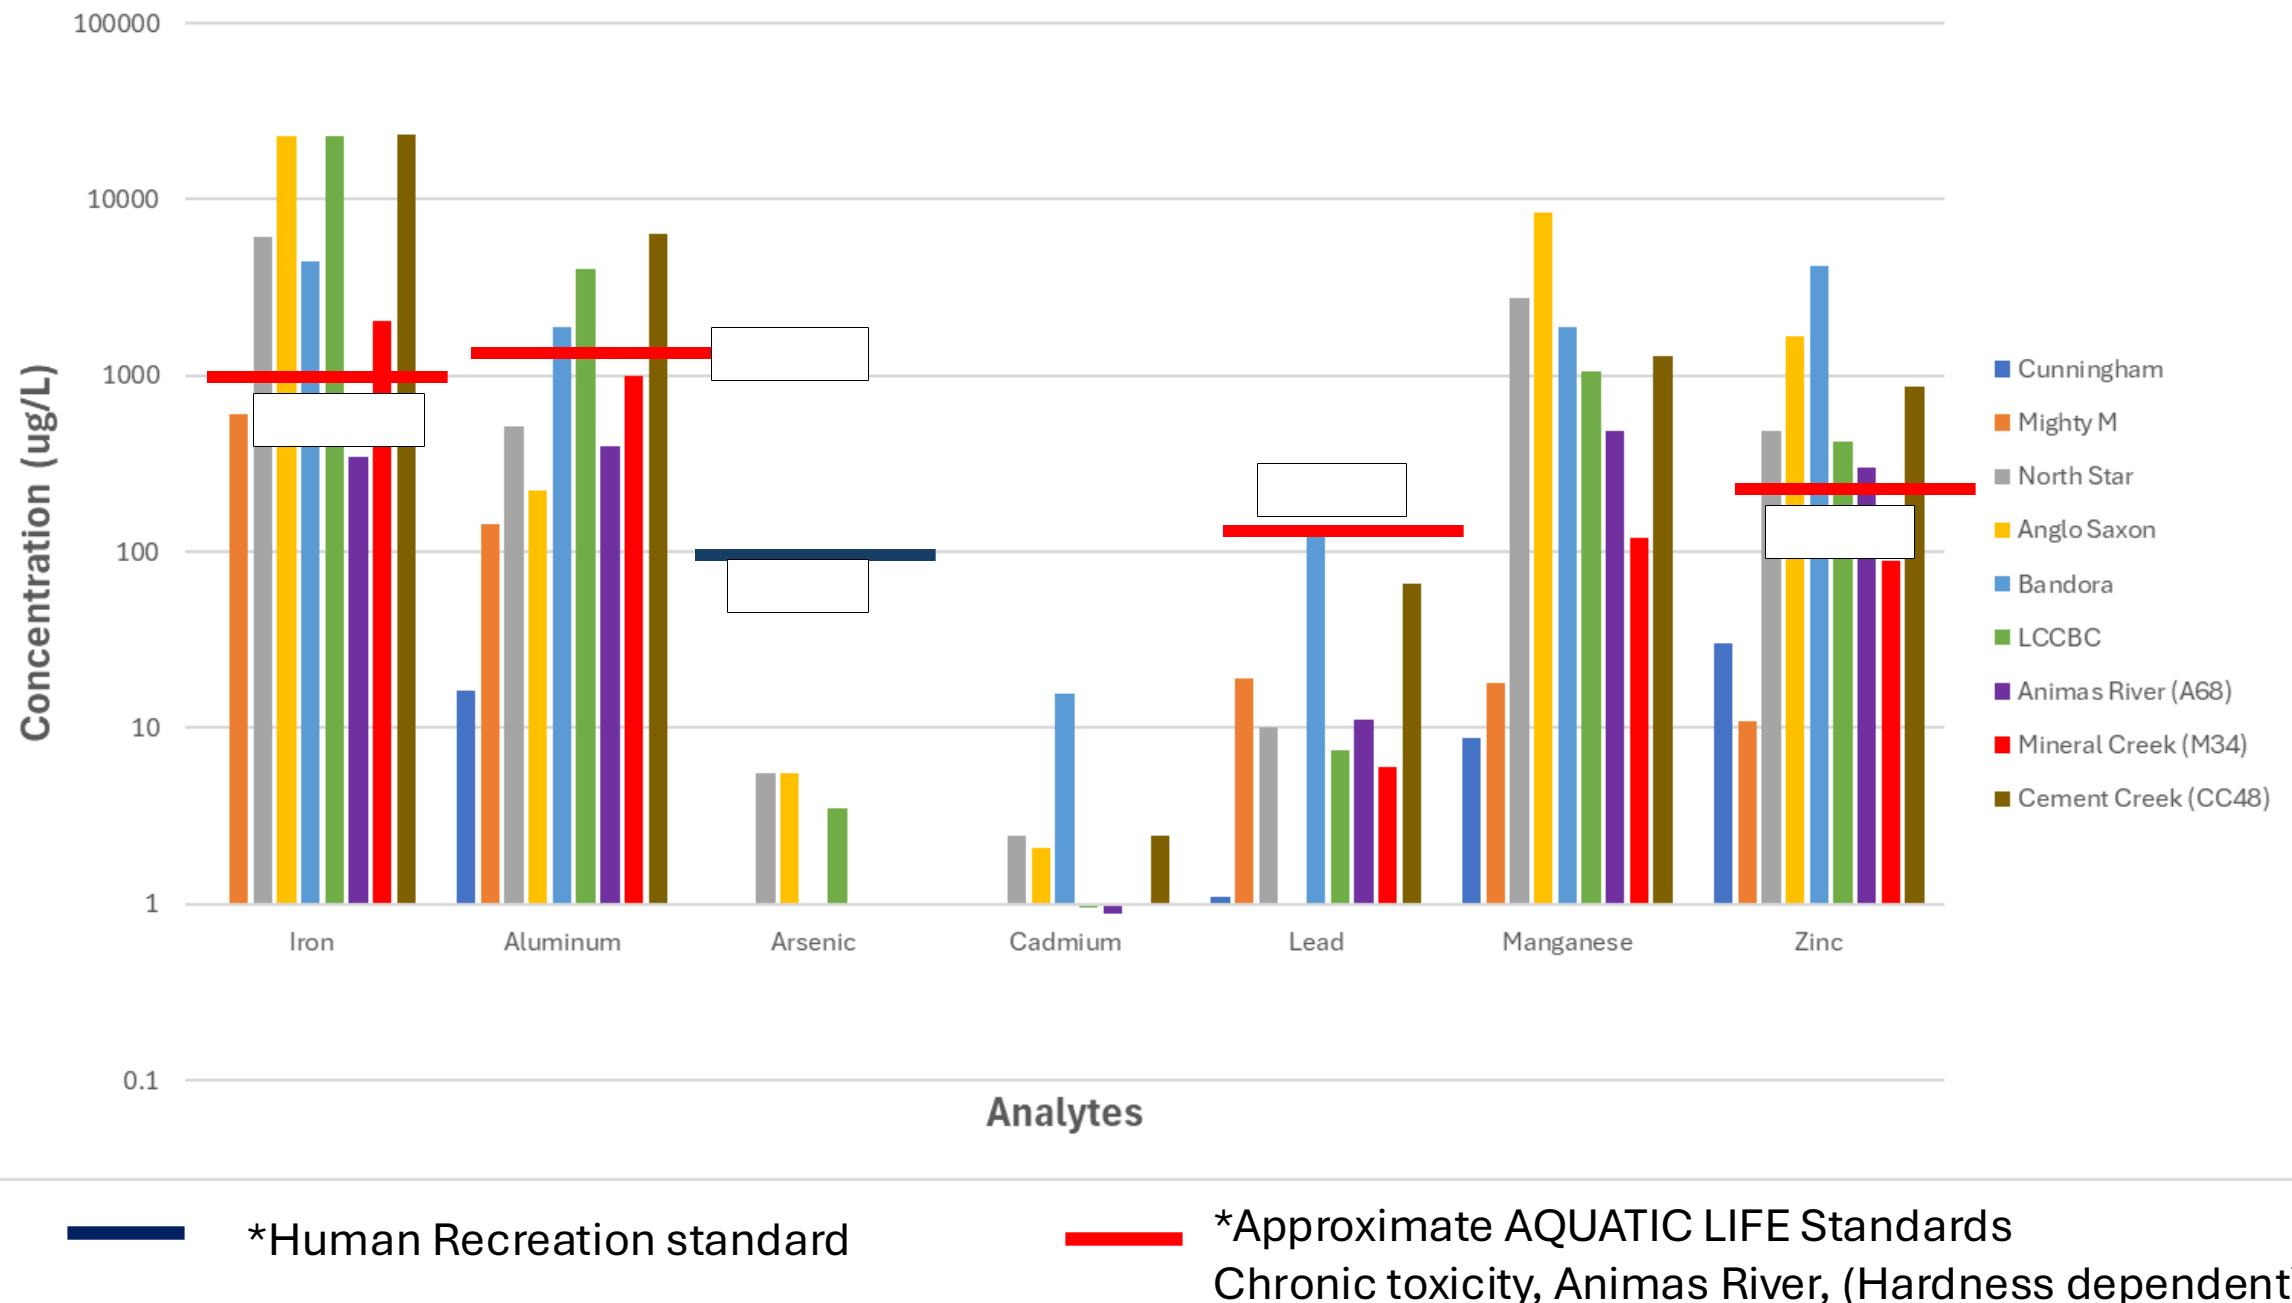
***** Animas River Approximate Metals Standards for Aquatic Life**

Total Metals Concentrations

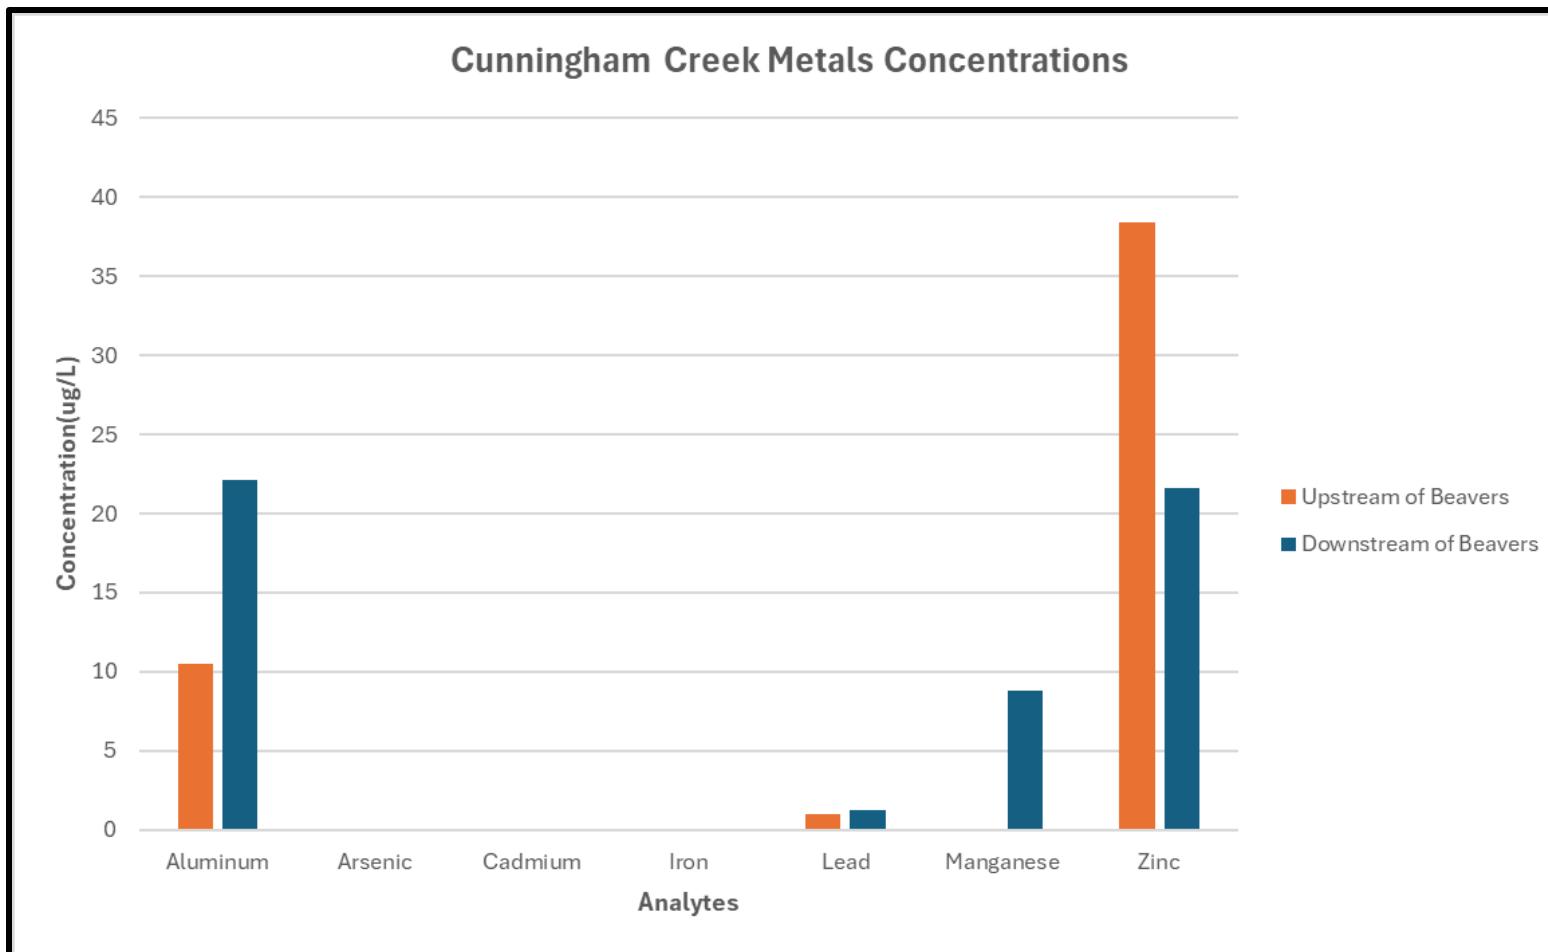
Cunningham Creek Water Quality Upstream and Downstream of Beaver Activity and Mine Water inflows

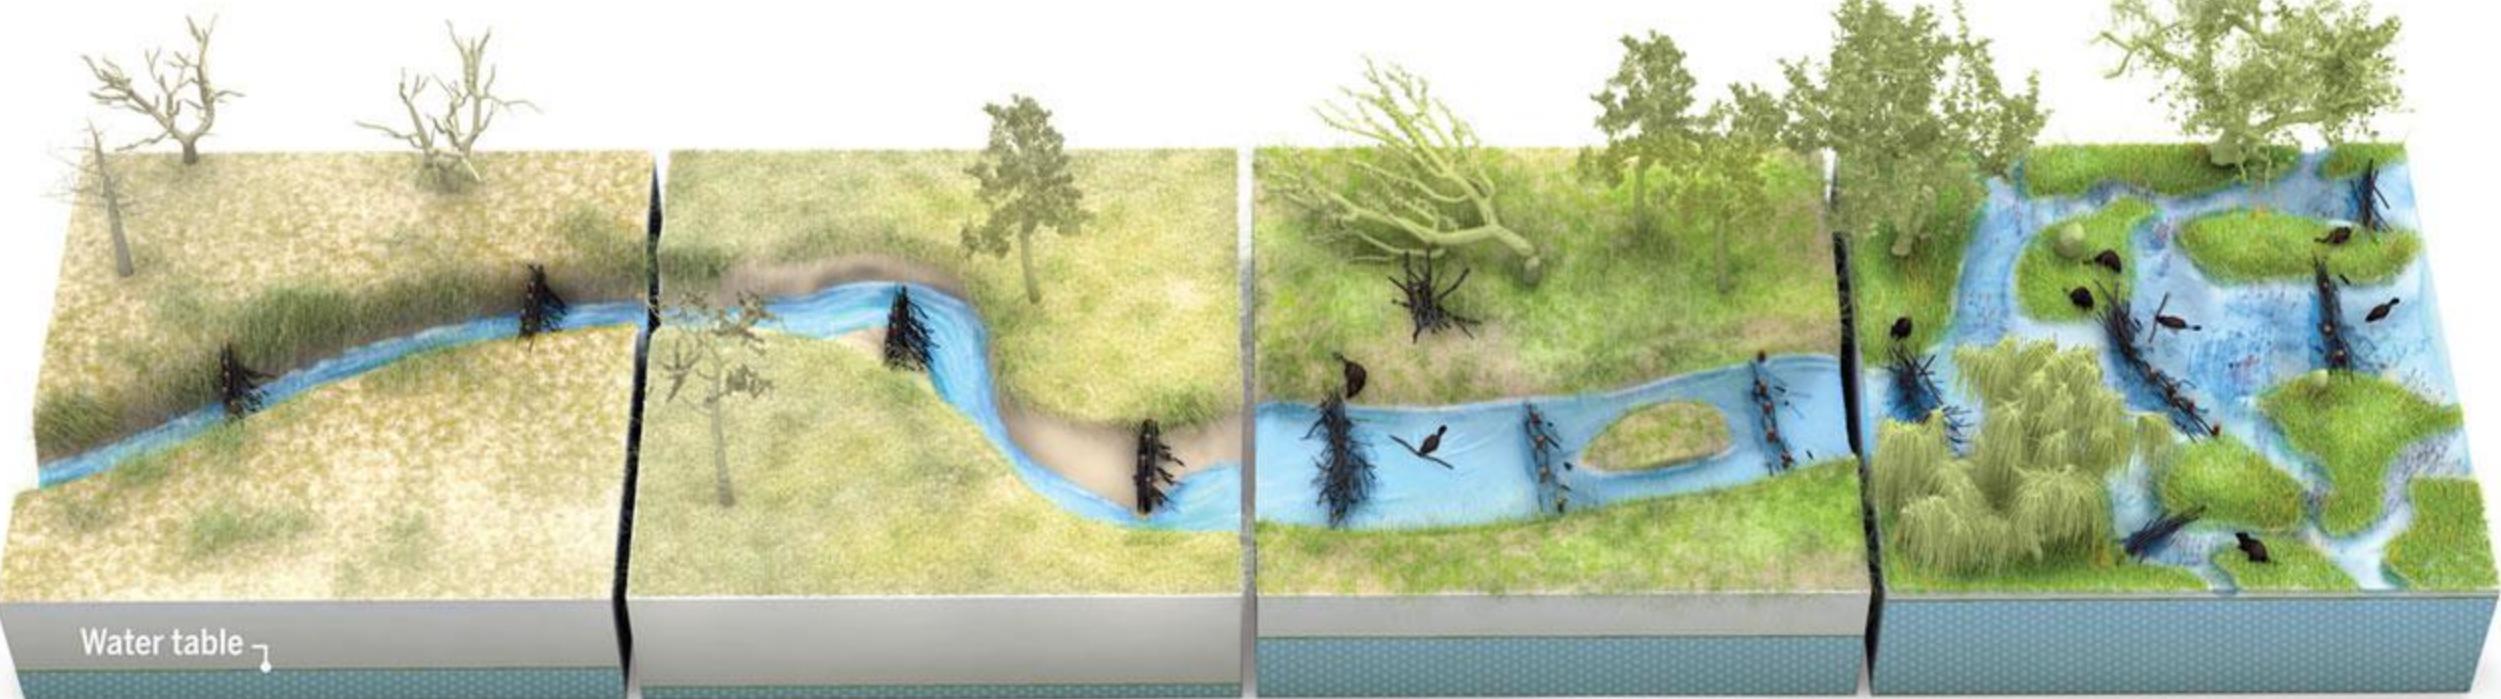
Across the U.S. West, scientists and land managers are using beaver dam analogs (BDAs) to heal damaged streams, re-establish beaver populations, and aid wildlife. In some cases, researchers have seen positive changes in just 1 to 3 years.

Beaver trapping and overgrazing have caused countless creeks to cut deep trenches and water tables to drop, drying floodplains. Installing BDAs can help.

Re-established beavers raise water tables, irrigate new stands of willow and alder, and create a maze of pools and side channels for fish and wildlife.

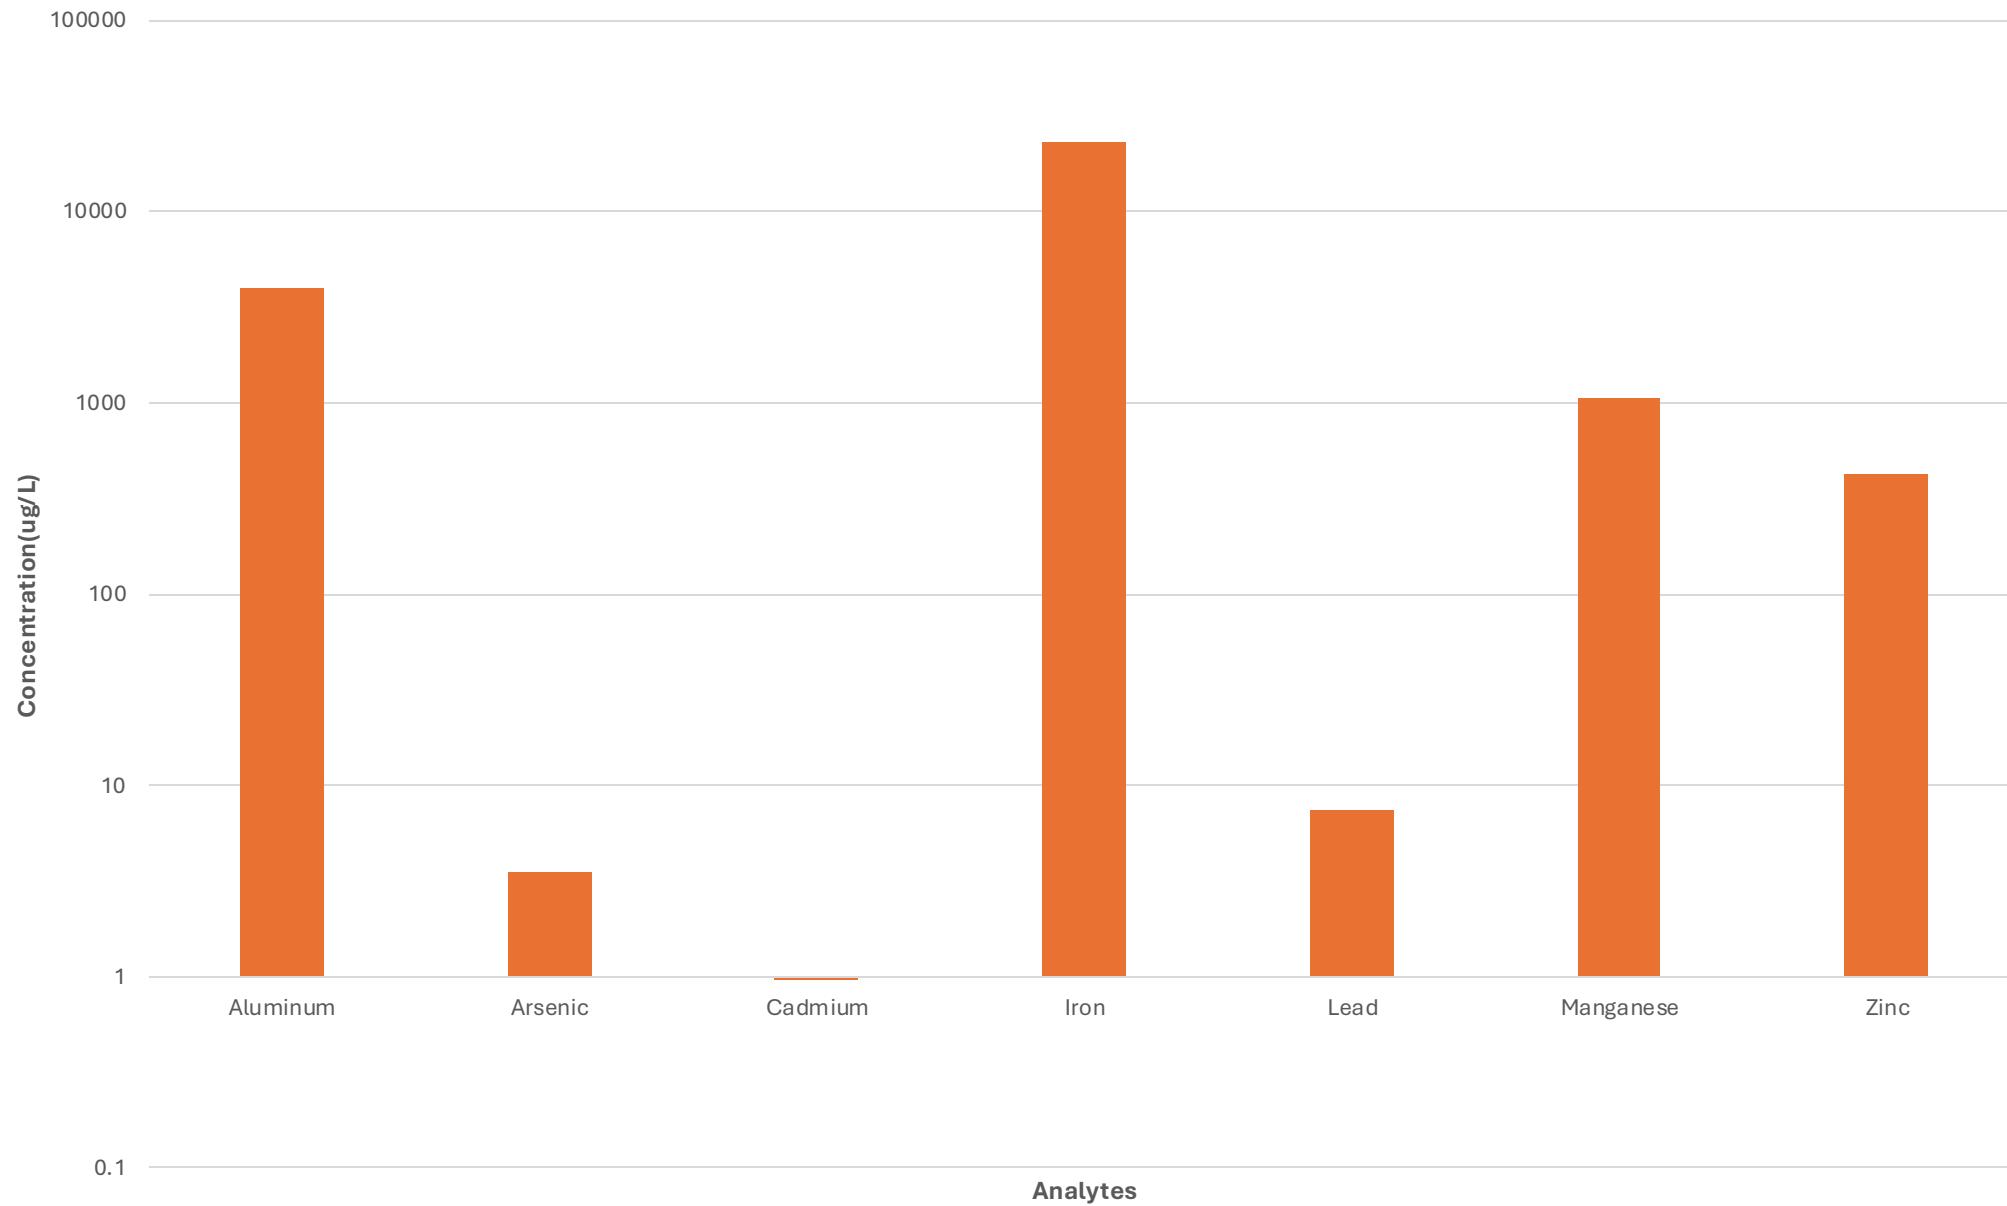
LCCBC Average Metals Concentrations

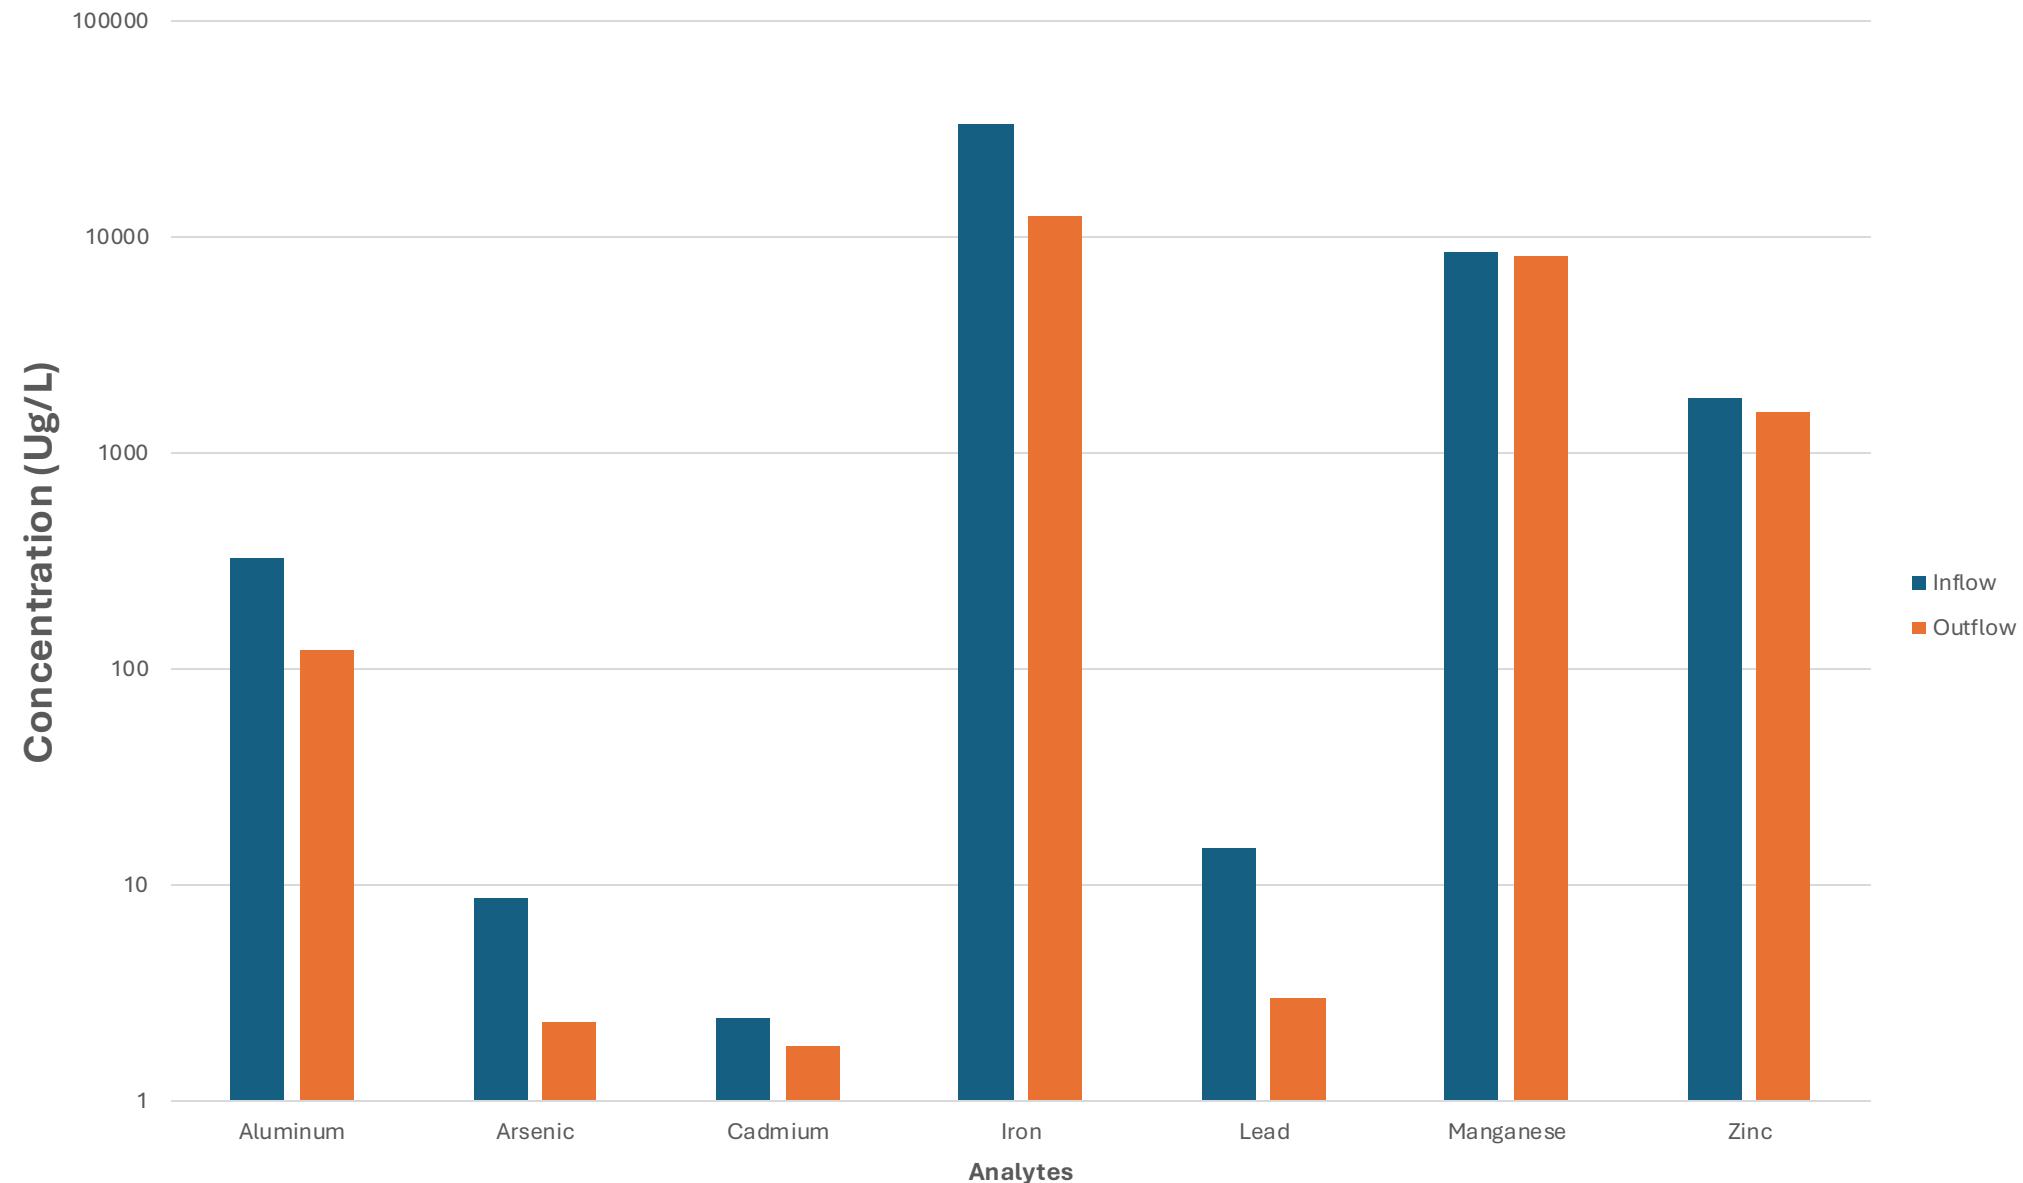
Anglo Saxon Mine Metals Concentrations
