2023-2025 San Juan County Beaver Habitat and Mine Remediation Study

Summary Report

January 2025

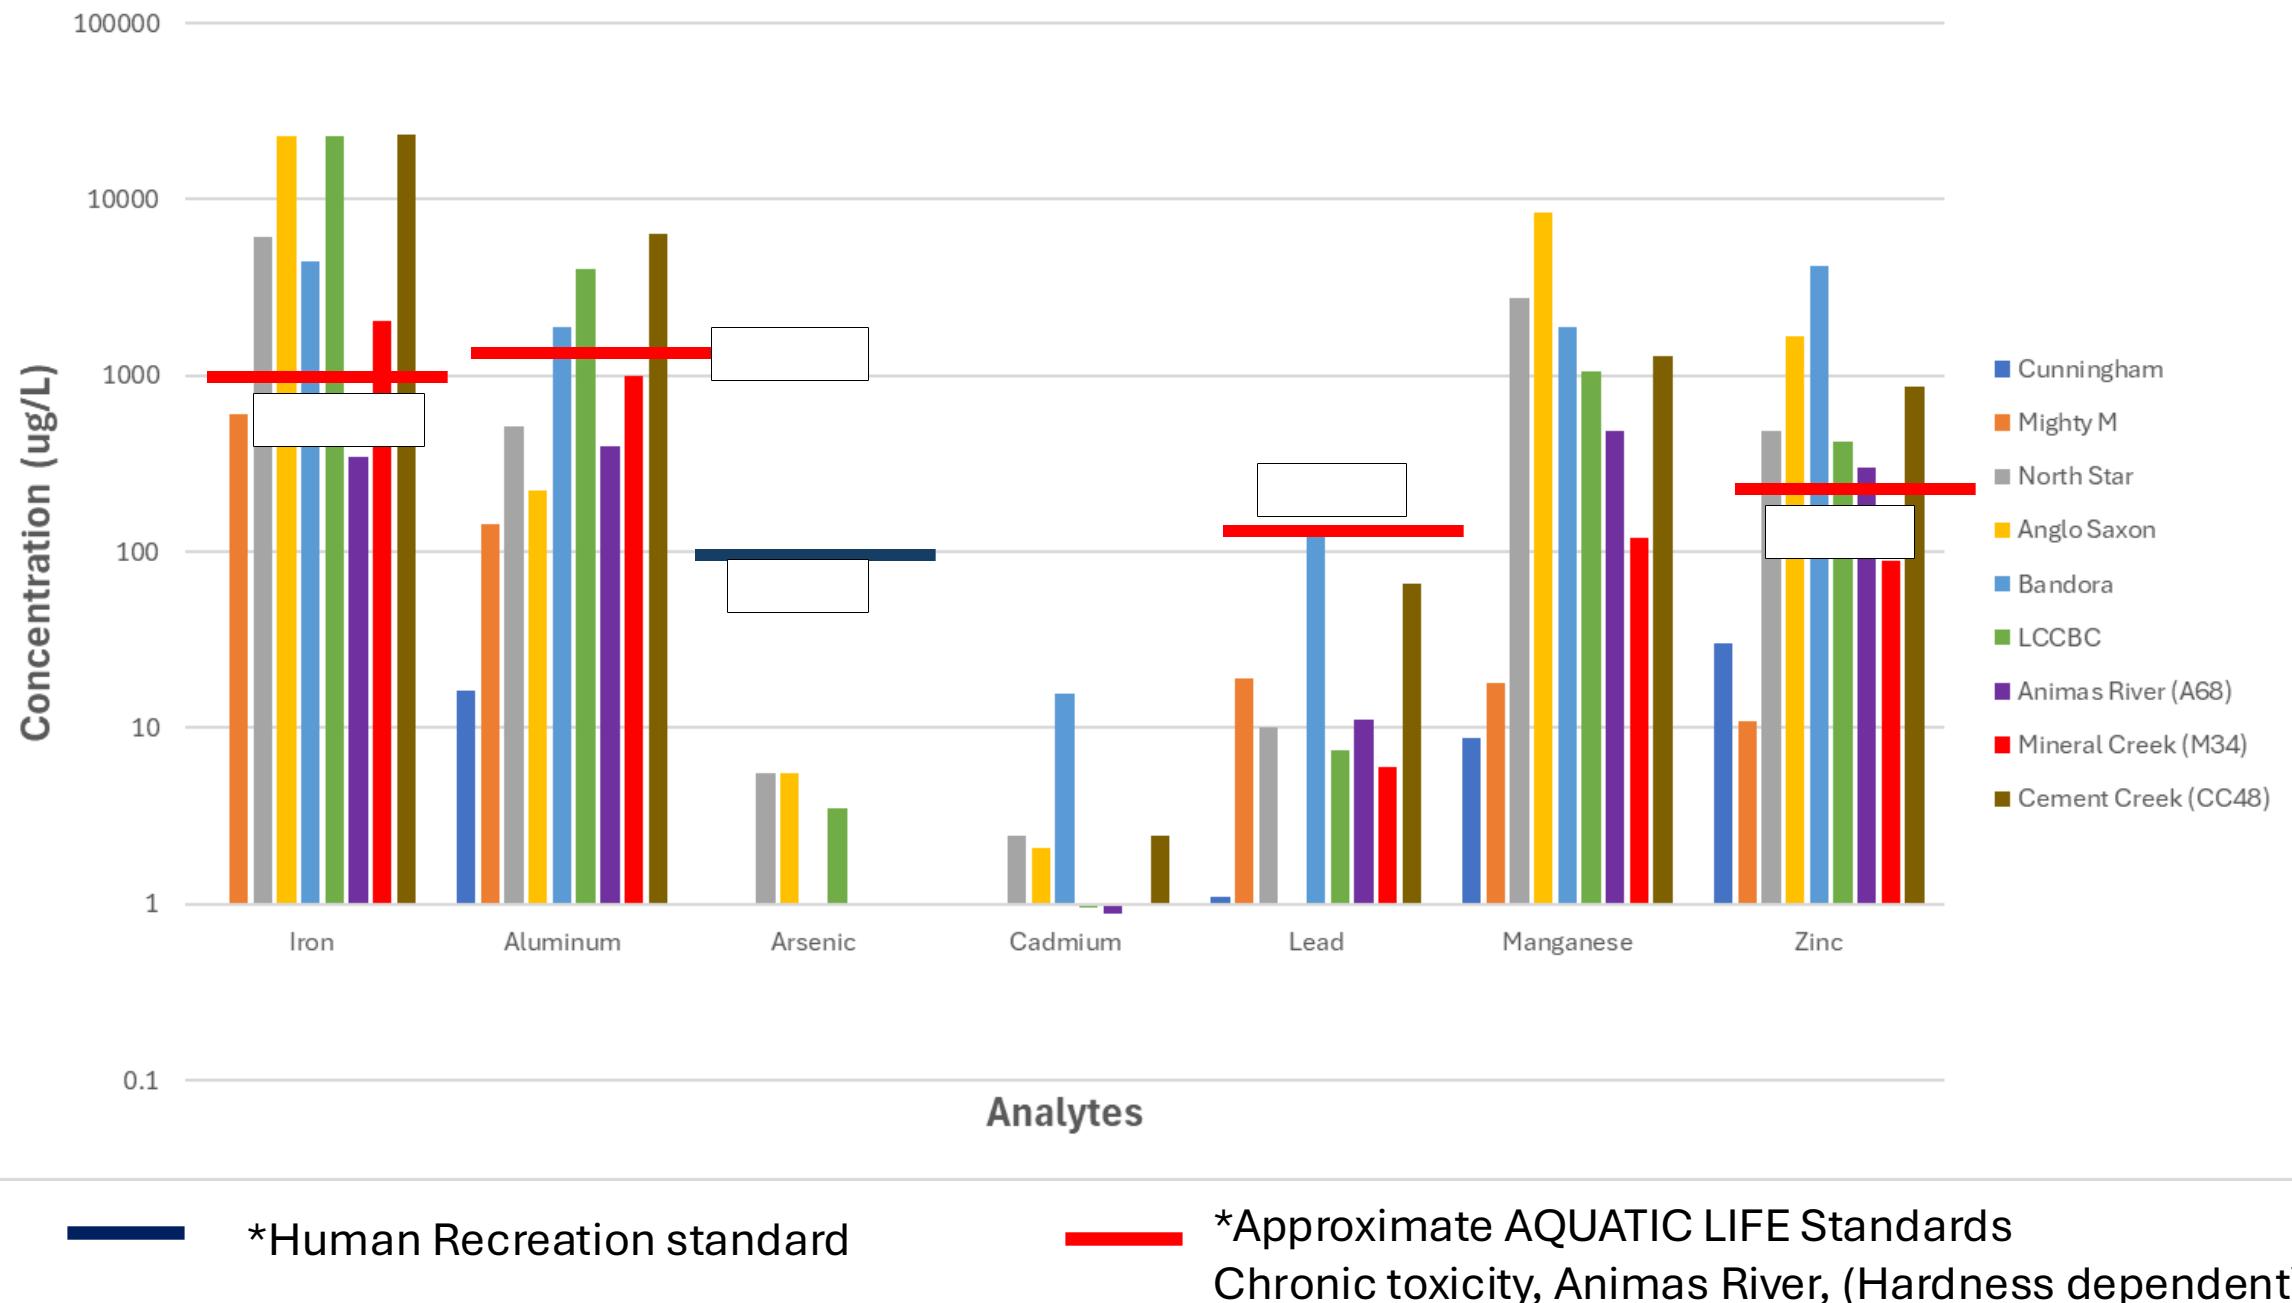
***** Animas River Approximate Metals Standards for Aquatic Life**

Total Metals Concentrations

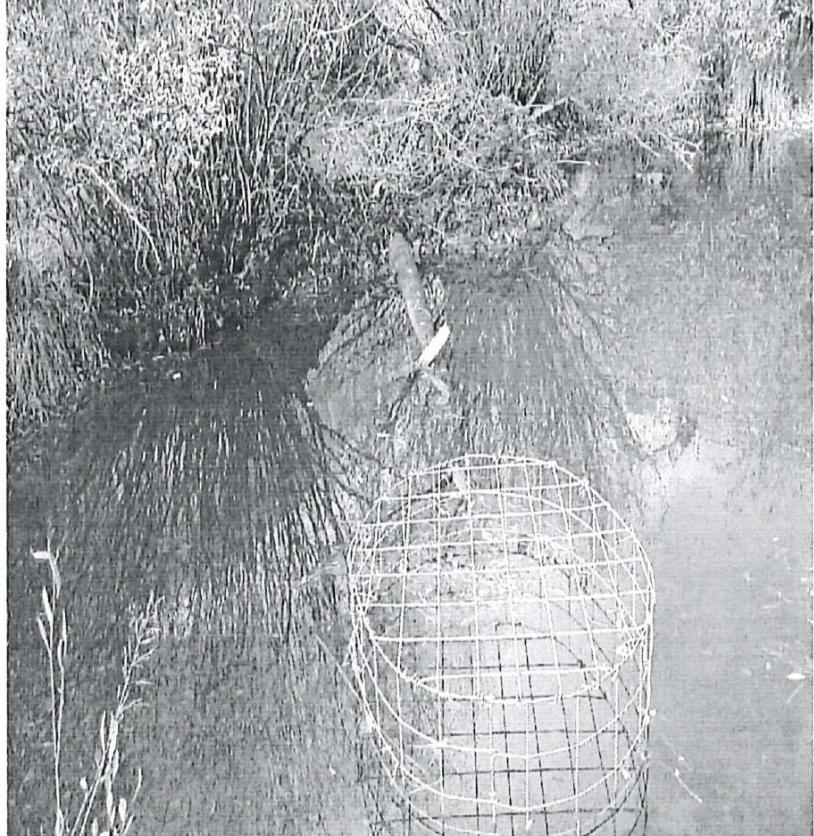
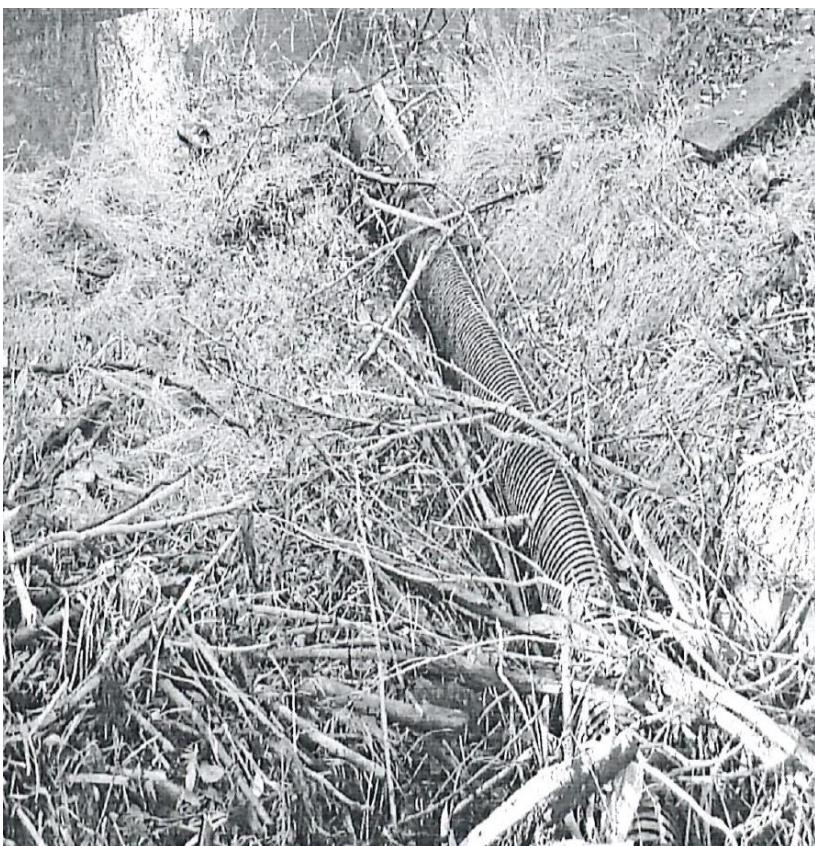
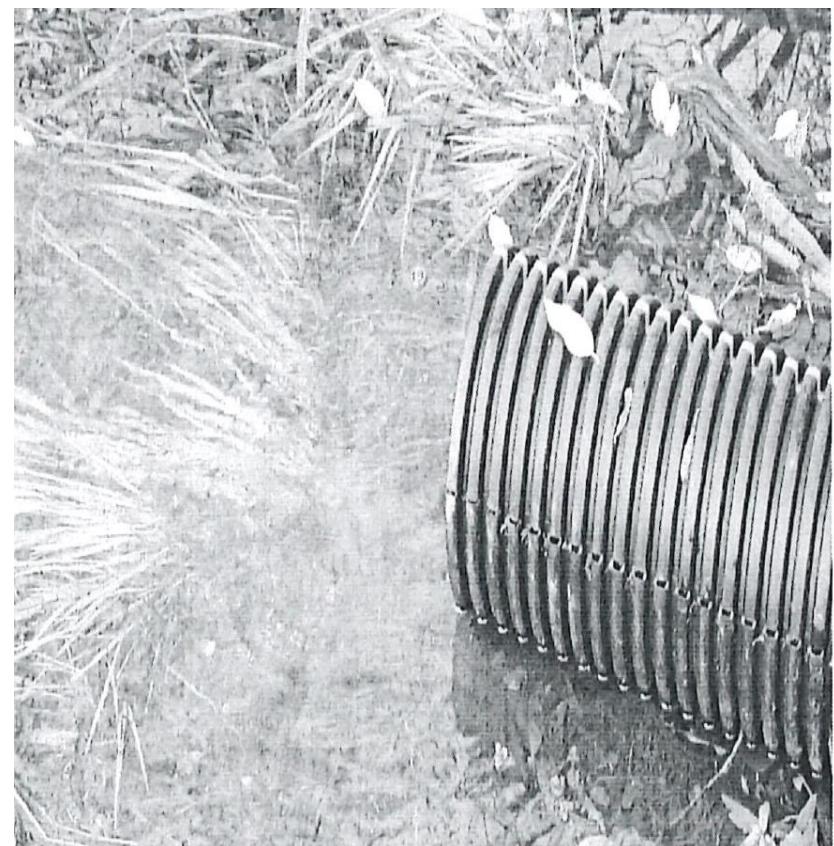
5 months after install

- No activity around the inflow fence
- Some activity over the dam section but no damming of outflow
