RE: **Long Term Stewardship Report**
International Paper, Richmond Gravure Facility
EPA ID VAD046979498

**Long-Term Stewardship Assessment Report
International Paper, Richmond Gravure Facility
EPA ID VAD046979498**

International Paper-Richmond
2025 Long-Term Stewardship Inspection

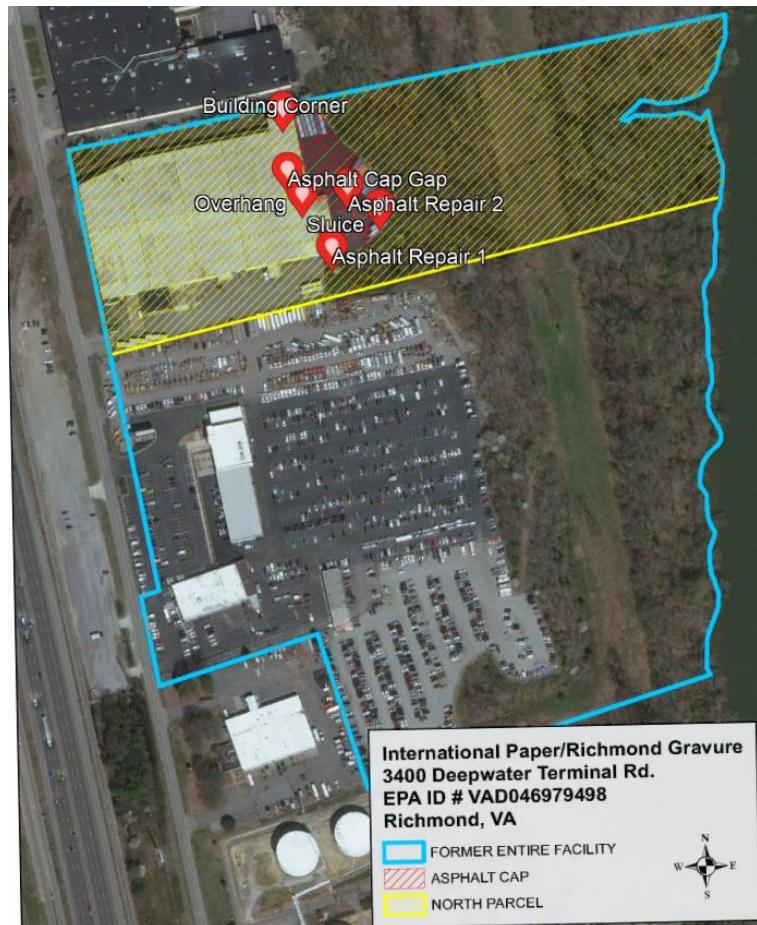
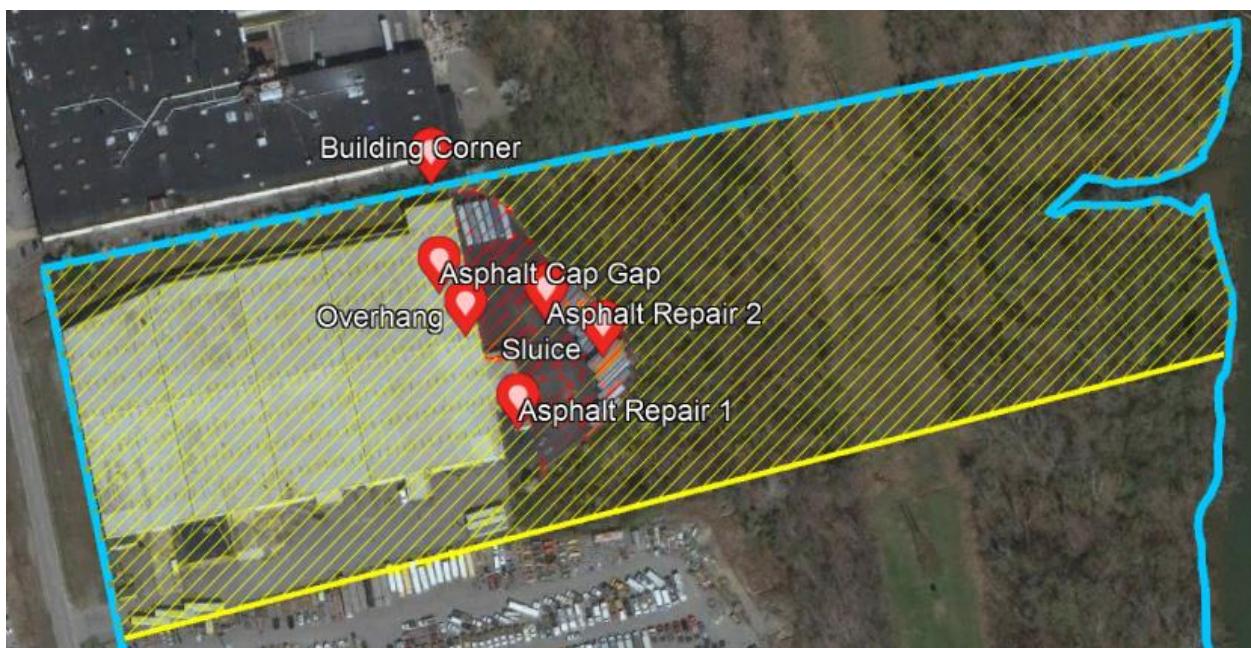
DEQ Long Term Stewardship Facility Map
International Paper-Richmond – Richmond, Virginia

Mapping: The EPA Facility website figure has been updated with a Geospatial PDF showing the use restriction boundaries. The map was field-verified, and the portion of the asphalt cap under the overhang is not fully represented in the Geospatial PDF.

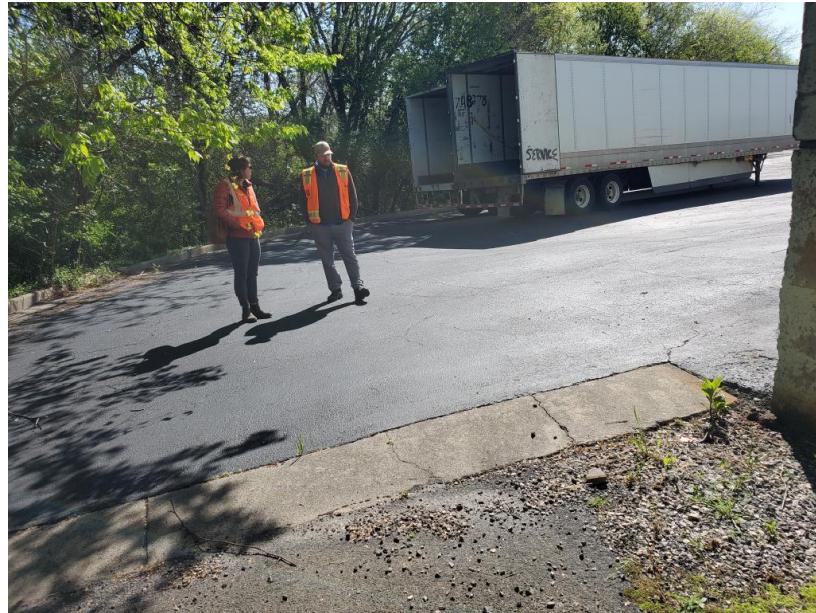
Building Corner

At northern building corner facing East. Edge of asphalt cap.

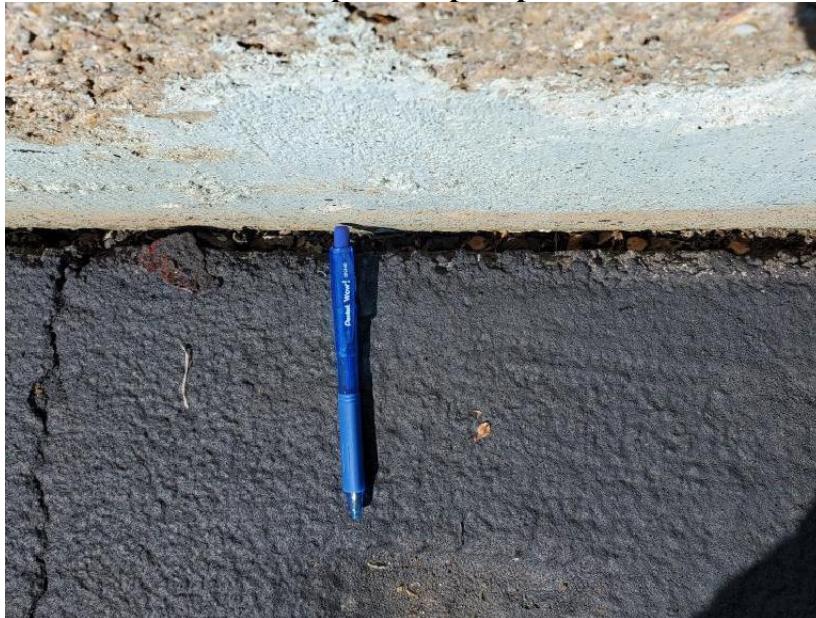
Asphalt Cap Gap

At eastern side of building facing West. A gap between the building and asphalt cap has been reported since the 2018 Annual Inspection and Cap Maintenance Report. Gap does not appear to have increased significantly.

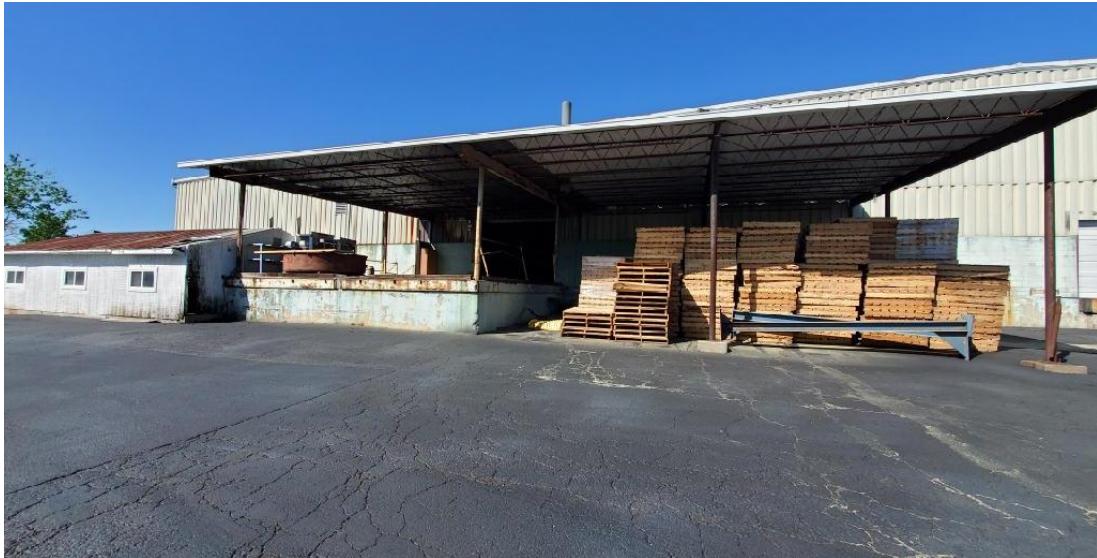
Overhang

At the eastern edge of the dock overhang facing West. Asphalt cap and new sealant were observed below the overhang adjacent to the dock.

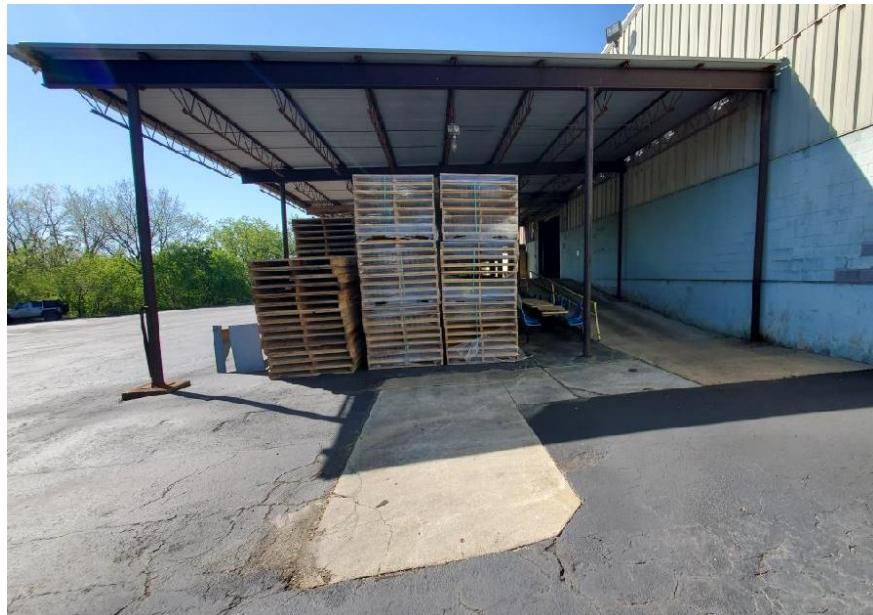
At the northern edge of the dock overhang facing South. Asphalt cap and new sealant appear to extend below the overhang.

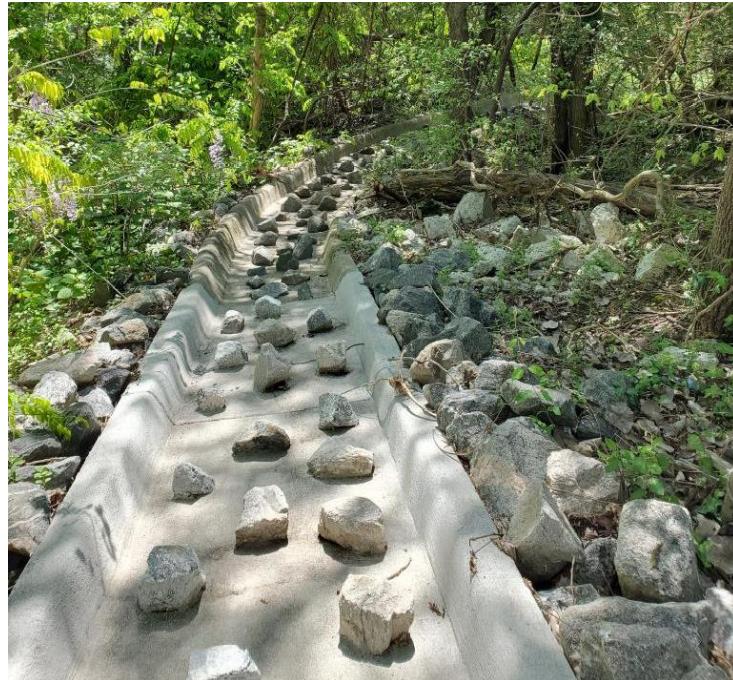
Sluice

At eastern edge of the Asphalt Cap facing east towards the sluice. The upper portion of the sluice starting from the Asphalt Cap has been replaced.

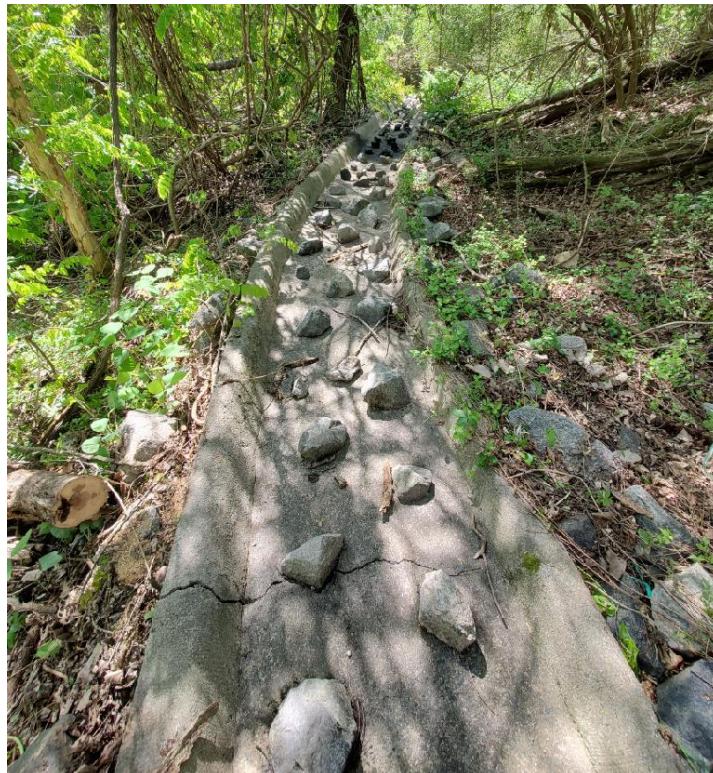
In the sluice facing East. Cracks were observed in the sluice. Facility stated that the cracks will be sealed.

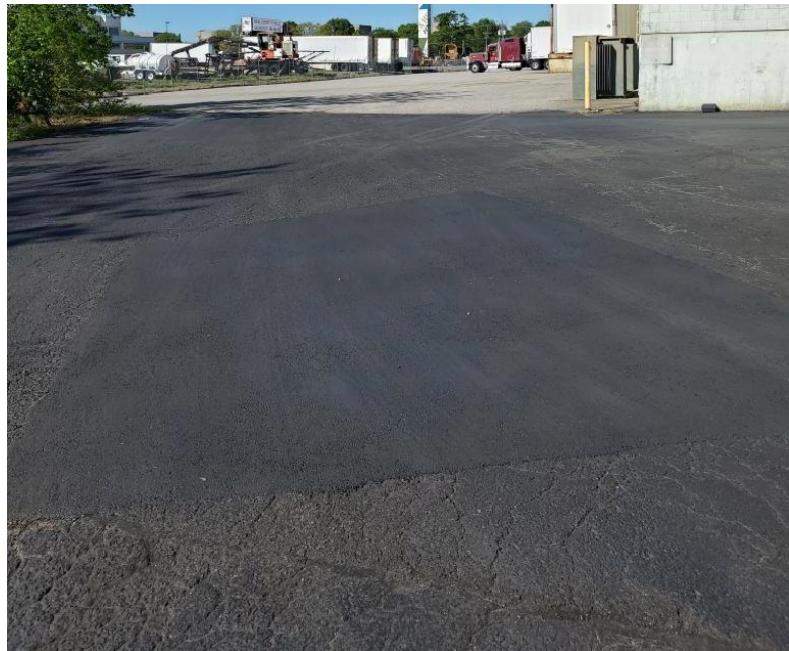
Asphalt Repair 1 and 2

Asphalt Repair 1: Southern boundary of Asphalt Cap facing Southwest. Repairs were made in an area of asphalt surface deterioration noted in 2024 annual report.

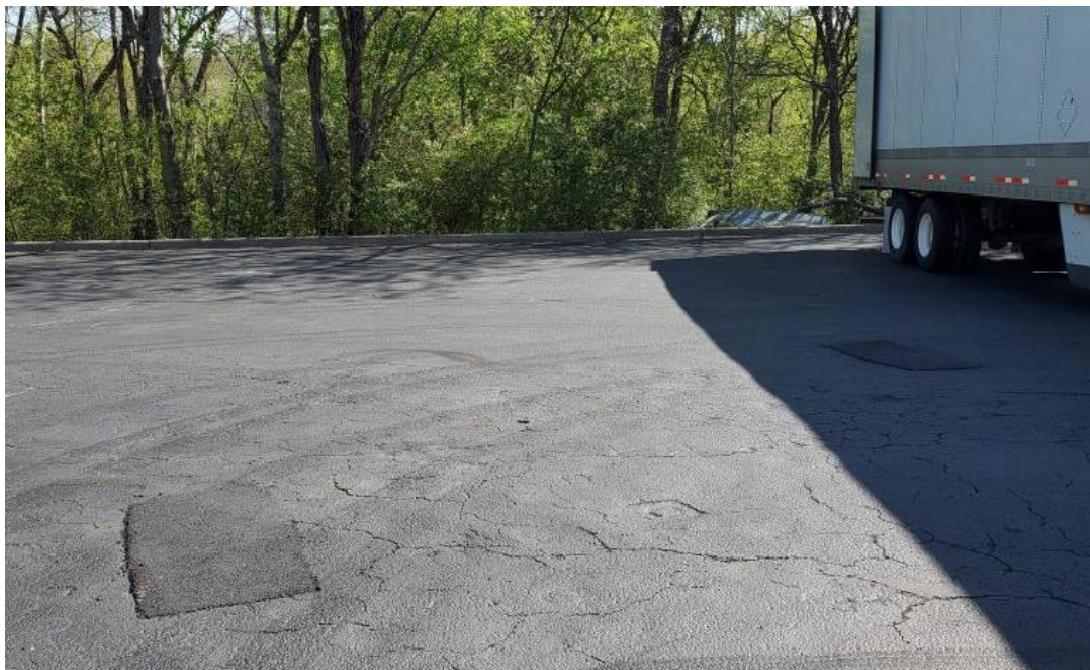
Asphalt Repair 2: Eastern portion of Asphalt Cap facing East. Additional examples of repairs to the asphalt.

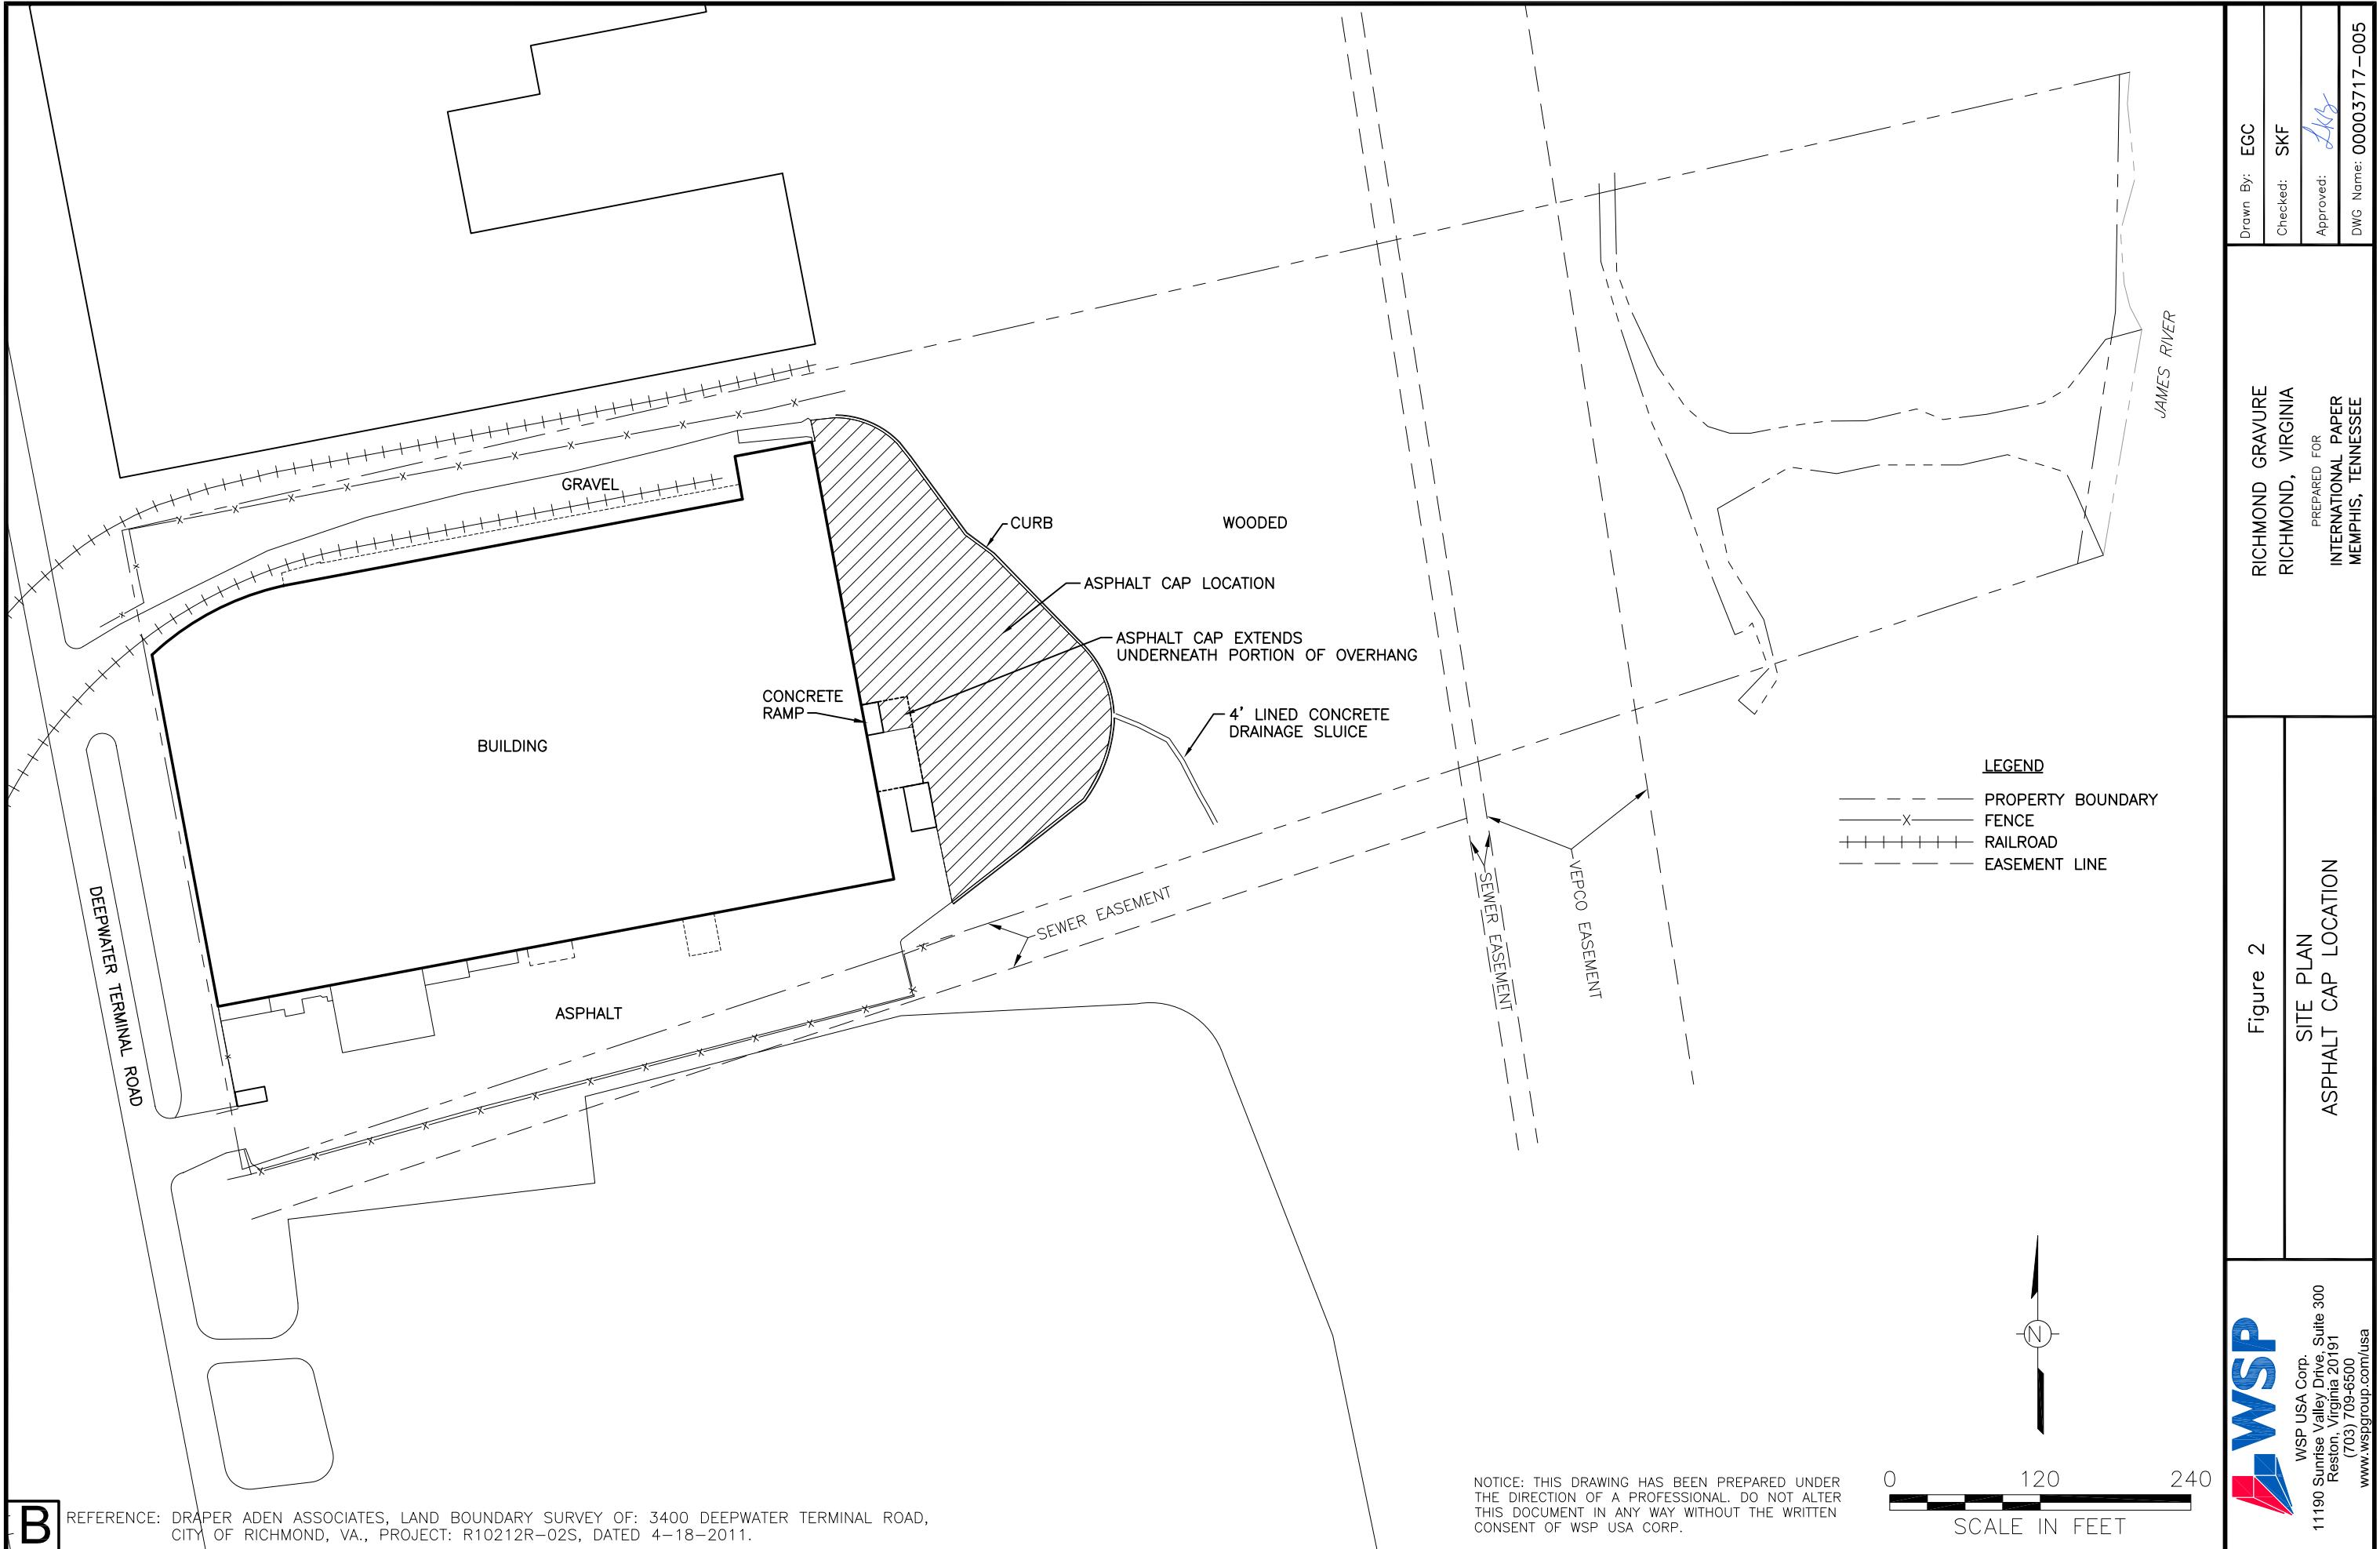
- The report noted repairs that were made on September 16, 2014 to the asphalt cap, which addressed the final note in the EPA assessment.
 - The report included a Site Plan (Figure 2) that depicted the most current boundaries of the asphalt cap. This figure is included in the attachments of this LTS report.

A minor follow-up action is to revise the EPA Geospatial PDF to include the asphalt cap under the dock overhang as per Figure 2 of the 2014 Annual Inspection and Asphalt Cap Maintenance report. Figure 2 has been included as part of the attachments to this LTS report.
