Municipality/Organization: Department of Conservation and Recreation

**Annual Report Number
& Reporting Period:** No. 6: May 08-April 09

Department of Conservation and Recreation NPDES PII Small MS4 General Permit Annual Report

Potential Illicit Discharge Detection and Elimination Report

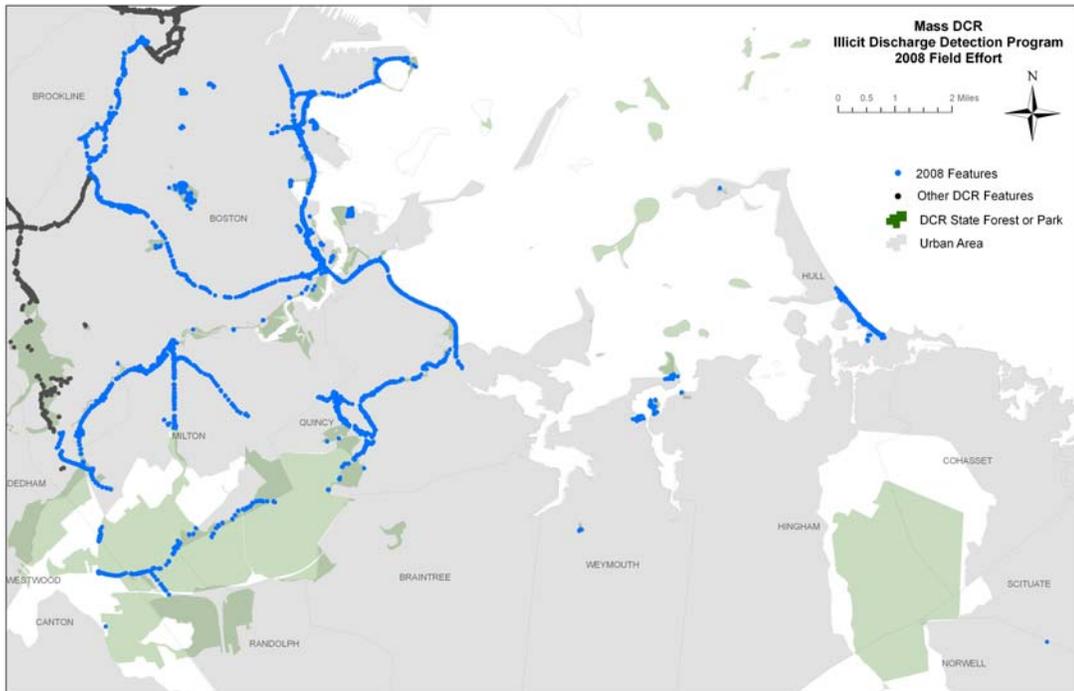
Figure 3-1 2008 IDD Inspection Area

AECOM implemented the IDD protocol outlined in Section 2.2 and began field investigations of DCR's drainage systems on July 29th 2008. The effort focused on the DCR parks and parkways of IDD Zone 1 located in the southern Boston metro area (Figure 3-1). This zone encompasses several large parks including the Blue Hills Reservation and Old Harbor Reservation along with major roads like the Furnace Brook Parkway, Morrissey Boulevard and the JamaicaWay. This section presents AECOM's inspection activities and results.

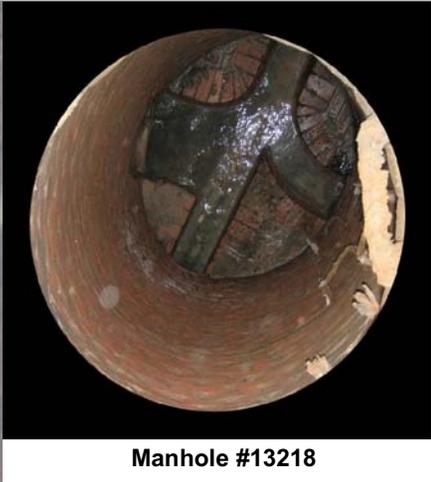
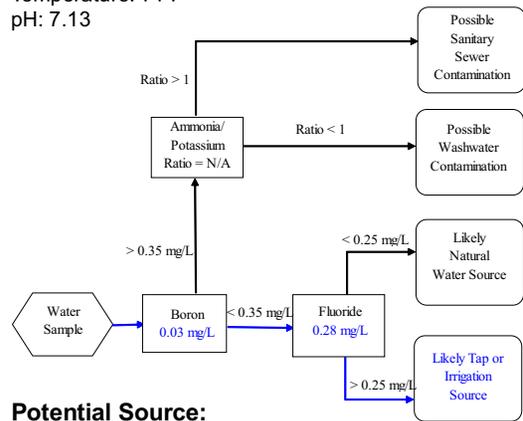
Figure 3-8 Summary for Feature 17063
Furnace Brook Parkway, Quincy
Inspection Date: 9/4/08

Days since last rain event: 16, (0.10")
 Temperature: 71 F
 pH: 7.13

Potential Source:

Discharge to Manhole #17063

-Source determination with City of Quincy

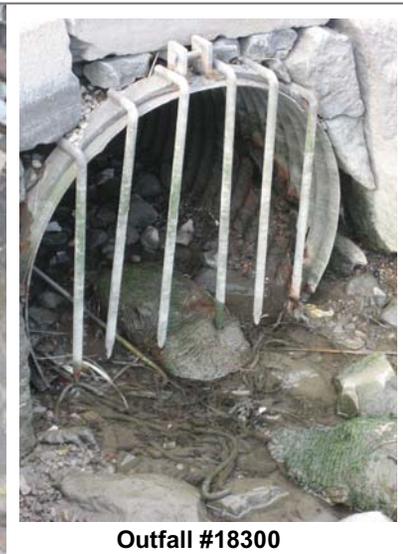
Figure 3-10 Summary for Feature 18313
Devine Rink, Boston
Inspection Date: 10/16/08

Days since last rain event: 15, (0.56")
 Temperature: 69 F
 pH: 7.14

Potential Source:

-Follow up with Devine Rink Manager (DCR) to identify and/or eliminate discharge

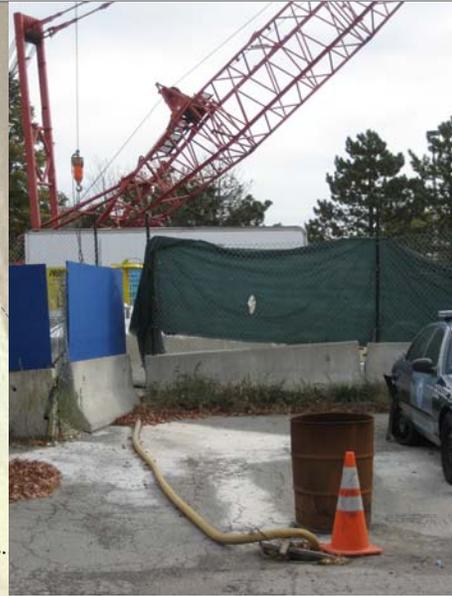
Figure 3-11 Summary for Feature 18480
Old Harbor Reservation, Boston
Inspection Date: 10/23/08

Days since last rain event: 22, (0.56")
 Temperature: 72 F
 pH: 7.12

Potential Source:
 Construction area (MWRA)
