Draft Wanaque River Corrective Measures Study

Pompton Lakes Works Site
Pompton Lakes, Passaic County, New Jersey

April 30, 2019

The Chemours Company FC, LLC
2000 Cannonball Road
Pompton Lakes, NJ 07442

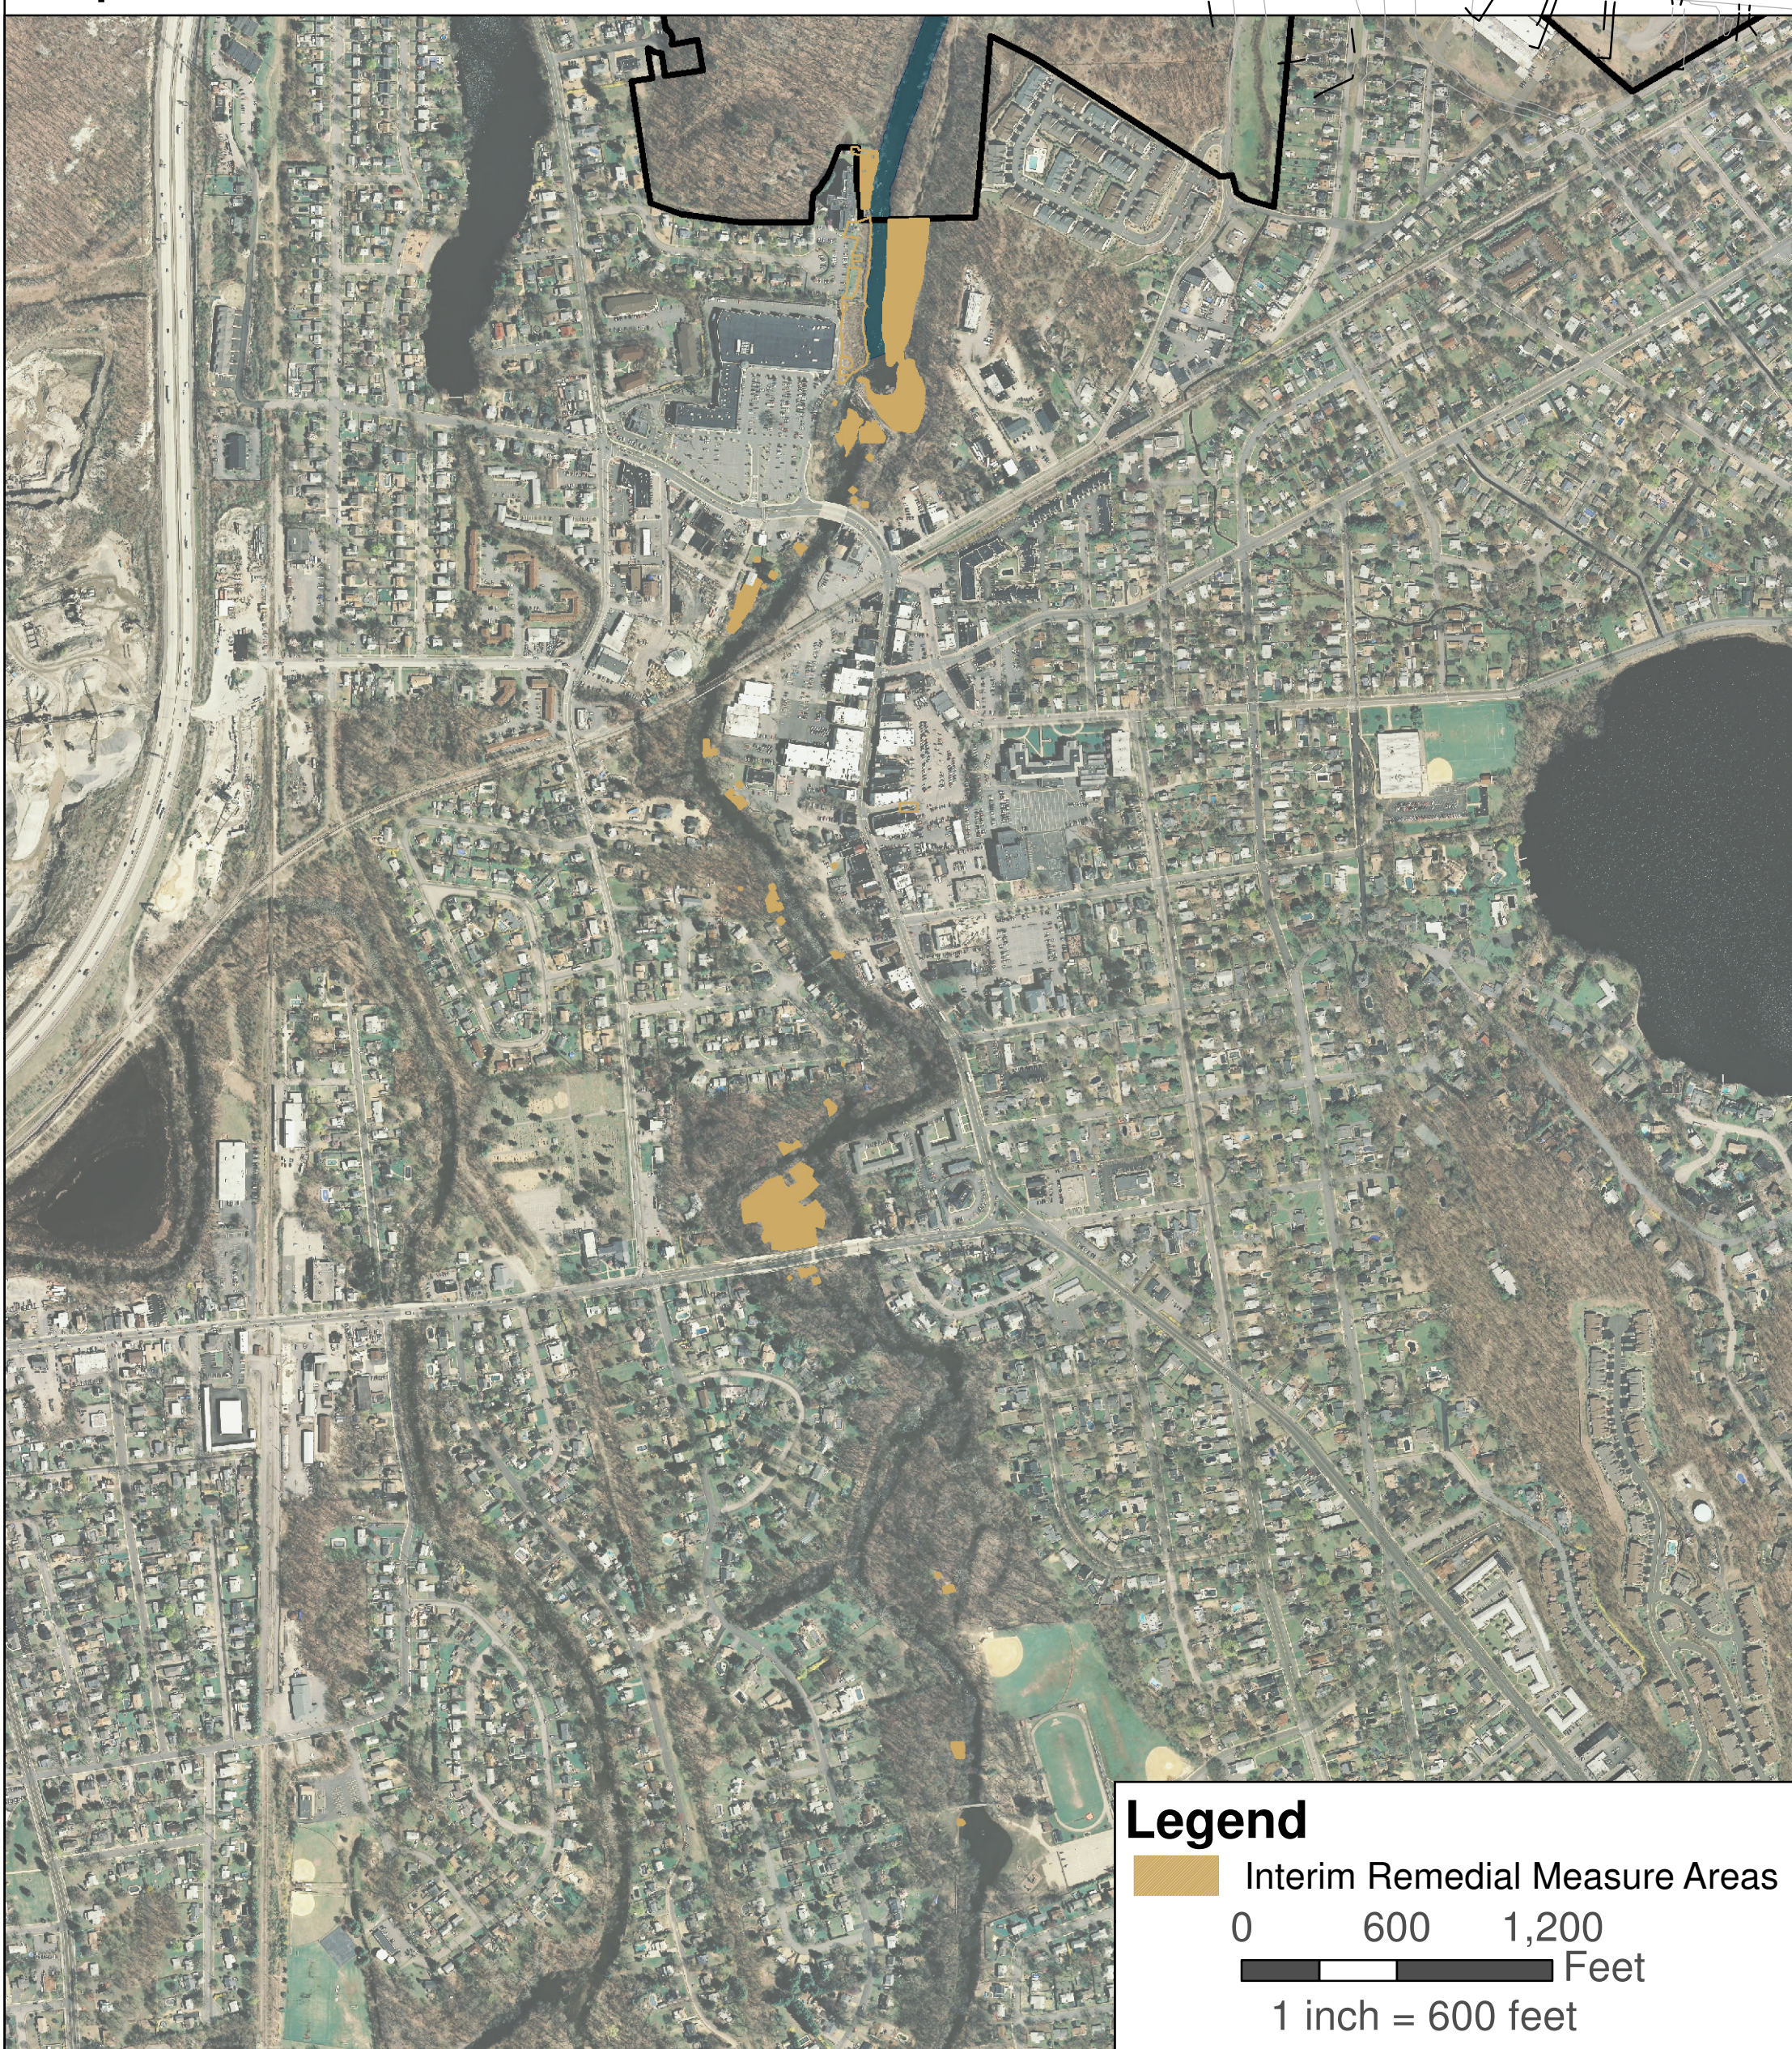
FIGURE 2

4. West Bank Remediation – During 2000, soils were excavated on the western bank of Wanaque River between the Site's property line and the approximate area of the former dam. The soils were excavated, post excavation samples collected, and the excavations backfilled and restored. Additional restoration work was completed in accordance with the stream encroachment and wetlands permits obtained for the remediation.

5. East Bank Remediation – During 2003 and 2004, soils were excavated on the east bank of Wanaque River between the Site's property line and the approximate area of the former dam. The soils were excavated, post excavation samples collected, and the excavations backfilled and restored. Additional restoration work was completed in accordance with the stream encroachment and wetlands permits obtained for the remediation.

IRM LOCATIONS

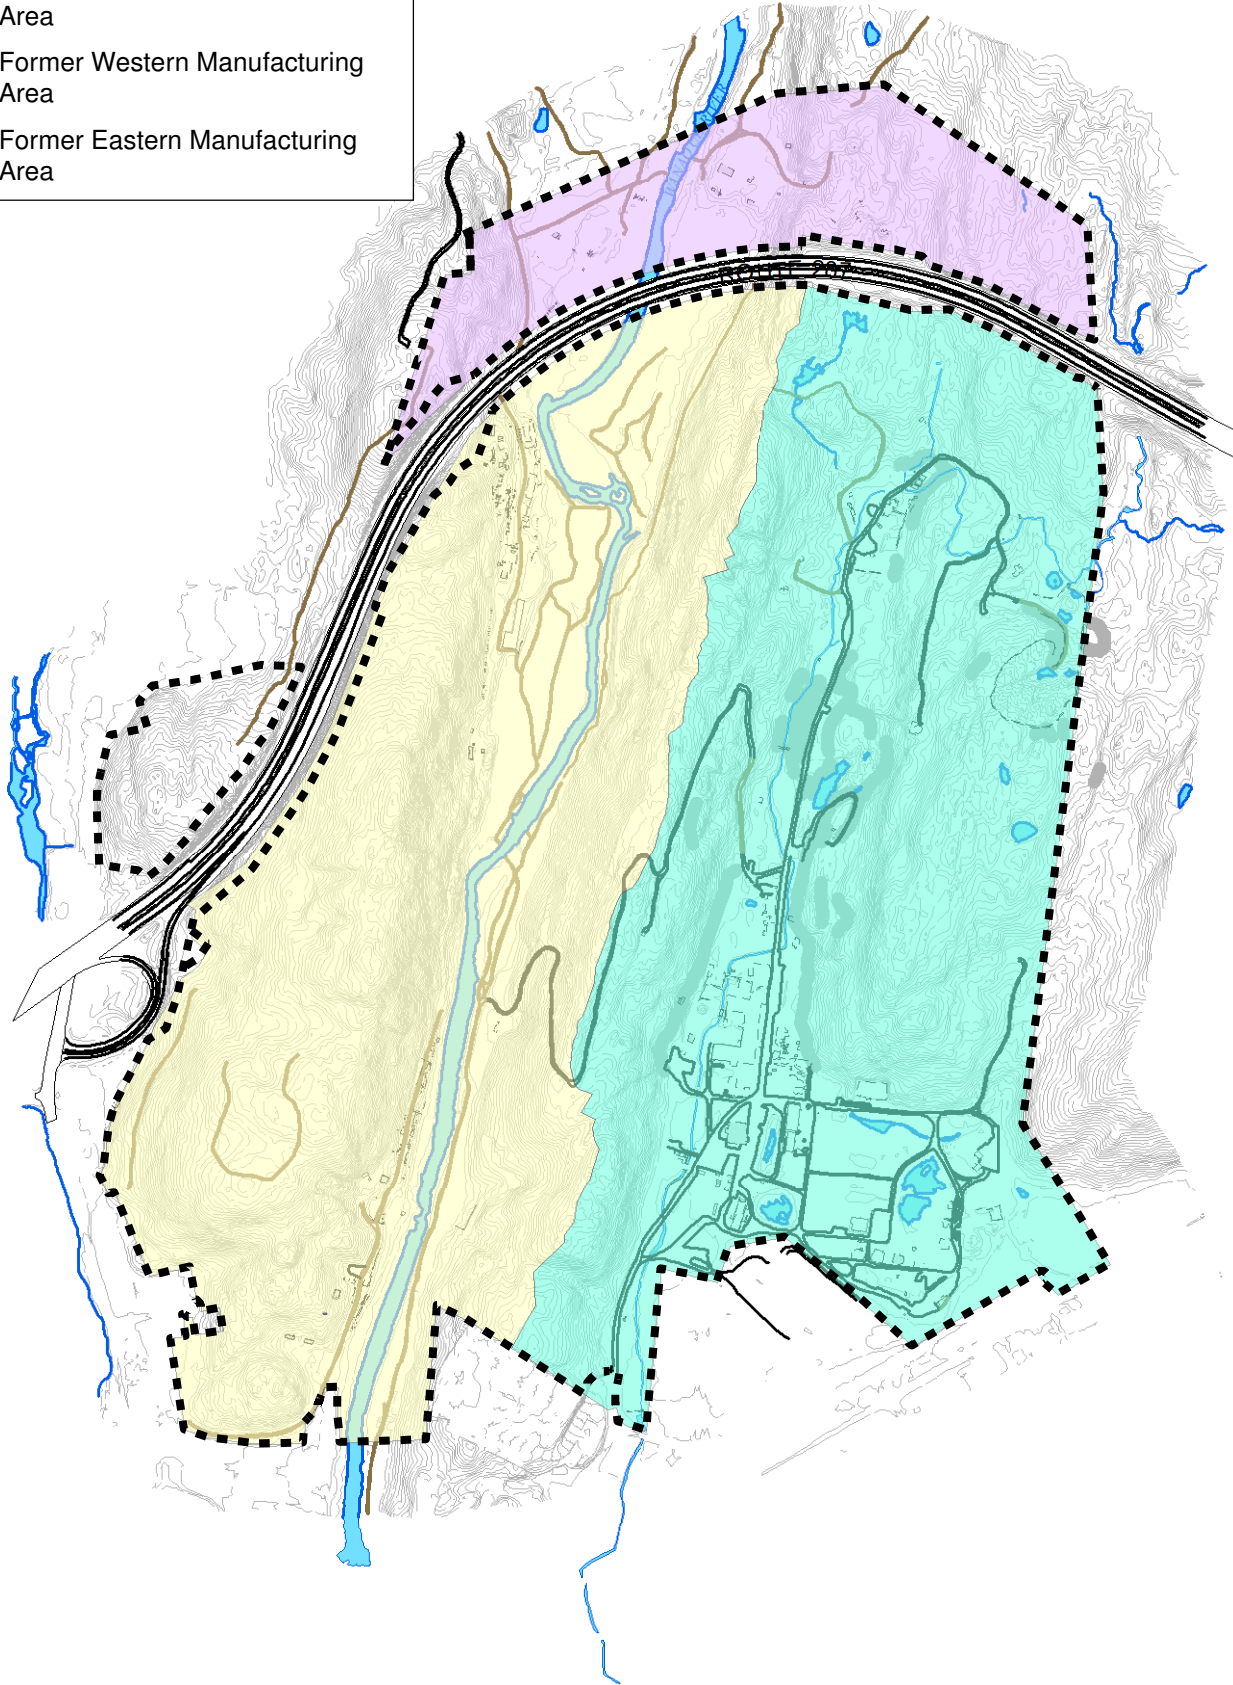
FIGURE 3

**FORMER
MANUFACTURING AREAS**

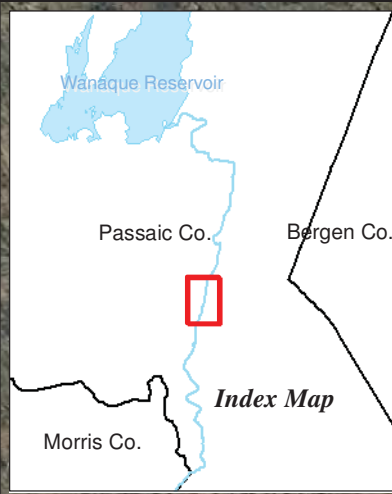
Figure 5
 Reach 2 Sediment and Pore Water Sampling Stations
 Upstream of the Proposed IRM Area to WR-12
 Wanaque River Investigation
 Interim Remedial Measure Work Plan
 DuPont Pompton Lakes Works
 Pompton Lakes, New Jersey

Phase I sampling was conducted to provide adequate surface water and sediment data to characterize baseline conditions in Wanaque River upstream (Reach 1), adjacent to (Reach 2), and downstream (Reach 3) of the Site. Based on the Phase I results, a baseline ecological evaluation (BEE) was conducted. The findings of the Phase I RI and BEE were used to focus additional data collection during the Phase II program to further refine the CSM and support ecological evaluations. An overview of sample stations/locations from the Phase I and II RIs is presented on Figures 5 and 6 and in Appendix A.

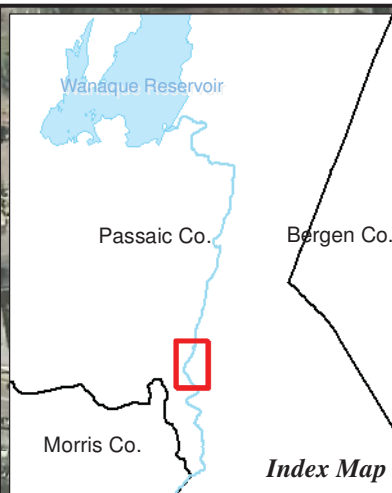
Analyte	Units	WR-19 Result
Sediment		
MERCURY	MG/KG	4.34
TOC	%	4.26
PERCENT FINES	% Passing	36
Pore Water (filtered)		
MERCURY	ng/L	44.5
METHYLMERCURY	ng/L	9.22

Analyte	Units	WR-19C Result
Sediment		
MERCURY	MG/KG	8.85
TOC	%	1.97
PERCENT FINES	% Passing	18
Pore Water (filtered)		
MERCURY	ng/L	7.05
METHYLMERCURY	ng/L	1.85

Figure 6
 Reach 3 Sediment and Pore Water Sampling Stations
 Downstream of the Proposed IRM Area to WR-20
 Wanaque River Investigation
 Interim Remedial Measure Work Plan
 DuPont Pompton Lakes Works
 Pompton Lakes, New Jersey

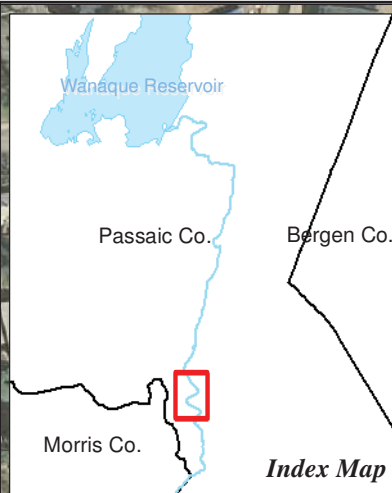
Analyte	Units	WR-21 Result
Sediment		
MERCURY	MG/KG	10.3
TOC	%	3.57
PERCENT FINES	% Passing	47.5

Analyte	Units	WR-21B(0-6)	WR-21B(6-12)	WR-21B(12-18)
		Result	Result	Result
Sediment				
MERCURY	MG/KG	7.37	0.33	1.65
TOC	%	1.42	0.22	1.58
PERCENT FINES	% Passing	NS	3.5	14
Pore Water (filtered)				
MERCURY	ng/L	2.38	NS	NS
METHYLMERCURY	ng/L	0.13	NS	NS

Figure 7
 Reach 3 Sediment and Pore Water Sampling Stations
 from WR-20 to WR-22
 Wanaque River Investigation
 Interim Remedial Measure Work Plan
 DuPont Pompton Lakes Works
 Pompton Lakes, New Jersey

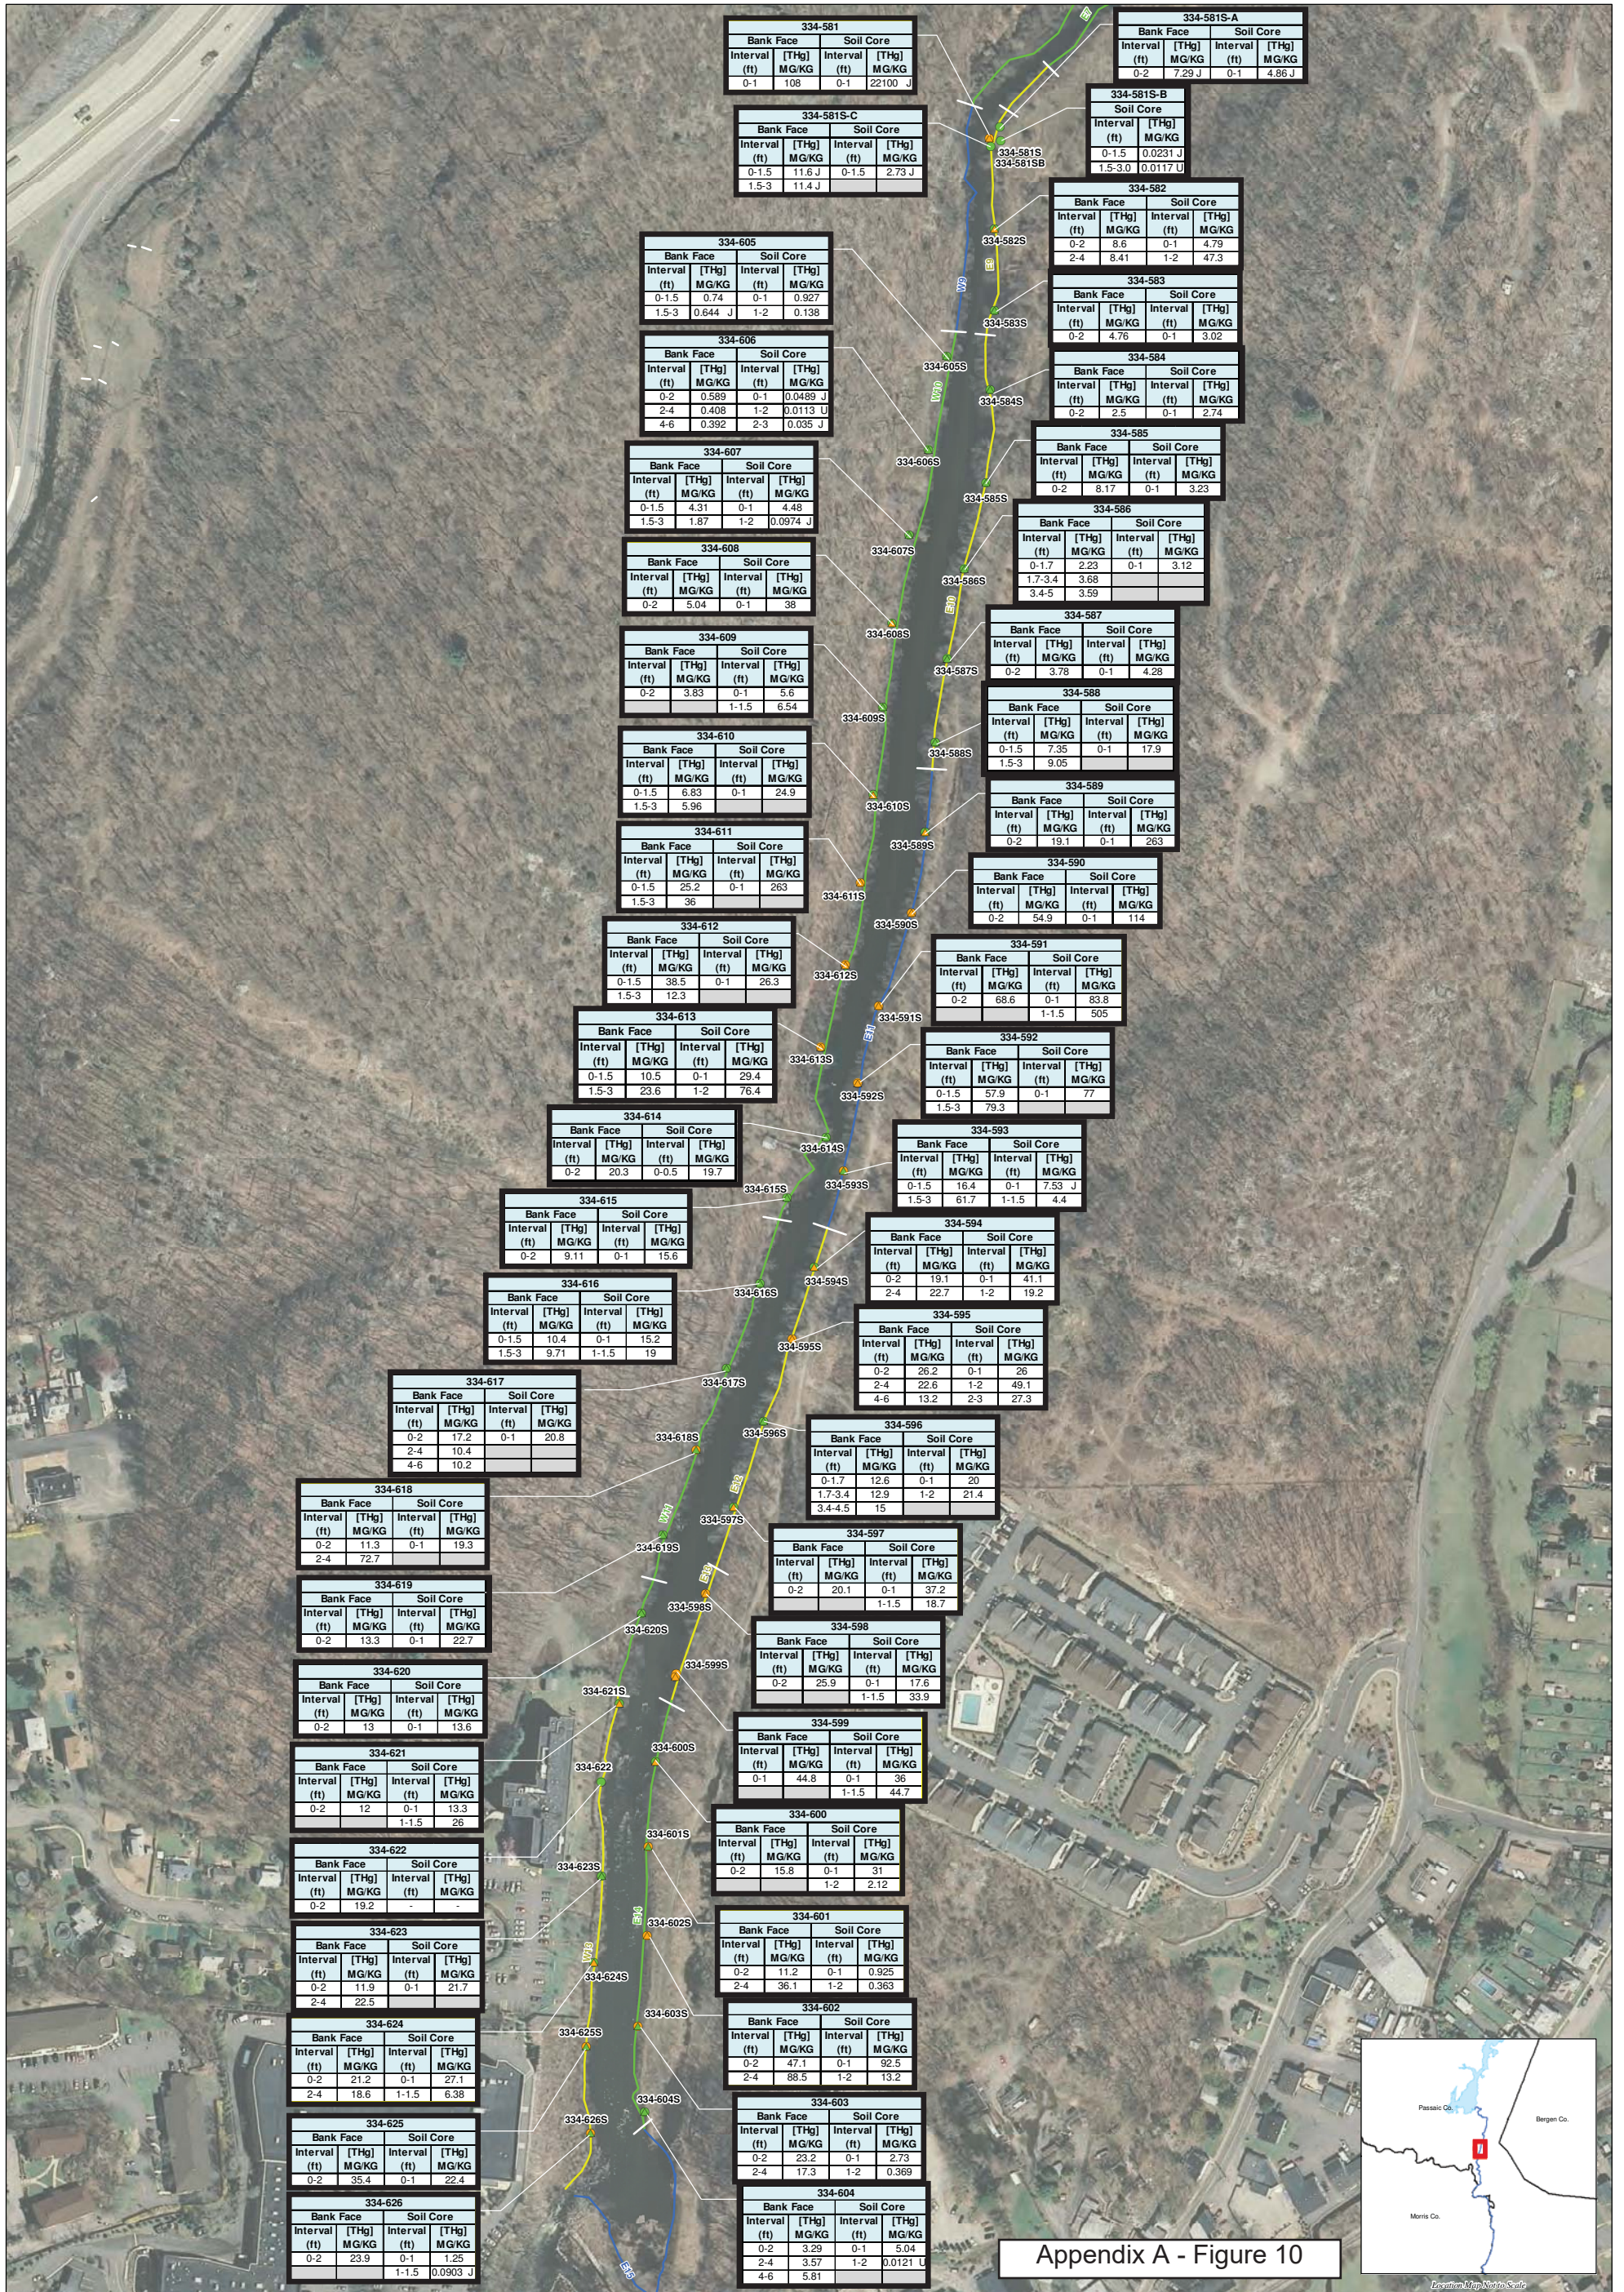
Figure 8
 Reach 2 Bank Soil Sampling Locations
 Wanaque River Interim Remedial Measure
 Data Collection Activities Report
 DuPont Pompton Lakes Works
 Pompton Lakes, New Jersey

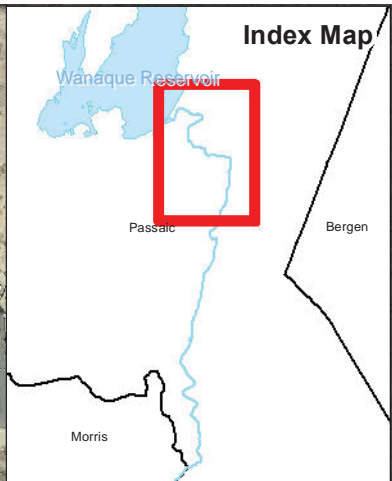
Analyte	Units	NJFWSC	Background Data ¹	WR-01 Result
BARIIUM	MG/KG	NA	136.8	113
BERYLLIUM	MG/KG	NA	0.976	0.504 J
CADMIUM	MG/KG	0.6	1.516	0.836 J
CHROMIUM	MG/KG	26	42.22	36.2
COPPER	MG/KG	16	96.48	37.5
LEAD	MG/KG	31	87.16	33.7
MERCURY	MG/KG	0.2	0.351	0.219 J
NICKEL	MG/KG	16	29.33	18.4
ZINC	MG/KG	120	219.7	170
SEM (total)	UMOL/G	--	--	0.579
AVS	UMOL/G	--	--	2.8

Analyte	Units	NJFWSC	Background Data ¹	WR-02 Result
ARSENIC	MG/KG	6	7.581	3.27 J
BARIIUM	MG/KG	NA	136.8	61.9
BERYLLIUM	MG/KG	NA	0.976	0.493 J
CADMIUM	MG/KG	0.6	1.516	0.756 J
CHROMIUM	MG/KG	26	42.22	30.5
COPPER	MG/KG	16	96.48	38.9
LEAD	MG/KG	31	87.16	40.5
MERCURY	MG/KG	0.2	0.351	0.114 J
NICKEL	MG/KG	16	29.33	18.4
ZINC	MG/KG	120	219.7	118
SEM (total)	UMOL/G	--	--	0.271
AVS	UMOL/G	--	--	<0.63 U

Figure 11
 Detected Constituents in Sediment- Reach 1
 Wanaque River
 Remedial Investigation Report
 DuPont Pompton Lakes Works
 Pompton Lakes, New Jersey
