**Municipality/Organization:** Town of Framingham

**EPA NPDES Permit Number:** MA R041116

**Annual Report Number  
& Reporting Period:** No. 10: March '12 – March '13

## NPDES PII Small MS4 General Permit Annual Report

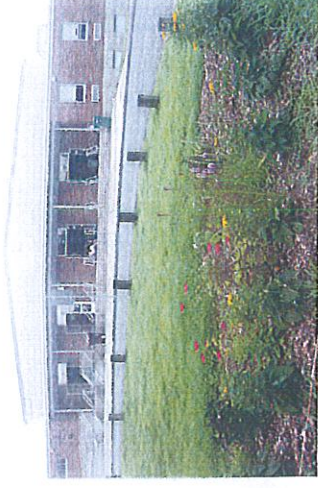
Frammingham High School Rain Garden

A rain garden is a shallow depression planted with perennial native plants that are tolerant of both dry and wet conditions. Rain gardens capture runoff from impervious surface areas such as rooftops and driveways and allow it to seep slowly into the ground. Rain gardens help preserve nearby streams and ponds by reducing the amount of polluted runoff and filtering pollutants.

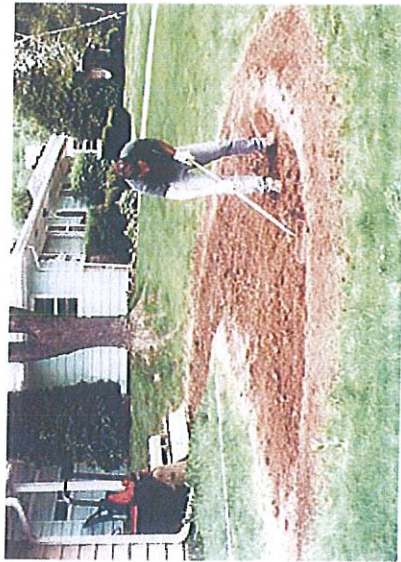
- The garden must be located where runoff can be diverted into it, at least 10 feet away from building foundations and septic systems.
- A shallow, saucer-shaped depression is created in the garden to hold rain as it soaks in. The garden should be about 20-30% of the area from which it is receiving runoff. Make the depression 6 to 18 inches deep, throughout the area of the garden.
- Soil replacement and additional preparations are sometimes needed for success. A good soil mix for rain gardens is 50-60% sand, 20-30% topsoil, and 20-30% compost. This mixture will allow excellent root growth and recharge of water
