**Municipality/Organization:** City of Malden  
**EPA NPDES Permit Number:** MA041046  
**MADEP Transmittal Number:** 041088  
**Annual Report Number  
& Reporting Period:** No. 15: April 1, 2017-March 31, 2018

## NPDES PII Small MS4 General Permit Annual Report

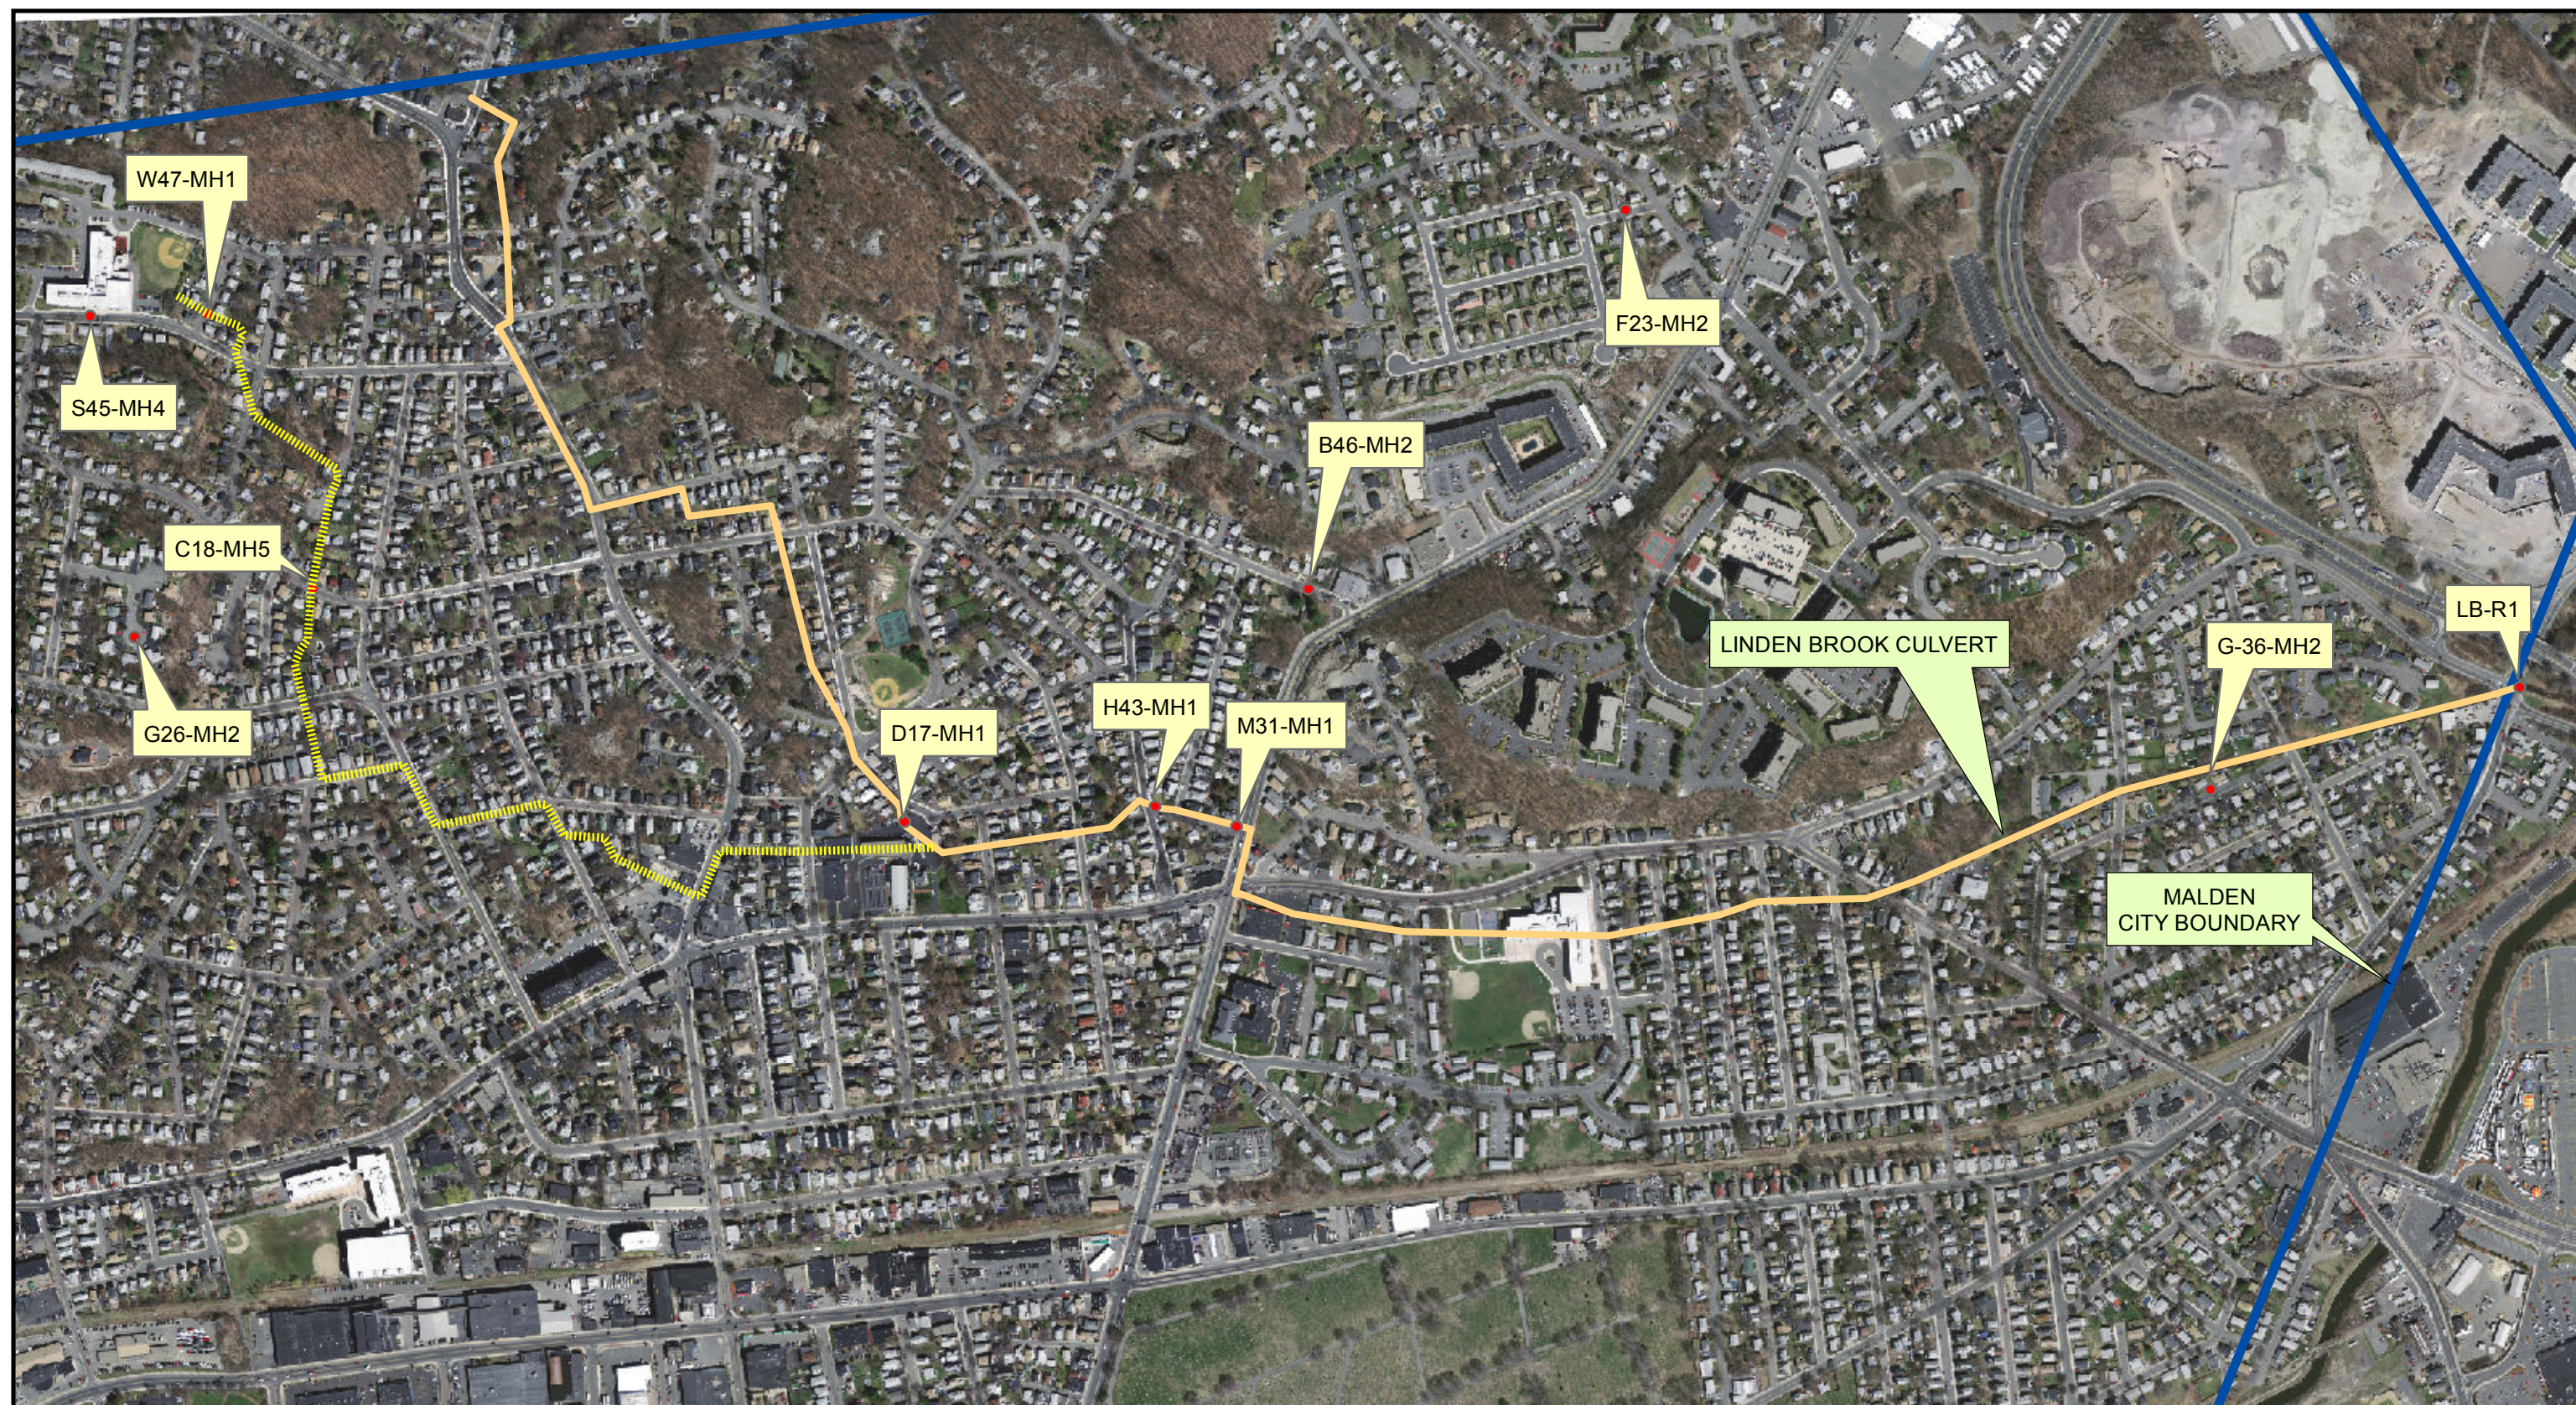
**Figure 9 - Dry and Wet Weather Sampling Program-Linden Brook**  
 MALDEN, MASSACHUSETTS

Linden Brook Culvert is the major stormwater conveyance network located in northeasterly portions of the City. Dry weather inspections have revealed base flow throughout the culvert at all times, with E. coli levels detected historically within the mid-portion of the culvert, at manhole H43-MH1, located on Home Street (Figure 9). Flow isolation studies performed to date within this portion of the City had not revealed any specific source conditions for the results of prior sampling. In an effort to identify source conditions, flow isolation studies have been conducted on upstream drainage connections to the Linden Brook Culvert. A dry weather flow (Flow # 18), was identified in the areas of Cherry and Gilbert Streets, which contributes flows from the northern and central portions of Malden to the Linden Brook Culvert (Figure 9).
