**Long-Term Stewardship Assessment Report**  
**Messer ASU Facility (former Airco Welding Products)**  
**EPA ID #: WVD980554760**  
**New Cumberland, WV 26047**  
**RCRIS CODE: CA88 (P2)**  
**Completed by: Kenan Cetin, WVDEP**

Assessment Visit Date: **October 14, 2025** Assessment Report Date: **12/26/2025**

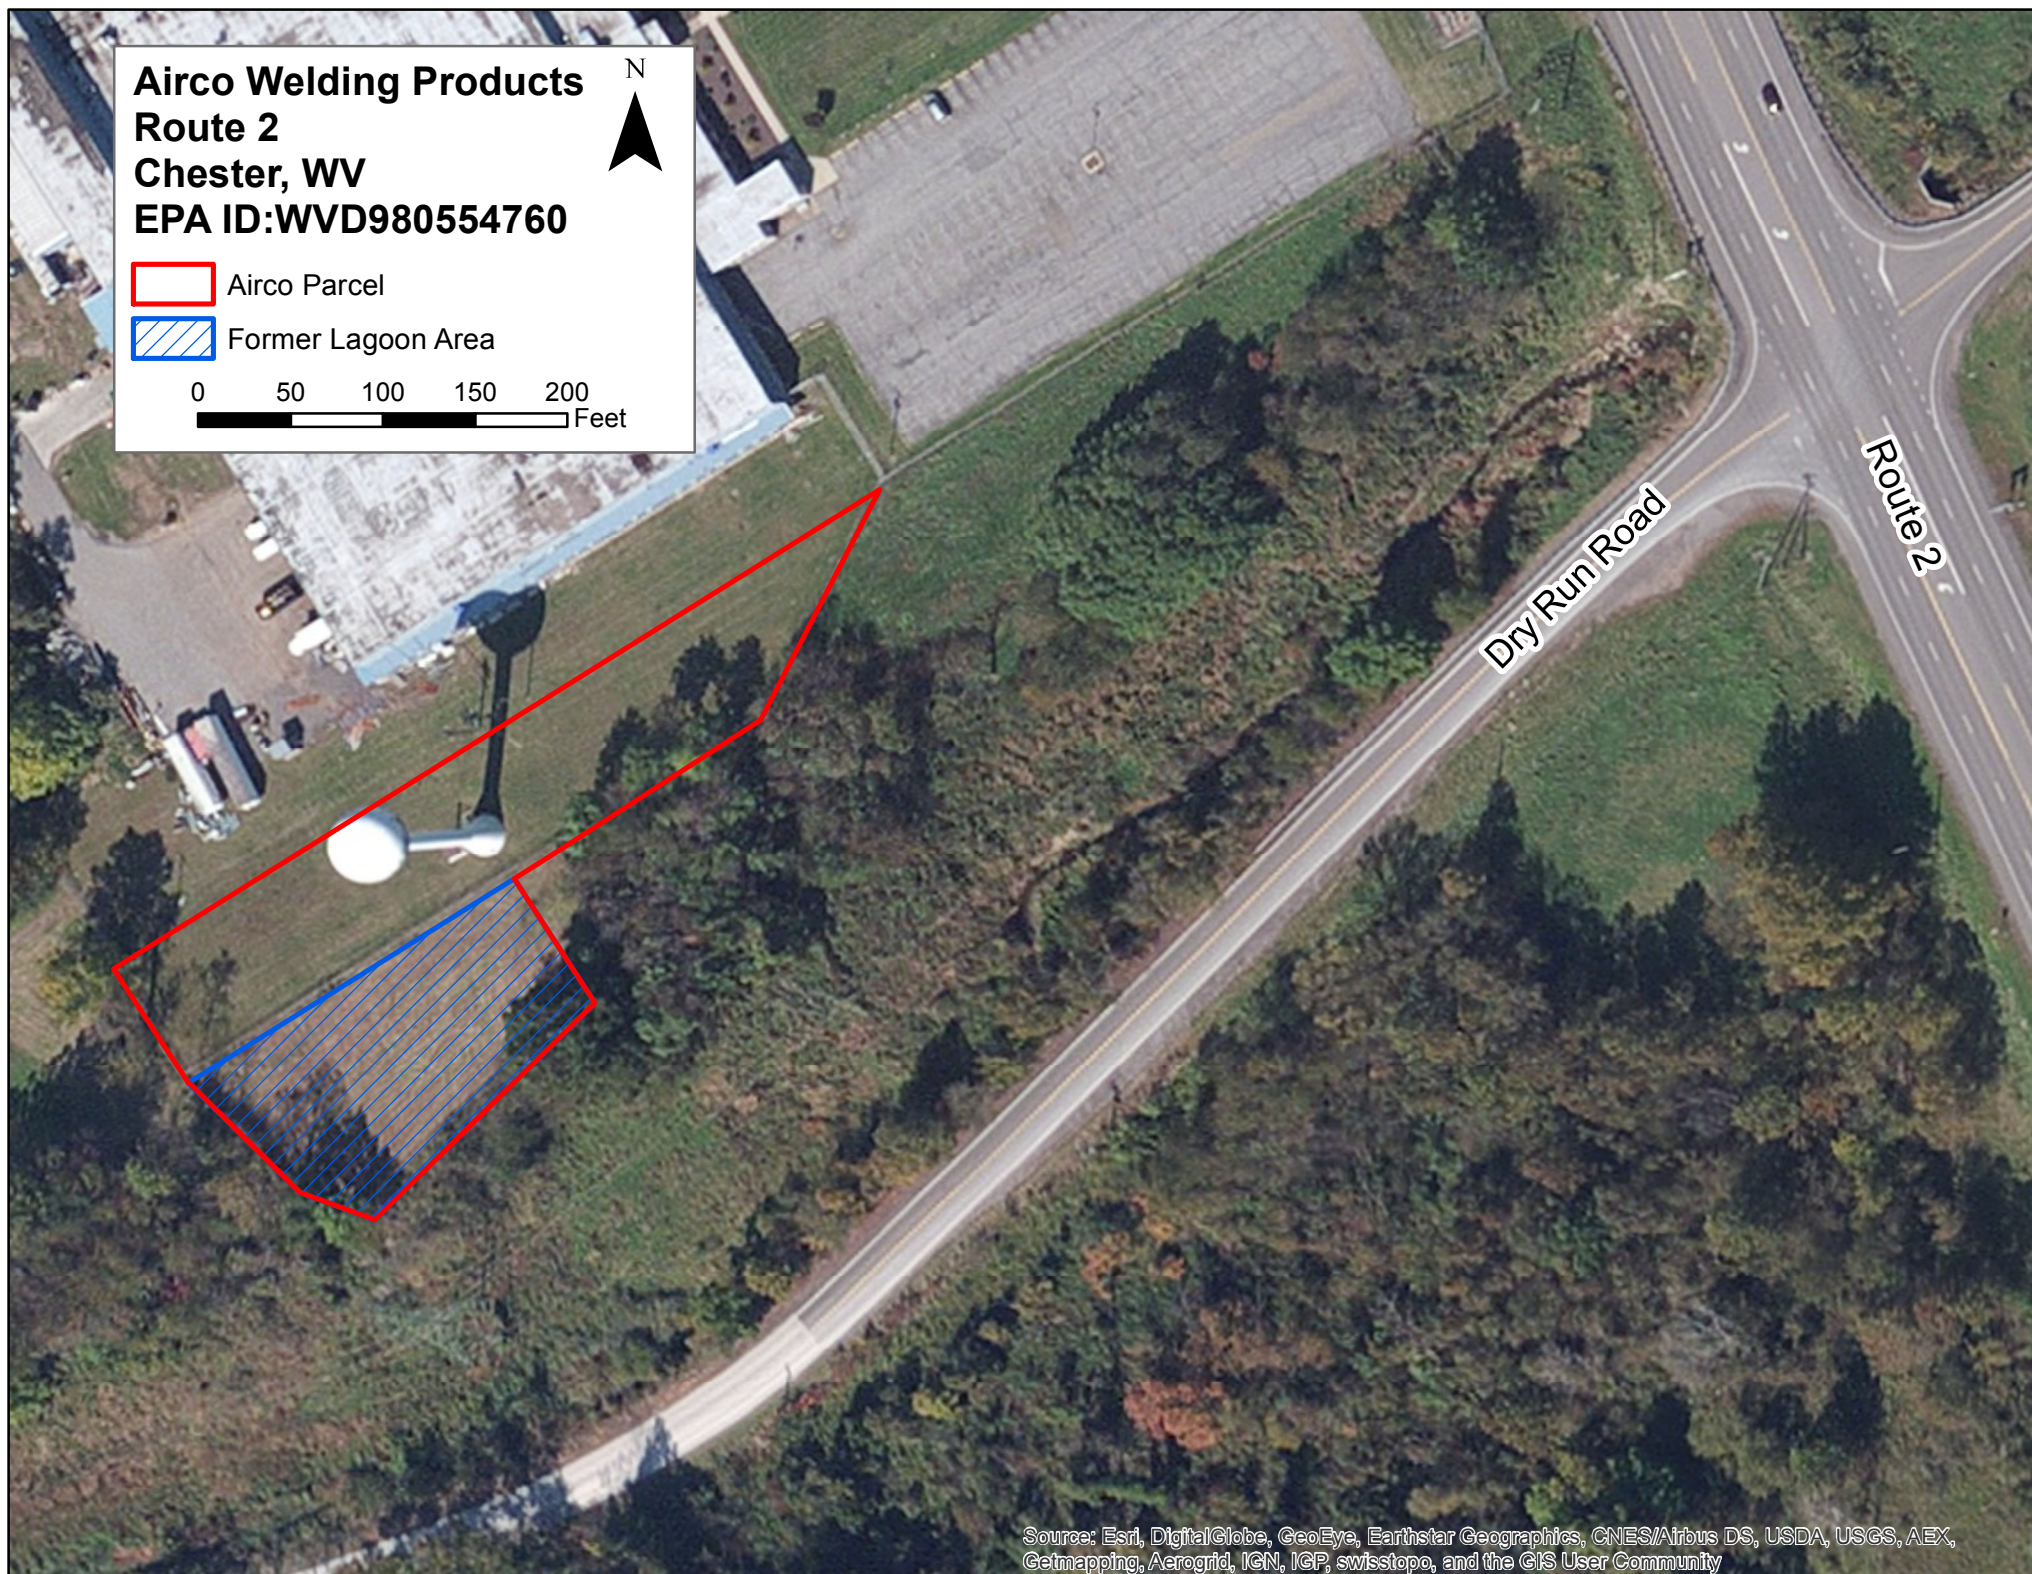
Figure 1: Geospatial Map of former Airco parcel showing former lagoon area.

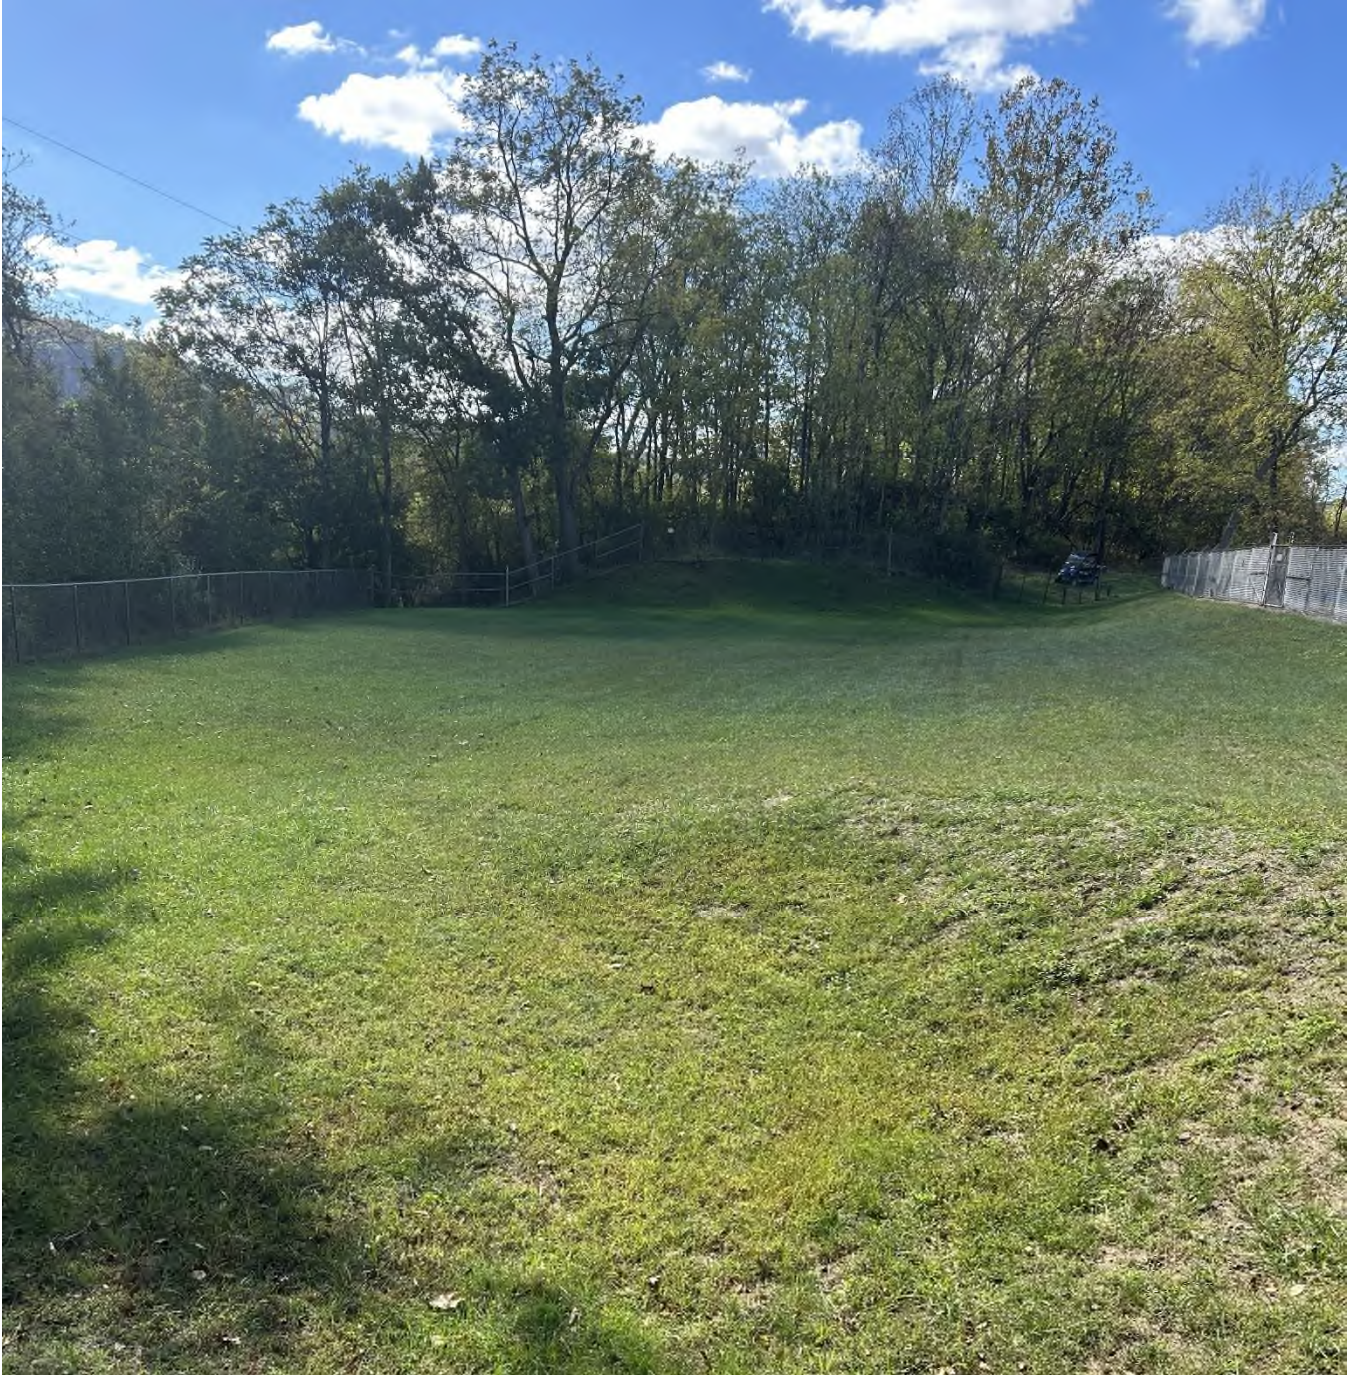
**Figure 2:** The former lagoon area, as seen looking southwest, with freshly moved grass surface.

**Figure 2:** The former lagoon area, as seen looking southwest, with freshly mowed grass surface.

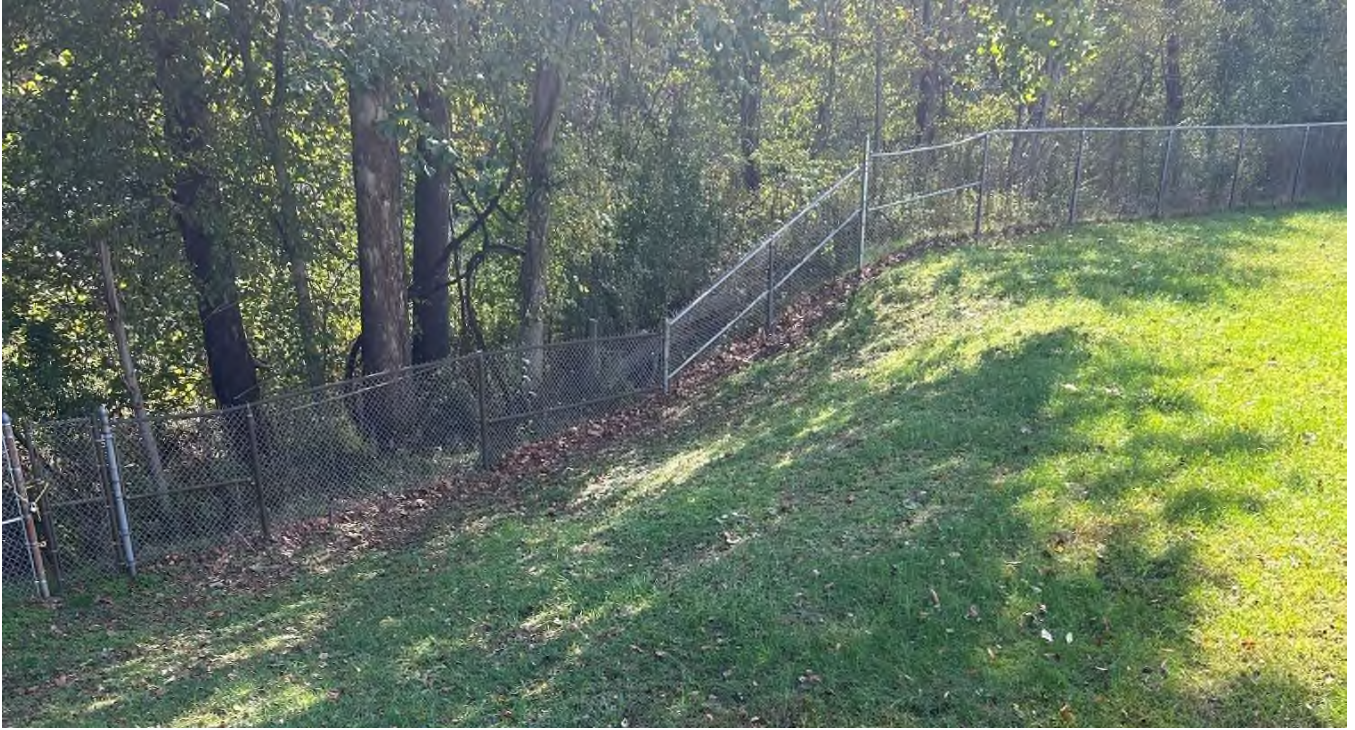
**Figure 3:** The former lagoon area, looking south toward the fencing in its current condition.

**Figure 3:** Inside the former lagoon area, looking south toward the fencing in its current condition.

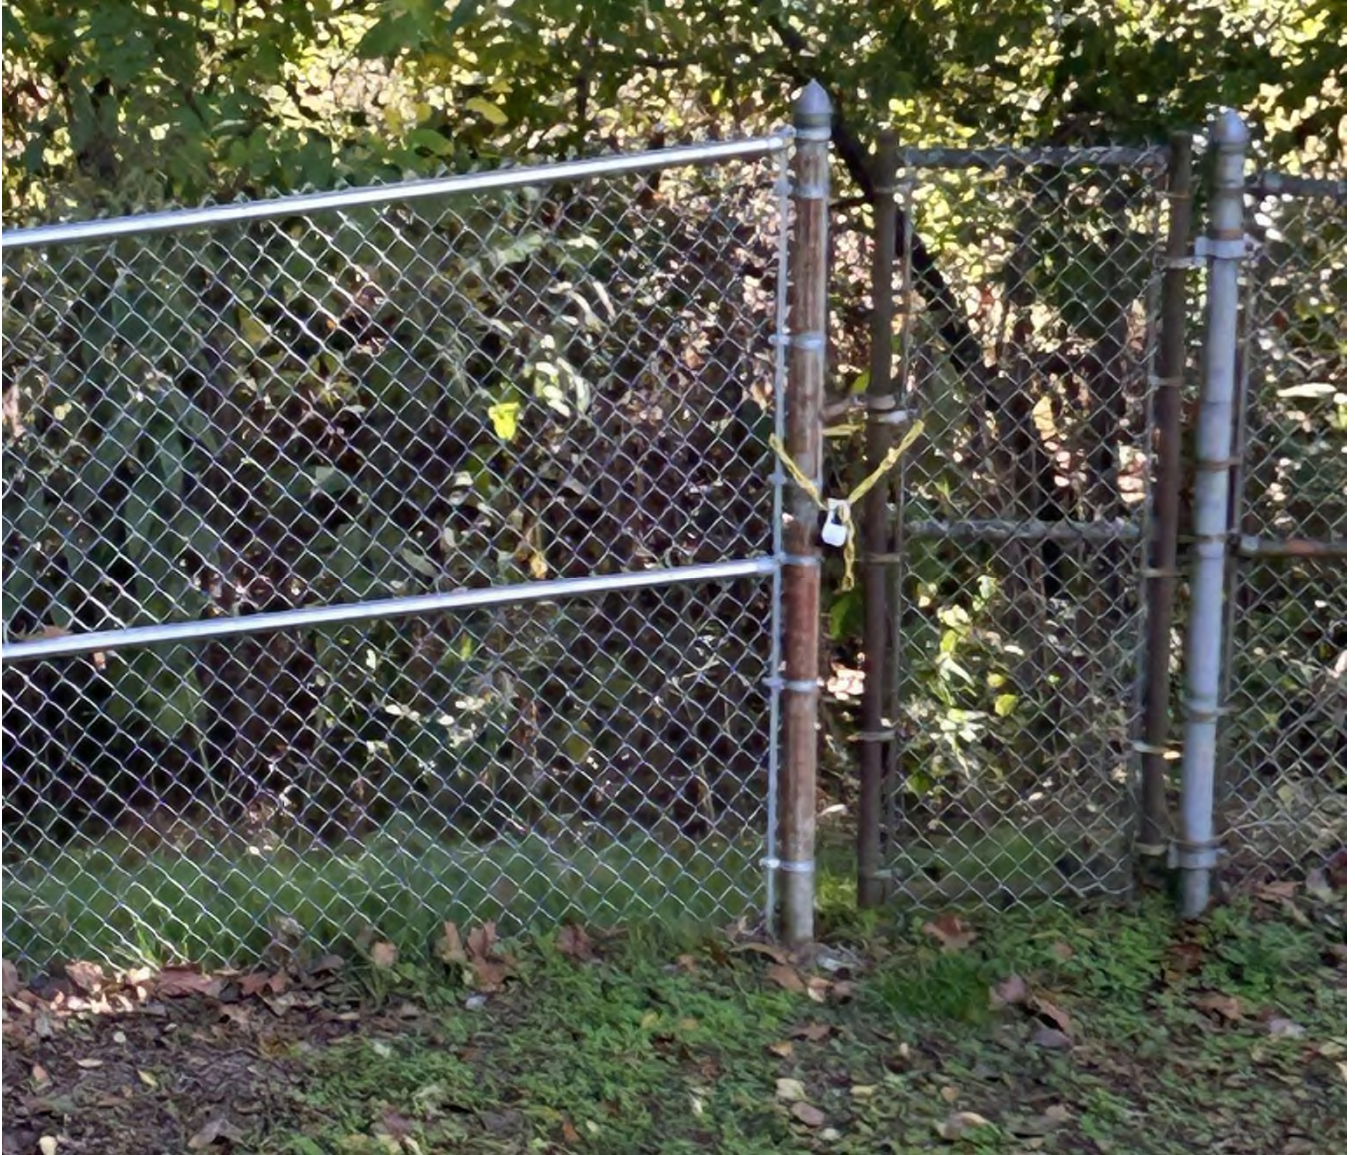
**Figure 4:** An image showing the locked fence gate in the southeast corner of the former lagoon area.

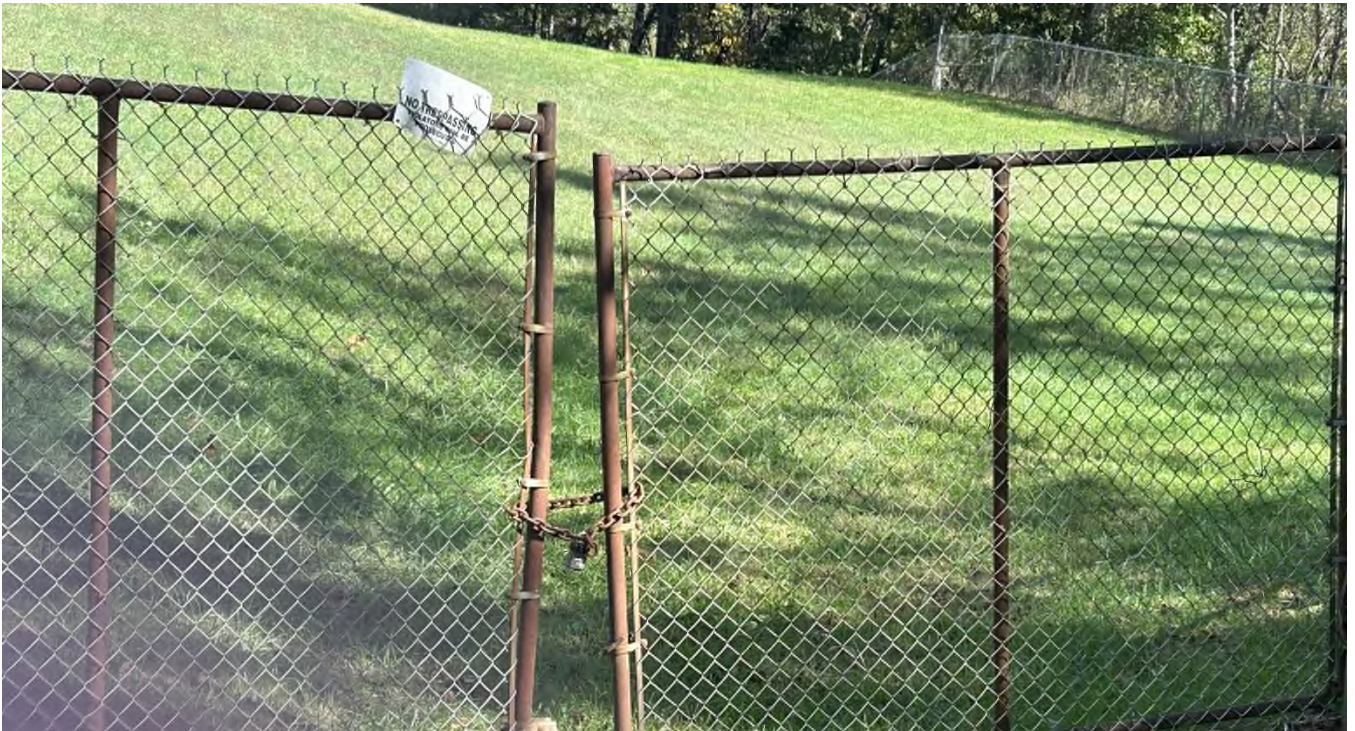
**Figure 5:** The locked main entrance gate and fence posting with "No Trespassing" sign.

**Figure 5:** The locked main entrance gate and fence posting with “No Trespassing” sign.
