Long-Term Stewardship Assessment Report

Empire Diversified Energy LLC (Formerly Koppers, Inc.)

EPA ID #: WVD004336749

Assessment Visit Date: **October 23, 2025** Assessment Report Date: **December 31, 2025**

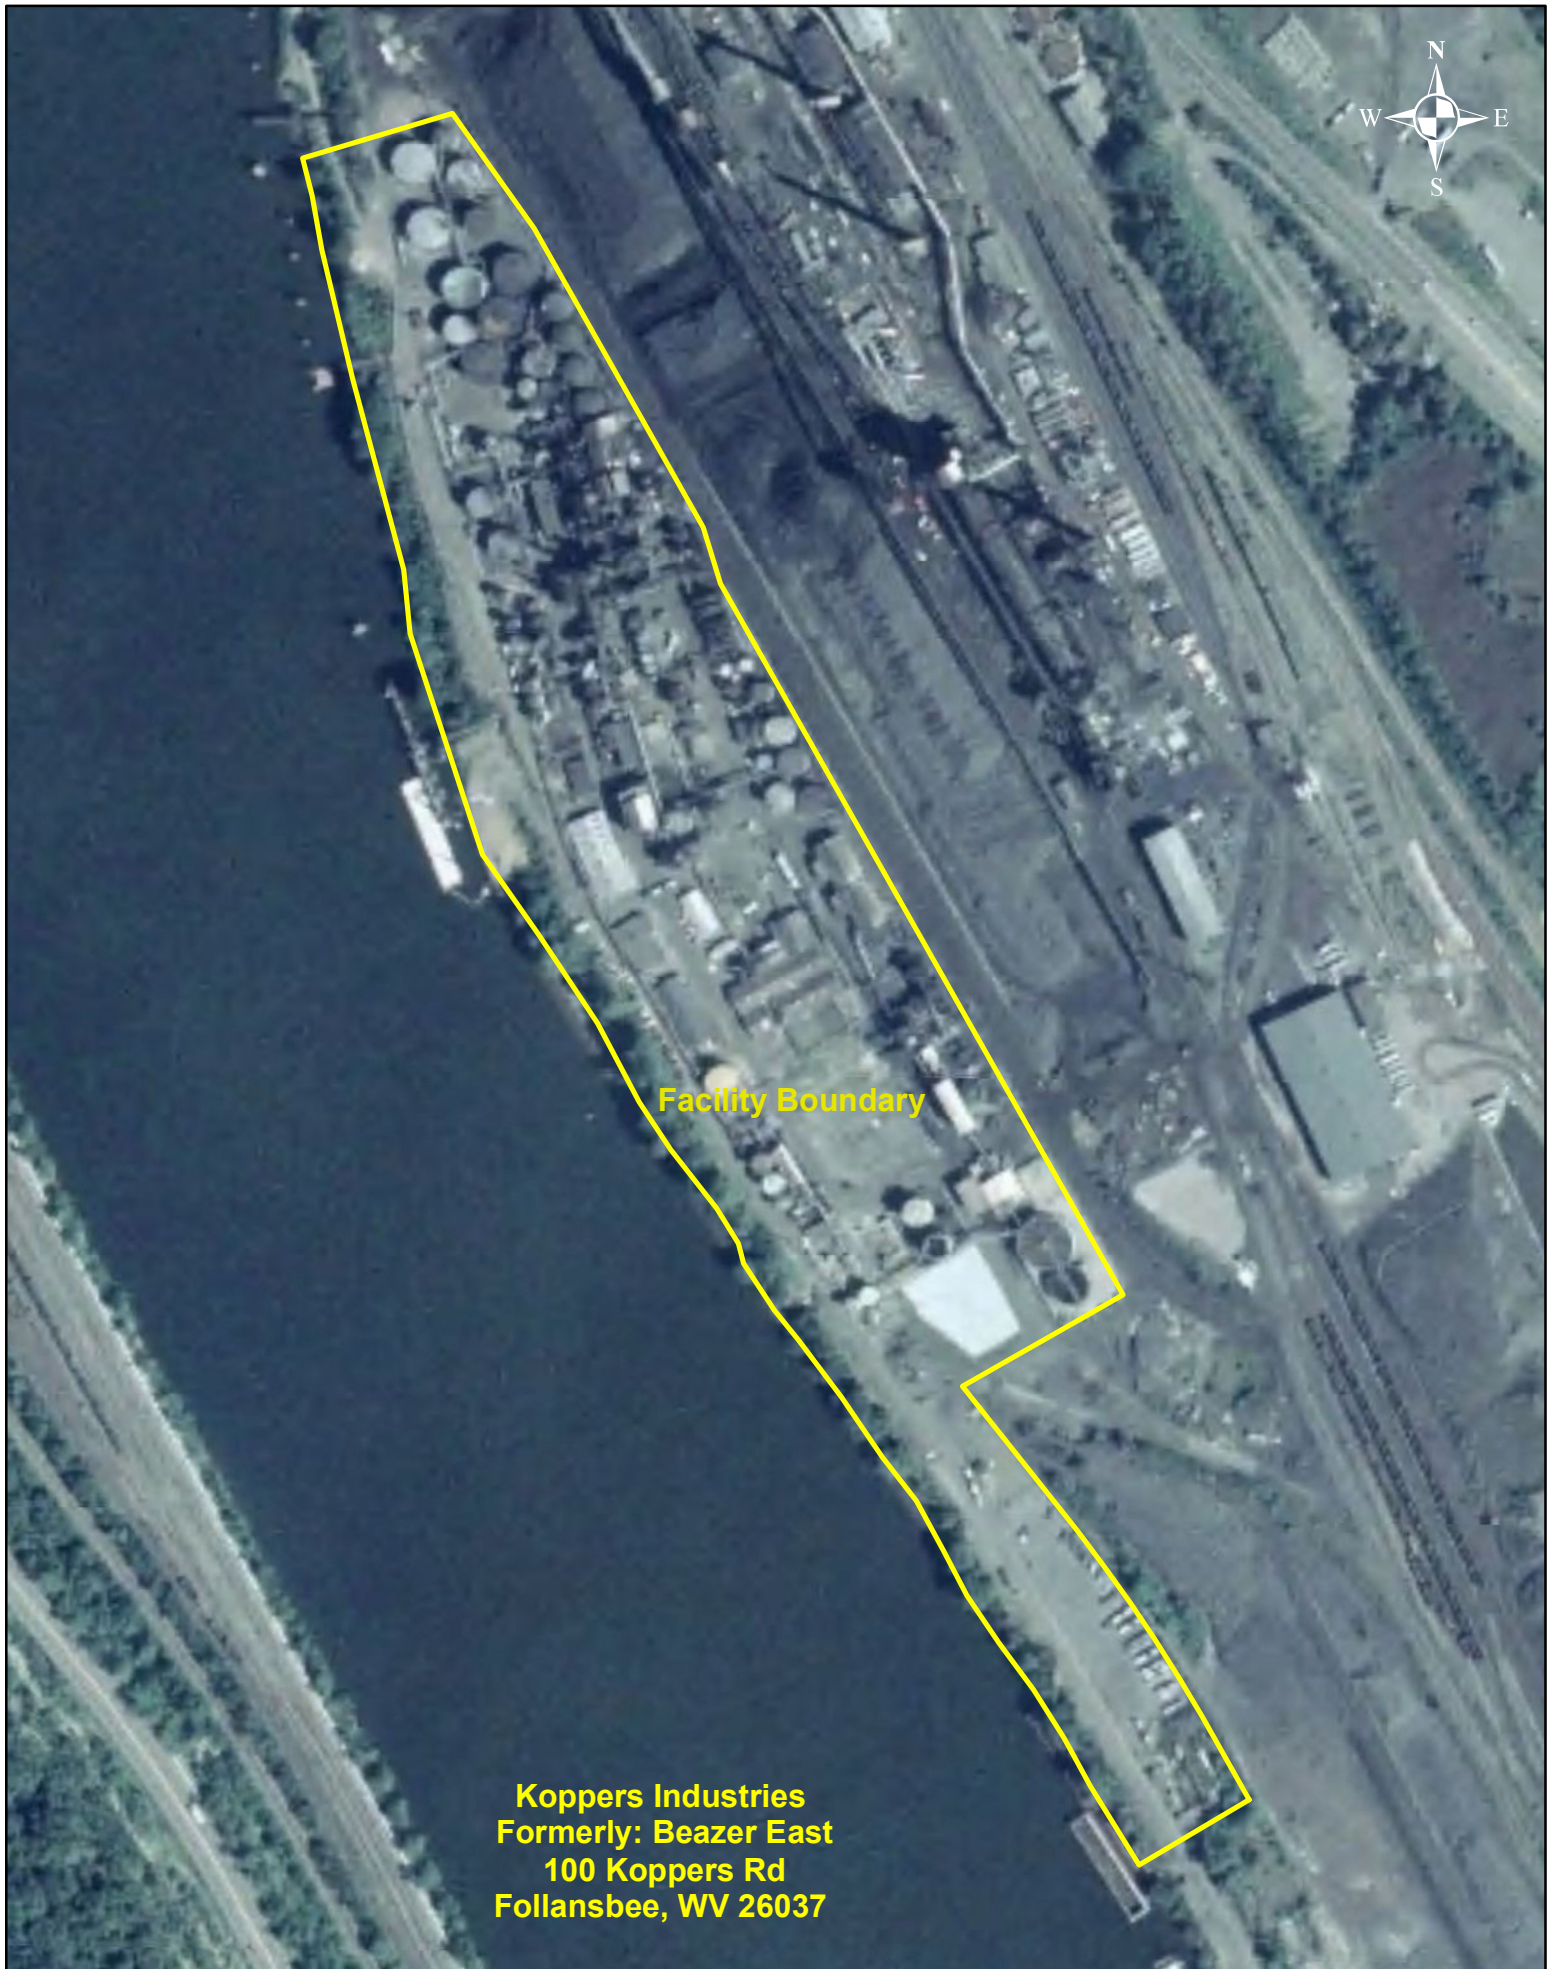
Figure 1: Geospatial map for Empire Diversified Energy LLC (Formerly Koppers, Inc.)

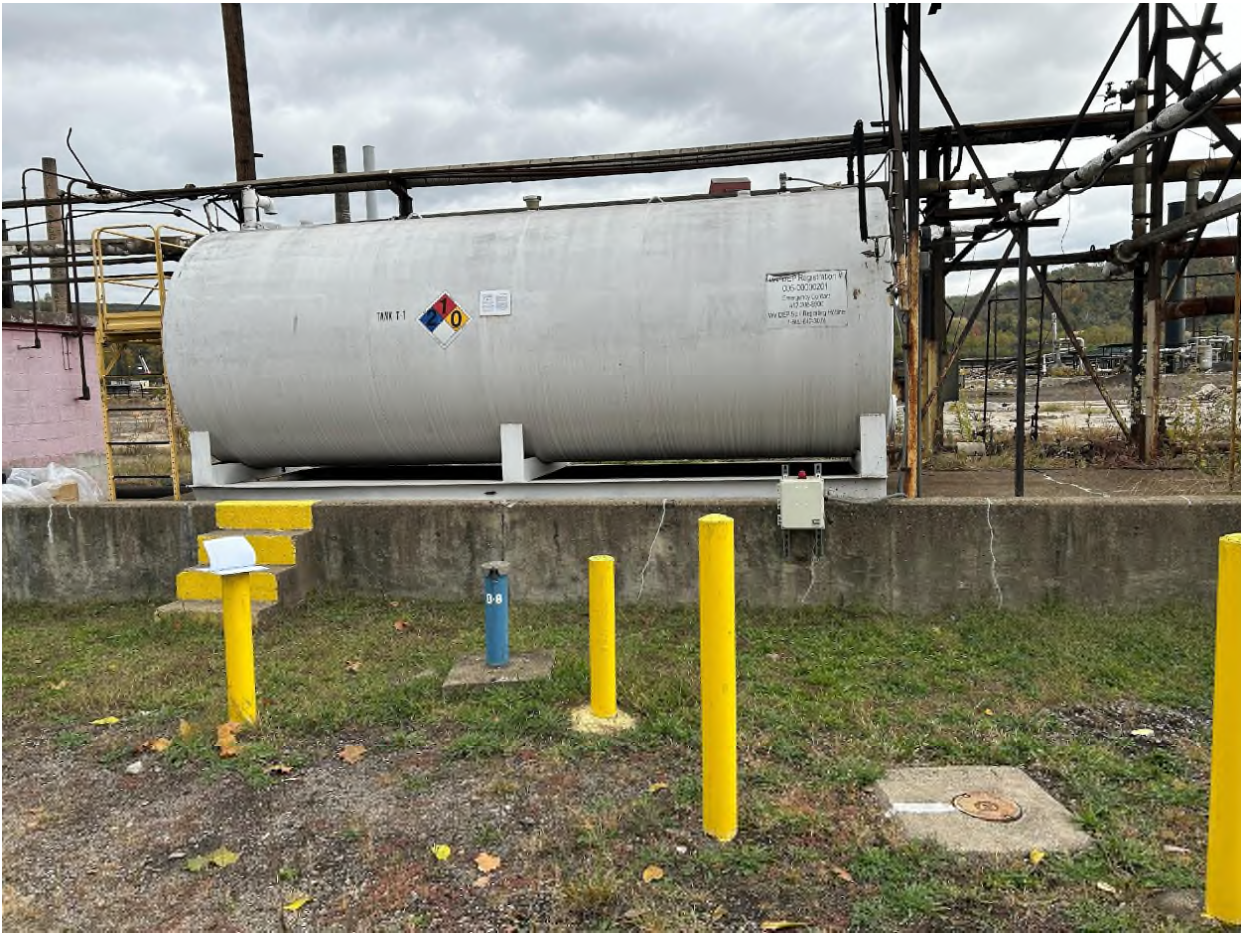
Figure 2: Temporary Storage Tank T-1 for recovered DNAPL before off-site transport and disposal.

The system was expanded in 2016 with the installation of Well R-401. In 2024, this well recovered an average of approximately 6 gallons of DNAPL per week. To date, the combined recovery system has removed a total of approximately 133,050 gallons of DNAPL, most of which have come from recovery well R-225D. Recovered DNAPL is routed to an on-site temporary storage tank prior to off-site transport and disposal.

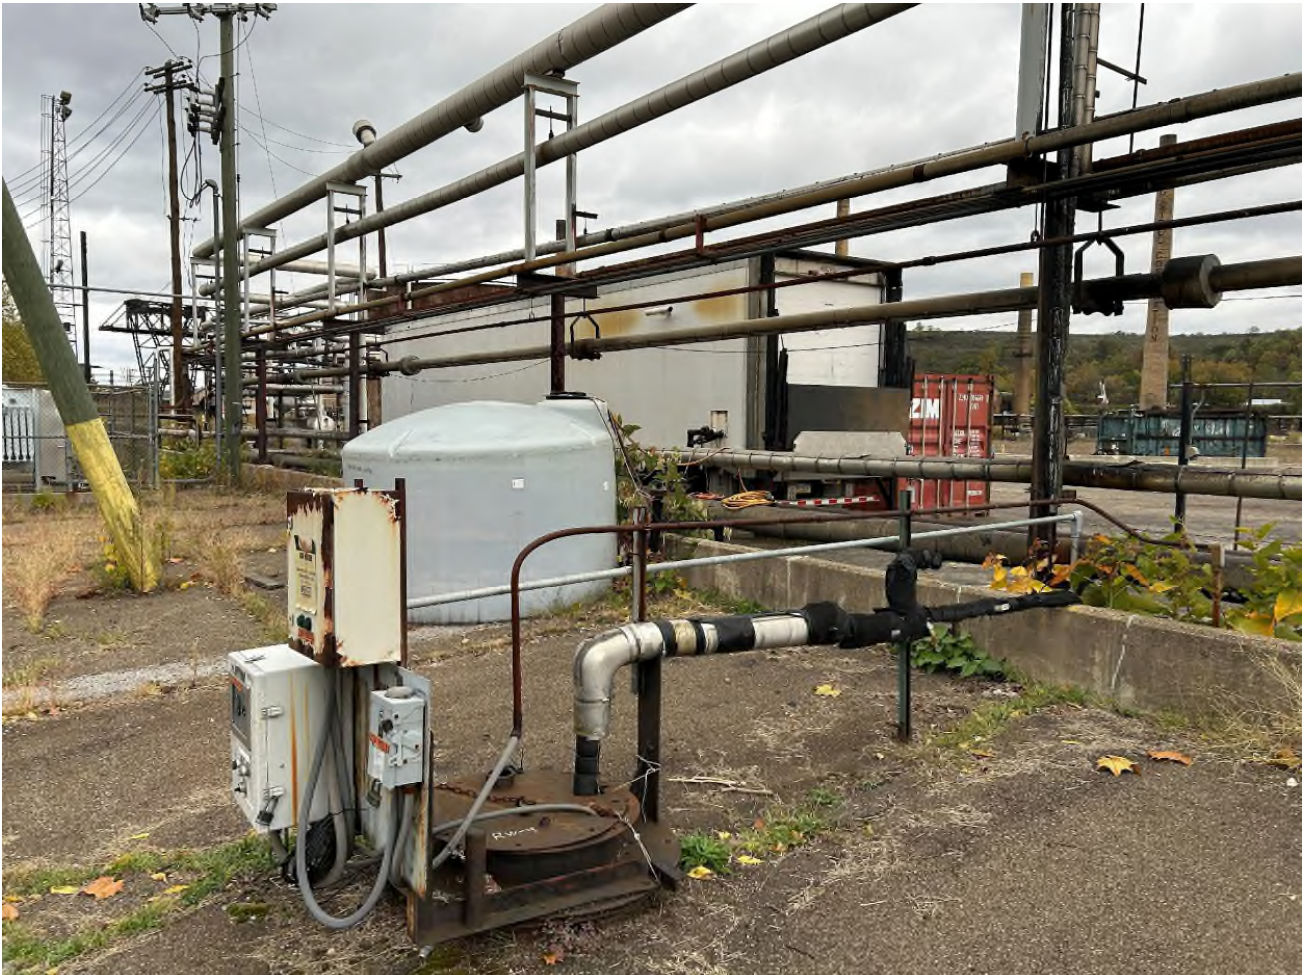
Figure 3: One of the perch groundwater recovery wells (RW-4) with the trailer that houses the standalone groundwater treatment system that became active in April 2021.

to seeps along the adjacent Mountain State coal pits on the Eastern edge of the Facility and to the Ohio River embankment on the western edge. In 2024, four (4) recovery wells, RW-1, RW-2, RW-4 and RW-5, operated continuously with a combined extraction rate of approximately 6.6 gallons per minute, extracting a combined total of 3.5 million gallons of groundwater. Captured water is directed to and treated by the groundwater remediation system groundwater treatment plant.

Until 2021, water produced by the perched system was treated by the former Koppers Plant's wastewater treatment plant. With the approaching shutdown of the operations of Koppers wastewater treatment plant, Beazer installed an independently operated standalone groundwater treatment system, that was constructed starting in September 2020 and completed on April 14, 2021. The modifications to the groundwater recovery system included the groundwater treatment system components and trailer in which those components are housed, new conveyance piping (mostly below ground) from the recovery wells to the groundwater treatment system, new discharge piping from the treatment system to the outfall, and a new outfall structure. Groundwater treatment was switched over from the previous system to the Beazer's system and brought online on May 6, 2021. Beazer obtained a National Pollutant Discharge Elimination System permit (Permit No. WV0113727), effective beginning on May 31, 2018, for discharge of treated groundwater to the permitted outfall on the Ohio River. A Permit Modification Application for Permit WVG910094-A, which allowed for the installation of an AST-244 Air Stripper to Groundwater Remediation Treatment System, was submitted on November 21, 2022 and subsequently approved on November 30, 2022.

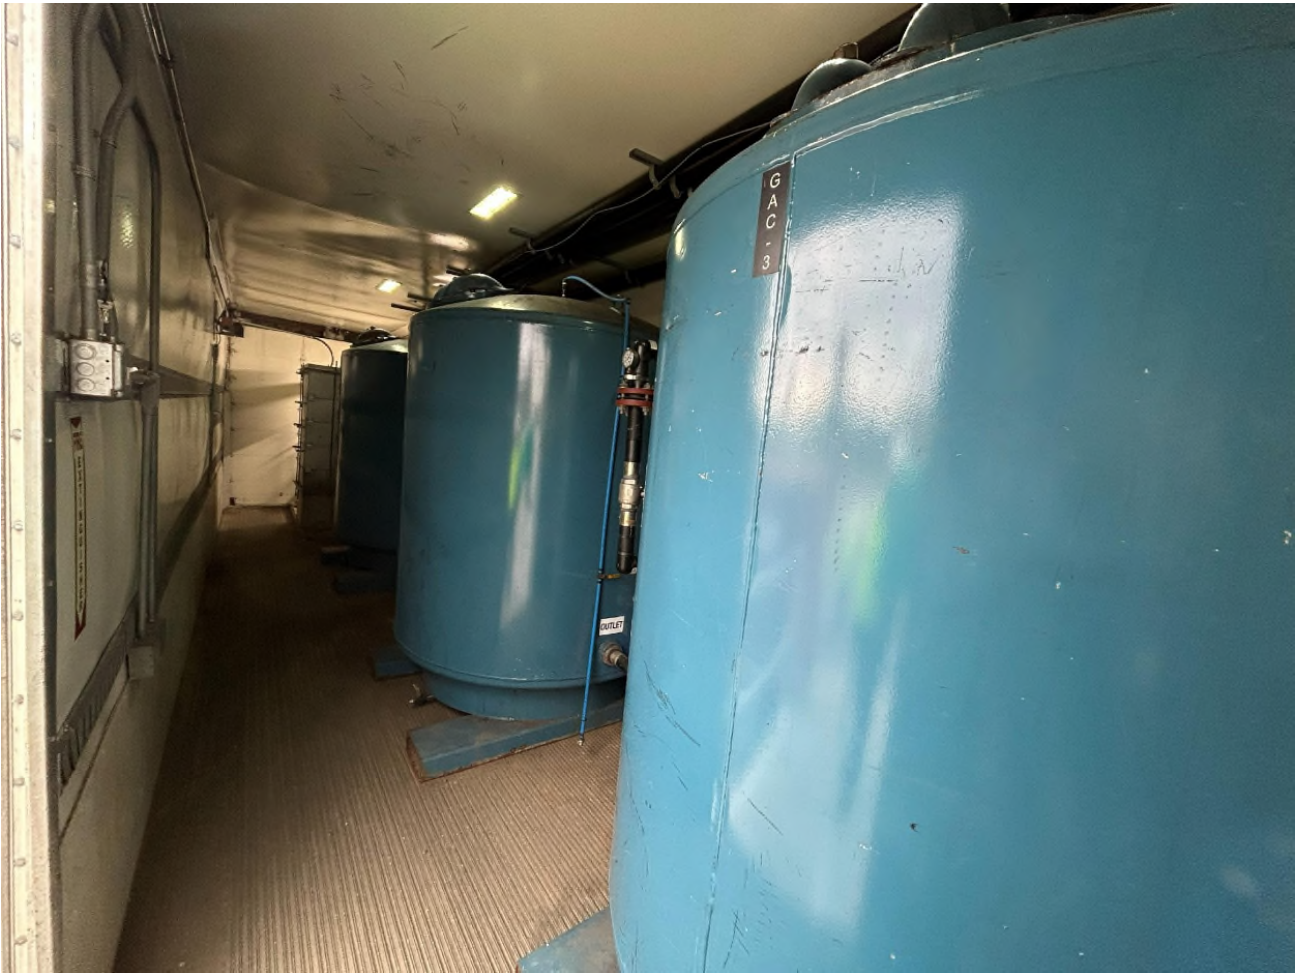
Figure 4: An image showing the inside of the trailer with the groundwater treatment system tanks.

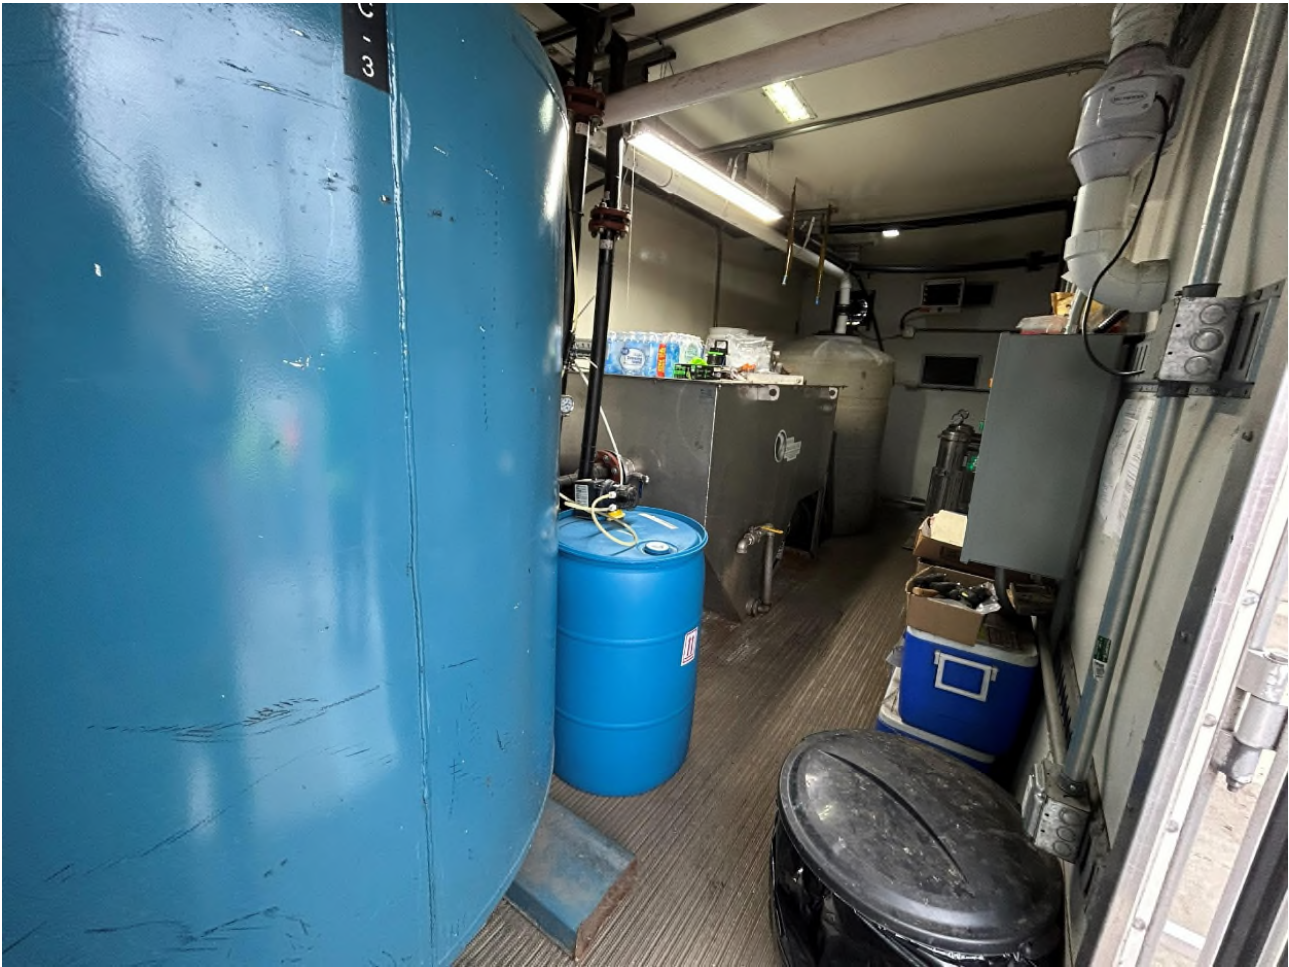
Figure 5: Another image from the inside of the trailer with perched groundwater treatment system components.

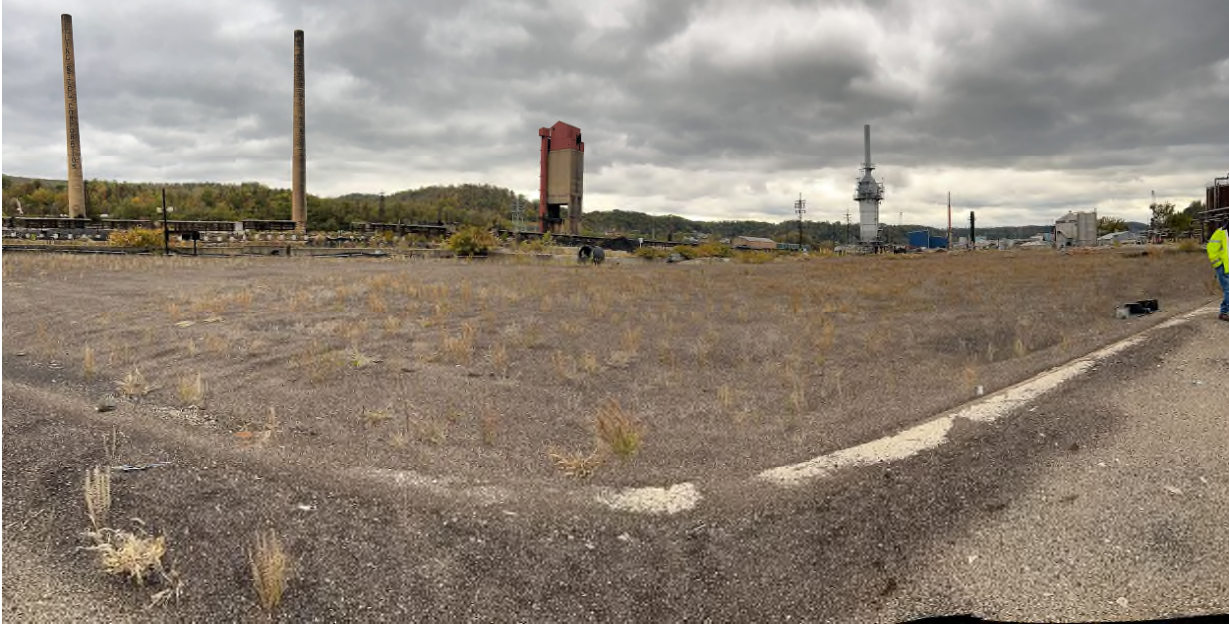
Figure 6: An open surface area of the former plant covered with what appears to be clean fill (smokestacks and process towers of the former Mountain State Carbon site in the background).

Materials Management Plan: Any construction activity, such as excavation, drilling, penetration or any other subsurface disturbance, must be conducted by a contractors who are informed and trained about the releases and potential exposure to contaminants known to exist at the site. All such work must follow a site-specific Health and Safety Plan and the December 2014 Materials Management Plan approved by EPA. Existing surface covers must be maintained over impacted areas to minimize surface water infiltration and prevent direct contact with soils. During the Facility tour no signs of earth-moving activities were observed and most asphalt or concrete paved surfaces were intact. As tanks and/or buildings are demolished, the current owner Empire is replacing the surface cover at the footprint of such structures.

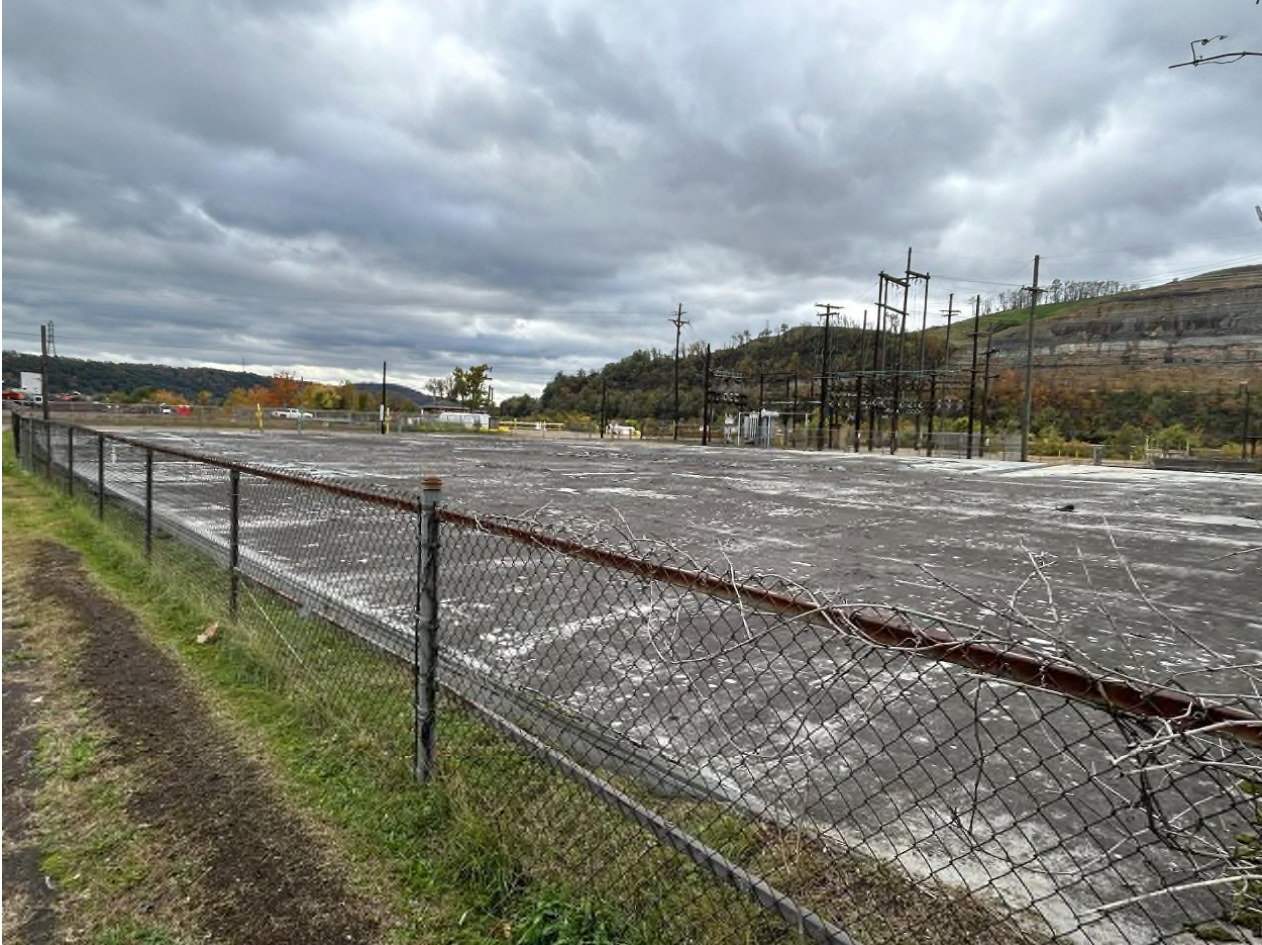
Figure 7: Looking southwest at the former aeration basins.

The aeration basins have been closed, are now concrete-lined and covered and enclosed in a security fence with appropriate signage. The groundwater monitoring network consist of ten (10) wells (R-208S, R-208D, R-216S, R-216D, R-218S, R-218D, R-222S, R-222D, R-222D, R-308 and R-313) that monitor shallow alluvial, deeper alluvial and bedrock water-bearing zones around this regulated unit. Groundwater generally flows from east to west toward the Ohio River.

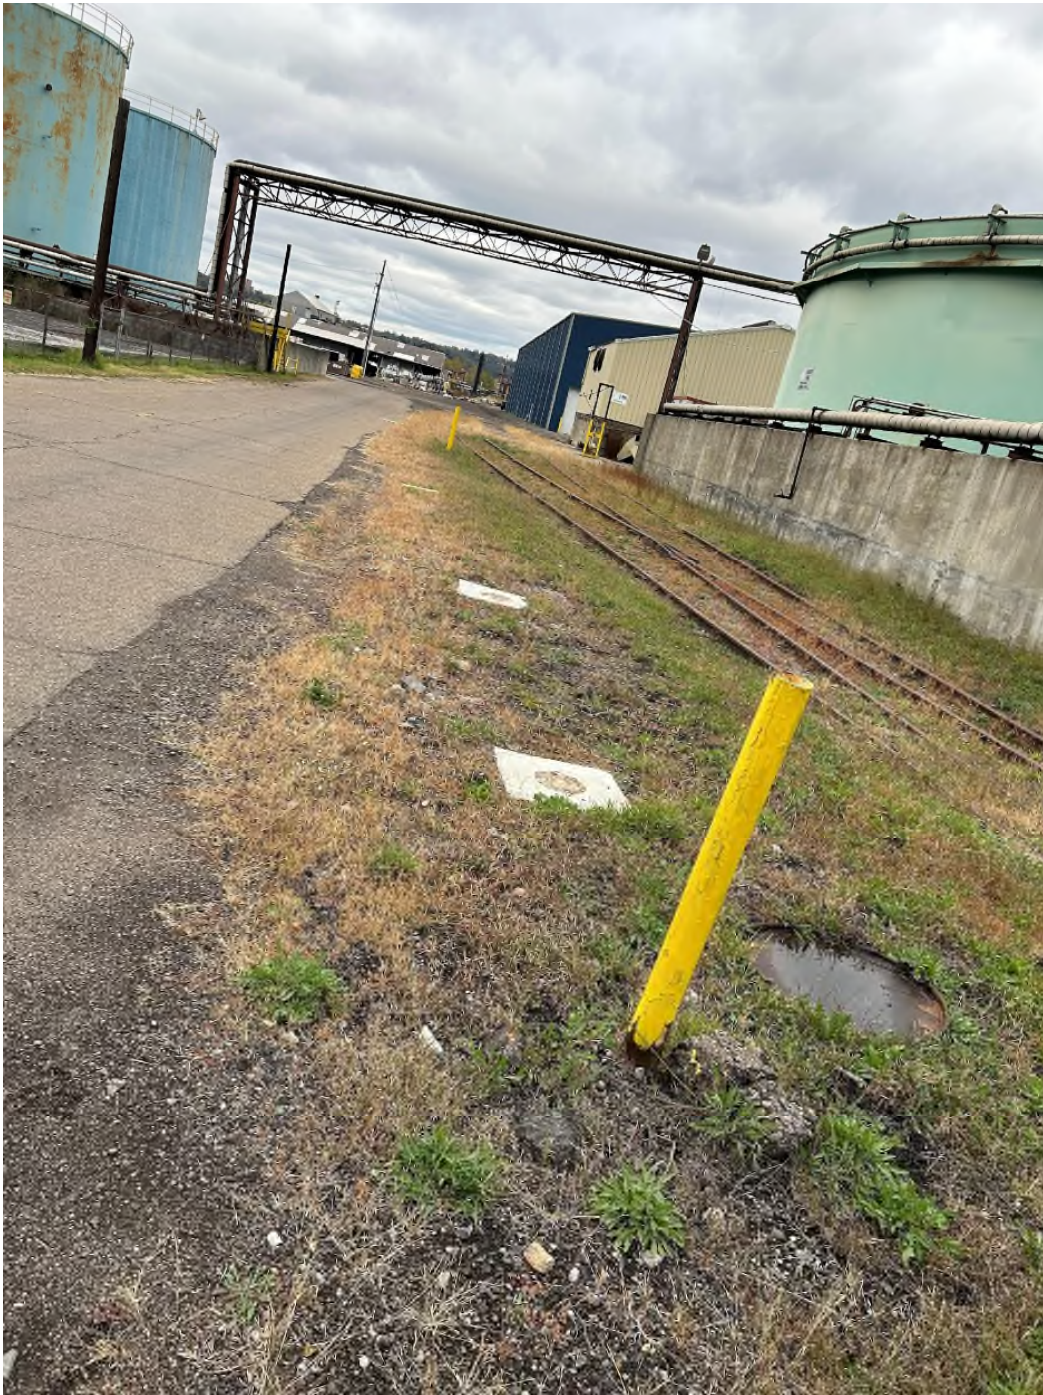
Figure 8: Looking north from the south end of the former plant. Flush mounted monitoring well cluster (R-222D, R-222I, R-222S) as well R-313 are in the foreground. Fresh appearance of concrete indicate recency of the flush mounts on the ground.

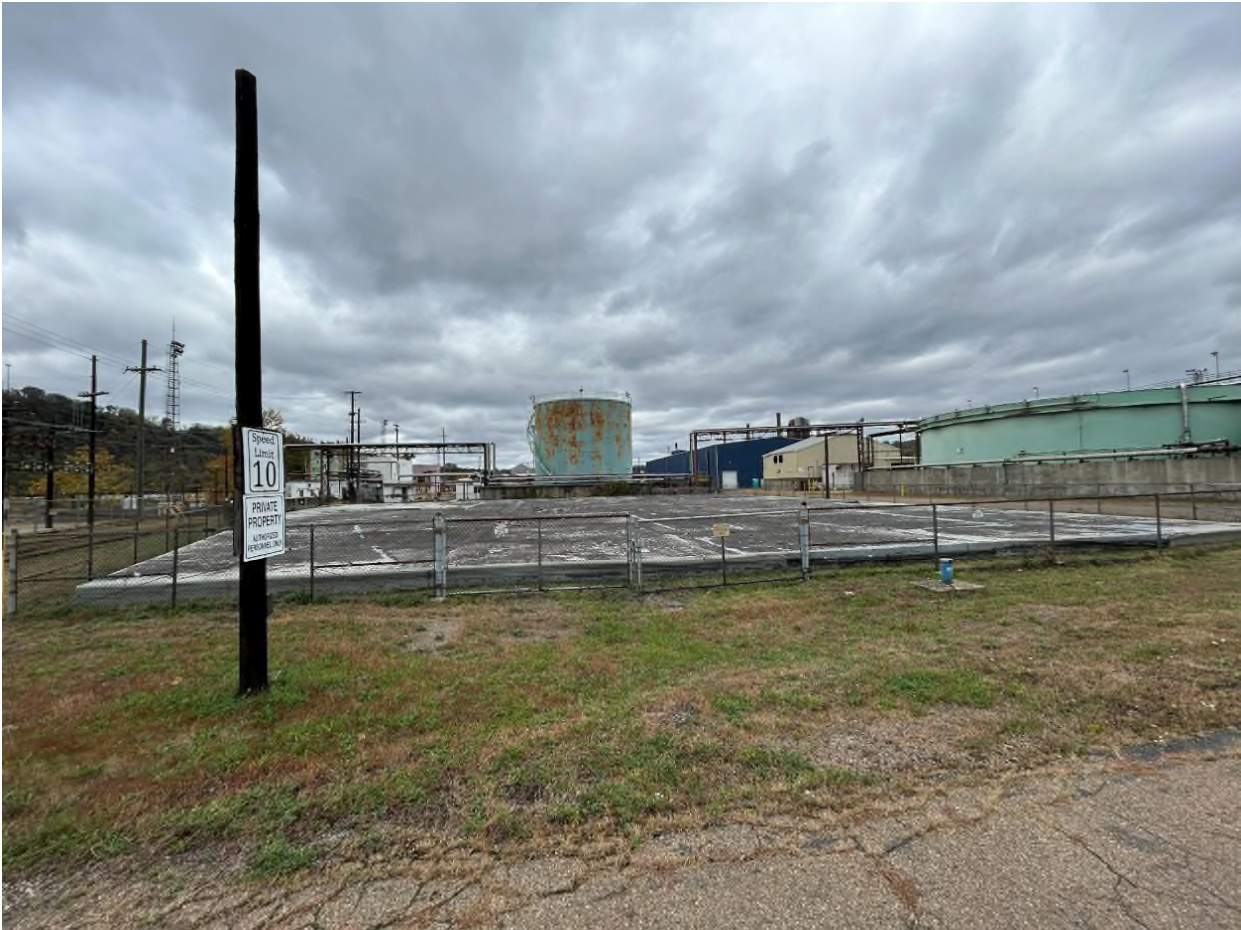
Figure 9: Looking north with the former aeration basins.

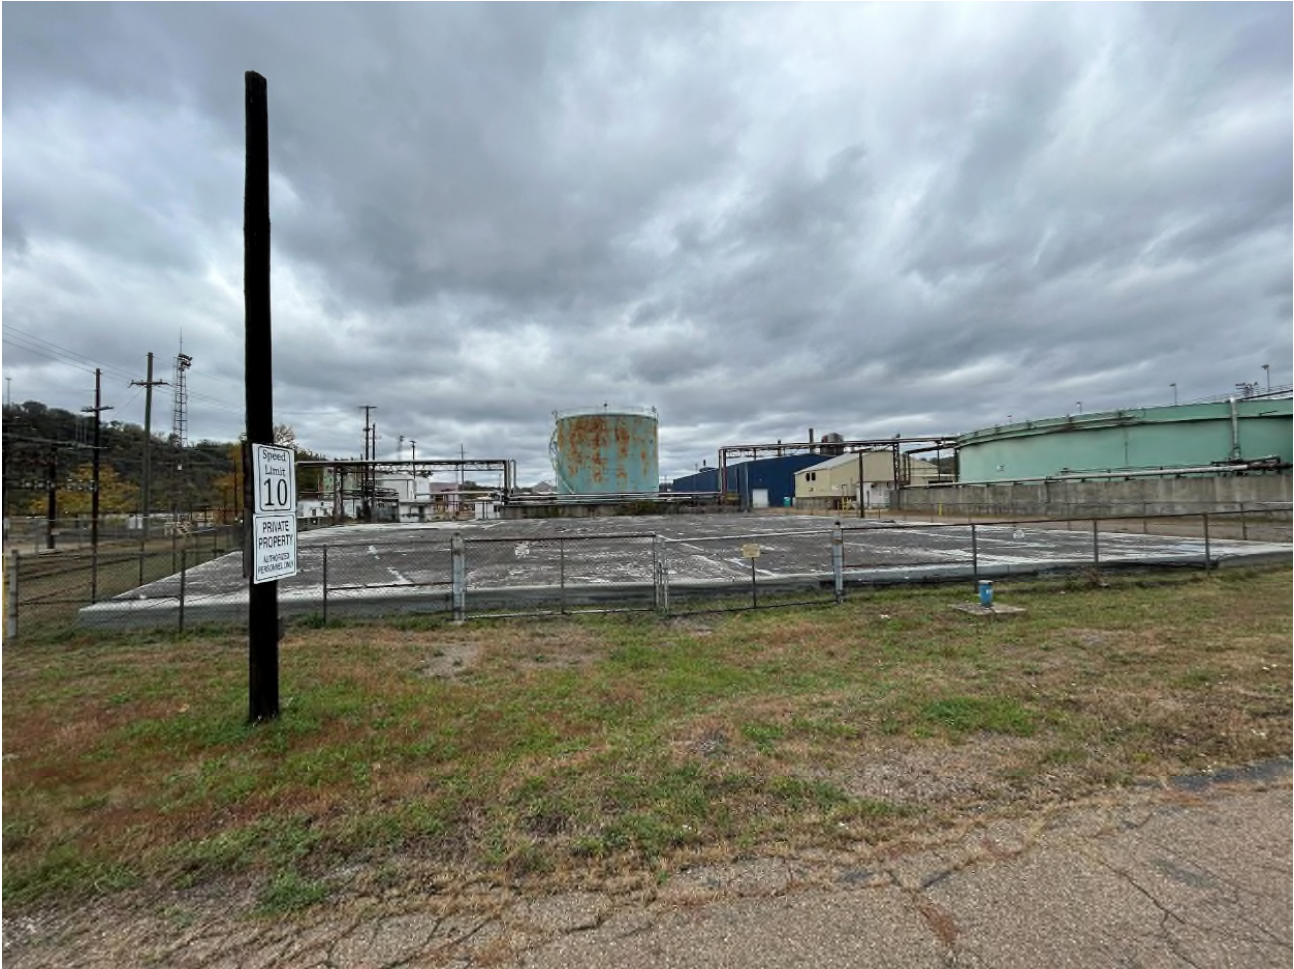
Figure 10: A cluster of monitoring wells (R-216D, R-216I and R-216S) at the southwestern corner of the former plant.

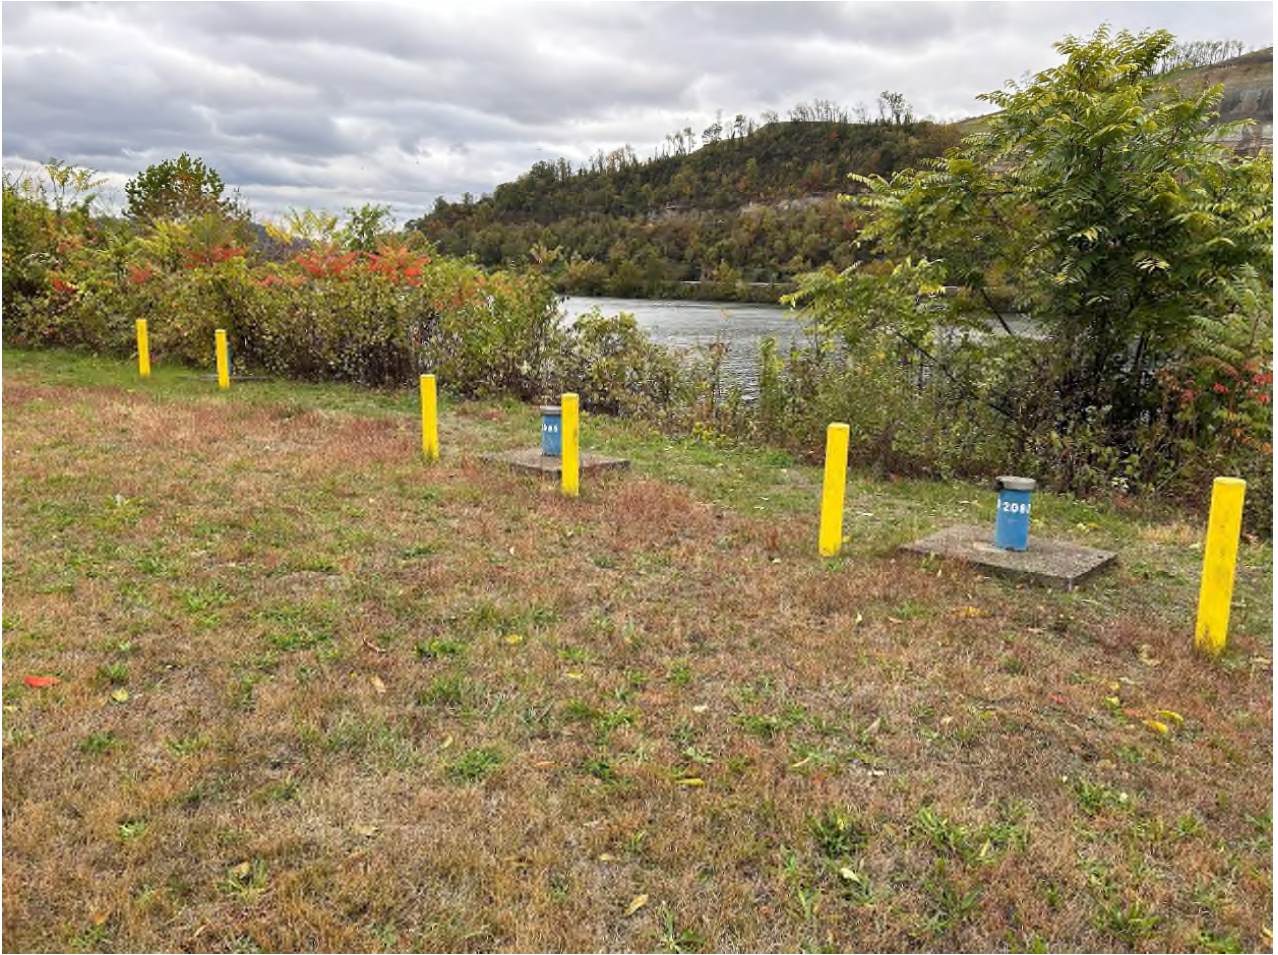
Figure 11: A cluster of monitoring wells (R-208D, R-208I and R-208S) with Ohio River just southwest of the tree-lined embankment.
