## Lessons from the Field with Ohio EPA's Compliance Assistance Unit

U.S. EPA Technical Assistance Webinar  
August 26, 2026

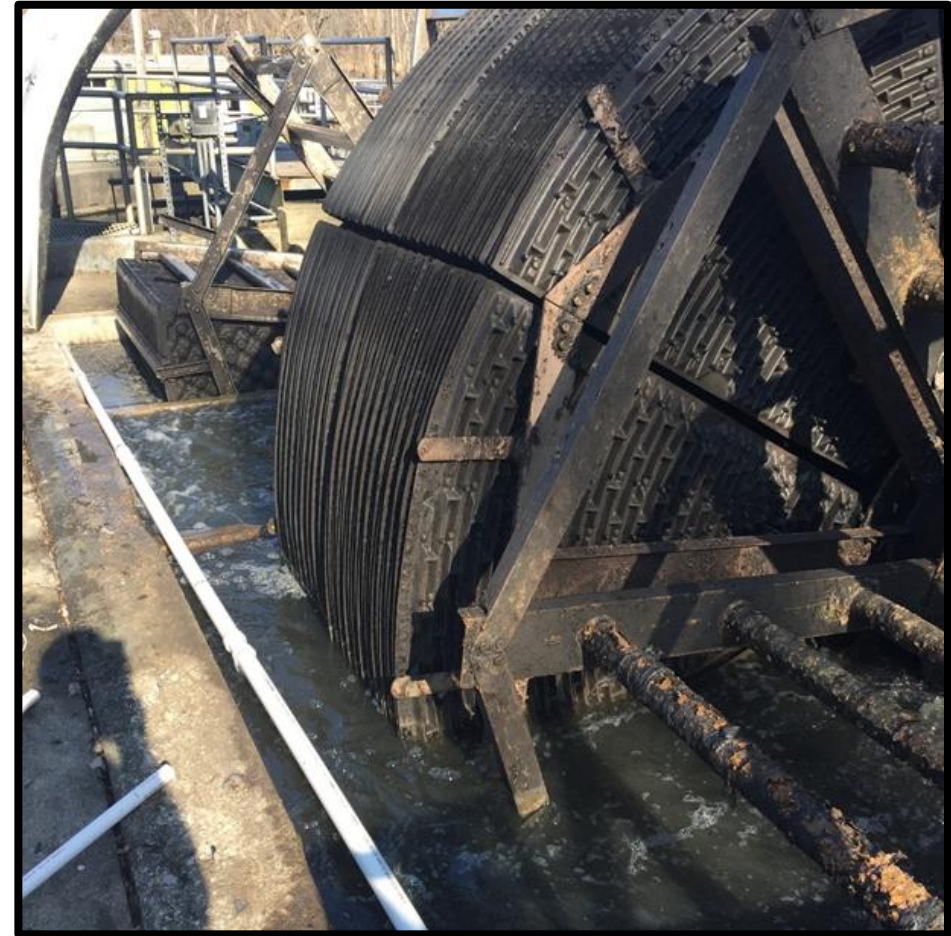
- Constructed diffusers out of PVC pipe and installed in the RBC tanks
- Repurposed an existing blower to provide air to the new diffusers

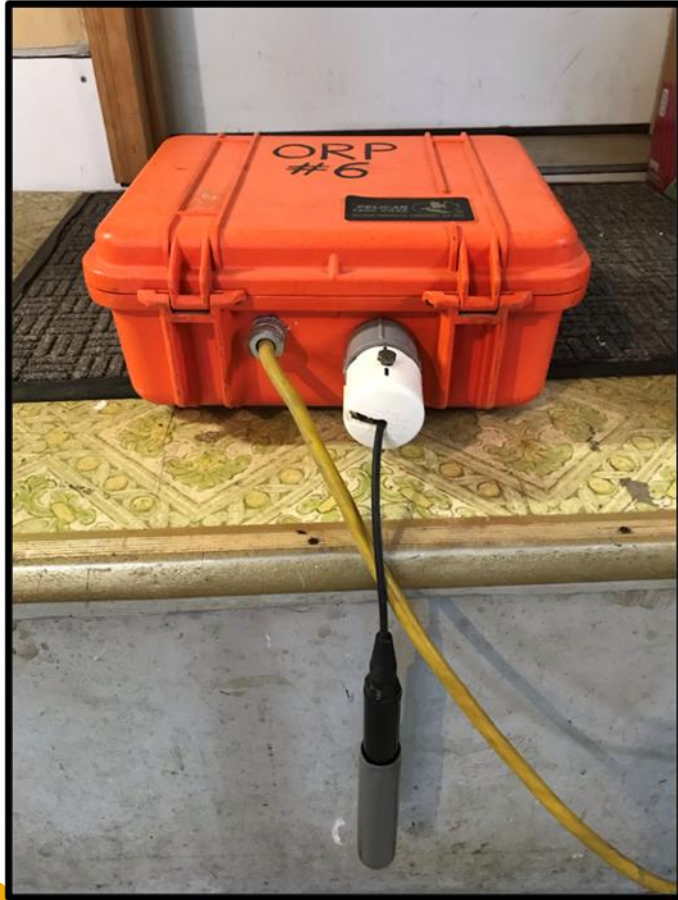
Clays Park Aeration Tank 4 North Dissolved Oxygen (mg/L) Before and After Memorial Day Weekend 2022

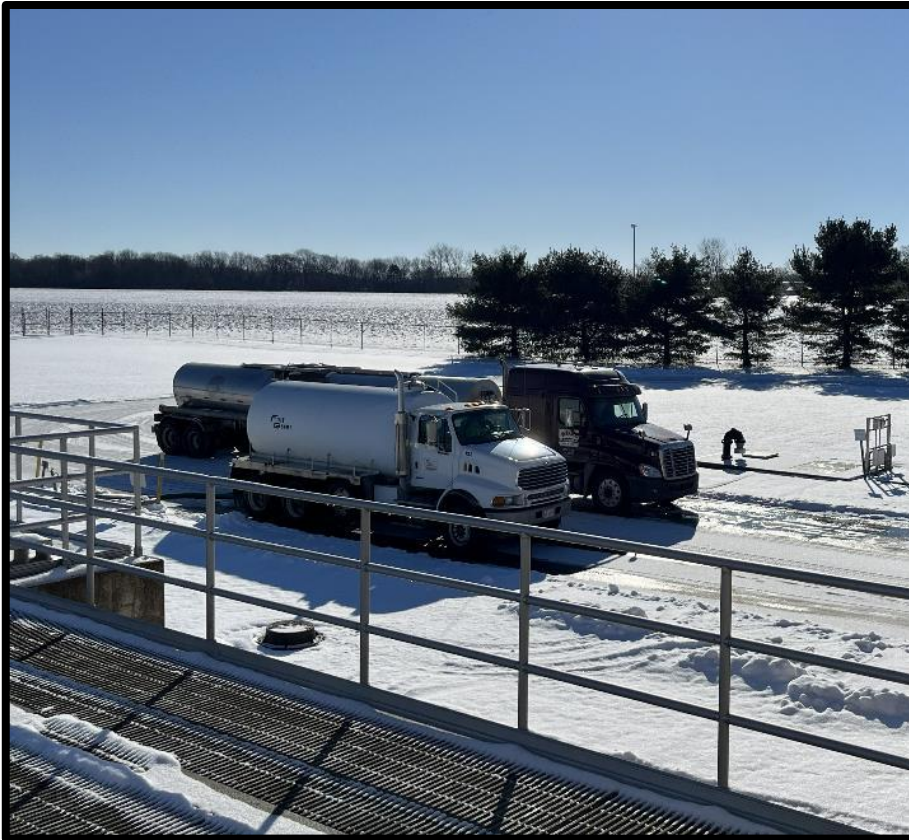
City of Eastoria 2025  
Leachate Hauler Daily Log

- Up to 30,000 GPD of leachate
- Ammonia concentration gradually increasing – in both Leachate and WWTP
- Ammonia effluent violations
- November 2024, ammonia was approximately 3,000 mg/L in leachate

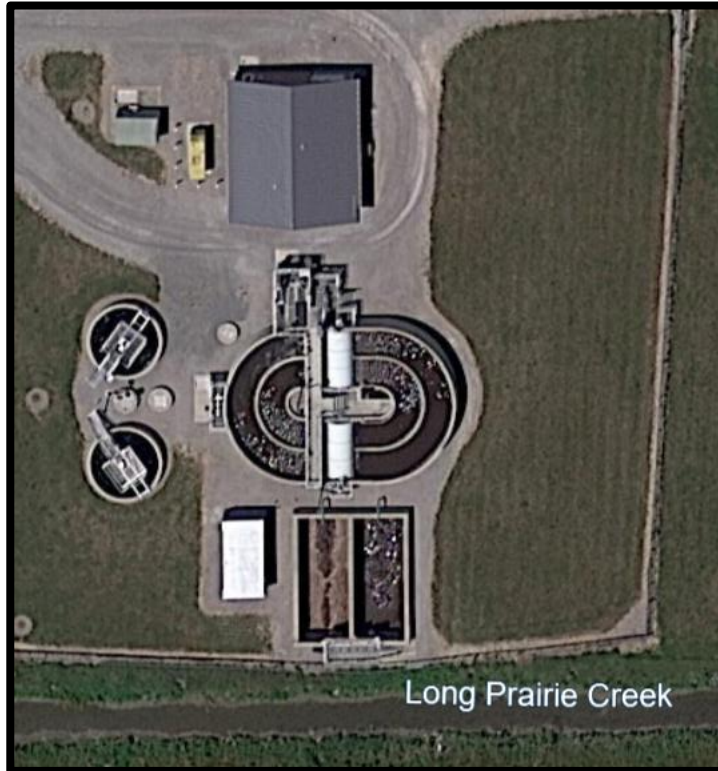
# Village WWTP in NW Ohio

- Small village in Van Wert County
- 0.2 MGD ADF design flow
- Orbal system constructed in 2010
- Asked CAU to assist with meeting final effluent total phosphorus limit of 1.0 mg/l

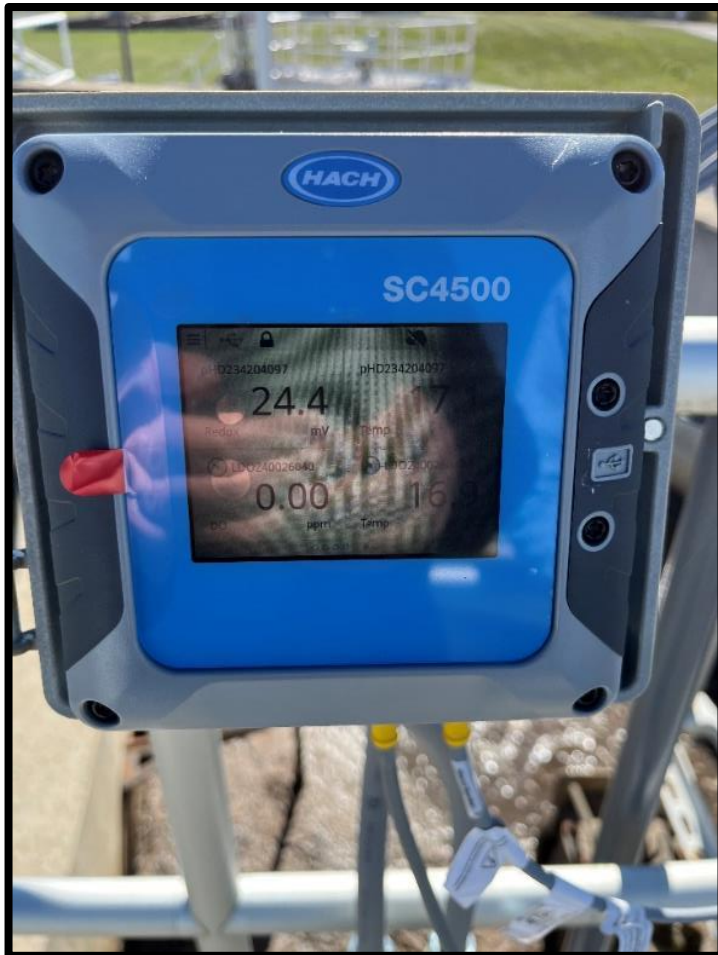
- Facility installed new DO and ORP probes
- Good data enabled adjustments to plant operation
- Adjusted rotor and mixer operation to create anaerobic and anoxic conditions
- BPR success in late 2024

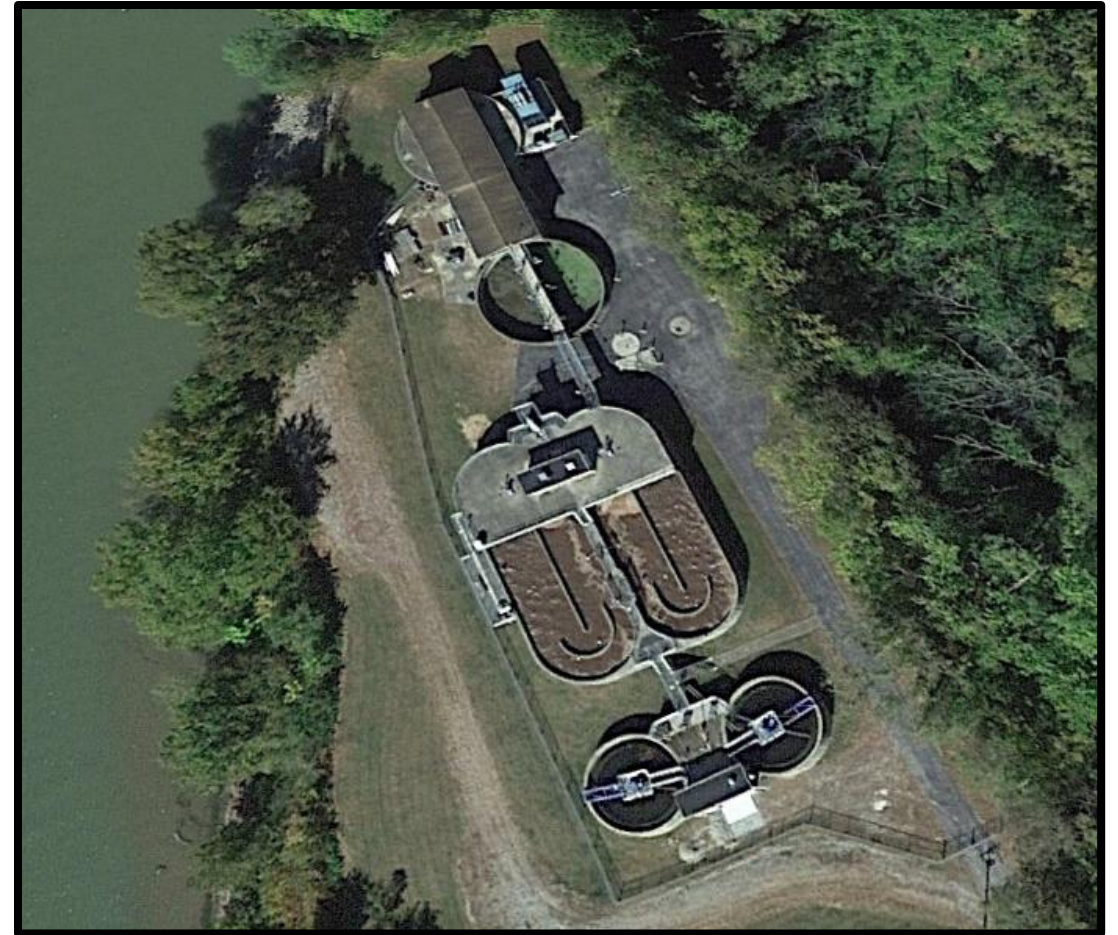
- Population of 1,600
- No industry
- Design Flow 0.4 MGD
- Requested assistance for effluent violations: TSS, Ammonia, & pH

Final Clarifiers

Oxidation  
Ditches

Influent Pump  
Station

Digester

UV  
Disinfection

Influent  
Screening

Outfall to the  
Ohio River

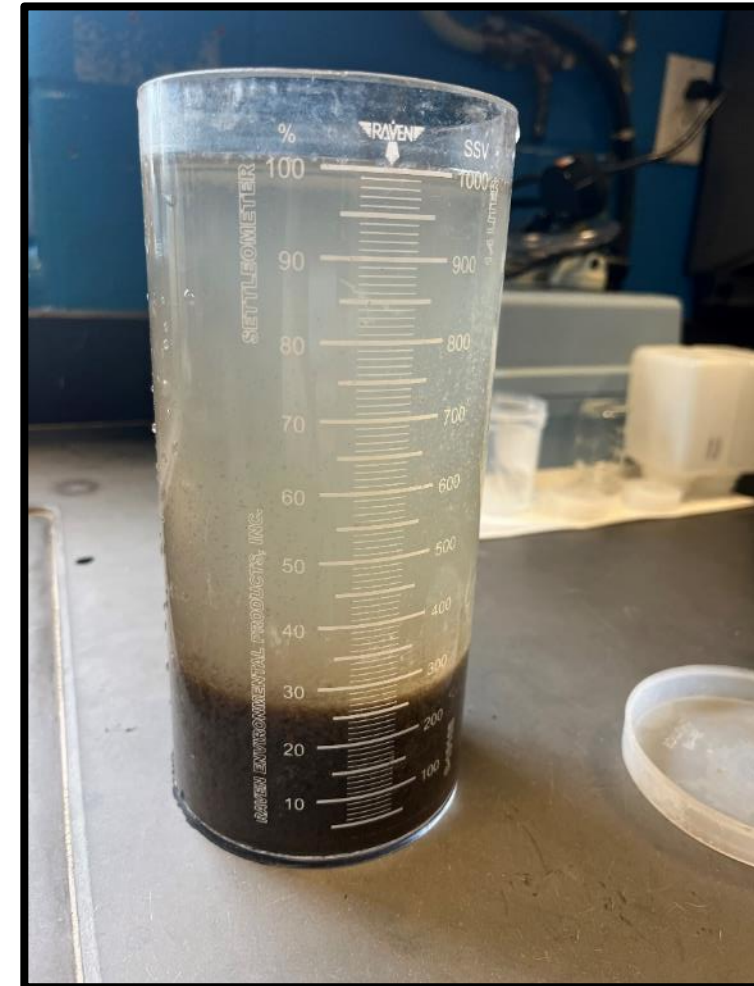
# Process Control Data

- Influent alkalinity = 180 mg/L
- Influent ammonia = 35.5 mg/L
- Oxidation ditch alkalinity = <20 mg/L (pH 5.9)
- Oxidation ditch ammonia = 8 mg/L

$35.5\text{mg/L} \times 7.14 = 253\text{ mg/L alkalinity needed}$

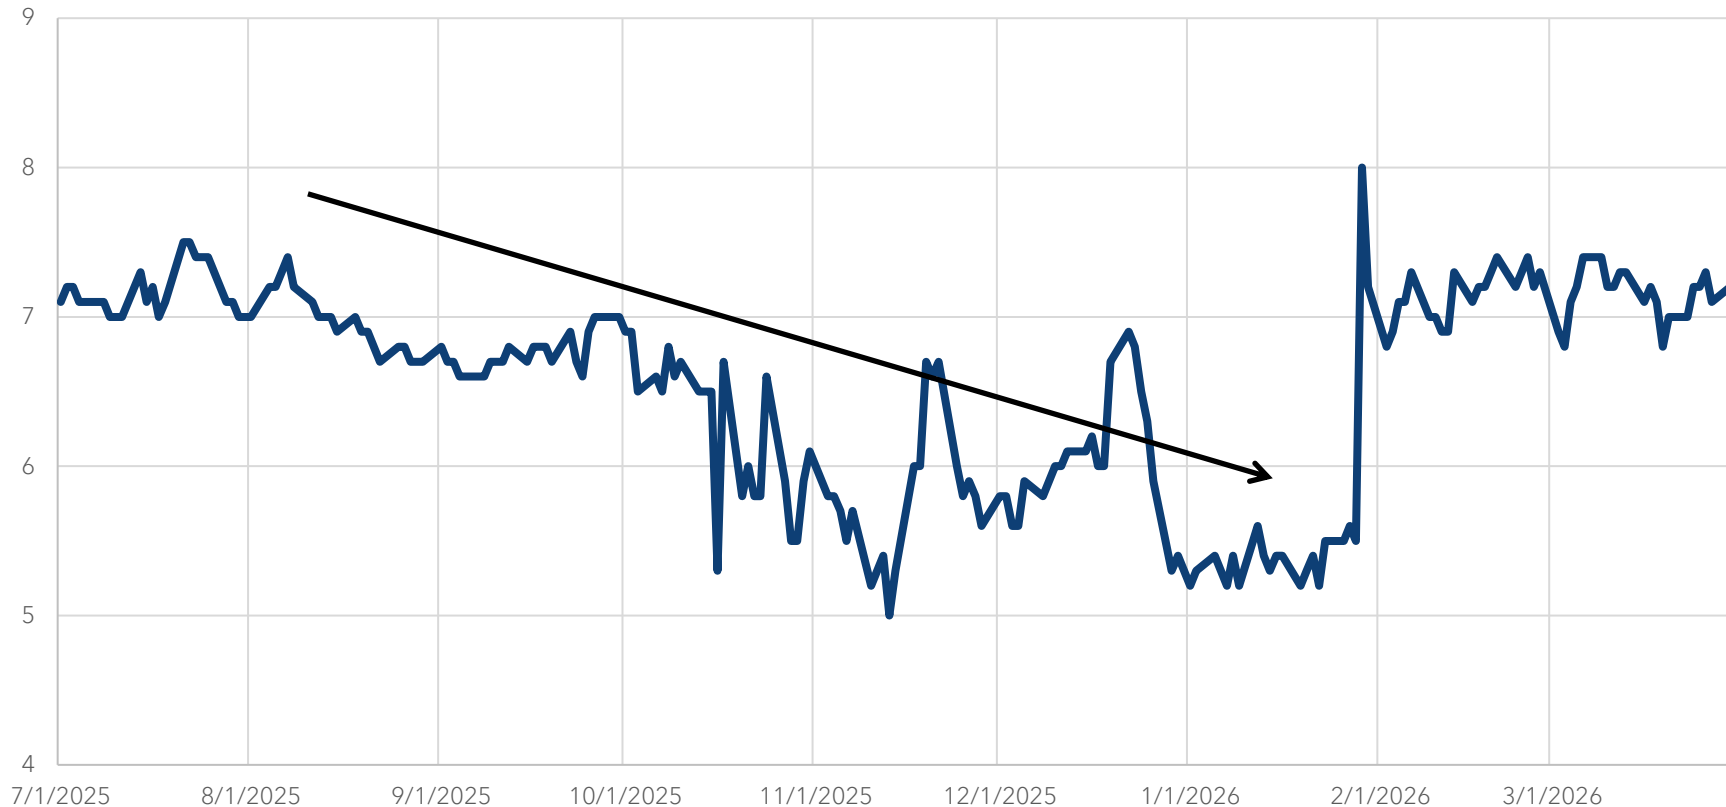
# Effluent pH

**What changed?**

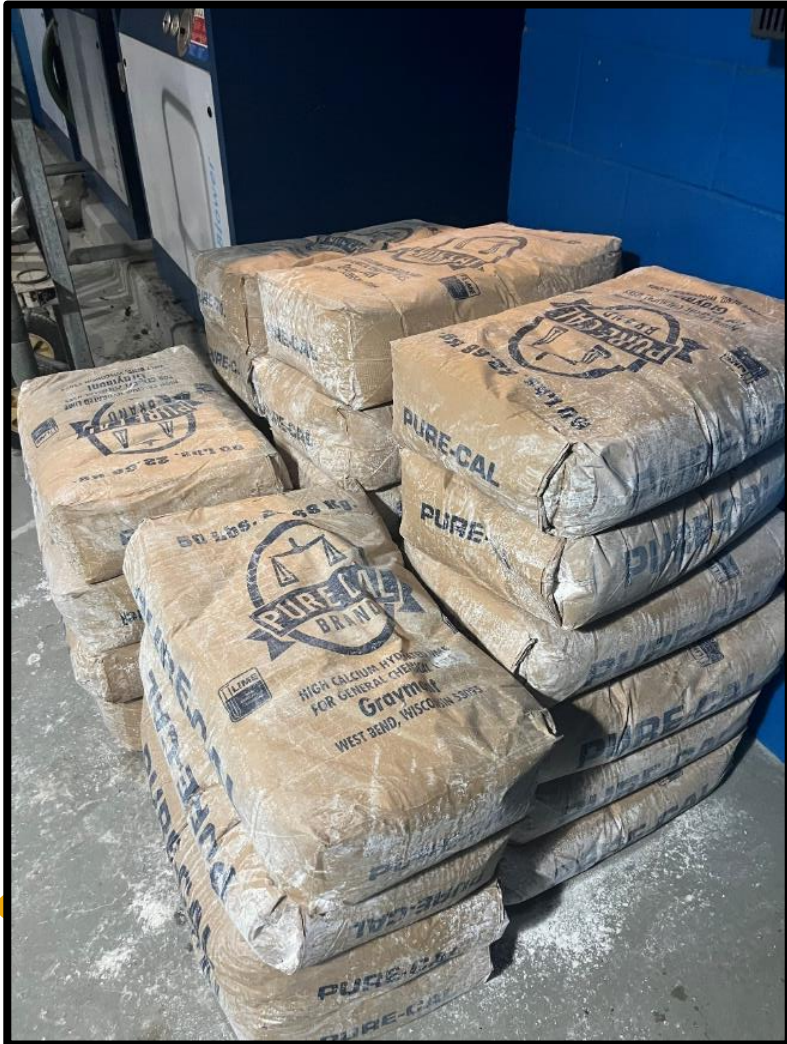
# Alkalinity Addressed

- Addition of hydrated lime to increase alkalinity
- Why not sodium bicarbonate?
- pH on January 29 = 8.0
- Alkalinity = 140 mg/L

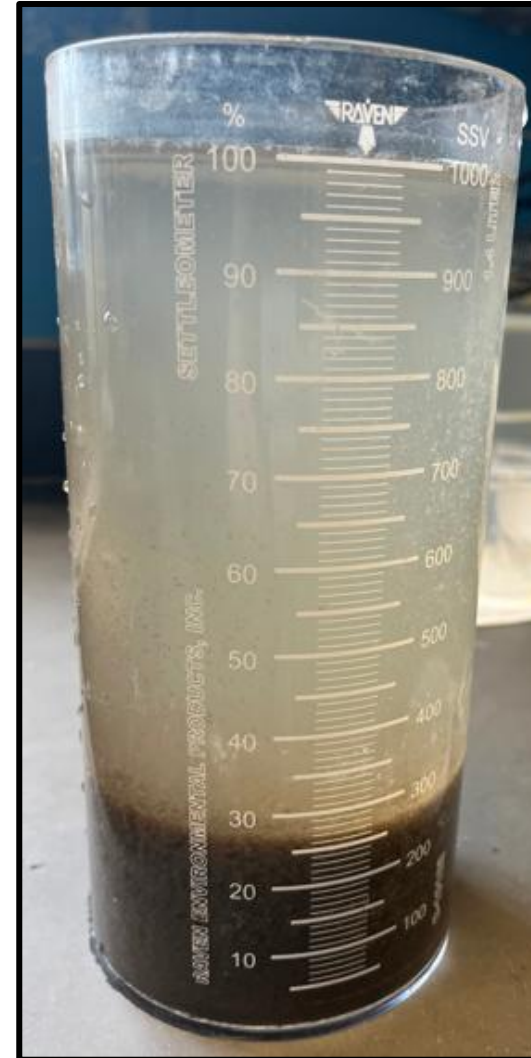
# Problem solved?

- pH & ammonia violations resolved
- TSS & fecal coliform violations persisted
- Minimal improvement in settleometer

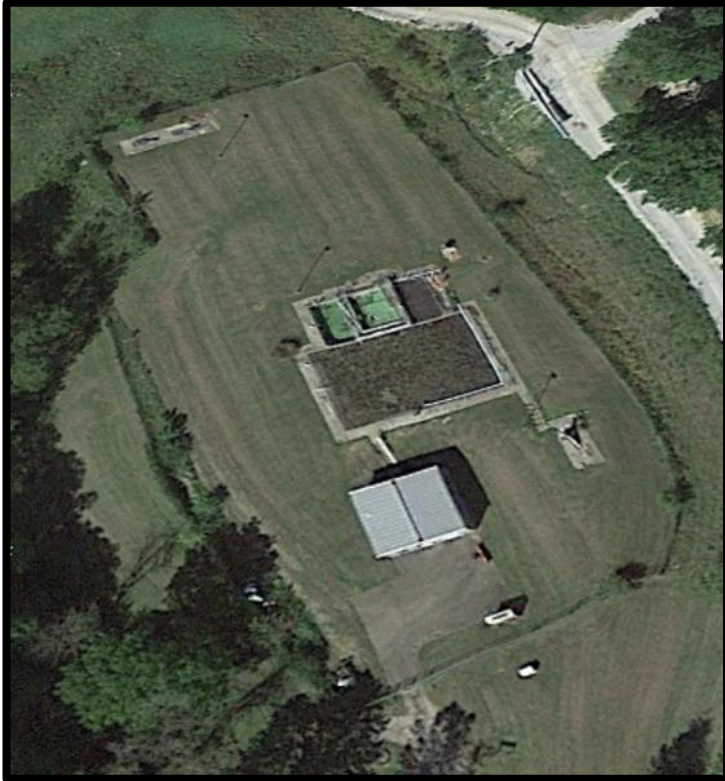
# Small Village in SE Ohio

- Population of 500
- No industry
- Parkson Biolac installed in 2002
- Design flow 93,000 gpd

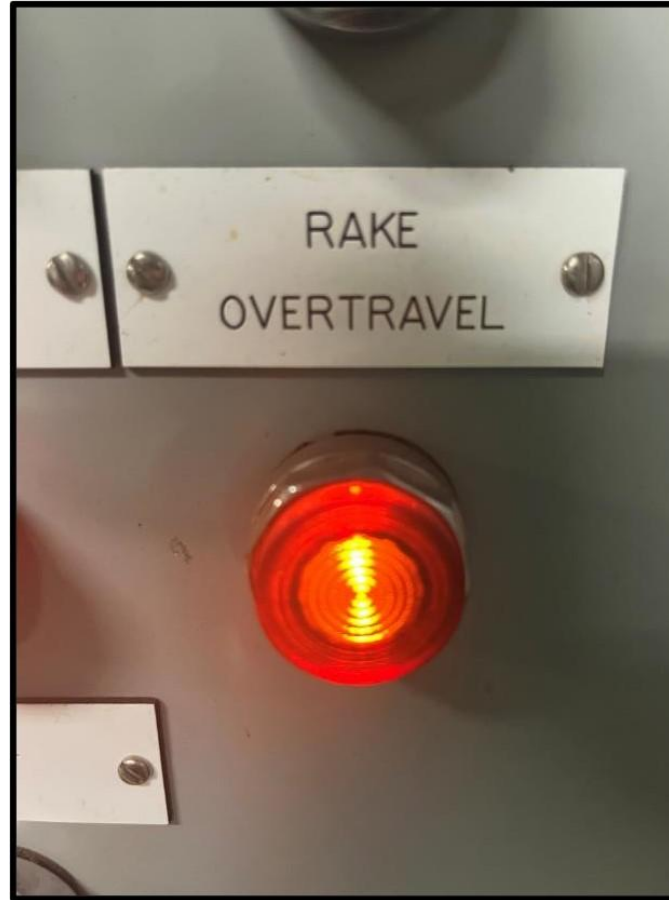
# Outstanding Issues

- No working flow meter
- Rake not in operation
- Waste valve replacement

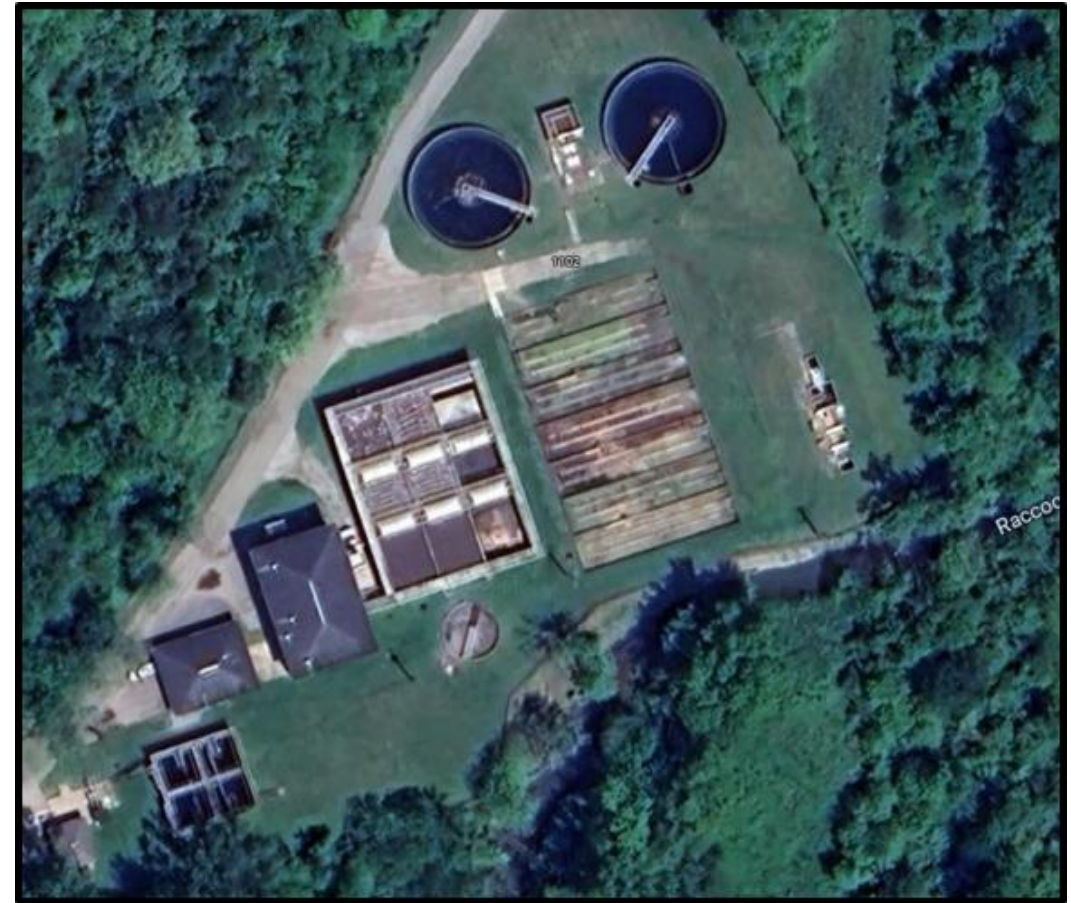
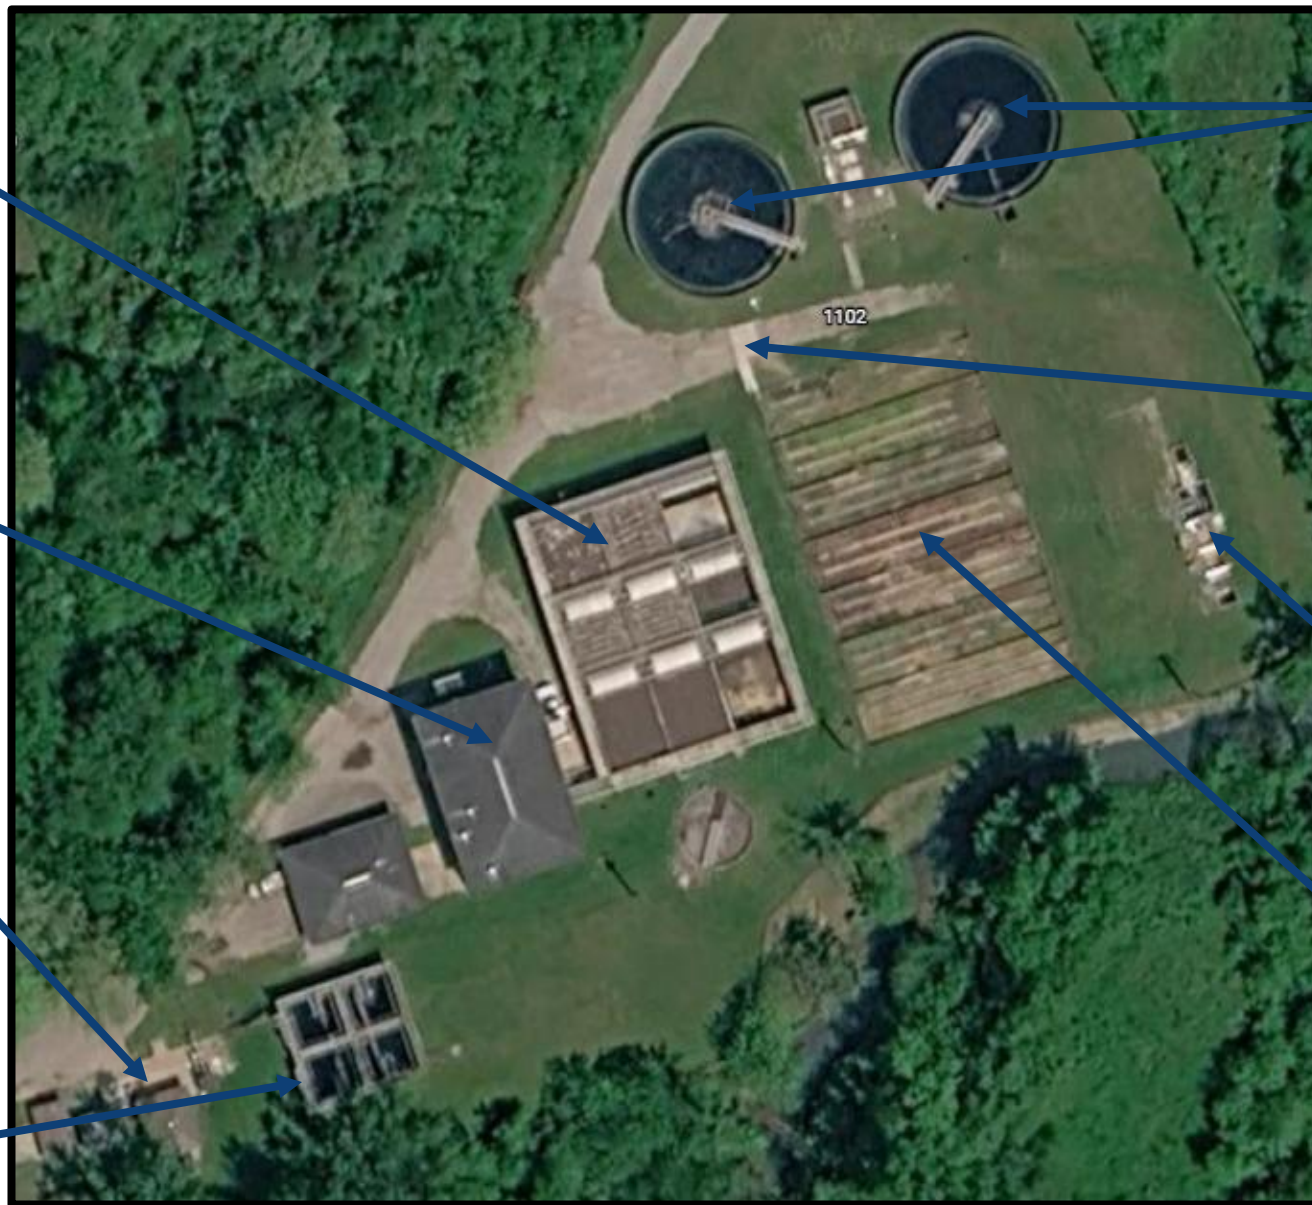
**Vertical  
Loop  
Reactors**

**Sludge  
Press**

**Influent  
Wet Well**

**Digesters**

**Final  
Clarifiers**

**Leachate  
Receiving  
Location**

**UV & Post  
Aeration**

**Old  
Sludge  
Drying  
Beds**
