Reconnaissance in situ
X-ray fluorescence
(XRF) measurement
collection at the Old
Church Rock Mine
(OCRM)

High-pressure slurry
ablation (HPSA) batch
unit at OCRM

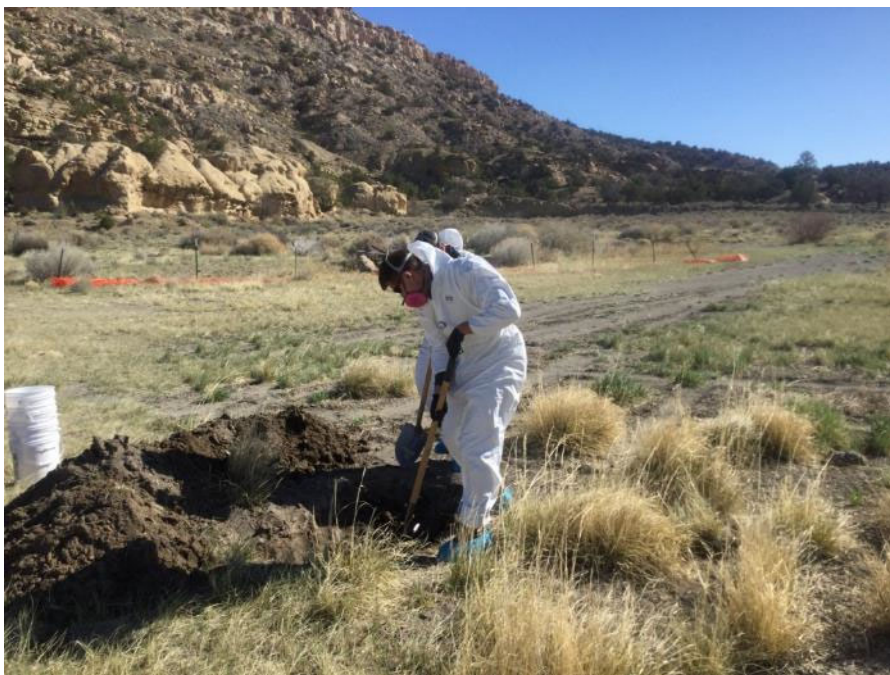
Photo 2

Reconnaissance
medium-concentration
sample collection at
the Quivira Church
Rock 1 Mine (CR-1)

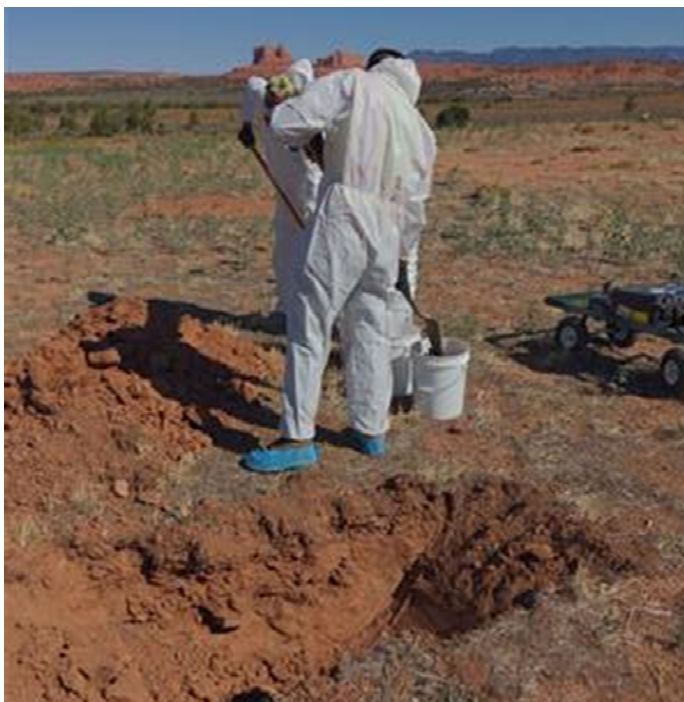
Photo 3

Reconnaissance
medium-concentration
sample collection at
Cove Transfer Station
(CTS) 2

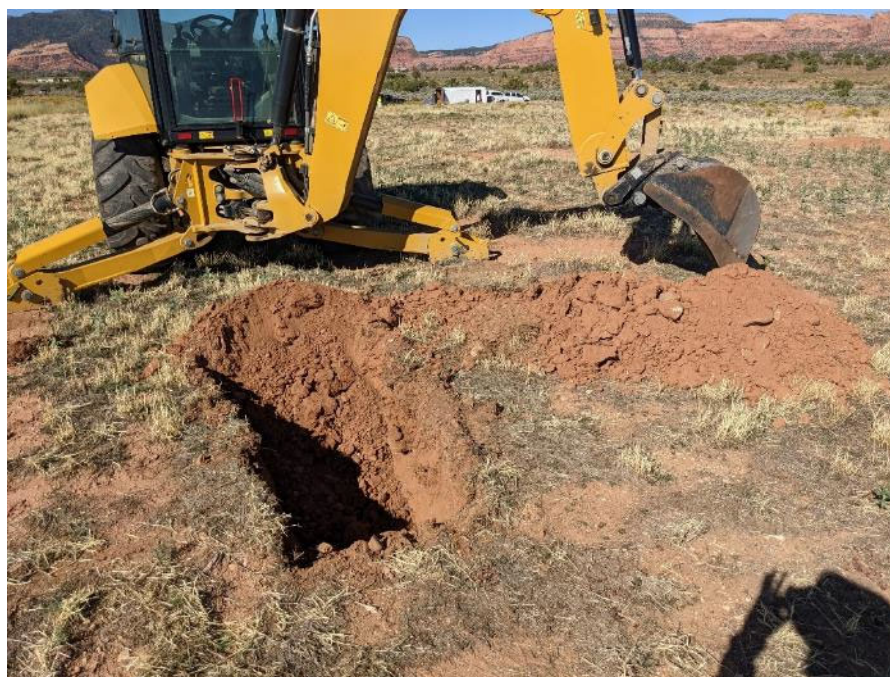
Photo 4

Backhoe excavation of
a bulk sample from
the CTS 2 mine waste
stockpile for use
during the field pilot
study

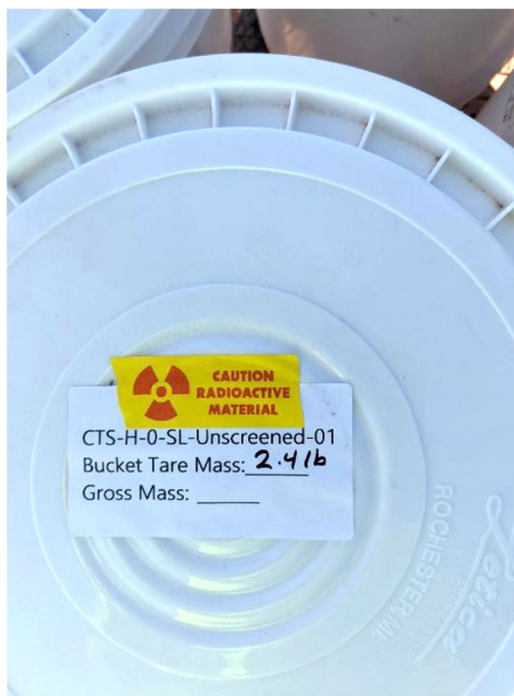
Photo 5

High-concentration bulk sample from the CTS 2 mine waste stockpile for use during the field pilot study

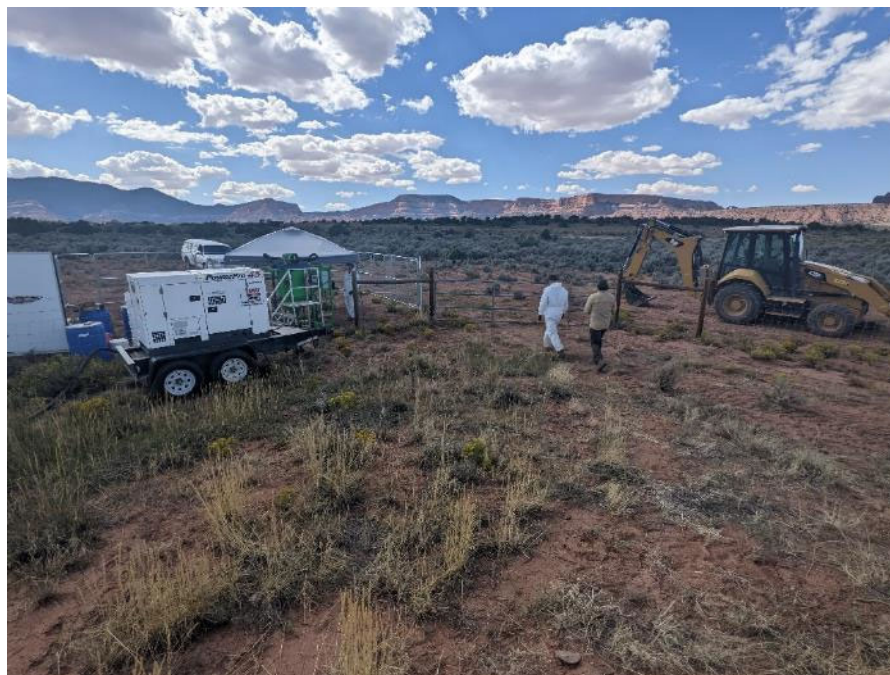
Photo 6

Setup of the pilot study test area at CTS 2

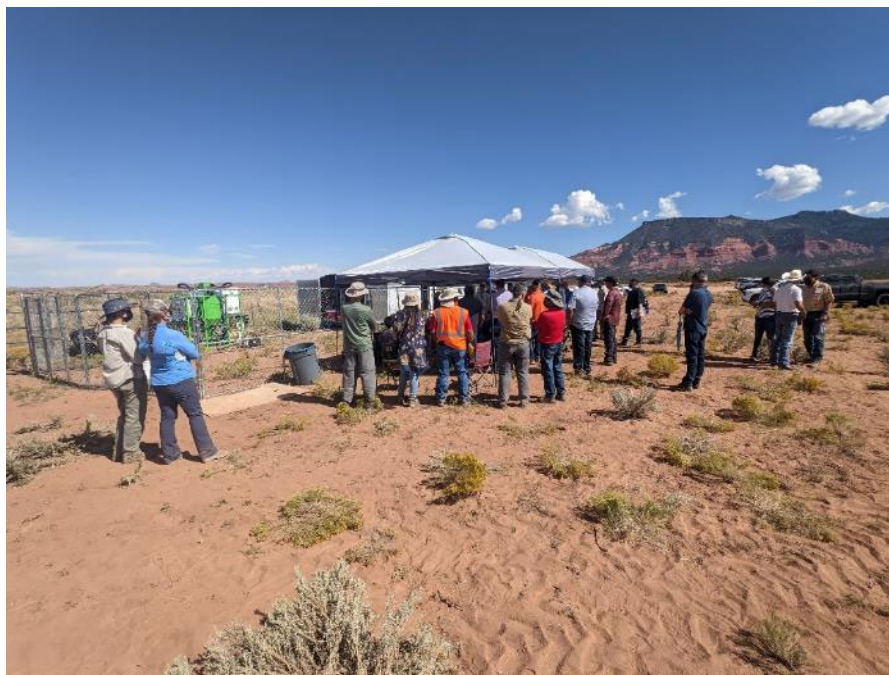
Photo 9

Treatment system and
community attendance
on the demonstration
day

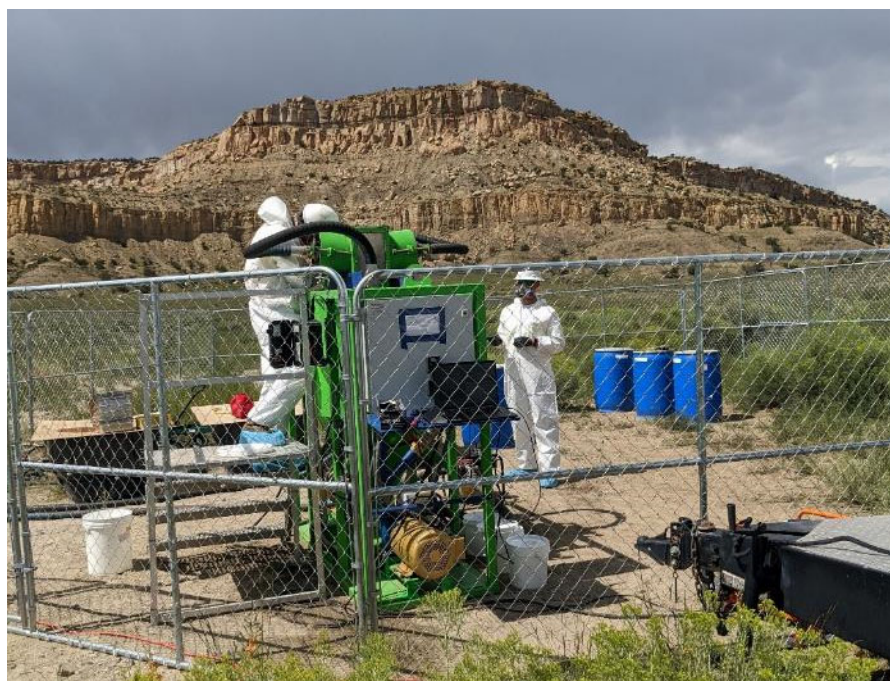
Photo 11

Bulk material added
into the top of the
HPSA batch unit at
OCRM

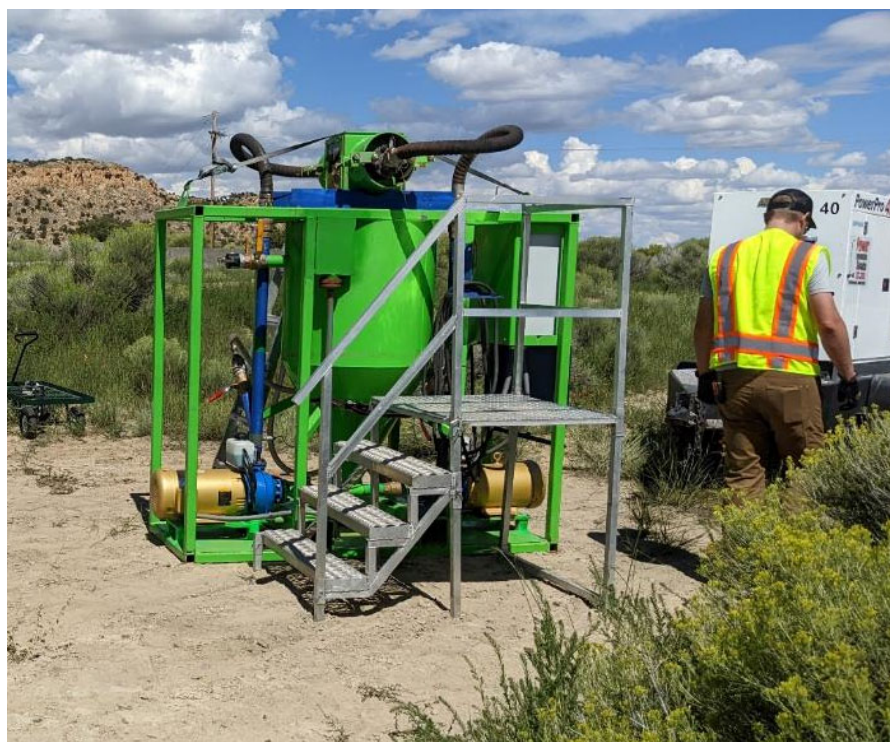
Photo 12

Slurry pumps (gold color)
and blue feed lines to collision
chamber at top of the
HPSA batch unit

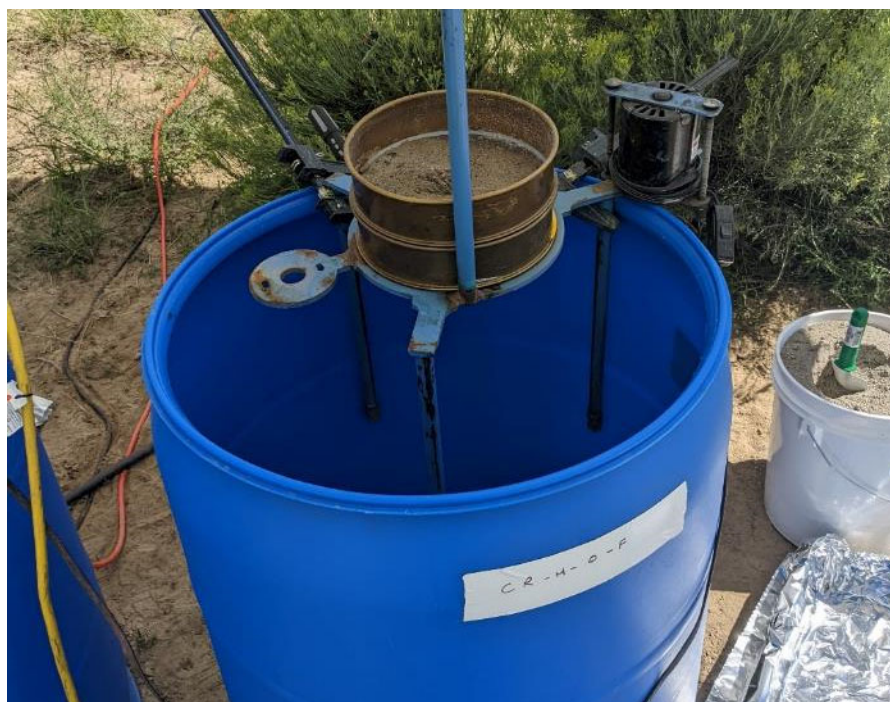
Photo 13

Pre-cut sieving of
passing 270-mesh
bulk feed sample at
OCRM

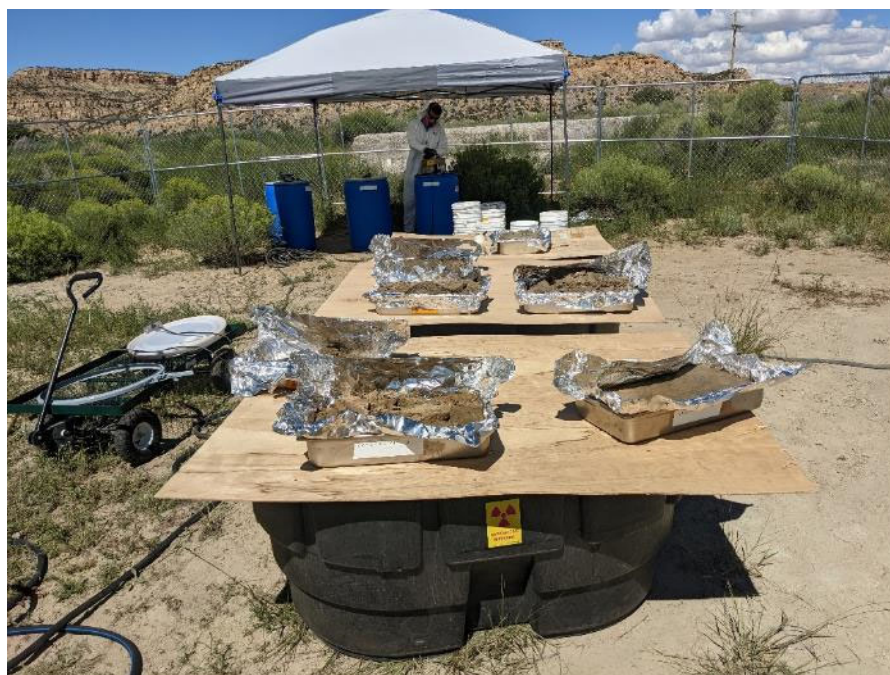
Photo 14

Pre-cut (retained on
270 mesh) time zero
samples staged for
treatment at OCRM

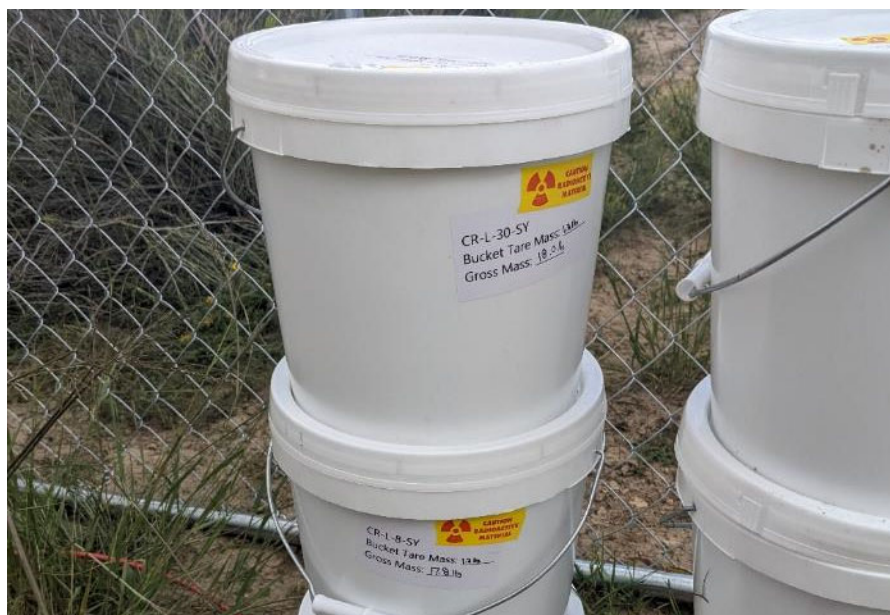
Photo 15

Post-treatment sample buckets ready for shipment to the Disa Technologies, Inc. process laboratory for wet sieving and subsampling

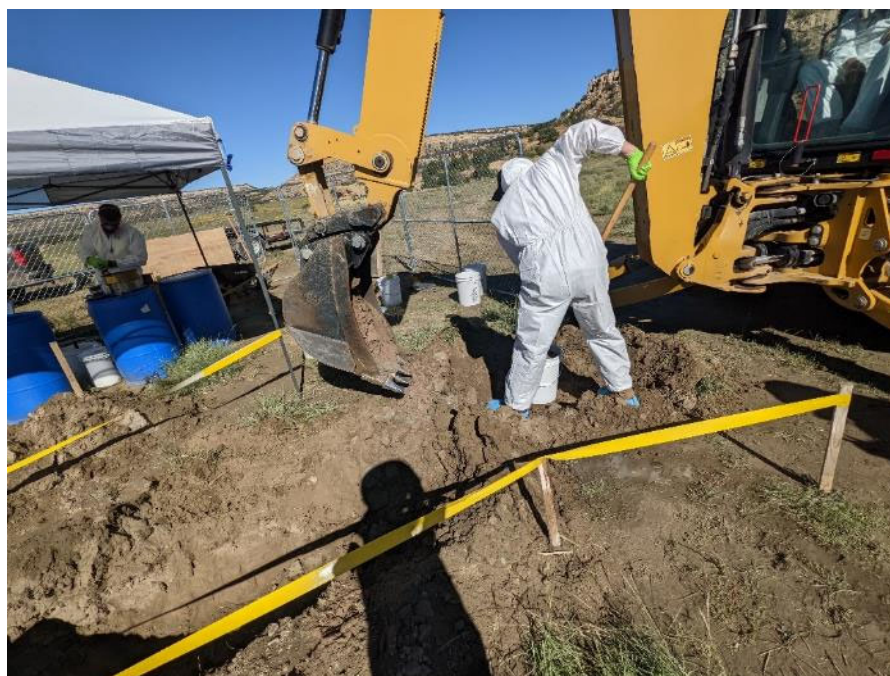
Photo 16

Bulk sample collection from backhoe bucket into 5-gallon buckets at Quivira CR-1

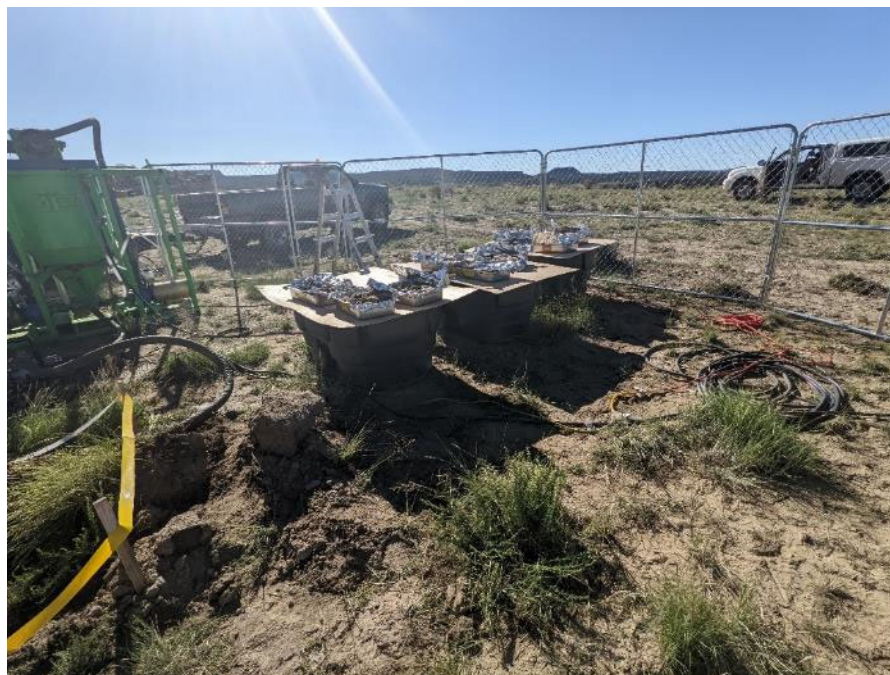
Photo 17

Pre-cut soil samples
(retained on 270
mesh) staged for
treatment at Quivira
CR-1

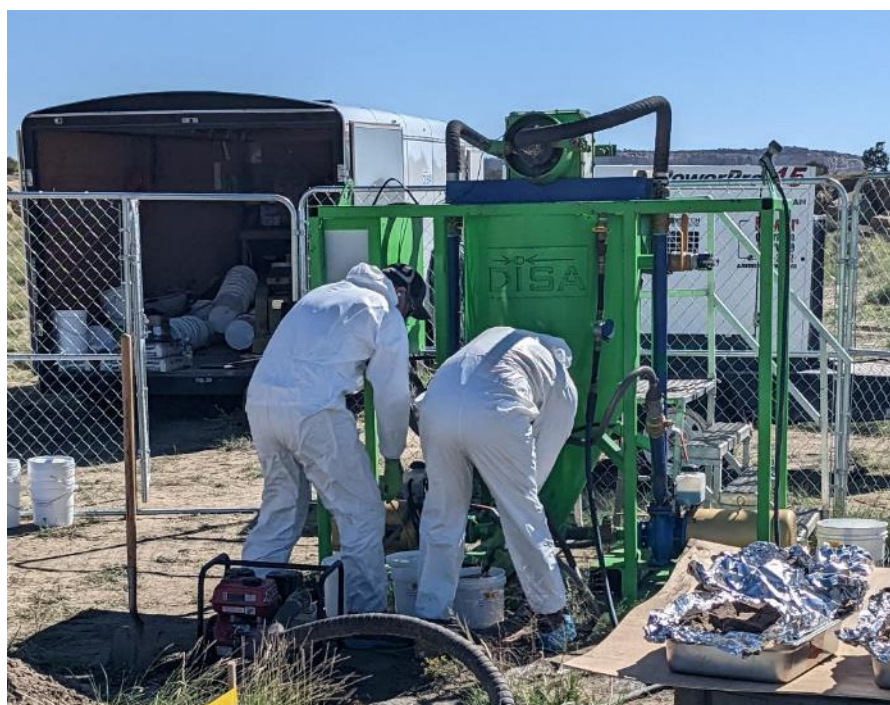
Photo 18

Collection of a treated
slurry sample from the
HPSA batch unit into
2-gallon buckets at
Quivira CR-1

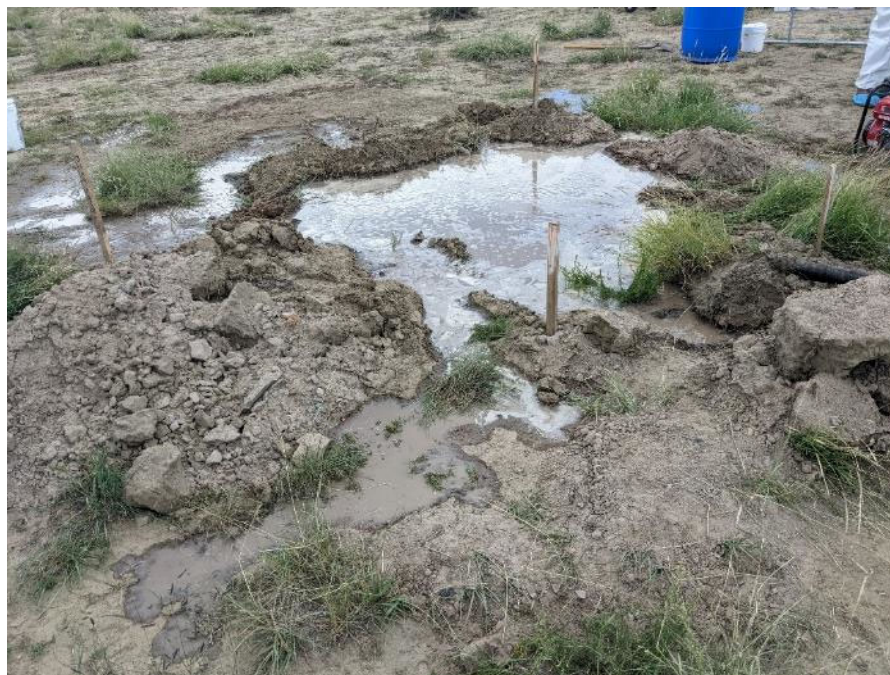
Photo 19

Return of excess treated soil slurry to open bulk sample excavation at the Quivira CR-1 high-concentration sample location

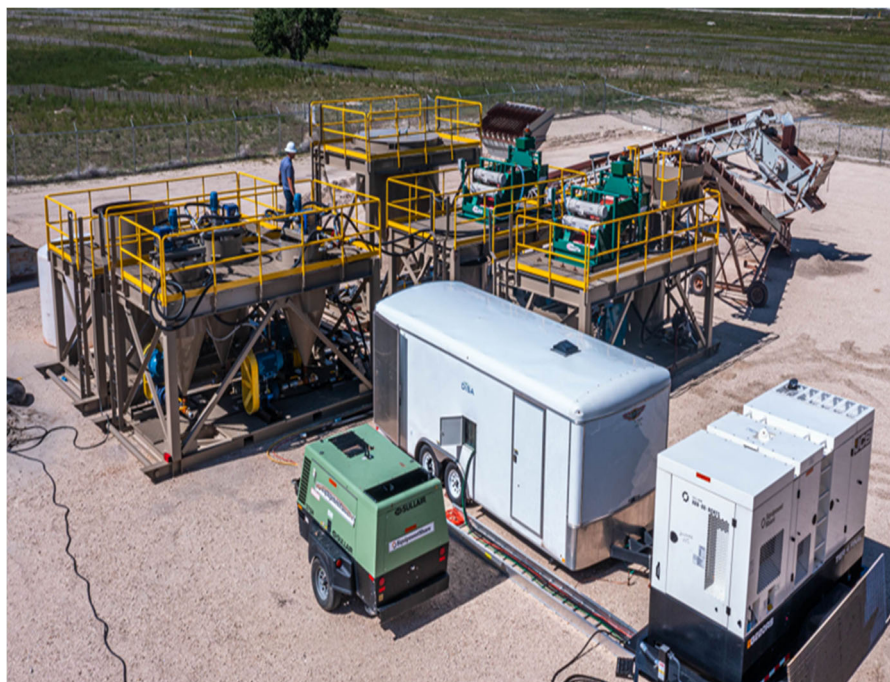
Photo 20

Overview of 5-ton-per-hour continuous-operation HPSA treatment system

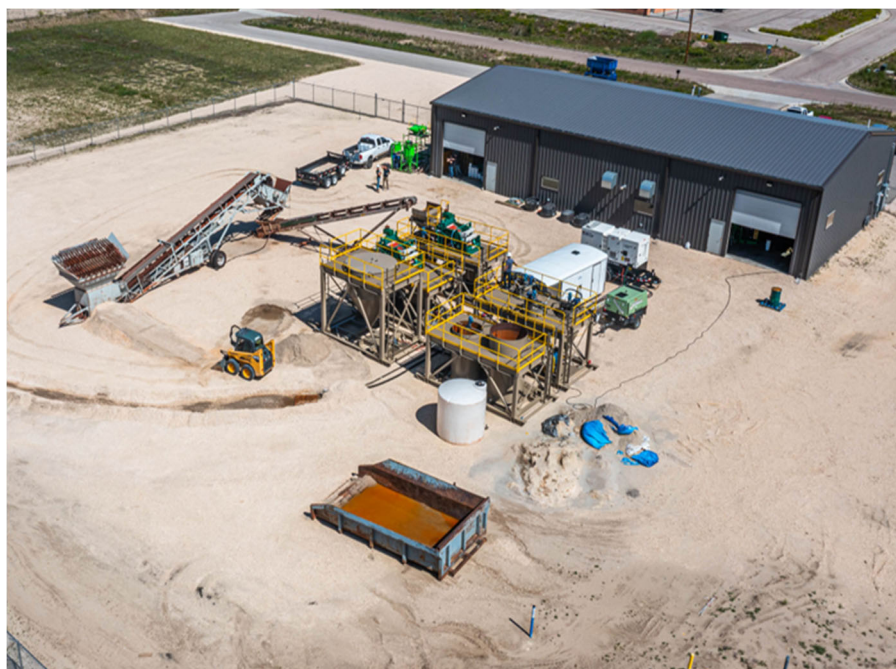
Photo 21

Overview of 5-ton-per-hour continuous-operation HPSA treatment system
