Assessment of Dam Safety
Coal Combustion Surface Impoundments (Task 3)
Draft Report

Allegheny Energy

R. Paul Smith Station

December 17, 2009

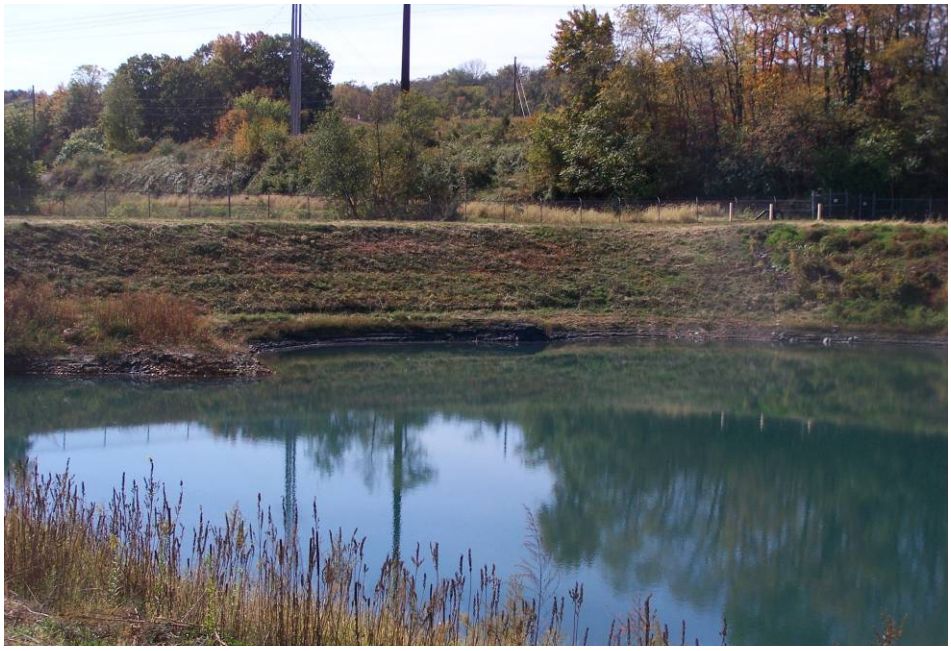
18

Upstream slope of south dike of Pond #3 looking southwest. South abutment at right of photo.
