Assessment of Dam Safety
Coal Combustion Surface Impoundments (Task 3)
Final Report

American Electric Power

Muskingum River Power Plant

March 23, 2010

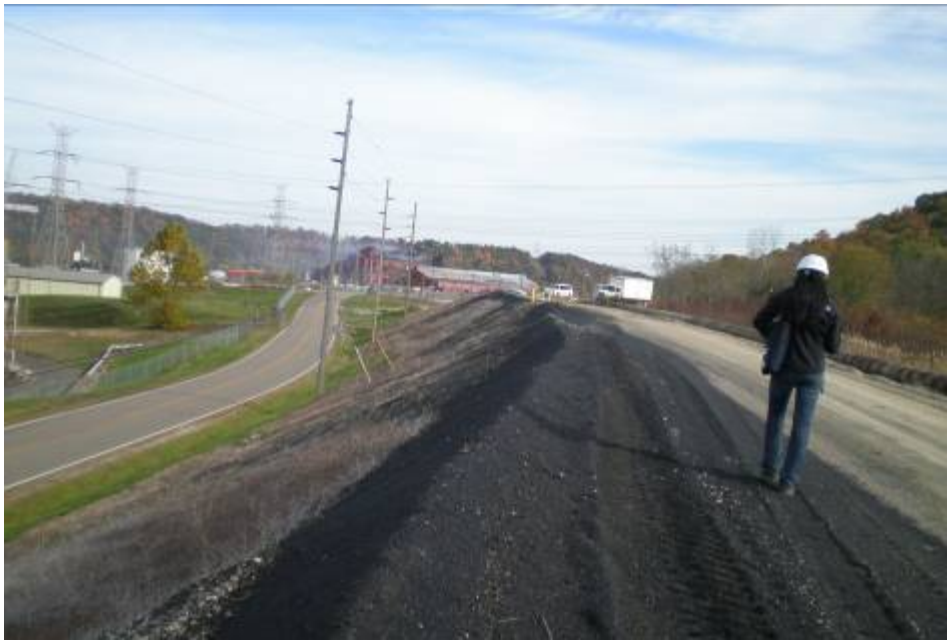
63

Lower Fly Ash Dam crest, looking southeast.
