SRI/USEPA-GHG-VR-07
September 2000

Environmental Technology Verification Report

A&A Environmental Seals, Inc. Seal Assist System (SAS)

Phase II Report

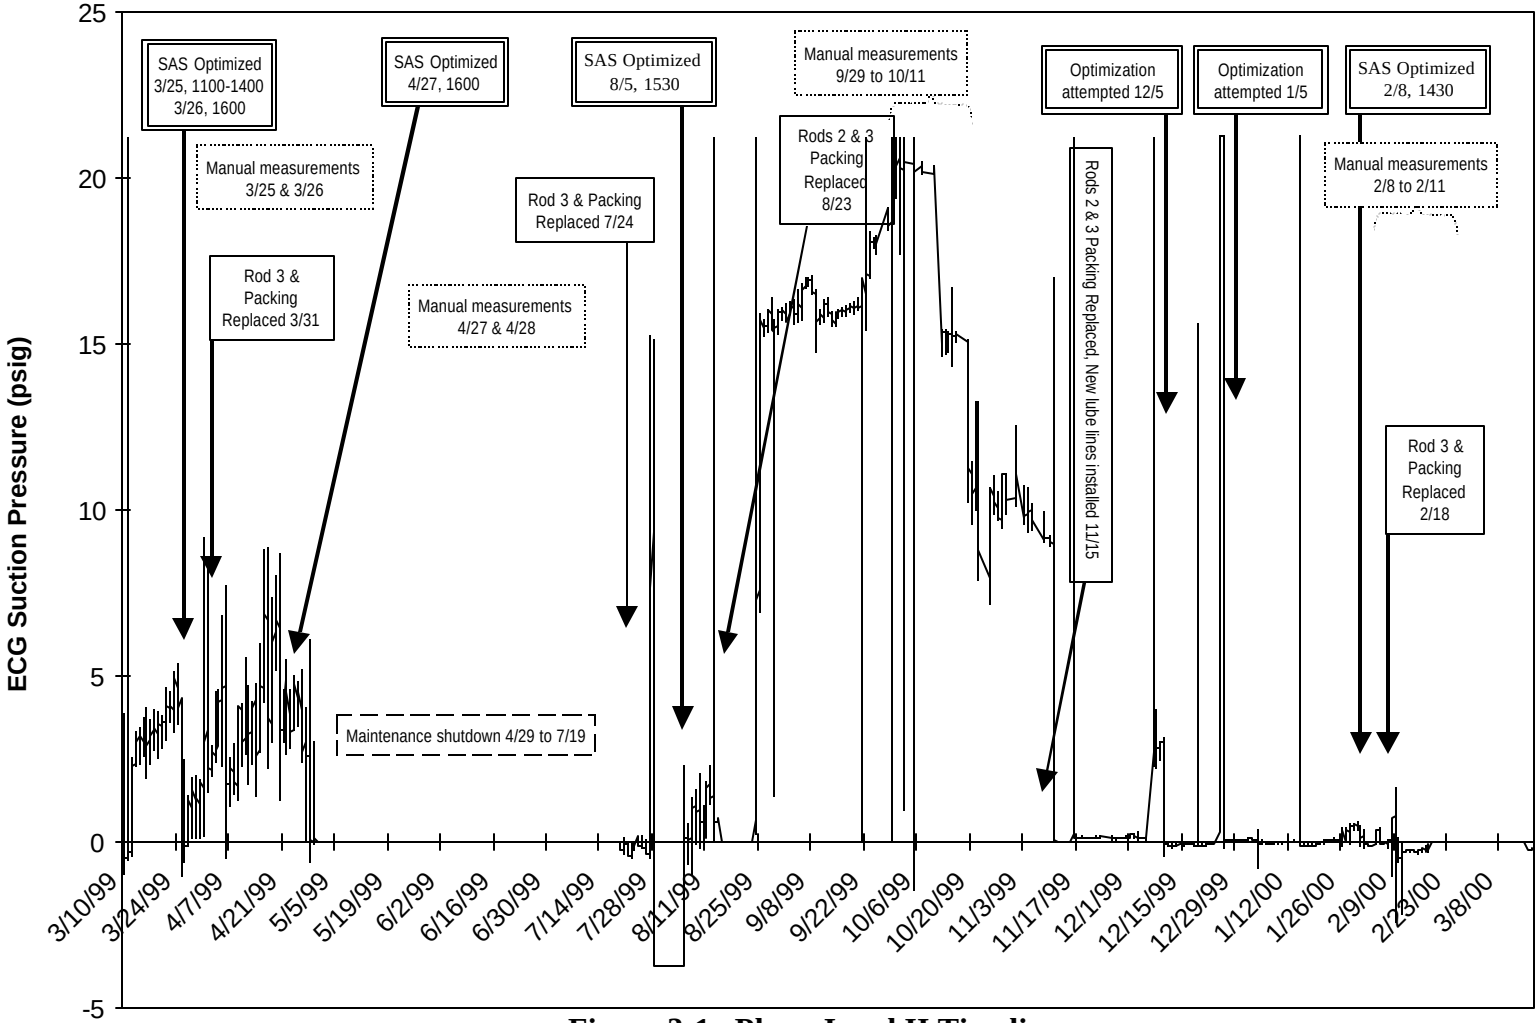
Figure 3-1. Phase I and II Timeline

Figure 3-1 is a timeline that covers the entire Phase I and II verification period. The figure shows the operational events listed above, identifies when SAS performance optimization efforts were conducted, and plots an important indicator of SAS performance, the pressures exiting the ECGs (ECG suction header pressure). Important maintenance downtime periods are also shown.

Close examination of the SAS pressures in Figure 3-1 reveals that, on a few occasions, slightly negative ECG suction pressure was achieved and maintained. This generally corresponded to times when SAS optimization was conducted and achieved, and soon after rod seal failure and replacement occurred. Given the generally unrepresentative operation experienced at the host site, these periods correspond to the most normal or representative system operation experienced during the verification test period. As such, data during these periods were used to quantify SAS performance for the Phase II verification. Given that these events often occurred at the same time as the manual emission measurement campaigns, the manual measurement data play a significant role in determining SAS performance under normal operating conditions. Continuous data collected with mass flow meters and other in-line devices are used to qualify SAS performance under more extreme conditions.

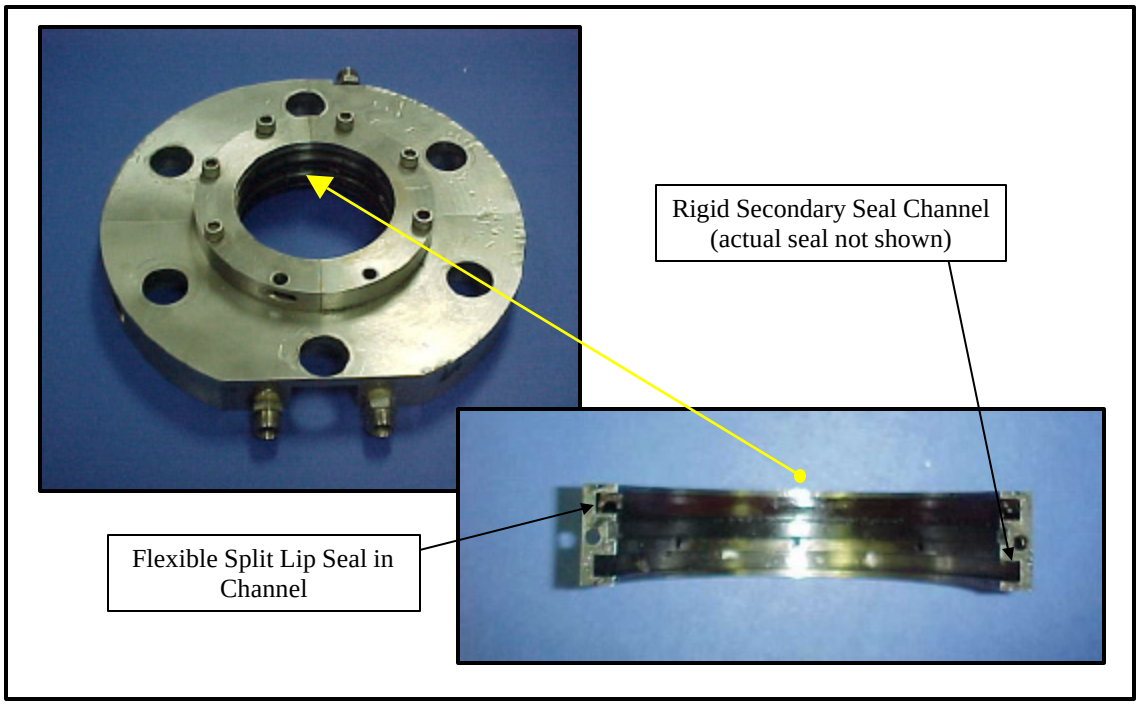
Figure 3-2. ECG and the tertiary seal system (photos taken after Phase II was completed)

Because the SAS operated at higher than design pressures for most of the test, significant stress was placed on the tertiary seals. They are designed to function only as a backup system when positive suction pressures are encountered, and under these conditions, the seals are intended to prevent leaks for short periods of time until repairs can be made or SAS optimization occurs. At the conclusion of Phase 1, the vendor confirmed the tertiary seals were severely worn, and the fastening mechanism used to bolt the seal to the rod had been damaged from the significant vibrations encountered at the test engine. A design modification to the tertiary seal was not made prior to Phase II, but the vendor used a stronger bolting mechanism to prevent further damage to the tertiary seal carrier.

- Tertiary ECG seal leaks: leaks from the ECGs are the most significant SAS leak source. When leaks occur, they escape from a flexible lip seal located at the back of the ECG (Figure 3-2), then vent into the doghouse for quantification by the Flow Tube. Flow Tube measurement and calibration procedures are described in Appendix A. Flow Tube performance data are presented in Section 4.

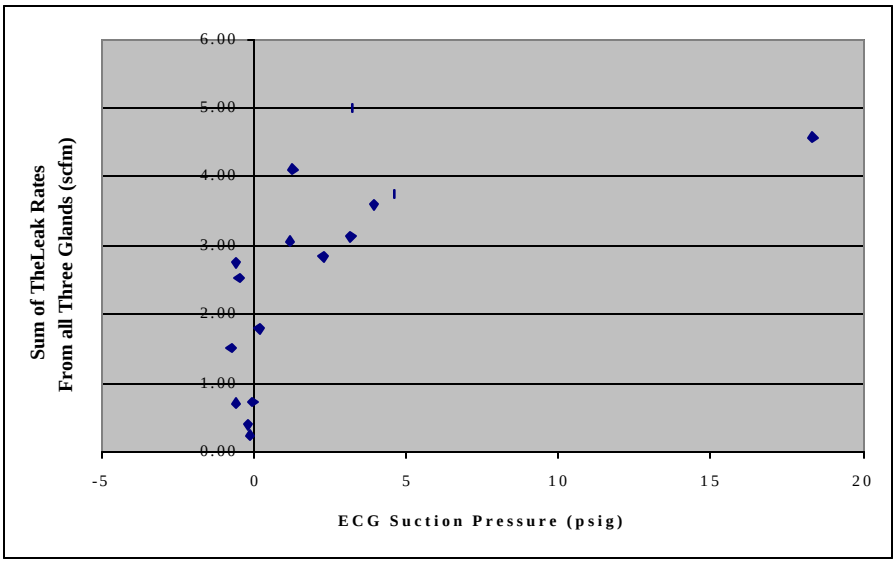
Figure 3-3. Impact of suction pressure on ECG leak rate

Table 3-2 also presents the average ECG suction pressure occurring during each test, whether SAS optimization occurred prior to conducting the test, and whether the optimization was successful at reducing ECG suction pressures. As Figure 3-3 indicates, ECG leak rates tend to be lowest when ECG suction pressures are very low or negative. However, the figure also shows that this is not always the case; moderately high leak rates occur even when SAS operates near design ECG suction pressure. The reasons for this are unclear, but could be related to excessive seal wear, which allows some leaking to occur at any pressure.

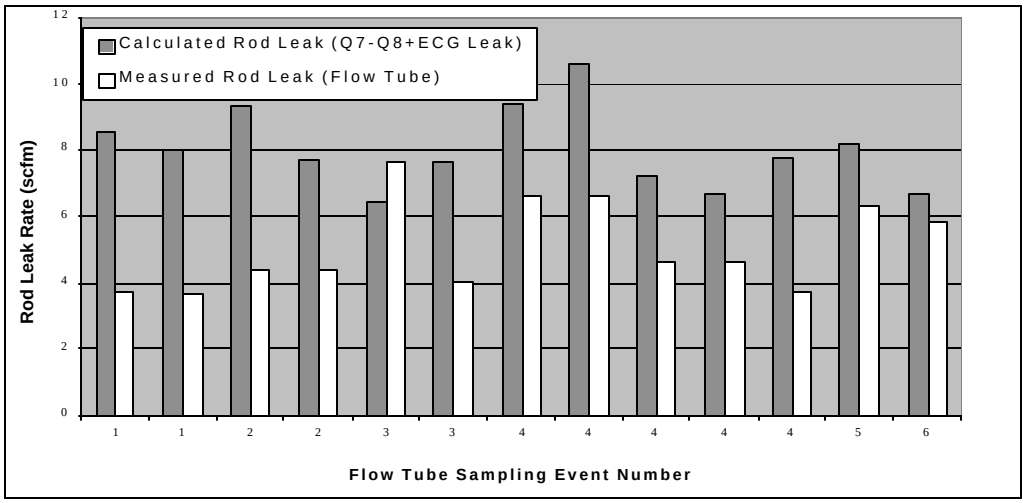
Figure 3-5. Comparison of rod leak rate determinations

Figure 3-5 shows that, with one exception, the "calculated" rod packing emissions are higher than actual rod packing emissions measured with the Flow Tube. This suggests that, in addition to the rod packing emissions, additional gas entered the SAS during operation. Efforts to identify the specific sources of this additional gas were unsuccessful. As mentioned previously, increased rod packing emissions may occur due to the negative pressures present in the ECG annulus area and, in at least one case, these negative ECG pressures pulled gas into the SAS from the doghouse header system.
