Coal Combustion Residue Impoundment

Round 9 - Dam Assessment Report

Clinch River Power Plant

Ash Pond Management Units
Appalachian Power
d/b/a American Electric Power
Carbo, VA

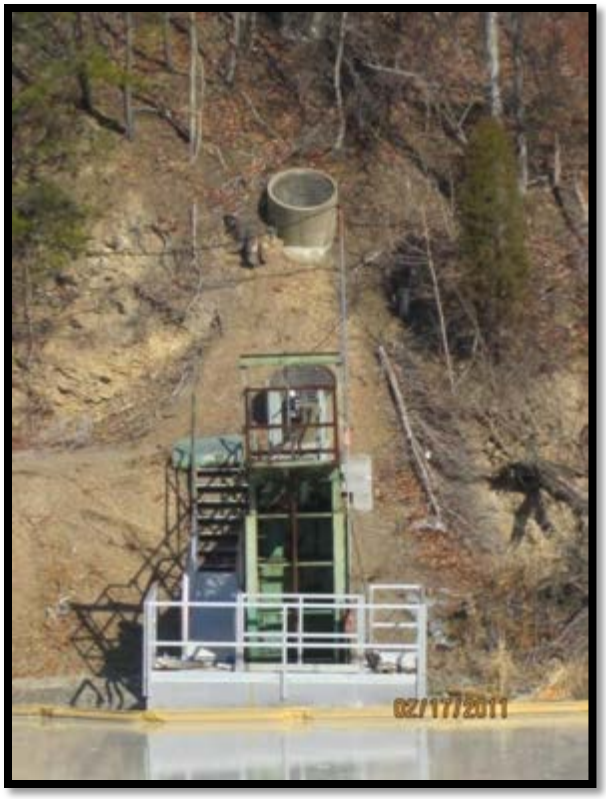
The overflow spillway structure for Ash Pond 1 is located in the north corner of the facility (Figure 5.4.1-1). The structure appeared to be in satisfactory condition and operating as designed. There were no obvious signs of trash and/or debris around the intake. Water was observed entering the spillway but could not be seen exiting the spillway as the outfall pipe consists of a long storm sewer that outfalls into the existing reclaim pond below its permanent pool.

Figure 5.4.1-1: Overflow spillway structure

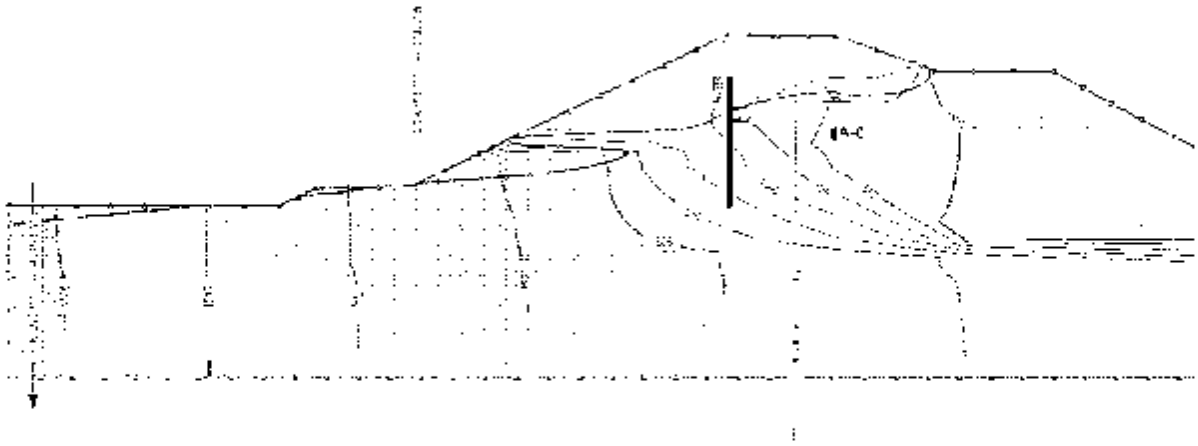
For the portion of the dike that is represented by Section B, the reported seepage at elevation 1533 ft continued even after construction of the cut-off wall. Furthermore, the observed piezometric level on the downstream side of the wall from piezometer A-7R has been at about the same elevation (1533 ft) since the construction of the wall. Water elevations in the piezometer B-4R and P-0904 have been at (approximately) elevation 1542 ft and 1546 ft, respectively. These observations suggest that a relatively permeable horizontal layer exists at about elevation 1533 ft, which acts as a conduit to transfer water to the slope face. Such a structure could have been formed by segregation of fine and coarse portions of the shale rockfill during placement. A high permeable layer over a low permeable layer within the outer shell is incorporated into the analytical model of Section B, as depicted in Figure 2. Figure 8 shows the computed total head distribution across the cross-section of the dike along with the seepage flow rates per unit length of the dike. A saturated hydraulic conductivity of 0.05 ft/hr was used for the outer shell at this section. The computed water levels for piezometers A-6 and A-7R are in agreement with the recorded water levels that are marked on this figure and also presented in Figure 9. The readings from the piezometers varied with the pool level, however, the maximum water levels (Figure 9), most likely corresponding to the maximum experienced pool level, were used to back-calculate the hydraulic conductivity. The computed levels are within few feet of field observations.

Figure 8. Computed total head distribution in Section B before installation of the cut-off wall.

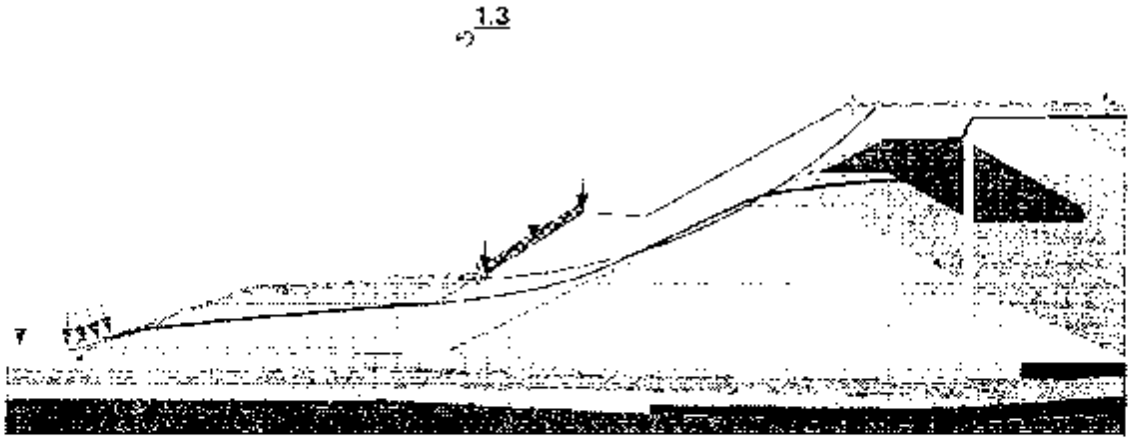
Figure 5.4. Critical failure surface and the corresponding factor of safety under seismic loading condition for Section A using drained material properties.

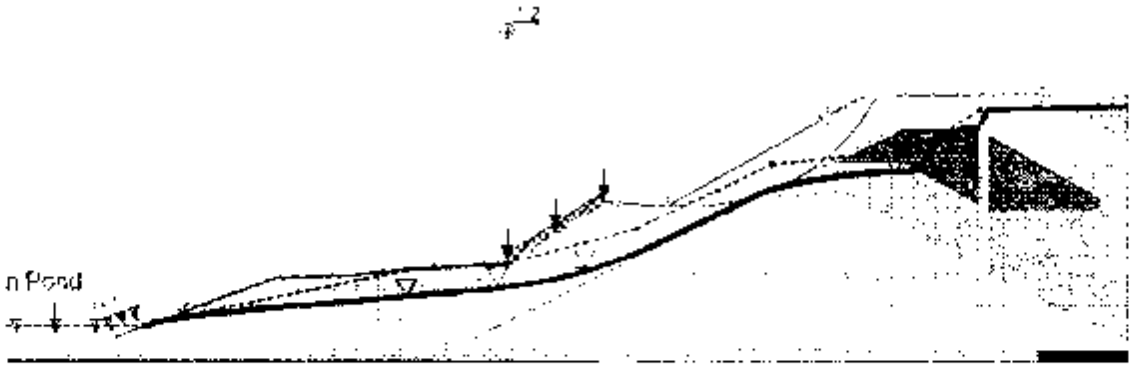
Figure 5.6. Stability of Section A after 7 ft raise in the piezometric water levels.

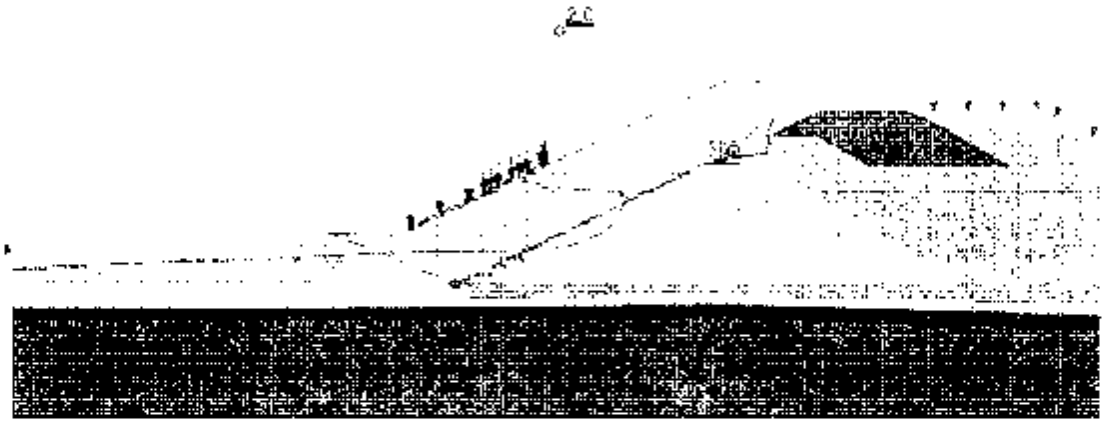
Figure 5.8. Stability of Section B under steady state seepage with a block failure mechanism.

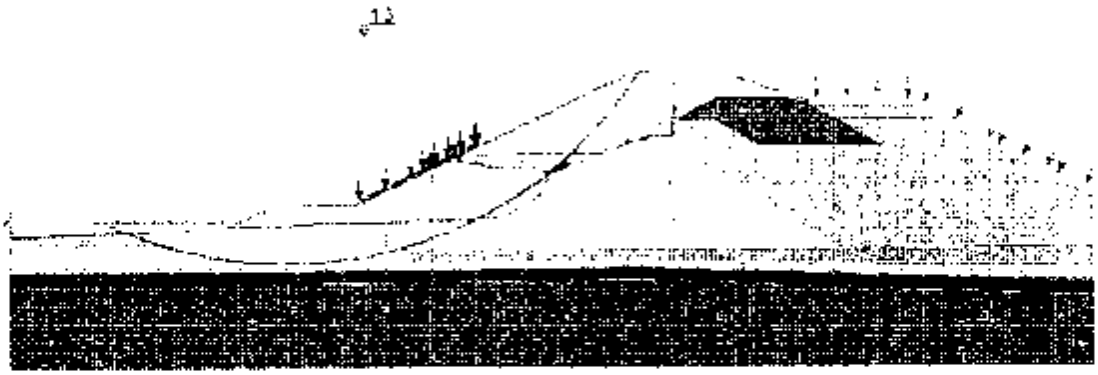
Figure 5.10. Stability analysis results of Section B under seismic loading using drained material properties.

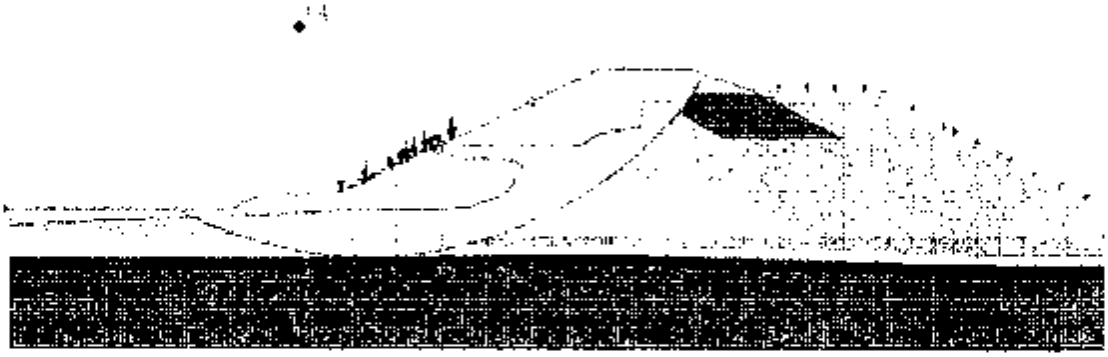
Figure 5.11. Stability analysis results of Section B under seismic loading using consolidated undrained material properties.

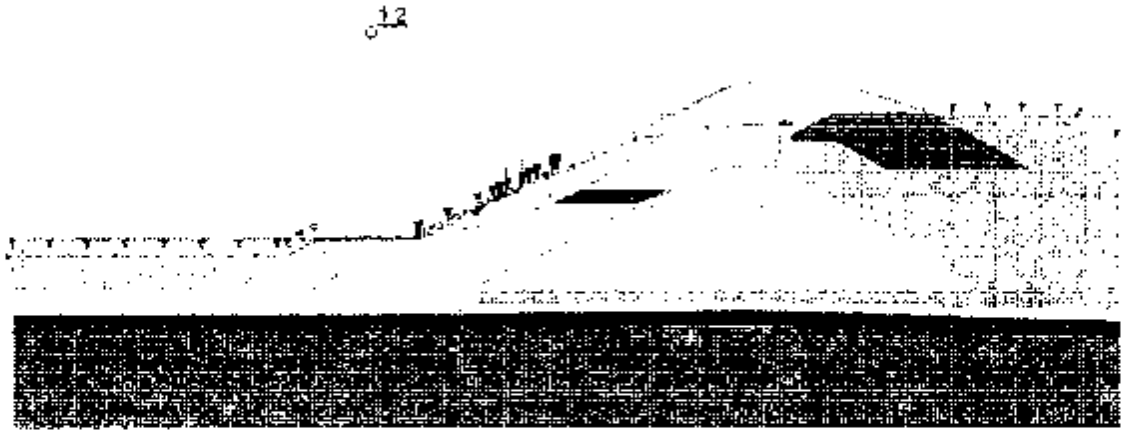
Figure 5.13. The critical water level for Section B is indicated by about 12 ft raise in the piezometric water levels at the crest or about 10 ft raise in the piezometric water levels at the toe.

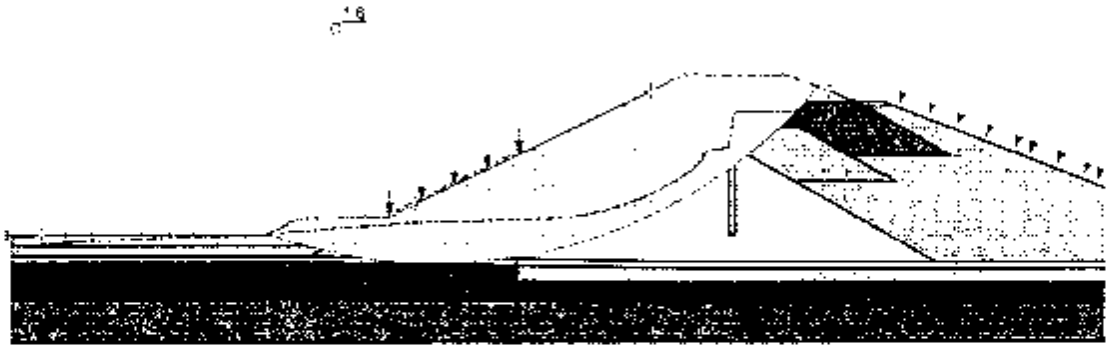
Figure 5.14. Stability of Section C under steady-state seepage condition with a deep failure surface.

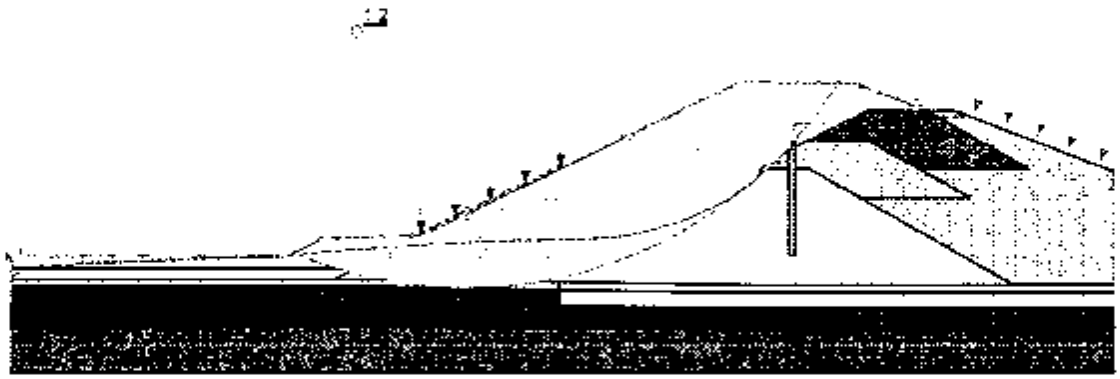
Figure 5.17. Stability of Section C under seismic loading condition using consolidated undrained shear strengths.

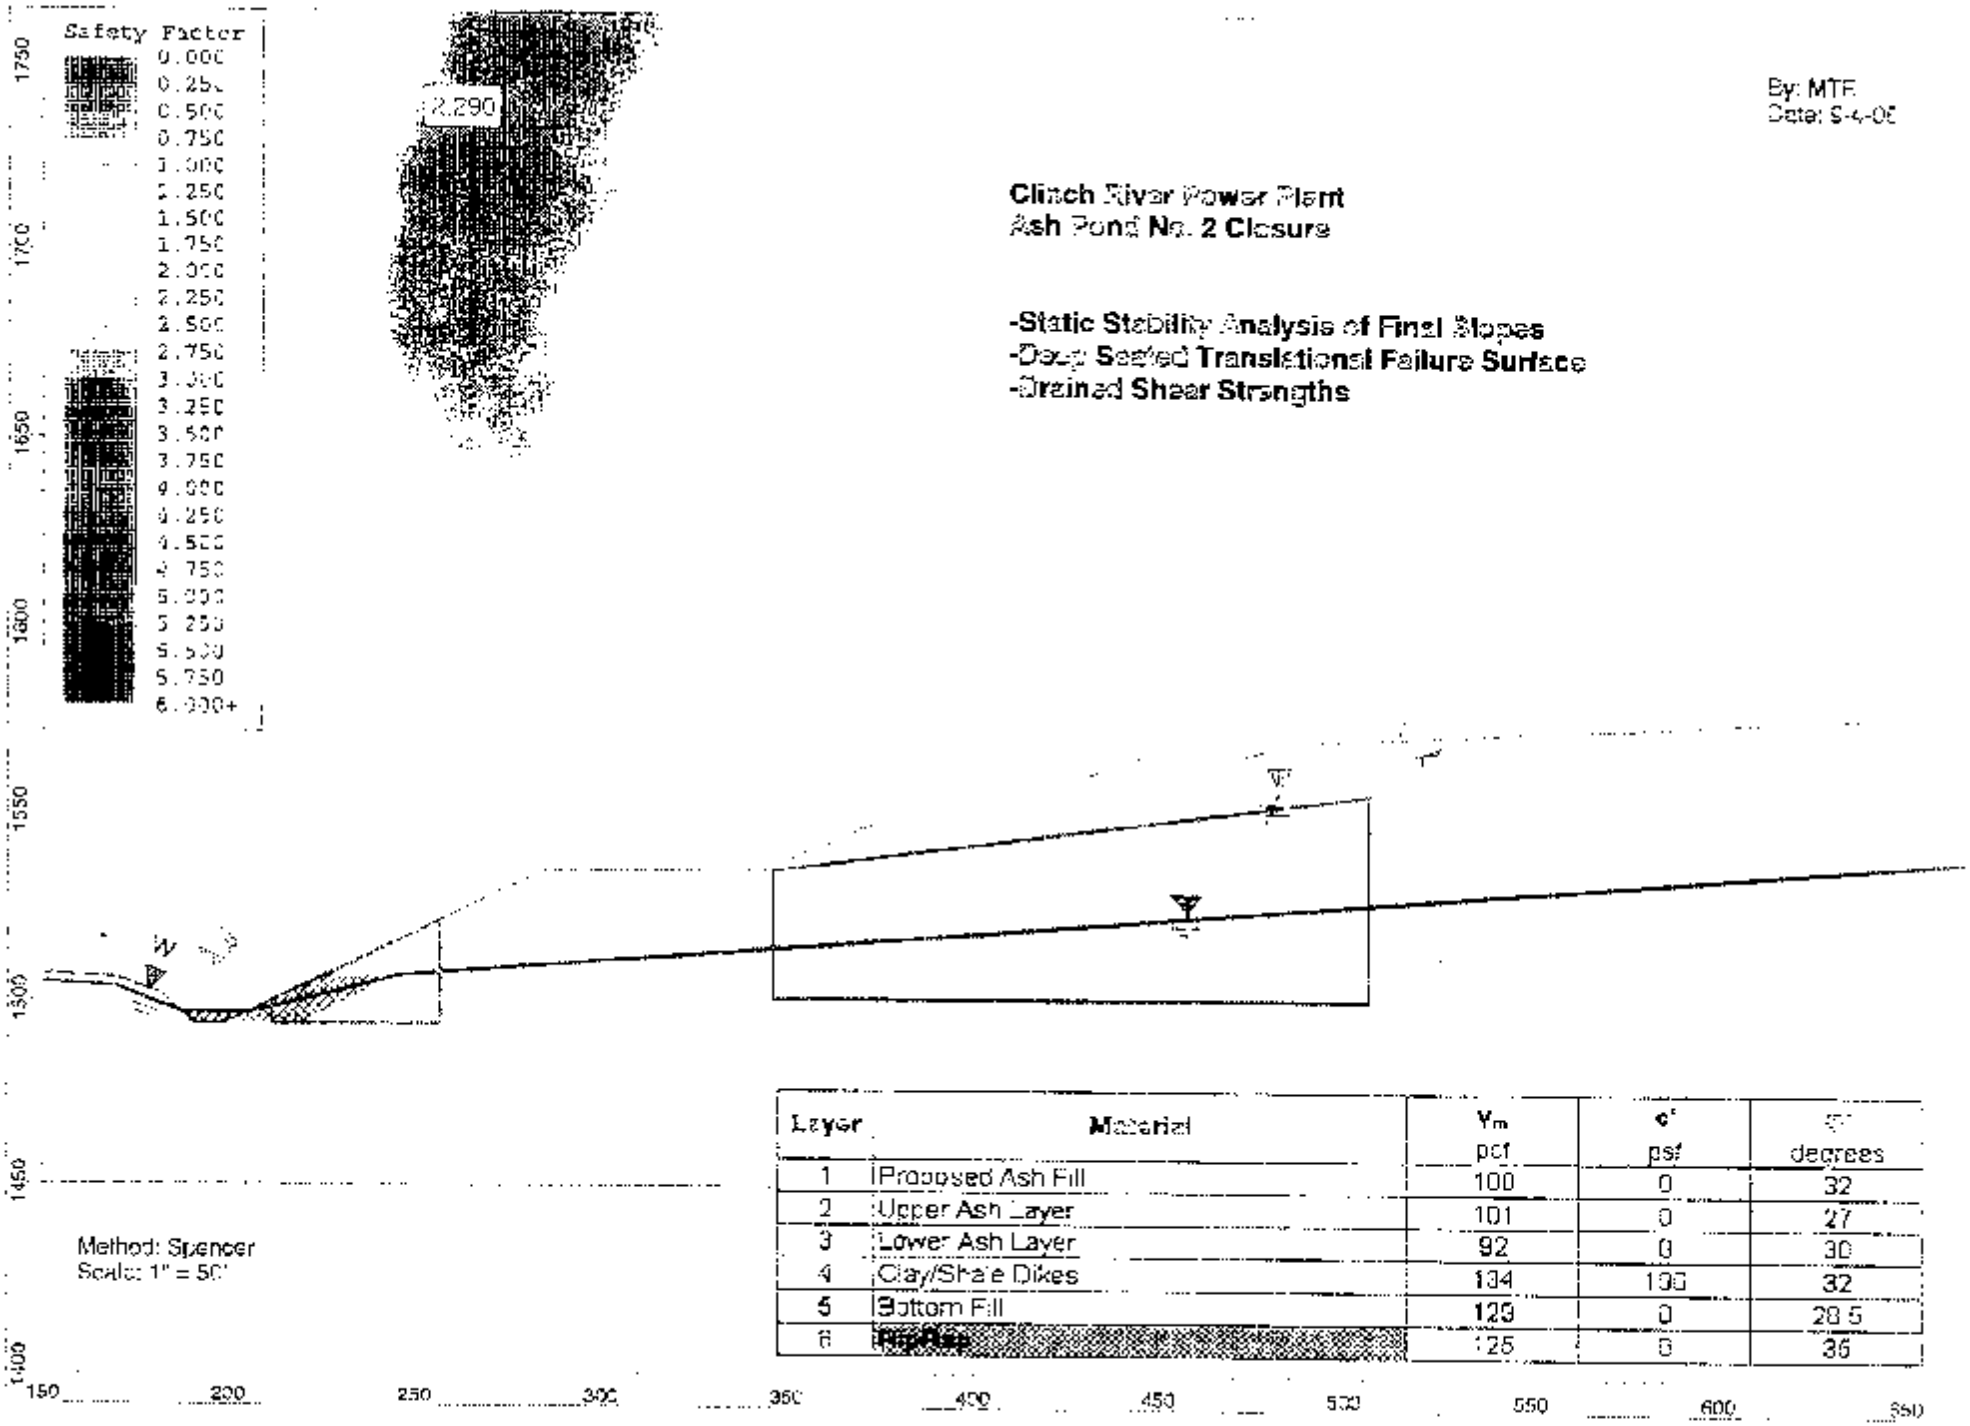
-Static Stability Analysis of Final Slopes
-Deep Seated Translational Failure Surface
-Drained Shear Strengths

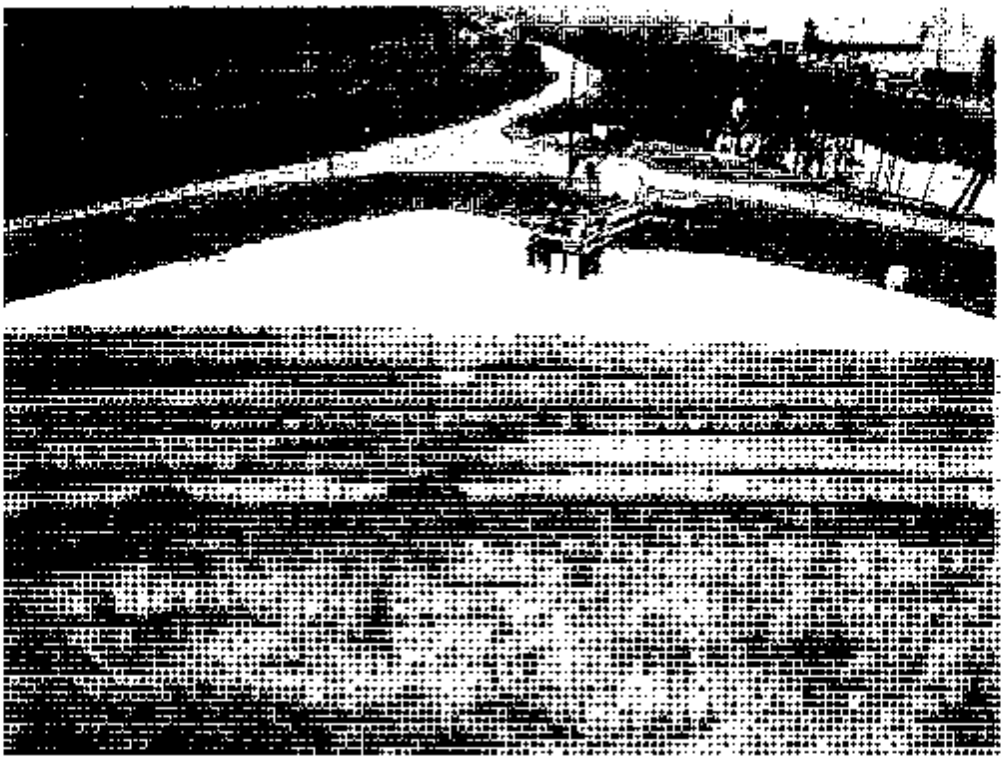
2. The V-notch weir boxes referenced as Nos. 2, 3, and 5 were in fair condition. Clear water flow was discharging from all the weirs. Gray precipitate was observed on the downstream of weir box No. 3 (Photo 2), and at the bottom of all the weir boxes.
3. The surface of the Reclaim Pond was entirely covered with cenospheres (Photo 3).

Photo 3. Reclaim Pond viewed from the crest of West 1A dike

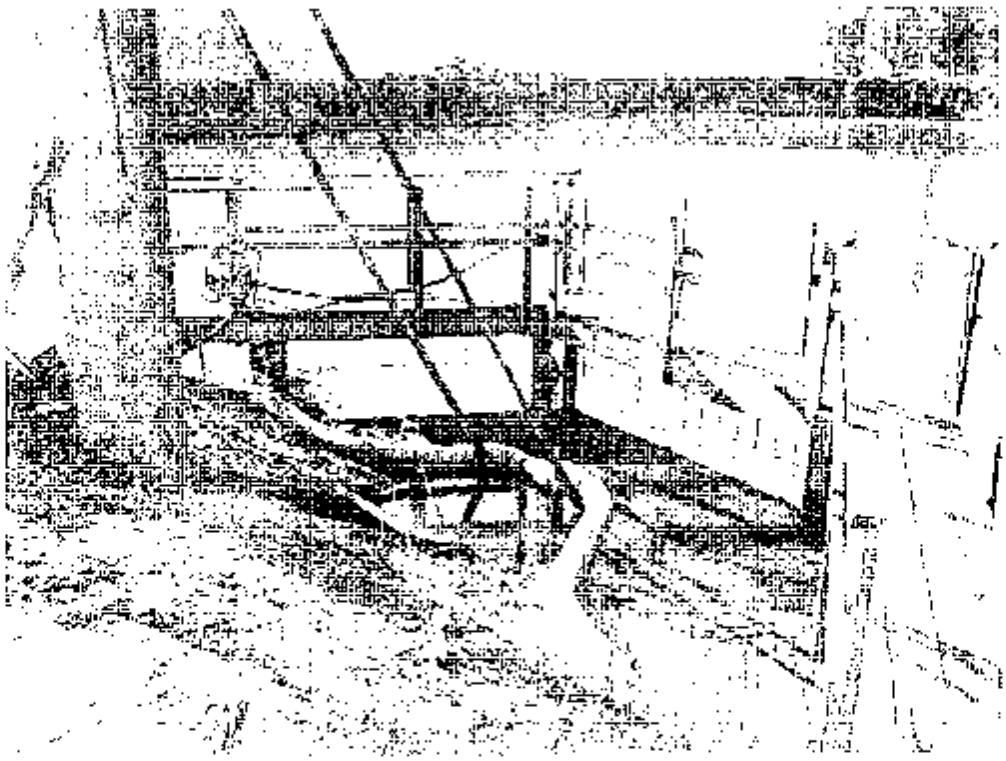
9. Reddish to light gray precipitate were present in most of the toe drain pipes (e.g. Photo 8).
10. The overflow tower from 1A to 1B ponds was in satisfactory conditions (Photo 9). There was no protective railing on the splitter dike around the overflow structure from 1A Pond to 1B Pond. The hand rail around the overflow structure was loose.

Photo 9. The overflow structure that discharges from 1A to 1B Ponds

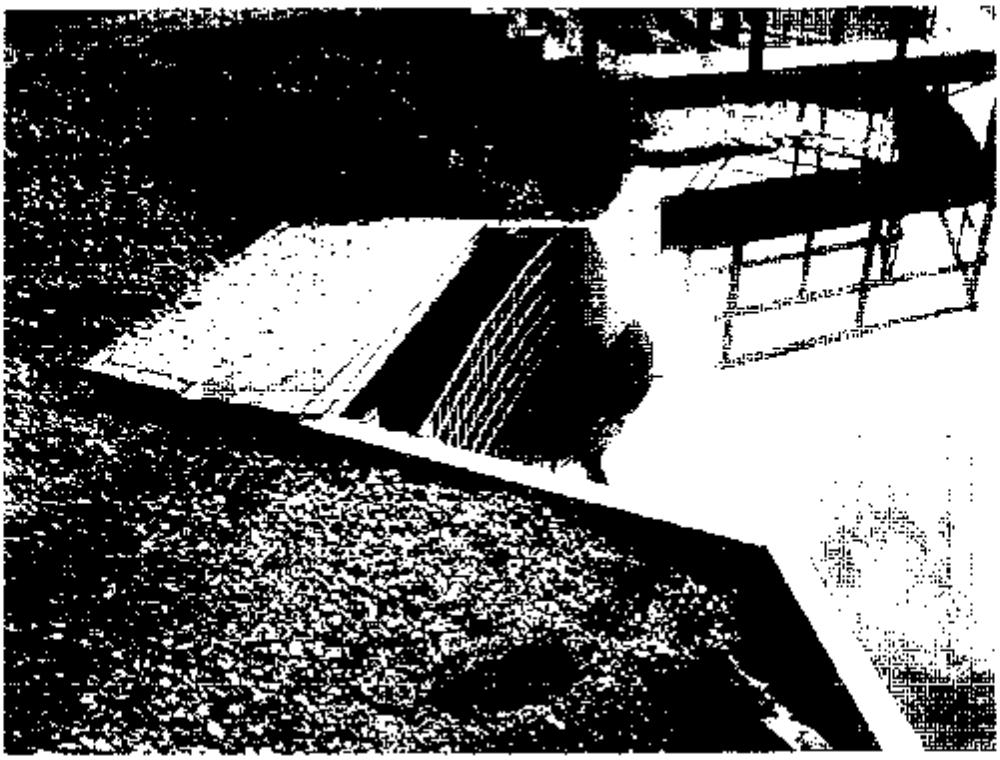
11. Two temporary spillway shafts have been installed to discharge the flow from 1A to 1B ponds to facilitate maintenance of the main spillway shaft. Photo 10 shows one of the new spillway shafts to the north of the overflow tower. The second shaft, located to the south of the overflow tower, has a higher invert elevation to pass discharge water from 1A to 1B ponds if the pool level increases to higher than normal levels during a storm event.

Photo 10. Inlet of the new spillway shaft from 1A to 1B ponds
