Coal Combustion Residue Impoundment

Round 9 - Dam Assessment Report

Flint Creek Power Plant

Bottom Ash Dike
SWEPCO
Gentry, Arkansas

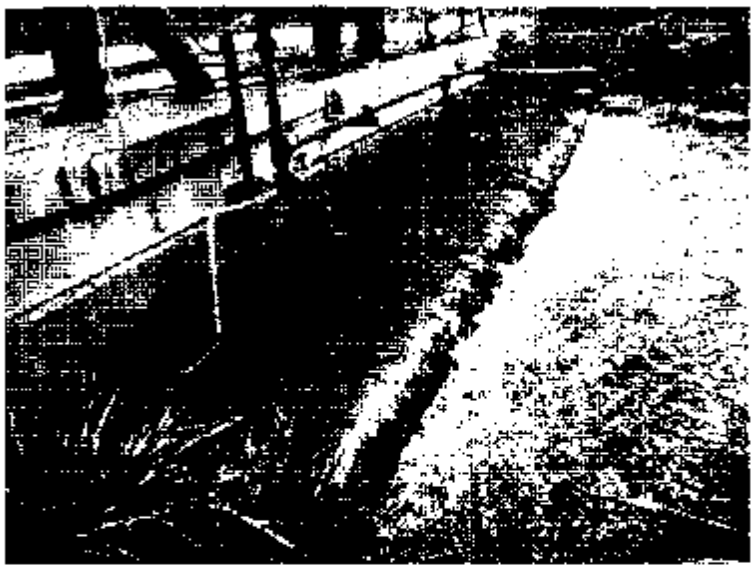
7.) Principal Spillway Weir – Secondary Impoundment. Fair condition. Concrete orifice and weir system

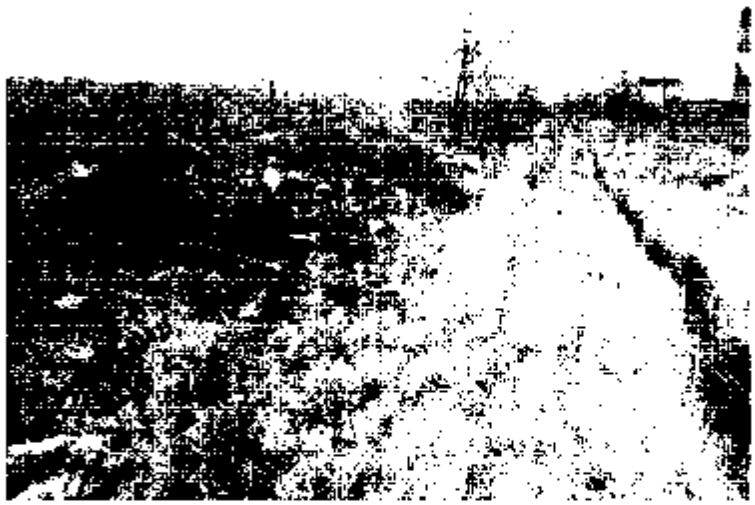
9.) Emergency Spillway Secondary Impoundment. Fair condition. Minor extent of woody vegetation partially obstructs entrance.

10.) Upstream Slope – Primary Impoundment: Fair condition. Undesirable vegetation on slope.

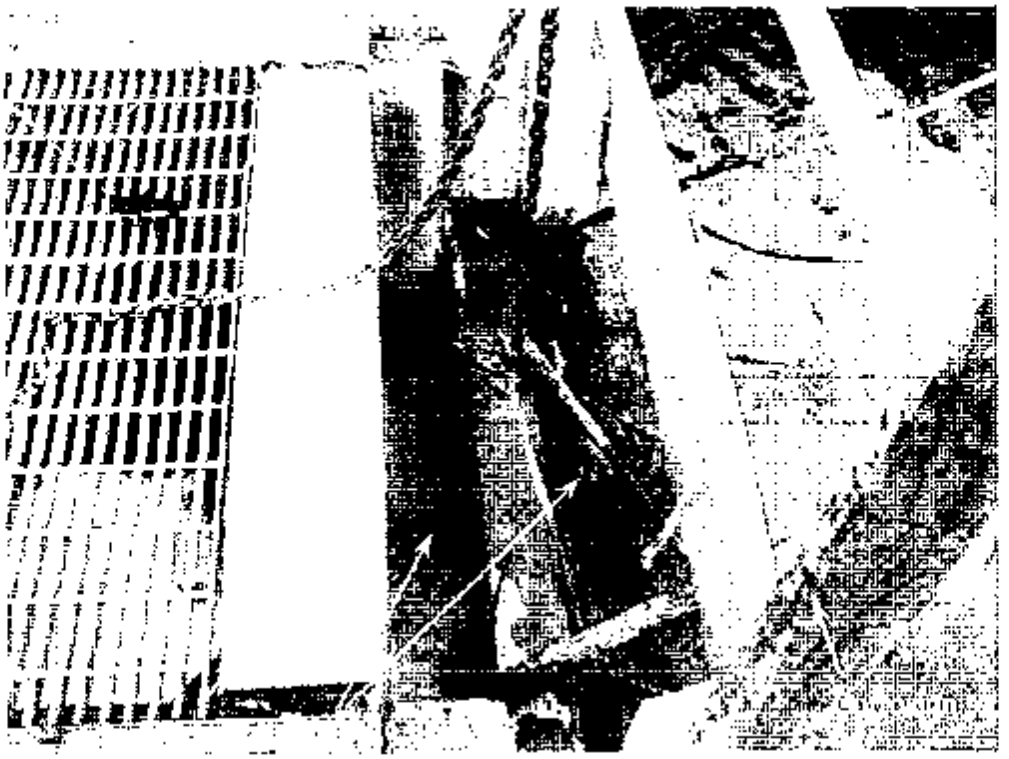
Photo 1. Primary ash pond principal spillway with significant blockage at inlet and minor corrosion of steel and chipping of concrete components.

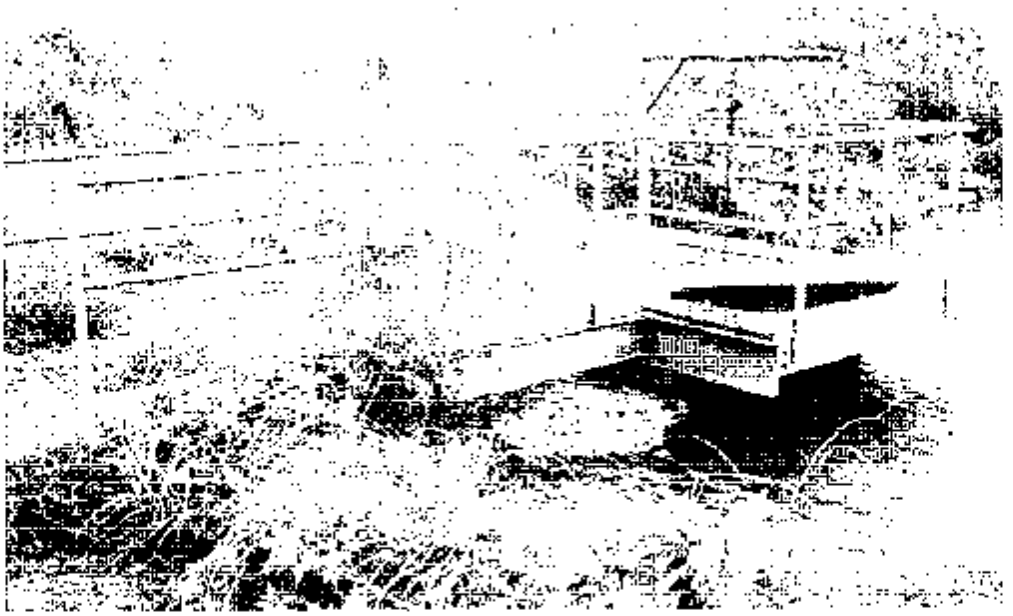
Photo 2. Primary ash pond principal spillway with significantly high and woody vegetation growing adjacent to it.

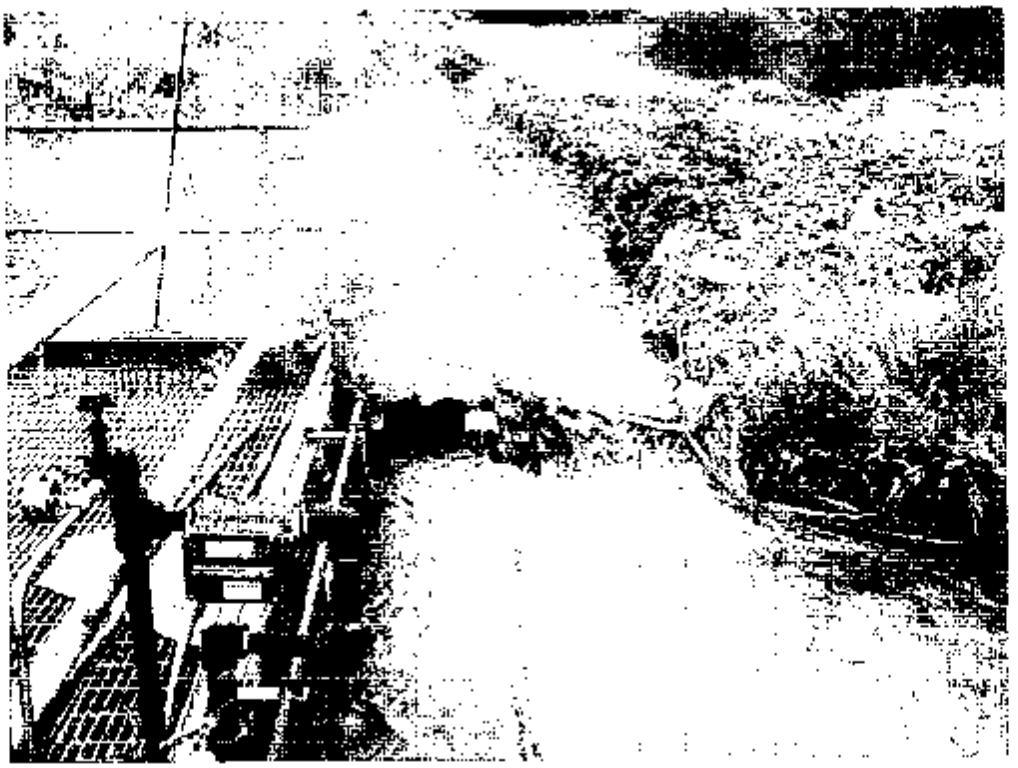
Photo 5. Secondary ash pond principal spillway weir with minor growth of woody vegetation and active emergency spillway prepared for reconstruction.
