Coal Combustion Residue Impoundment

Round 9 - Dam Assessment Report

Glen Lyn Power Plant

Ash Pond Management Units
Appalachian Power
d/b/a American Electric Power
Glen Lyn, VA

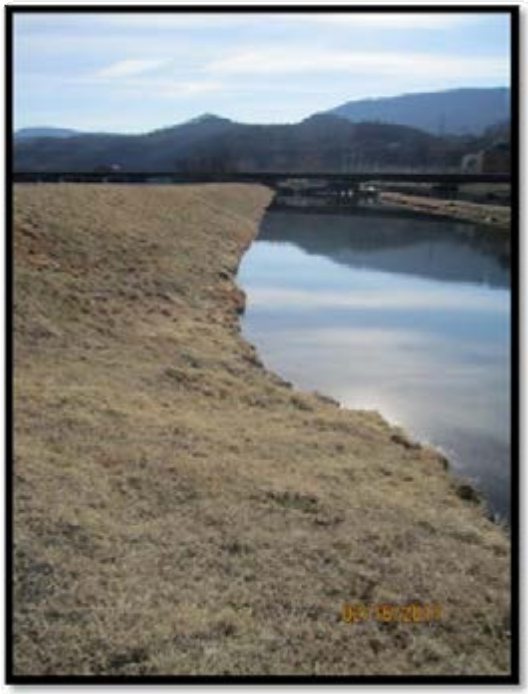
Figure 5.3.2-1: Upstream slope, Southwest.

The upstream slope of the perimeter dike, including all groins, had adequate and well maintained cover of grasses/weeds. Some minor erosion repair work done along the upstream slope adjacent to outlet structure but overall no obvious signs of scarps, bulging cracks, depressions or other indications of slope instability. Figures 5.3.2-1 and 5.3.2-2 show representative upstream slope sections of the perimeter dike.

Figure 5.3.2-2: Upstream slope, Southwest. Outlet structure in the background with erosion repairs to the right.

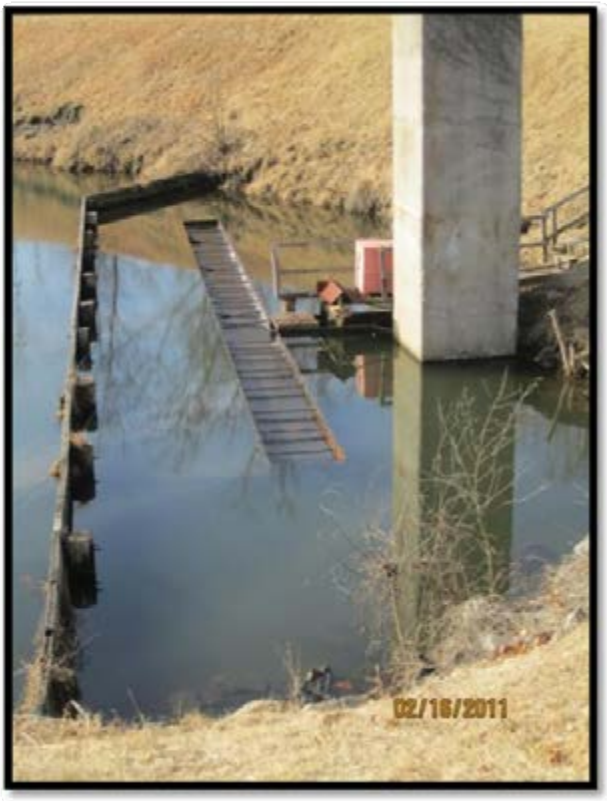
Figure 5.4.1: Outlet Structure, Southwest.

The overflow spillway structure is located at the northwest perimeter dike (Figure 5.4.1). The structure appears to be in satisfactory condition. The water exiting the outlet structure into the East River appeared to be flowing clear and there were no signs of clogging.

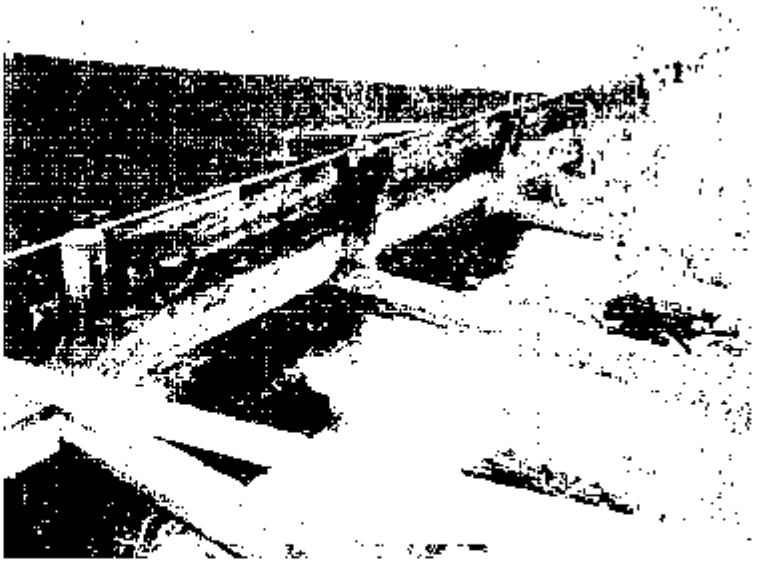
Photo # 1 Pond outlet structure, sk mmer and low water level.

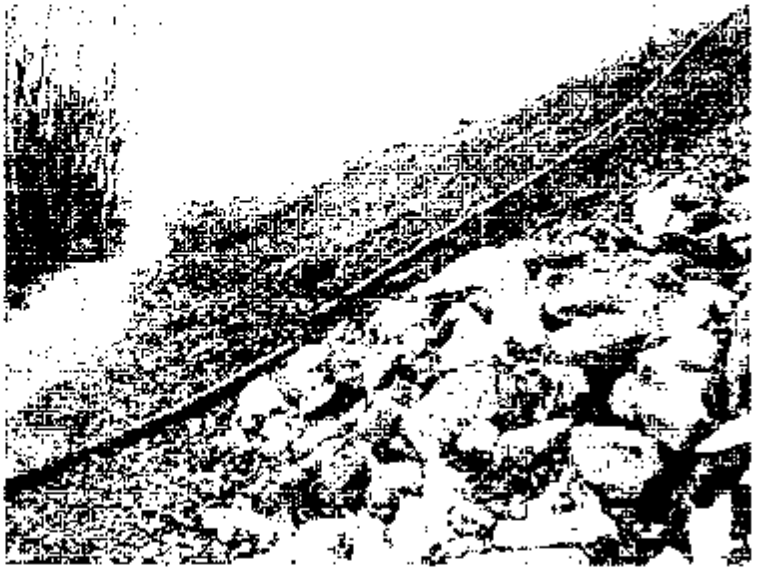
Photo # 6 Exterior slope of berm for the ash landfill. Berm was cleared in 2009
