Assessment of Dam Safety
Coal Combustion Surface Impoundments (Task 3)
Final Report

Big Sandy Generating Station

Louisa, Kentucky

February 17, 2010

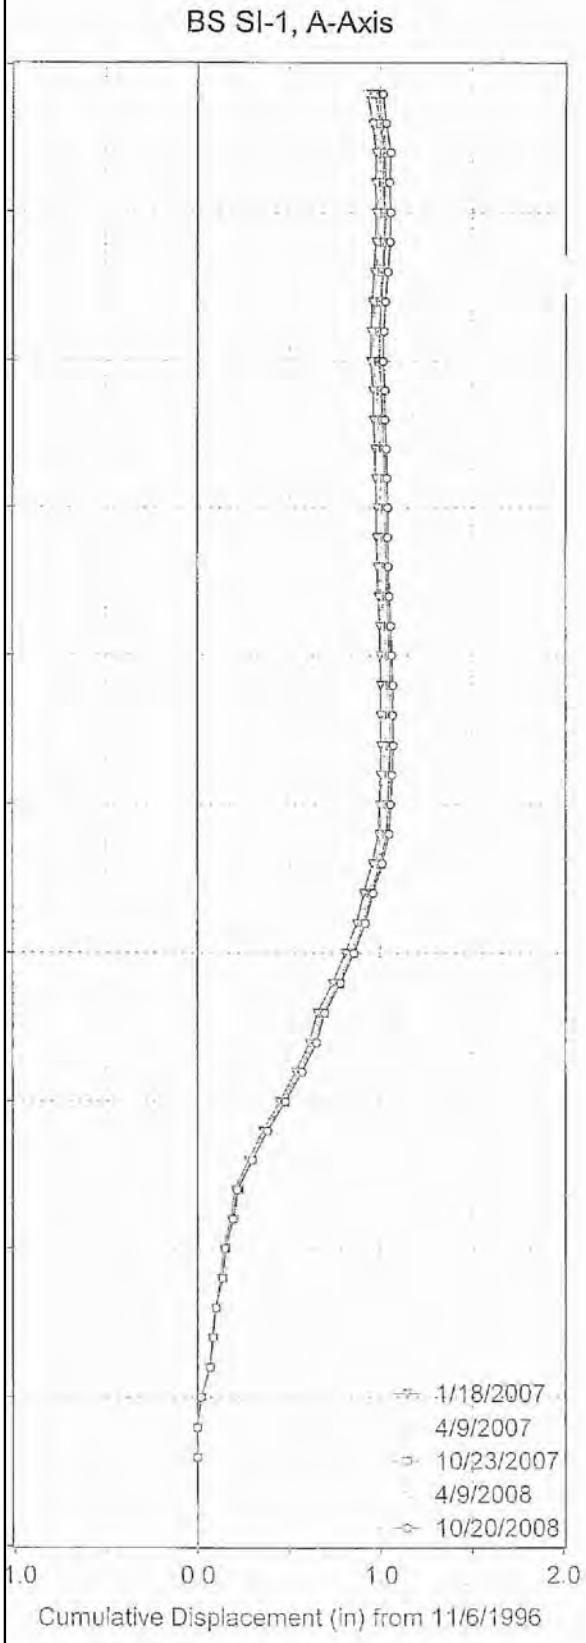
FIGURE 12A

Inclinometer SI-1 is located in the crest of the berm at El. 590; a cumulative deformation plot is included in Figure 12A. The maximum movement in the downstream direction is approximately 1.07 inches. Inclinometer SI-2 is located on the downstream slope at approximately El. 665; a cumulative deformation plot is included in Figure 12B. The top of this instrument was struck by a bulldozer during a previous construction period resulting in the large displacements between El. 631 and 611 within the embankment fill indicated on the plot on Figure 12B. Accounting for this damage, AEP (2008) reported that the maximum movement in the downstream direction is approximately 1.04 inches.
