Coal Combustion Waste Impoundment
Round 7 - Dam Assessment Report

Lansing Generating Station

Interstate Power and Light Company (IPL)
Lansing, Iowa

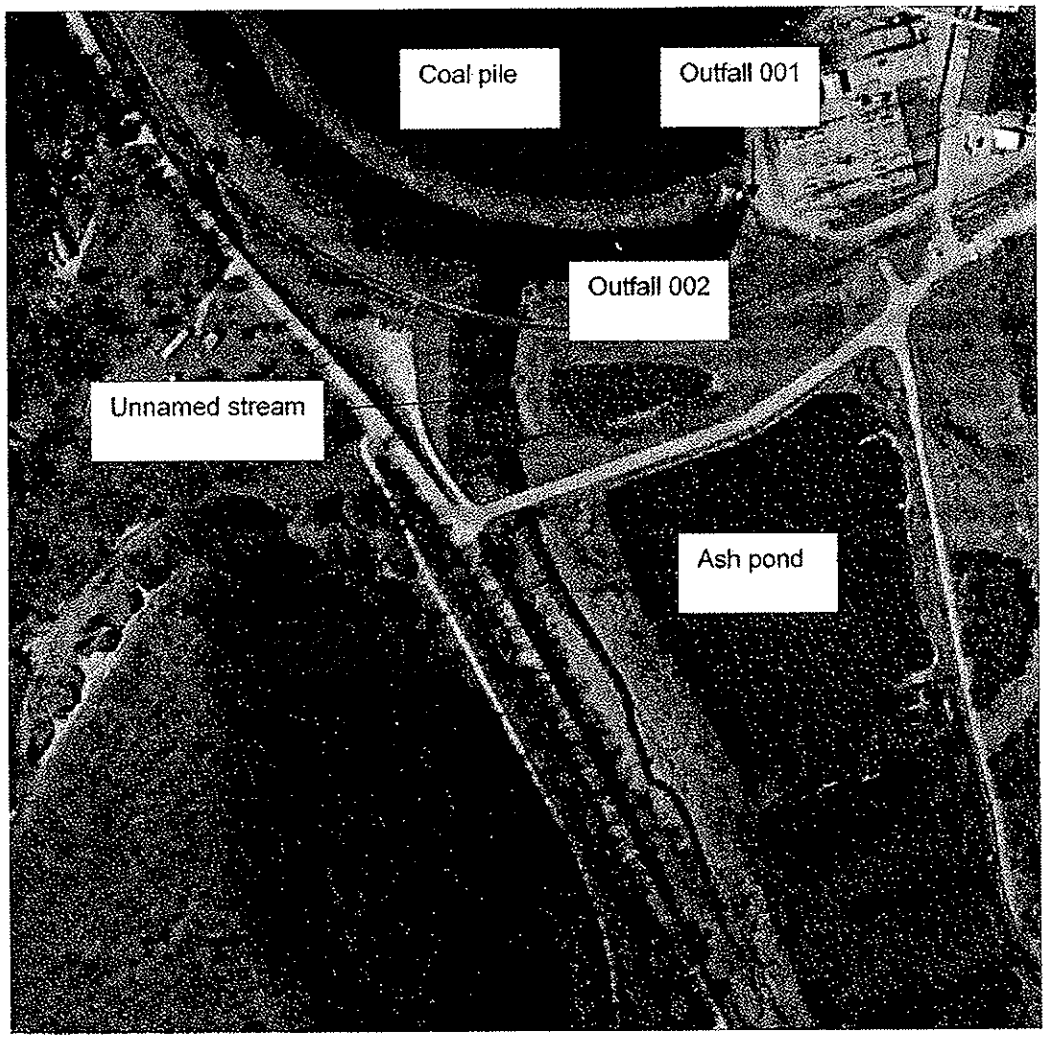
2. Visual observations lead me to suspect that the turbidity is being increased excessively by the discharge from Outfall 002. Therefore, the company must collect upstream and down stream turbidity samples from the receiving stream.

3. The company must begin reporting net addition for iron on the monthly operation reports that are submitted to the department.
