Specific Site Assessment for Coal Combustion Waste Impoundments at Basin Electric Antelope Valley Station

Beulah, North Dakota

November 2010
Project 092884

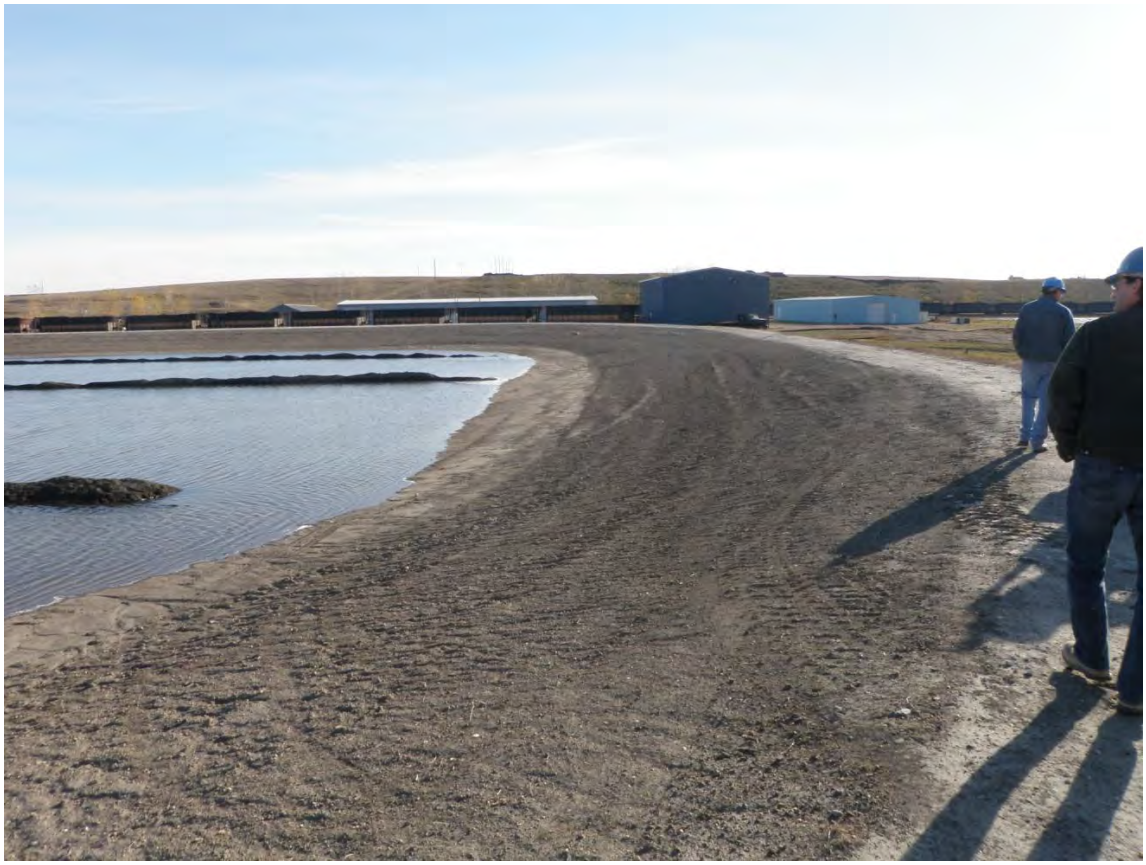
Photo 21: SDA Decantation Pond – West dike upstream slope, looking south

Photo 22: SDA Decantation Pond – West dike downstream slope, looking south

Photo 23: SDA Decantation Pond – South dike upstream slope, looking east

Photo 24: SDA Decantation Pond – South dike downstream slope, looking east
