# FINAL
# Coal Ash Impoundment - Specific Site Assessment Report PacifiCorp Energy

Jim Bridger Power Station

September 2009
Project 091330

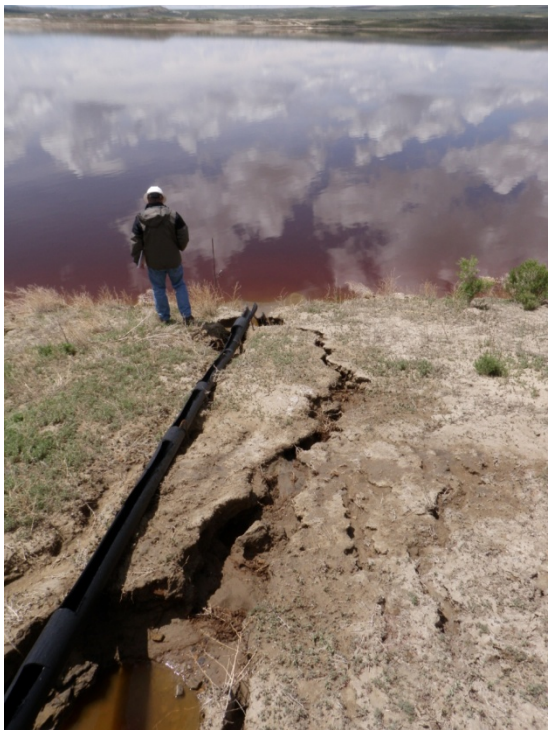
**Photo 19: FGD Pond 2, Upstream Face Erosion and Pipe from Sump Drain Pump Back Near Station 84+00**

**Photo 20: FGD Pond 2, Upstream Face Erosion and Pipe from Sump Drain Pump Back Near Station 84+00**
