Dam Safety Assessment of CCW Impoundments

J.R. Whiting Plant

United States Environmental Protection Agency
Washington, DC

June 27, 2011

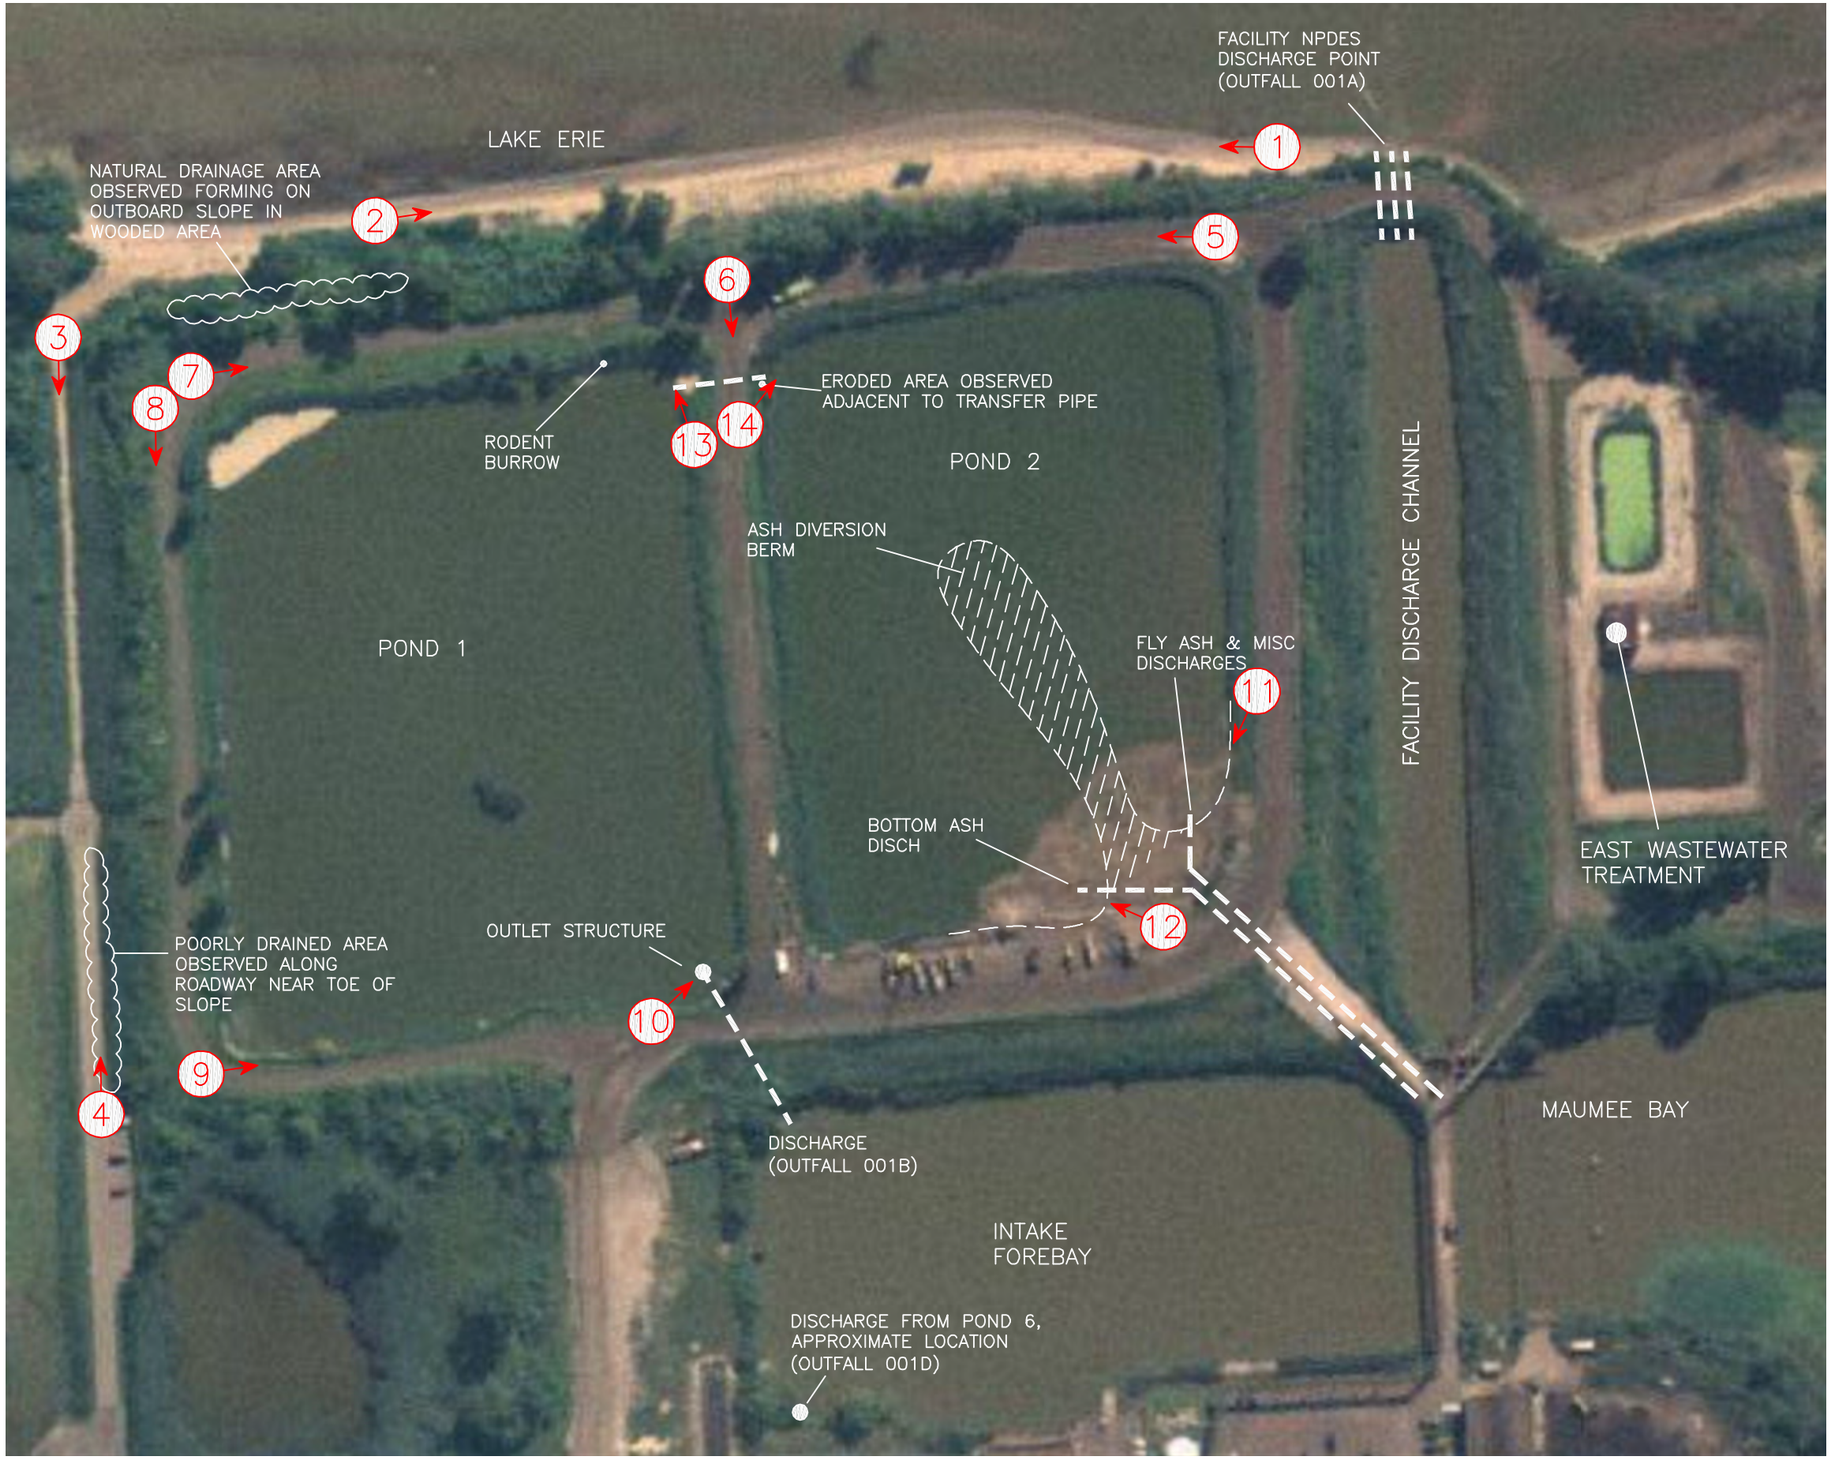
FIGURE 3

- A few mature trees were observed on the inboard slopes of Ponds 1 & 2.
- A wet area was observed along the roadway at the toe of the north embankment. This appeared to be a poorly drained area due to runoff from the roadway from recent heavy rains (approximately one day prior).

- Rodent burrows were observed at Pond 1 on the inboard slope of the east embankment.
- A natural drainage swale (1' to 2' deep, 5' to 6' wide) was observed in the wooded area at the toe of the outboard slope of the northern portion of the east embankment.

- A minor eroded area was observed adjacent to and just west of the inlet side of the transfer pipe between Ponds 1 & 2.
