Coal Combustion Residue Impoundment
Round 9 - Dam Assessment Report

Cliffside Steam Station

Ash Basin Dikes
Duke Energy Corporation
Mooresboro, North Carolina

Dewberry & Davis, LLC
Fairfax, Virginia

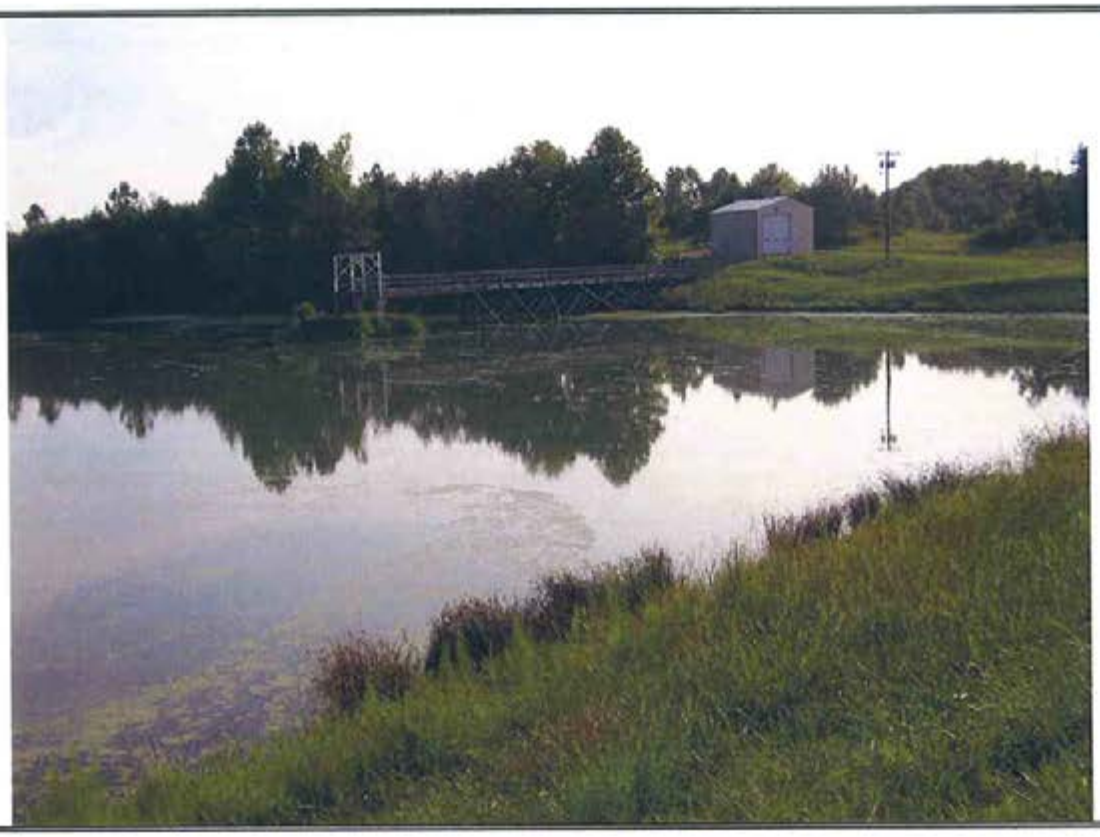
Photograph 4-27 View of Suck Creek ash basin drainage tower.

Outlet Works - The visible portion of the drainage tower was in good visual condition (Plate 26). Water was flowing into the drainage tower at the time of inspection and discharging from the outlet end of the 42-inch diameter bottom discharge pipe (Plate 27) which also was in good visual condition. Some surface erosion was observed in the soil fill just back of the headwall at the outlet. However, no seepage was seen around the pipe outlet and no dropouts were observed in the embankment soils over the pipe.

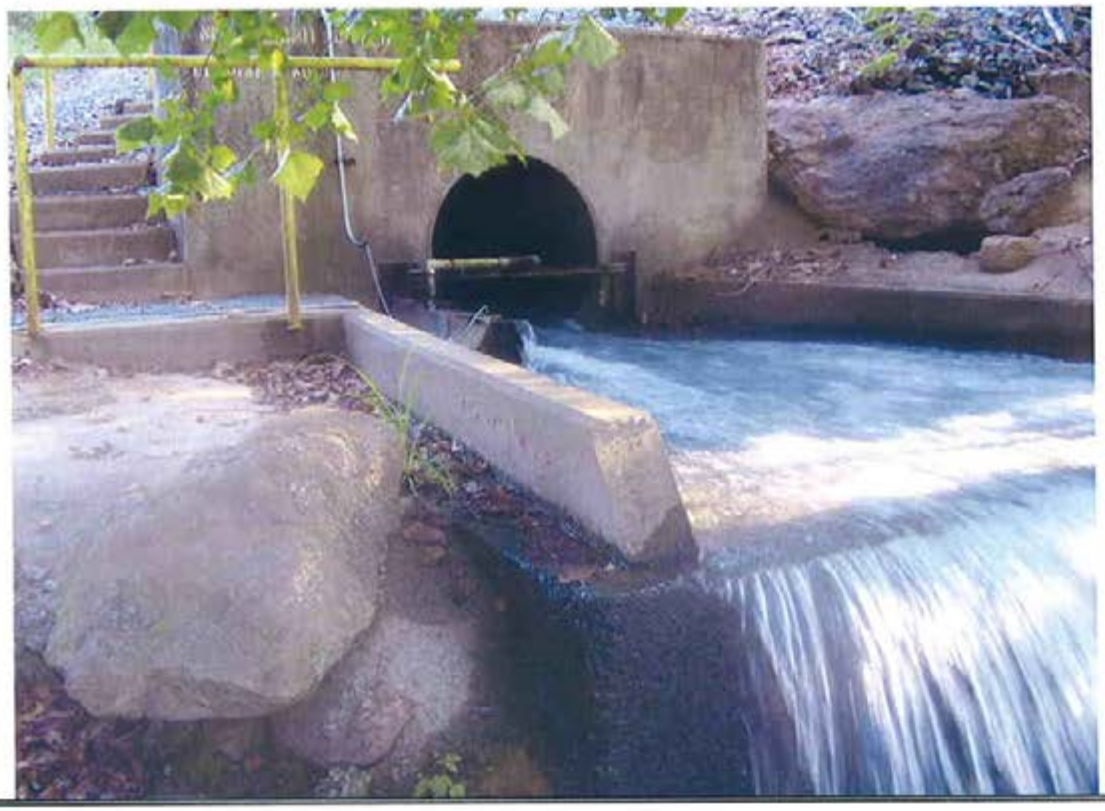
Photograph 4-28 Outlet end of 42-inch RCP outlet for Suck Creek ash basin.

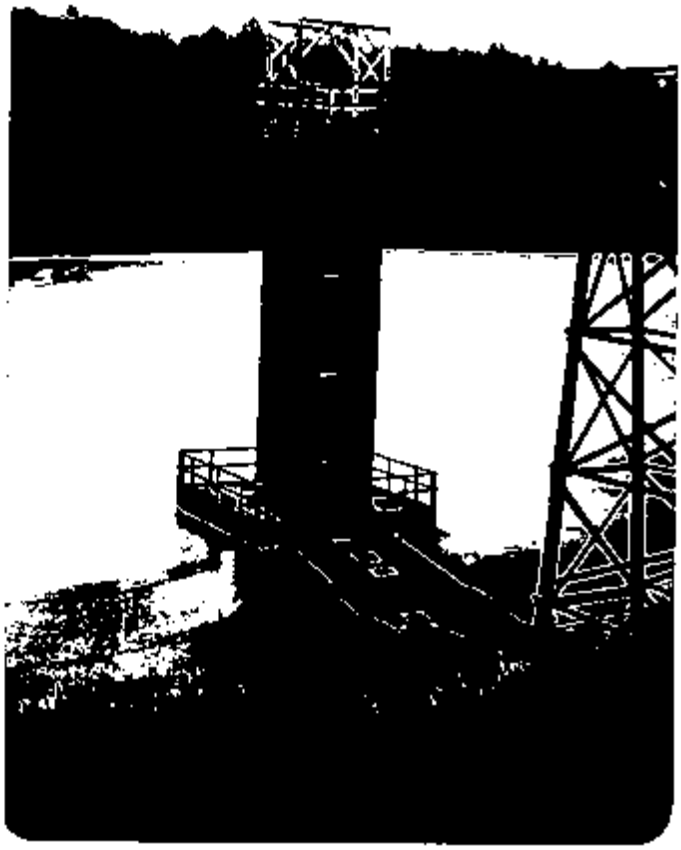
PLATE 26. - VIEW OF SUCK CREEK ASH BASIN DRAINAGE TOWER

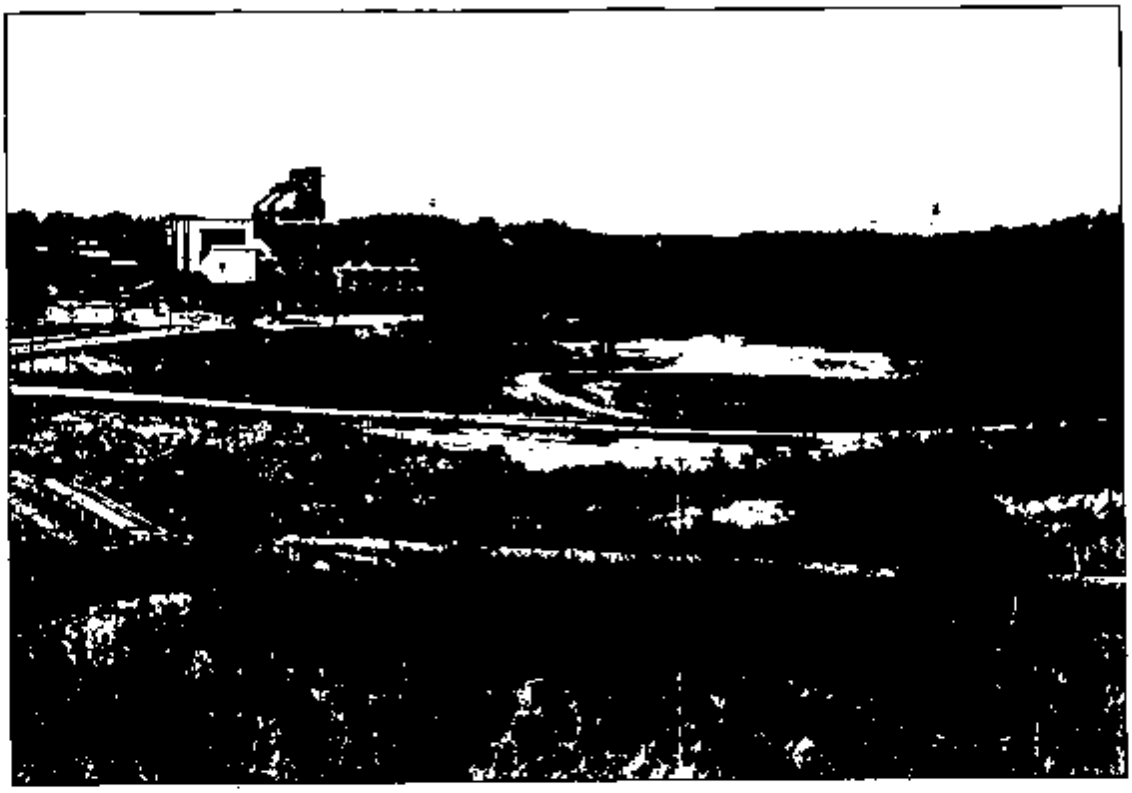
PHOTO 4-3 Yard Drainage Holding Pond and Dredge Spoil Pond in Units 1-4 Old Ash Basin Area

PHOTO 4-4 Wooded Outside (Downstream) Slope of Units 1-4 Old Ash Basin Dike

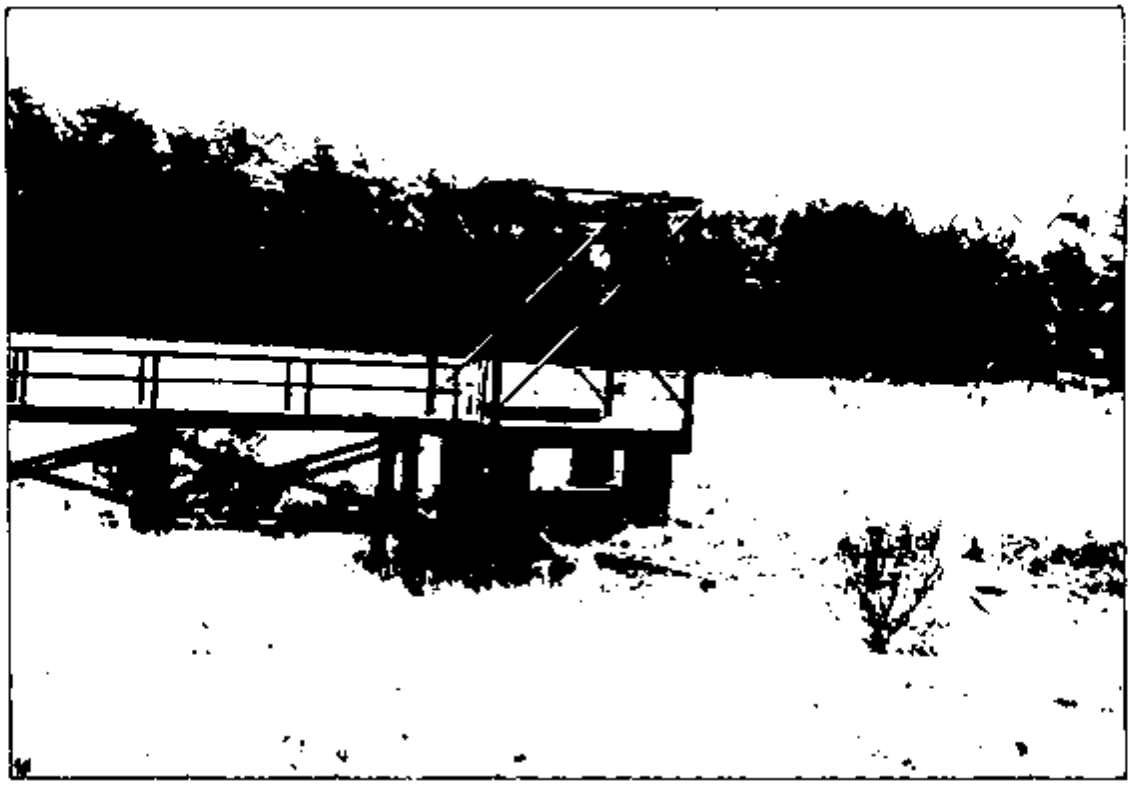
The visible part of the Unit 5 retired ash basin drainage tower is shown in Photo 4-13; the structure was observed to be in good condition. The outlet end of the 60-inch diameter RCP outlet is shown in Photo 4-14. There appeared to be some spalling along the invert of the pipe, but otherwise the pipe was in good visual condition.

PHOTO 4-13 View of Unit 5 Retired Ash Basin Drainage Tower

PHOTO 4-14 Outlet End of 60-Inch RCP Outlet for Unit 5 Retired Ash Basin

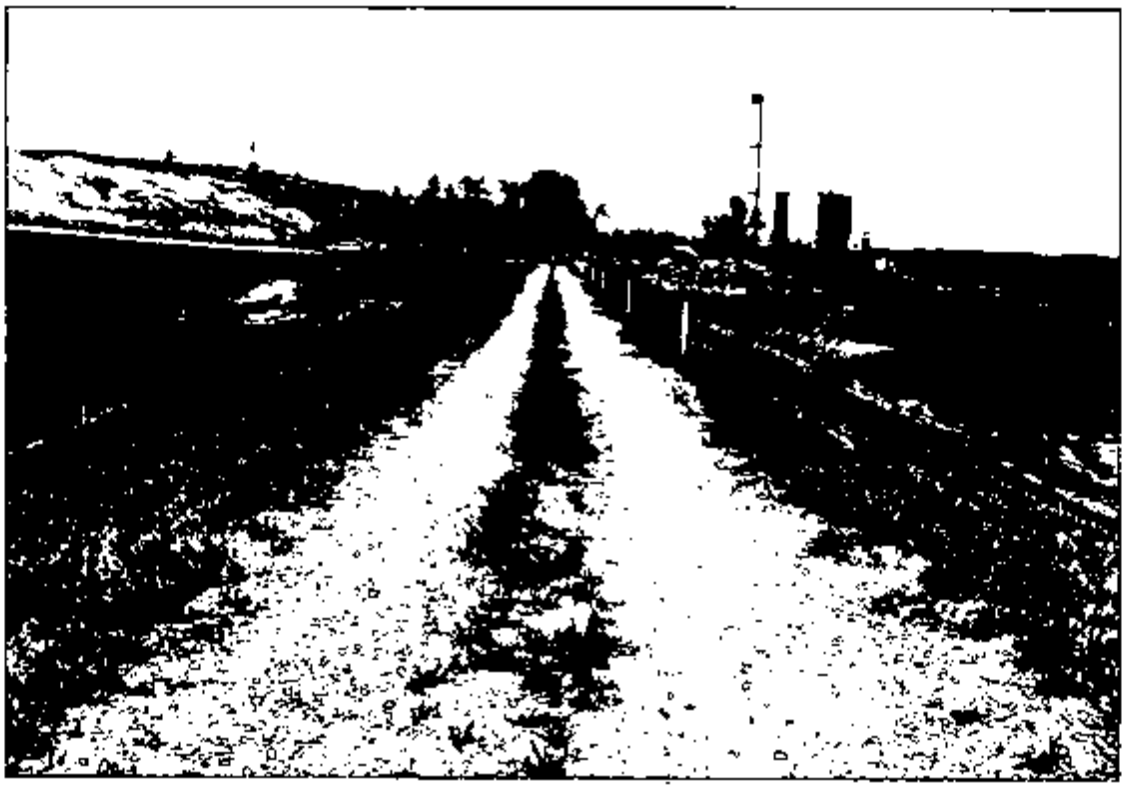
The crest of the downstream dike of the Suck Creek ash basin was observed to be in good condition with no visible tension cracks, major depressions, sags or other signs of shear failure or excessive settlement; a view of the crest is shown in Photo 4-15.

PHOTO 4-15 Crest of Suck Creek Downstream Dike (E to W View)

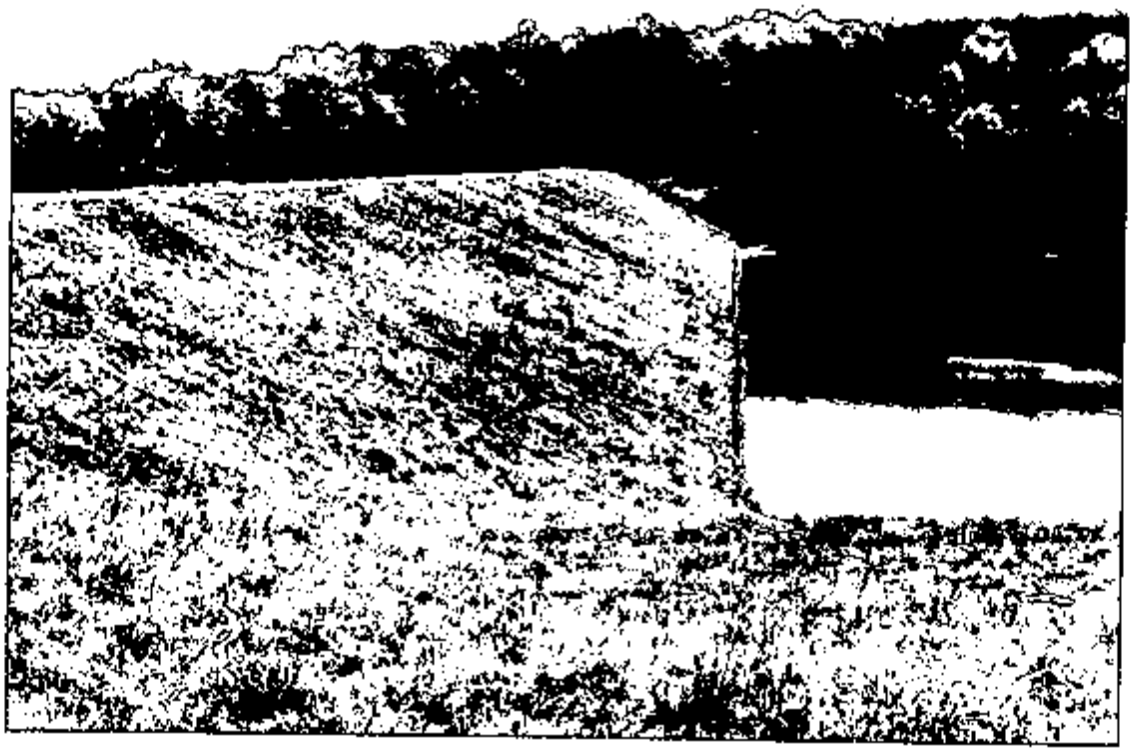
The inside slope of the downstream dike was observed to be in good condition with a well maintained grass cover as shown in Photo 4-16. There were no signs of shear failure or major erosion on this slope. The riprapped-lined intercept ditches at the abutment contacts were in good visual condition.

PHOTO 4-16 Inside Slope of Suck Creek Downstream Dike (W to E View)

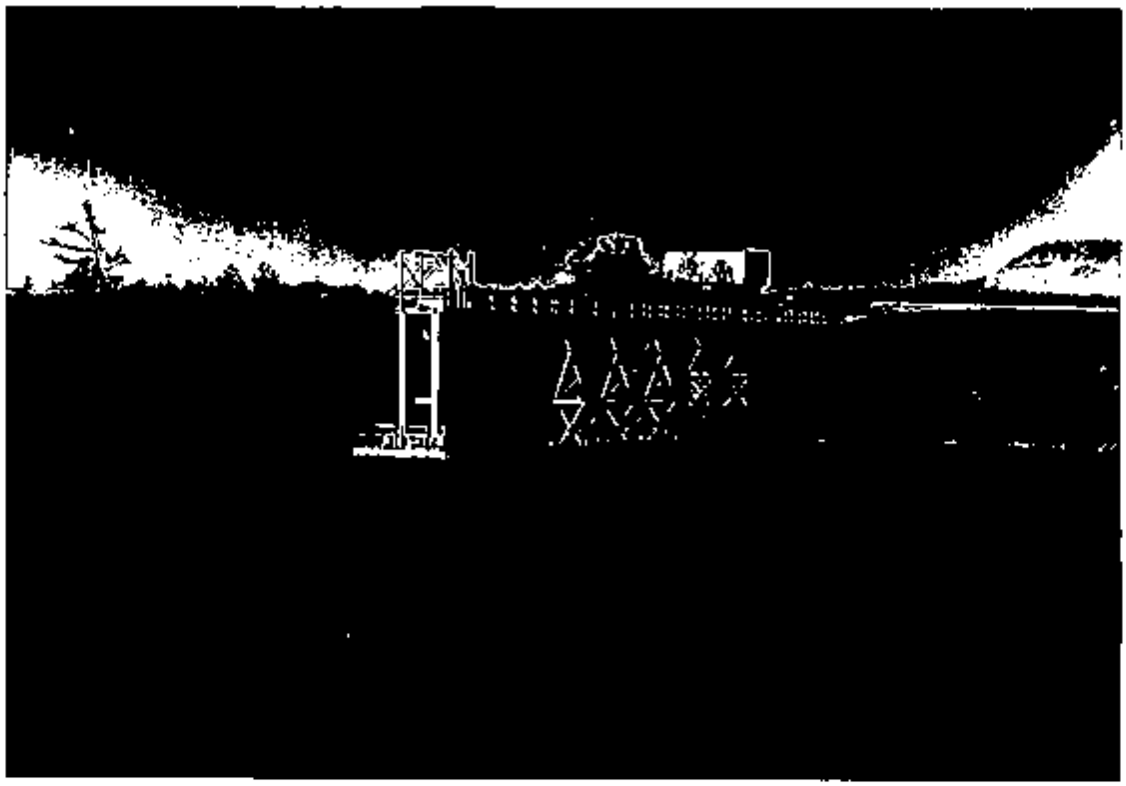
The visible part of the drainage tower is shown in Photo 4-29, and the outlet end of the 42-inch diameter reinforced concrete bottom discharge pipe is shown in Photo 4-30. These structures were observed to be in good condition. Discharge from the pipe was clear, and no dropouts or sinkholes were observed in the soils over the buried outlet pipe. No seepage was observed around the outside of the pipe at the outlet end.

PHOTO 4-29 View of Suck Creek Ash Basin Drainage Tower

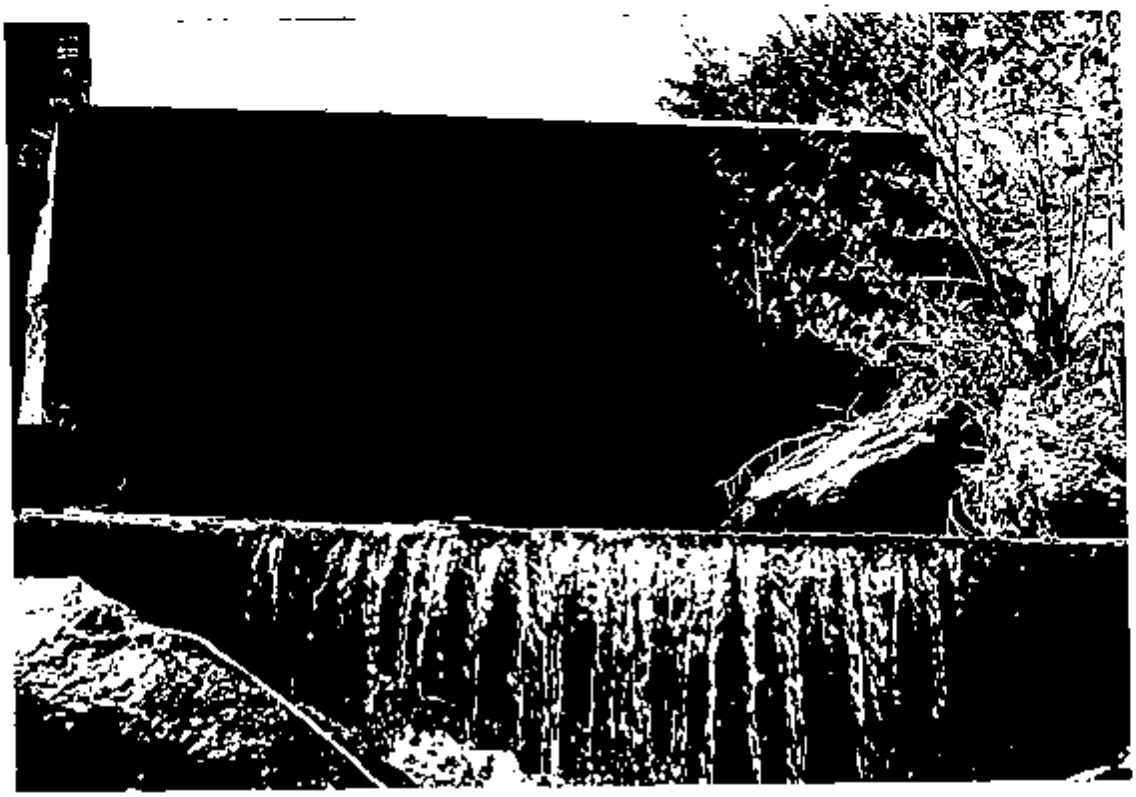
PHOTO 4-30 Outlet End of 42-Inch RCP Outlet for Suck Creek Ash Basin
