Dam Safety Assessment of CCW Impoundments

WH Zimmer Station

United States Environmental Protection Agency
Washington, DC

September 27, 2010

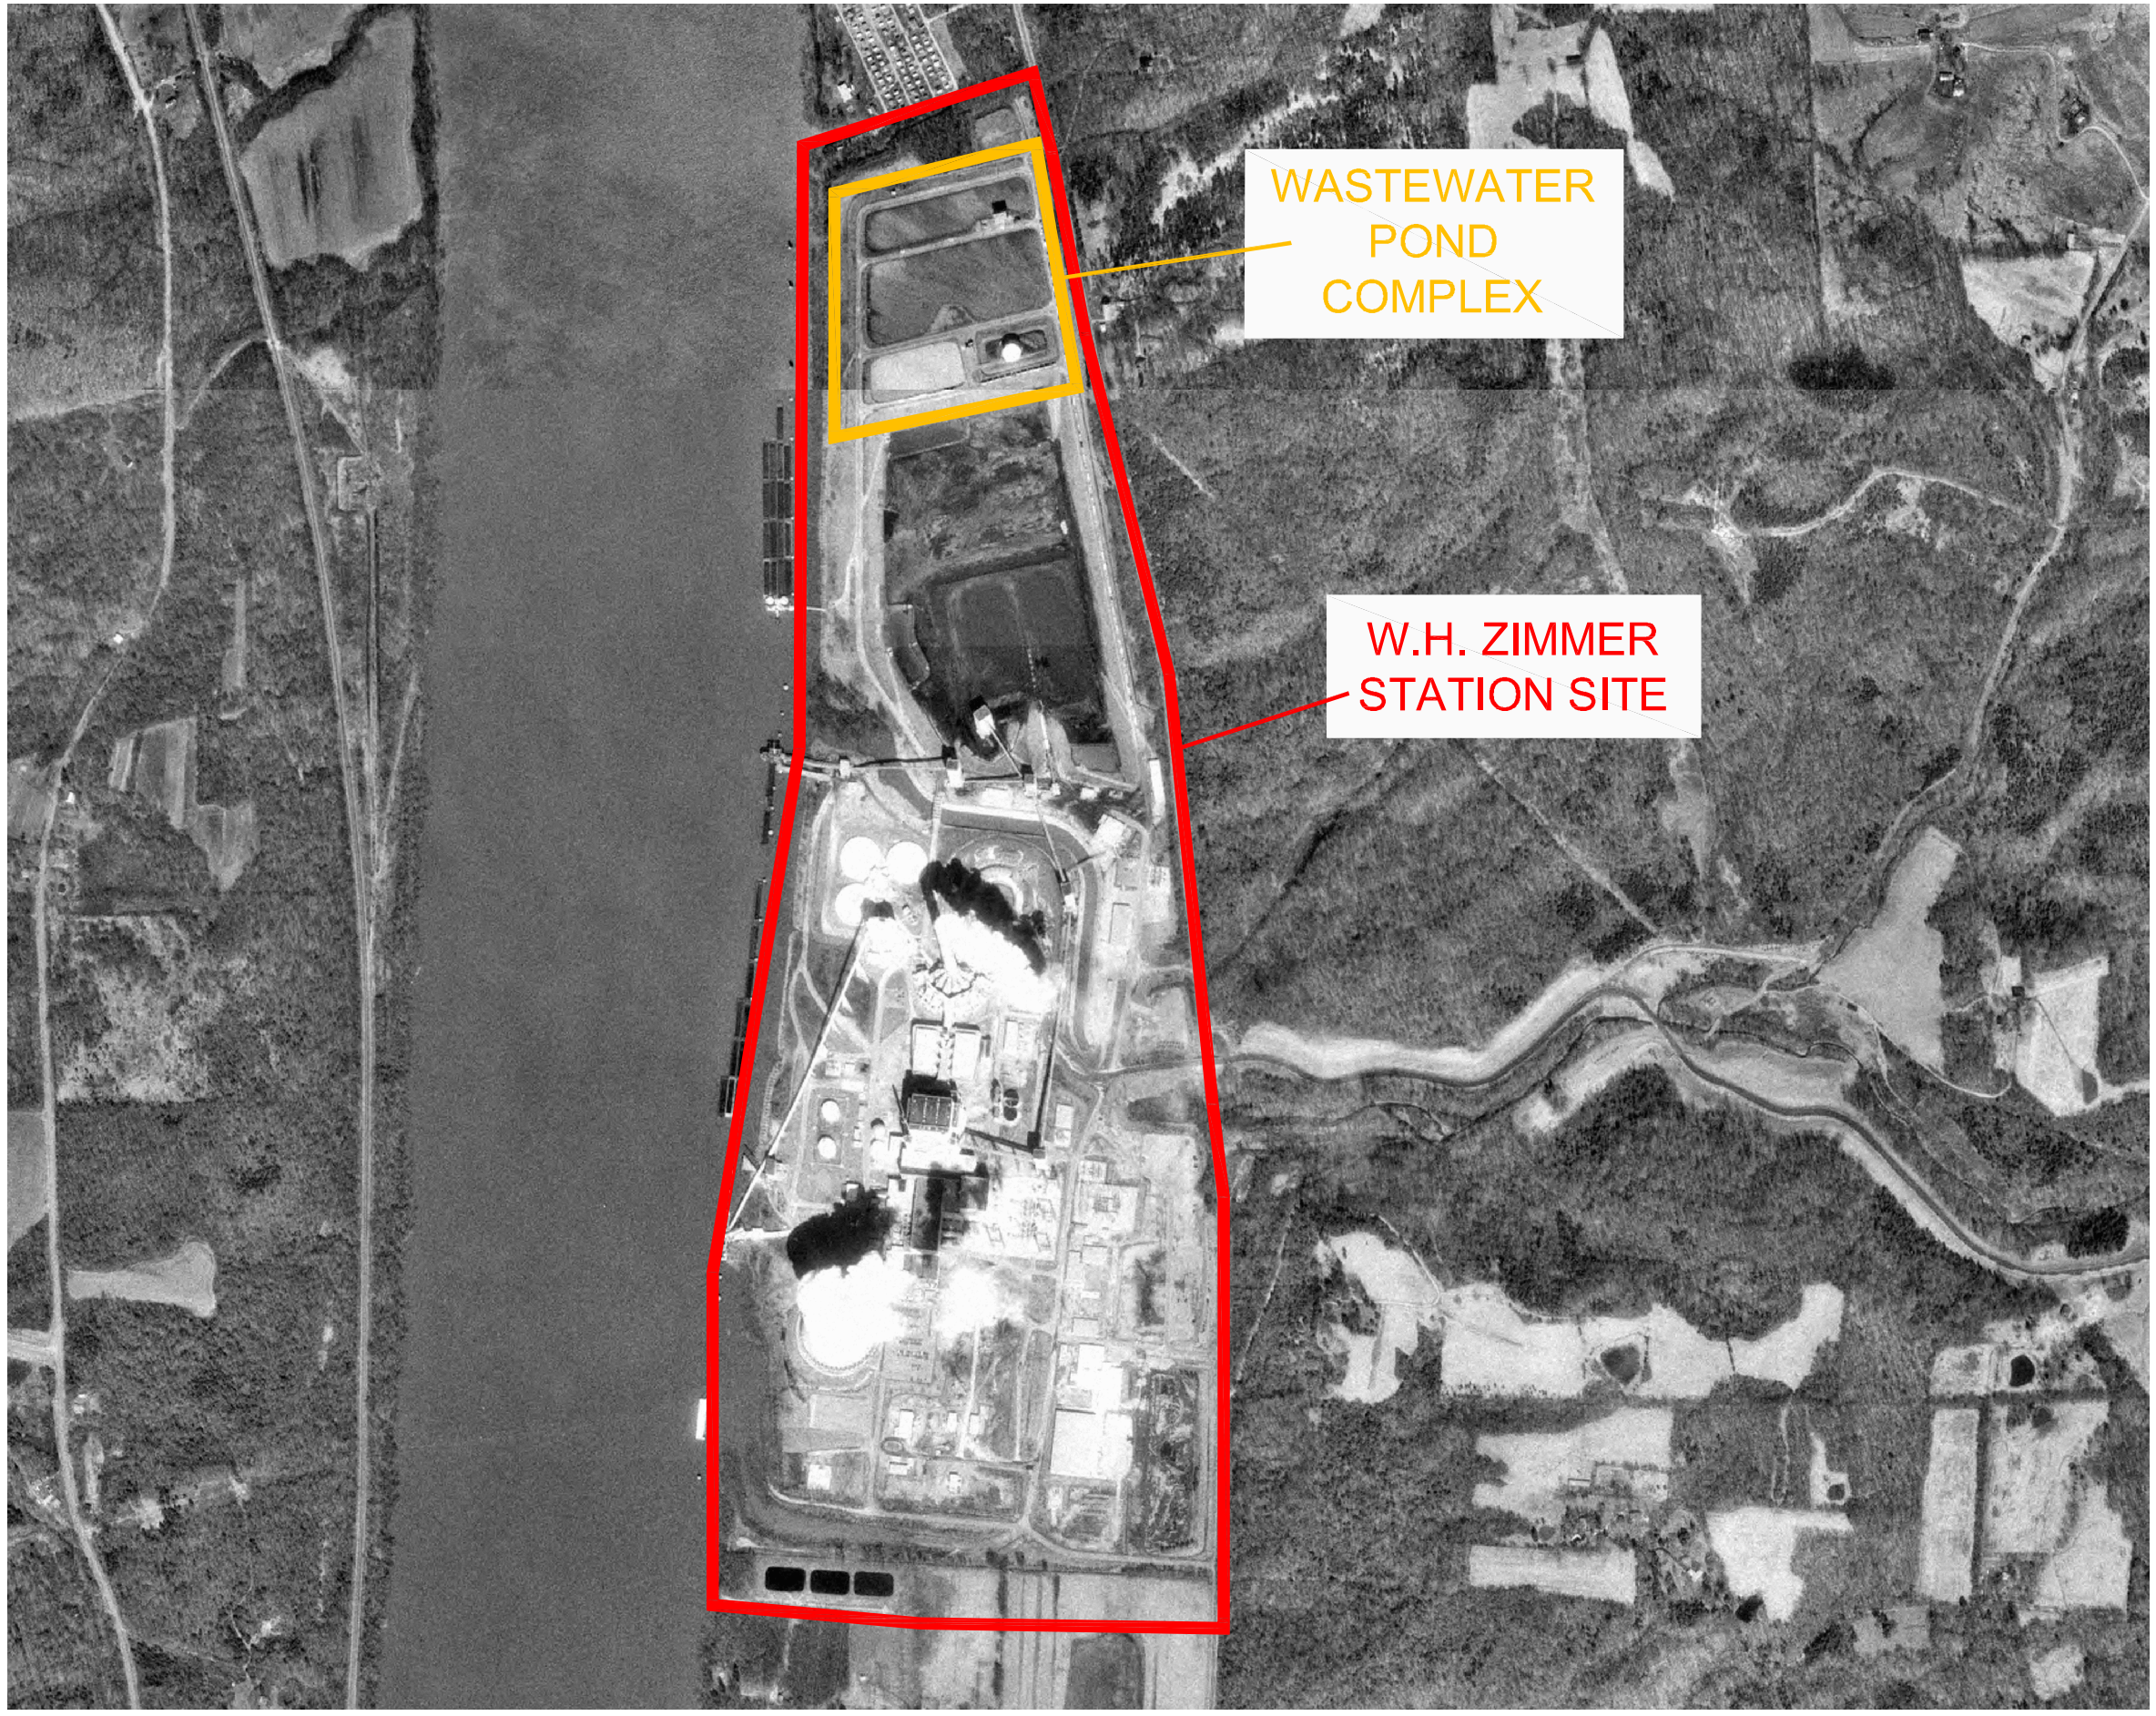
FIGURE 2

1. RODENT BURROW(S)
2. MINOR SCARPING/WAVE ERODED AREAS ALONG WATER'S EDGE OF WASTEWATER AND CLEAR WATER PONDS
3. ERODED GULLY ACROSS GRAVEL ACCESS DRIVE ON NORTH EMBANKMENT
4. NON-UNIFORM SLOPE AT NORTH PORTION OF EAST EMBANKMENT
5. WET/POORLY DRAINED AREAS OBSERVED AT TOE ALONG WEST EMBANKMENT AND NORTH EMBANKMENT

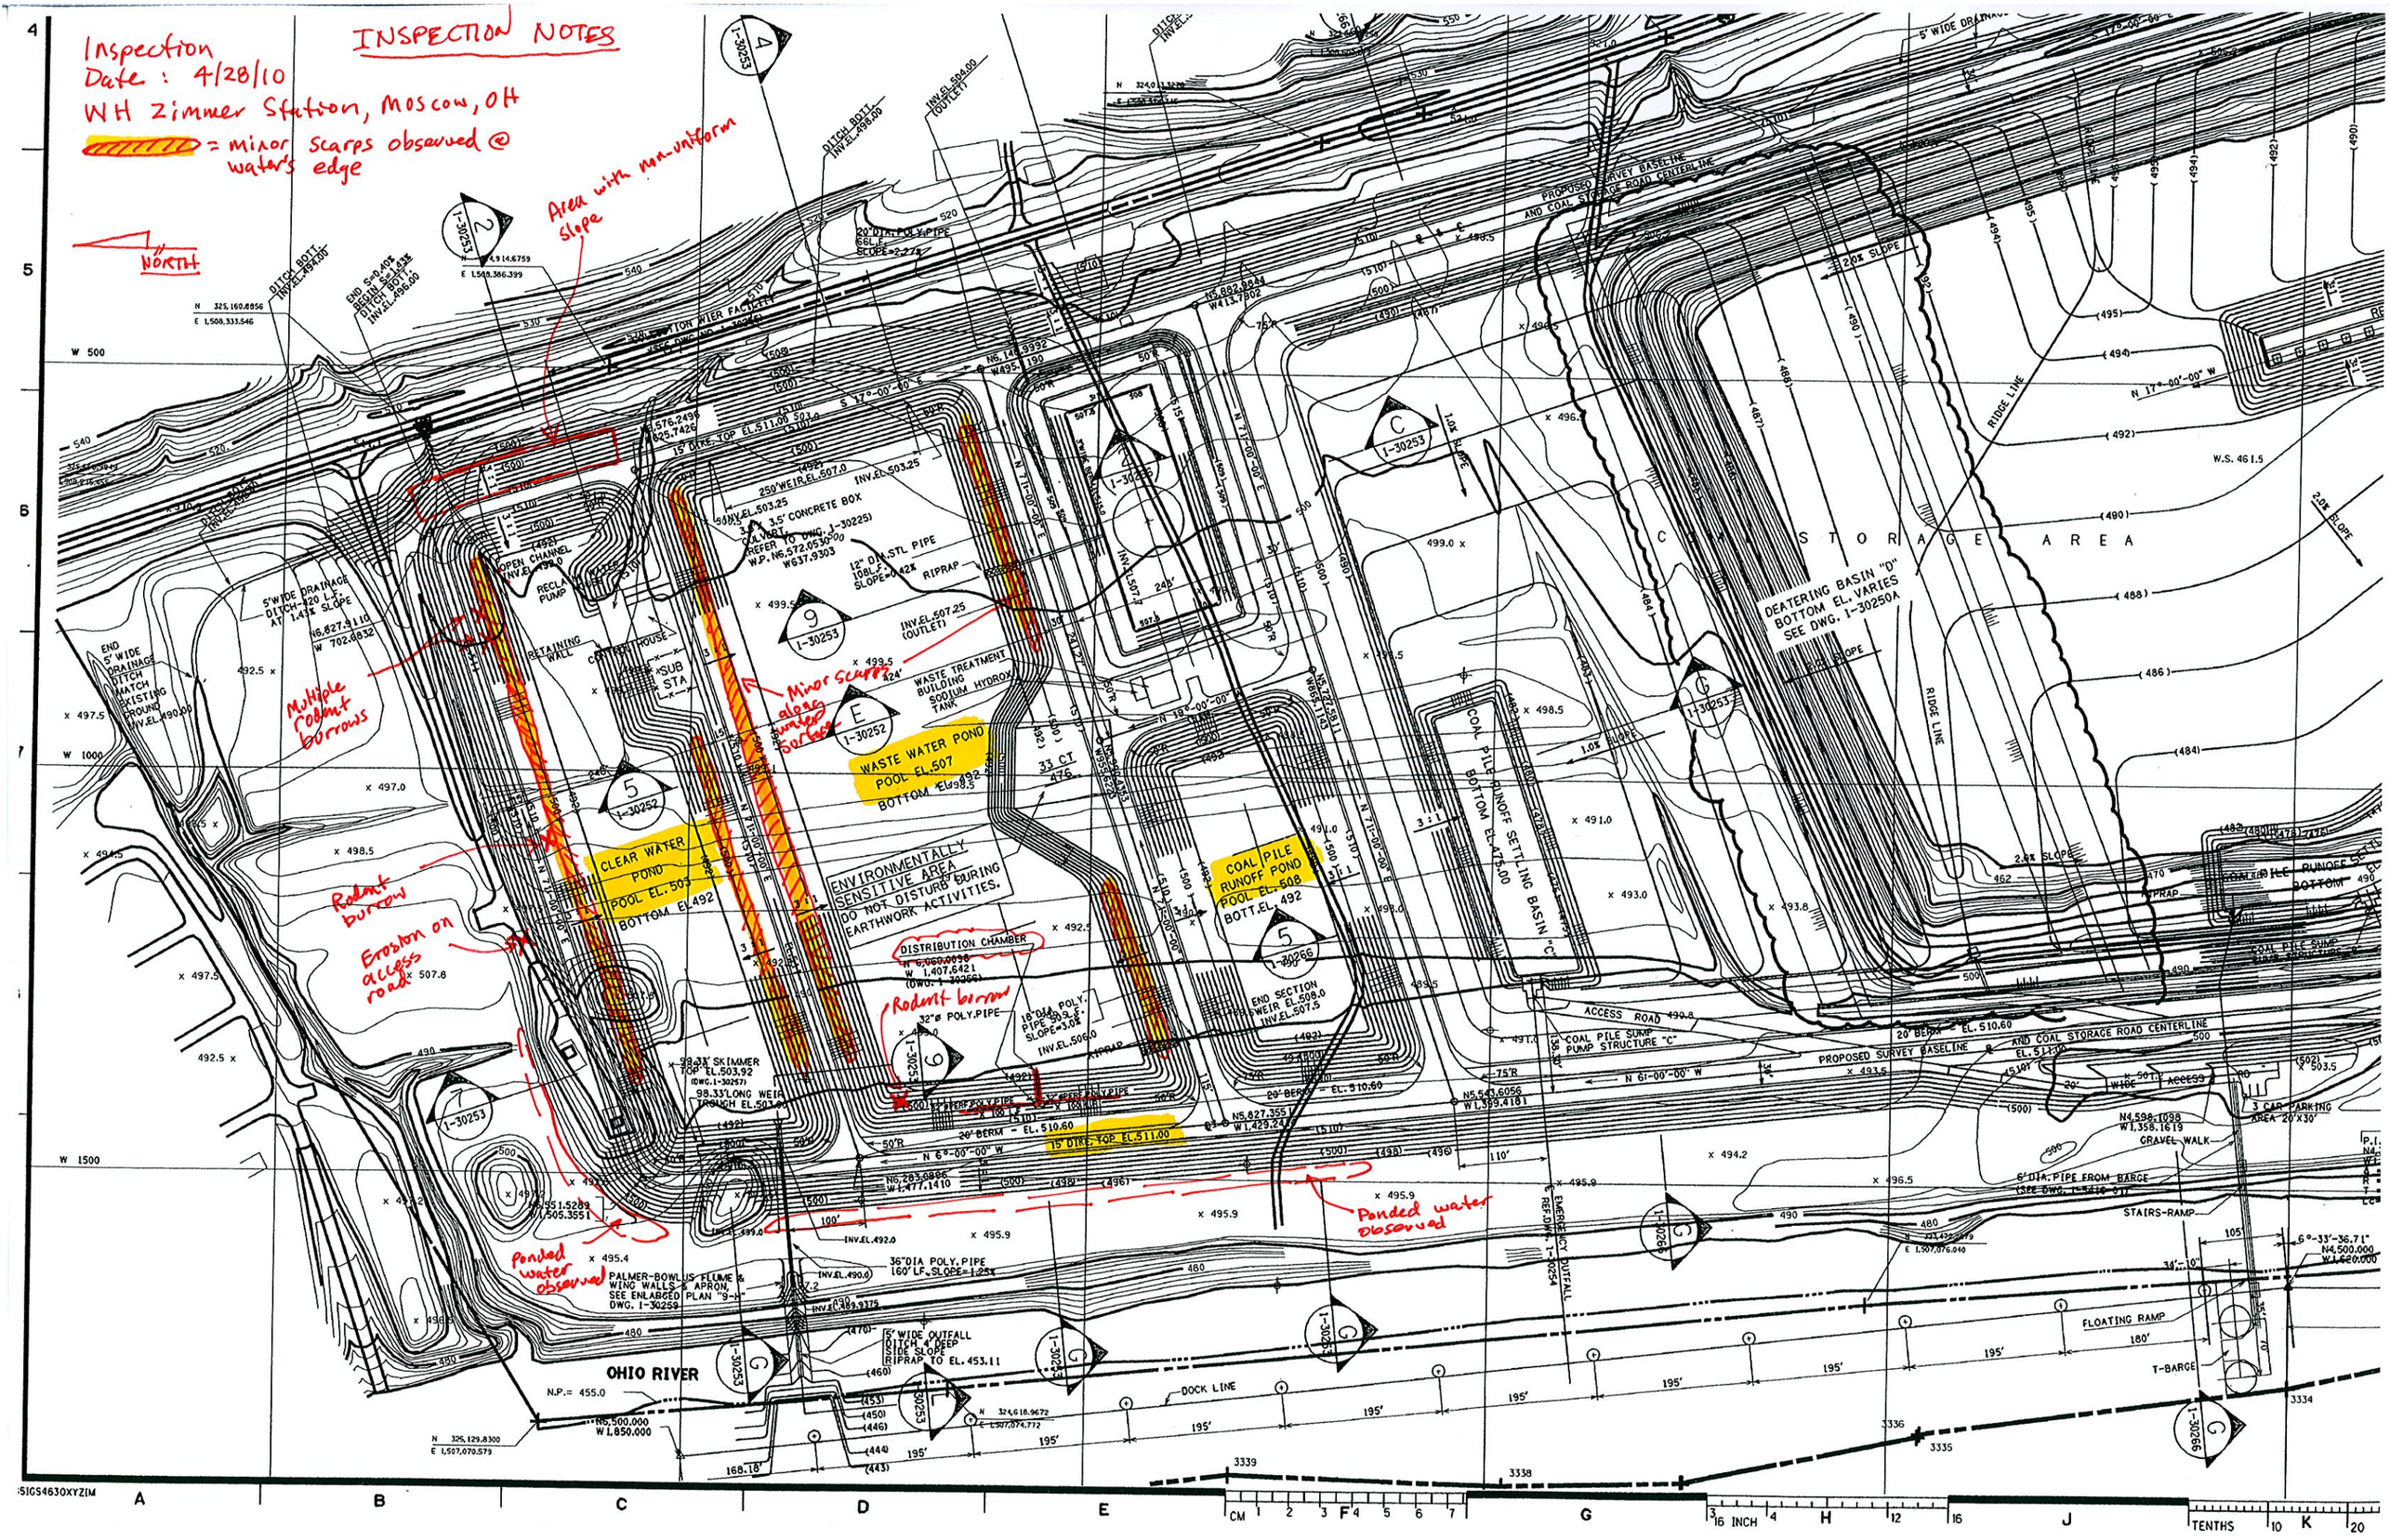
INSPECTION NOTES

Inspection
Date : 4/28/10
WH Zimmer Station, Moscow, OH
= minor scarps observed @ water's edge
