Assessment of Dam Safety
Coal Combustion Surface Impoundments (Task 3)
Final Report

American Electric Power
General James Gavin Power Plant

Cheshire, Ohio

September 14, 2009

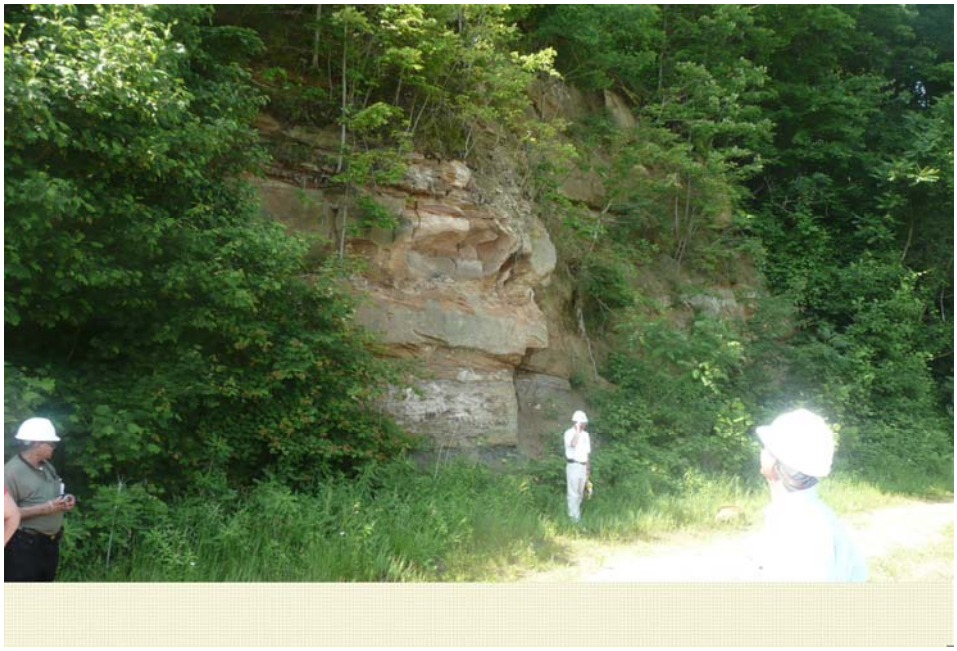
Right (south) abutment.
