Report of Dam Safety Assessment of Coal Combustion Surface Impoundments
Hoosier Energy
Frank E. Ratts Generating Station
Petersburg, IN

AMEC Project No. 3-2106-0177.0005

April 2011

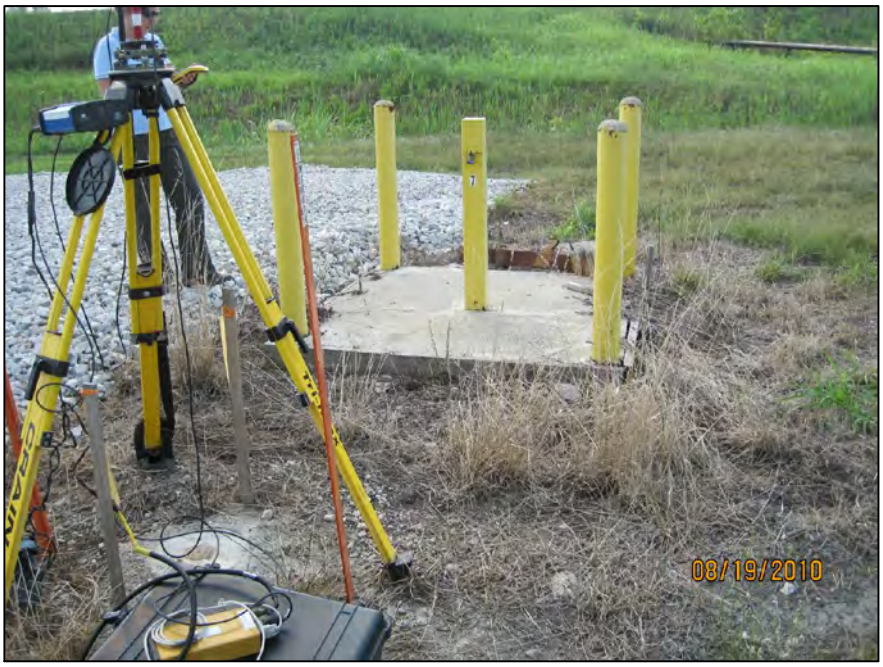
2-1

MONITORING WELL 7
