Assessment of Dam Safety of Coal Combustion Surface Impoundments

Sam Seymour - Fayette Power Project Station

Lower Colorado River Authority
6549 Power Plant Road
La Grange, Texas

April 18, 2011

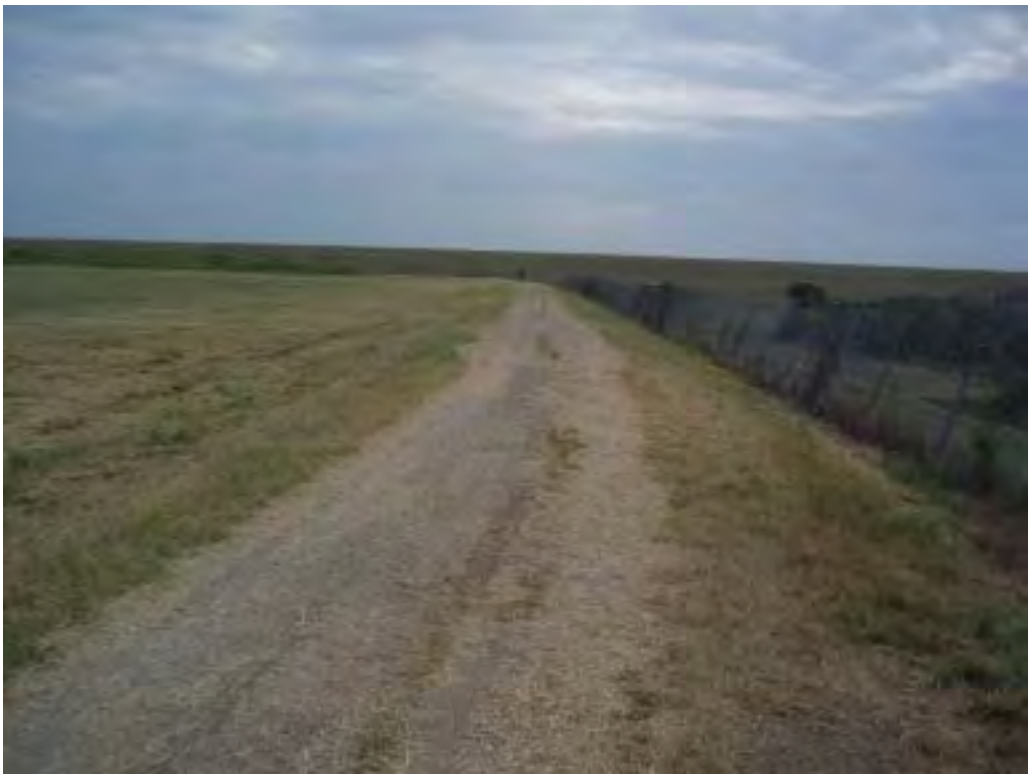
The crest of the CADP appeared to be generally in fair condition (Photos 53, 56, 59, 72, 75, 86, 89, 90, 91, 99, 100, 101, 102, 103, and 104). The crest surface consisted of gravel road base material and was used as an access road. Some minor rutting and depressions were observed on the east and west embankment crest. A tension crack in the previously raised portion of the crest was observed on the north embankment (Photo 99). The chain link fence and posts appeared to be holding the raised section of the crest preventing it from sloughing. The water level was at about El. 355 and there was approximately seven (7) feet of freeboard at the time of the site visit.

Photo No. 72: CADP – East embankment crest, looking north.
