CCW IMPOUNDMENTS INSPECTION REPORT

MITCHELL POWER PLANT MARSHALL COUNTY, WEST VIRGINIA

TRANSMITTAL
ASSESSMENT OF DAM SAFETY OF
COAL COMBUSTION SURFACE IMPOUNDMENTS
DRAFT INSPECTION REPORT
SITE 24 (MITCHELL)

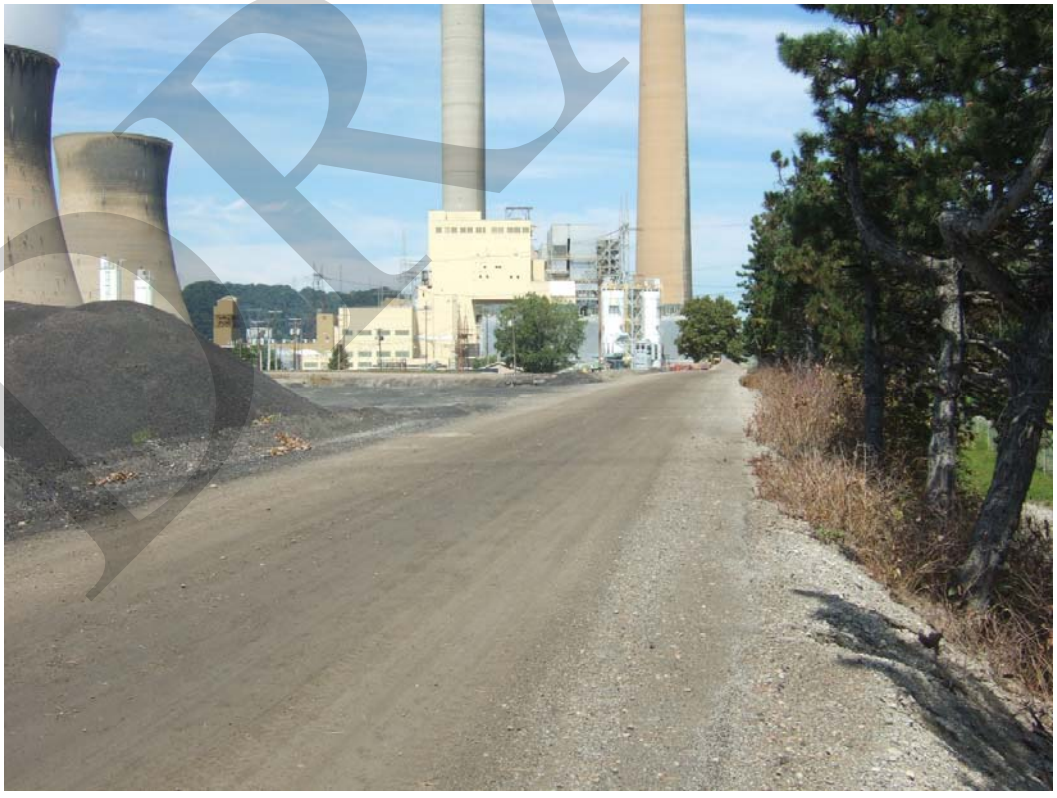
along the upstream and downstream slopes was considered to be good. A line of trees exists along the downstream slope of east embankment. This slope exists well above the normal pool elevation, and the trees do not pose a hazard to the safety of the impoundment.

PHOTO 19: TREE LINE ALONG EAST CREST OF BOTTOM ASH POND
