Mountaineer Bottom Ash Complex Report

December 2009

Mountaineer Bottom Ash Complex Assessment Report

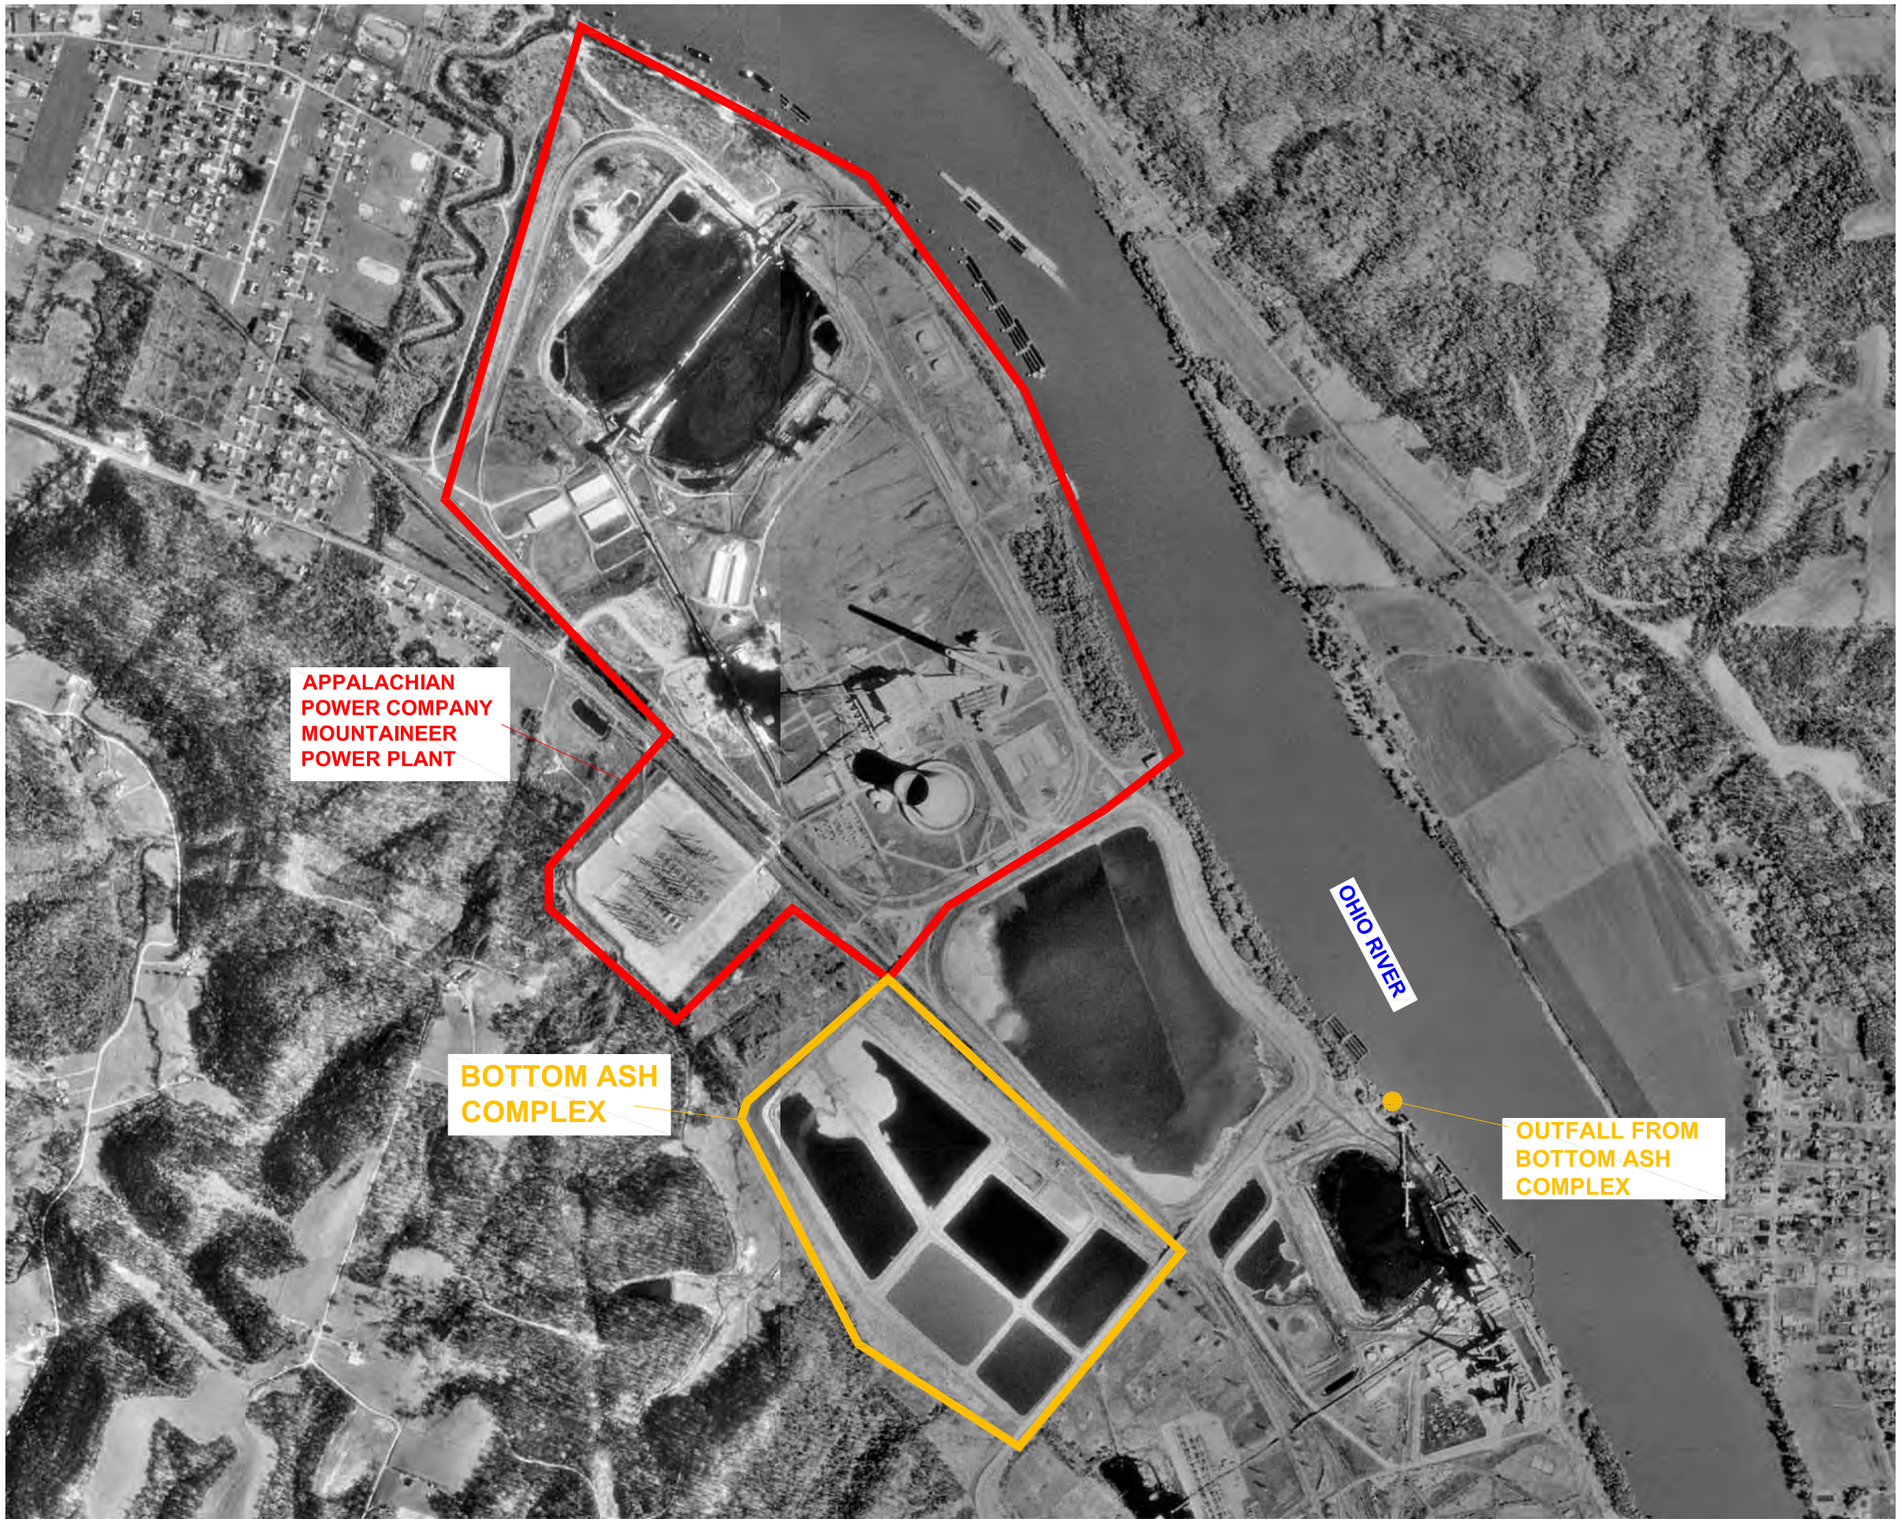
FIGURE 2

A site layout map highlighting the location of the Bottom Ash Complex is provided as Figure 2. Please note the direction of plant north as commonly used by plant personnel. Plant north is referenced for convenience when describing the Bottom Ash Complex features and is not true north. Plant north will be used for compass reference of locations within this report.

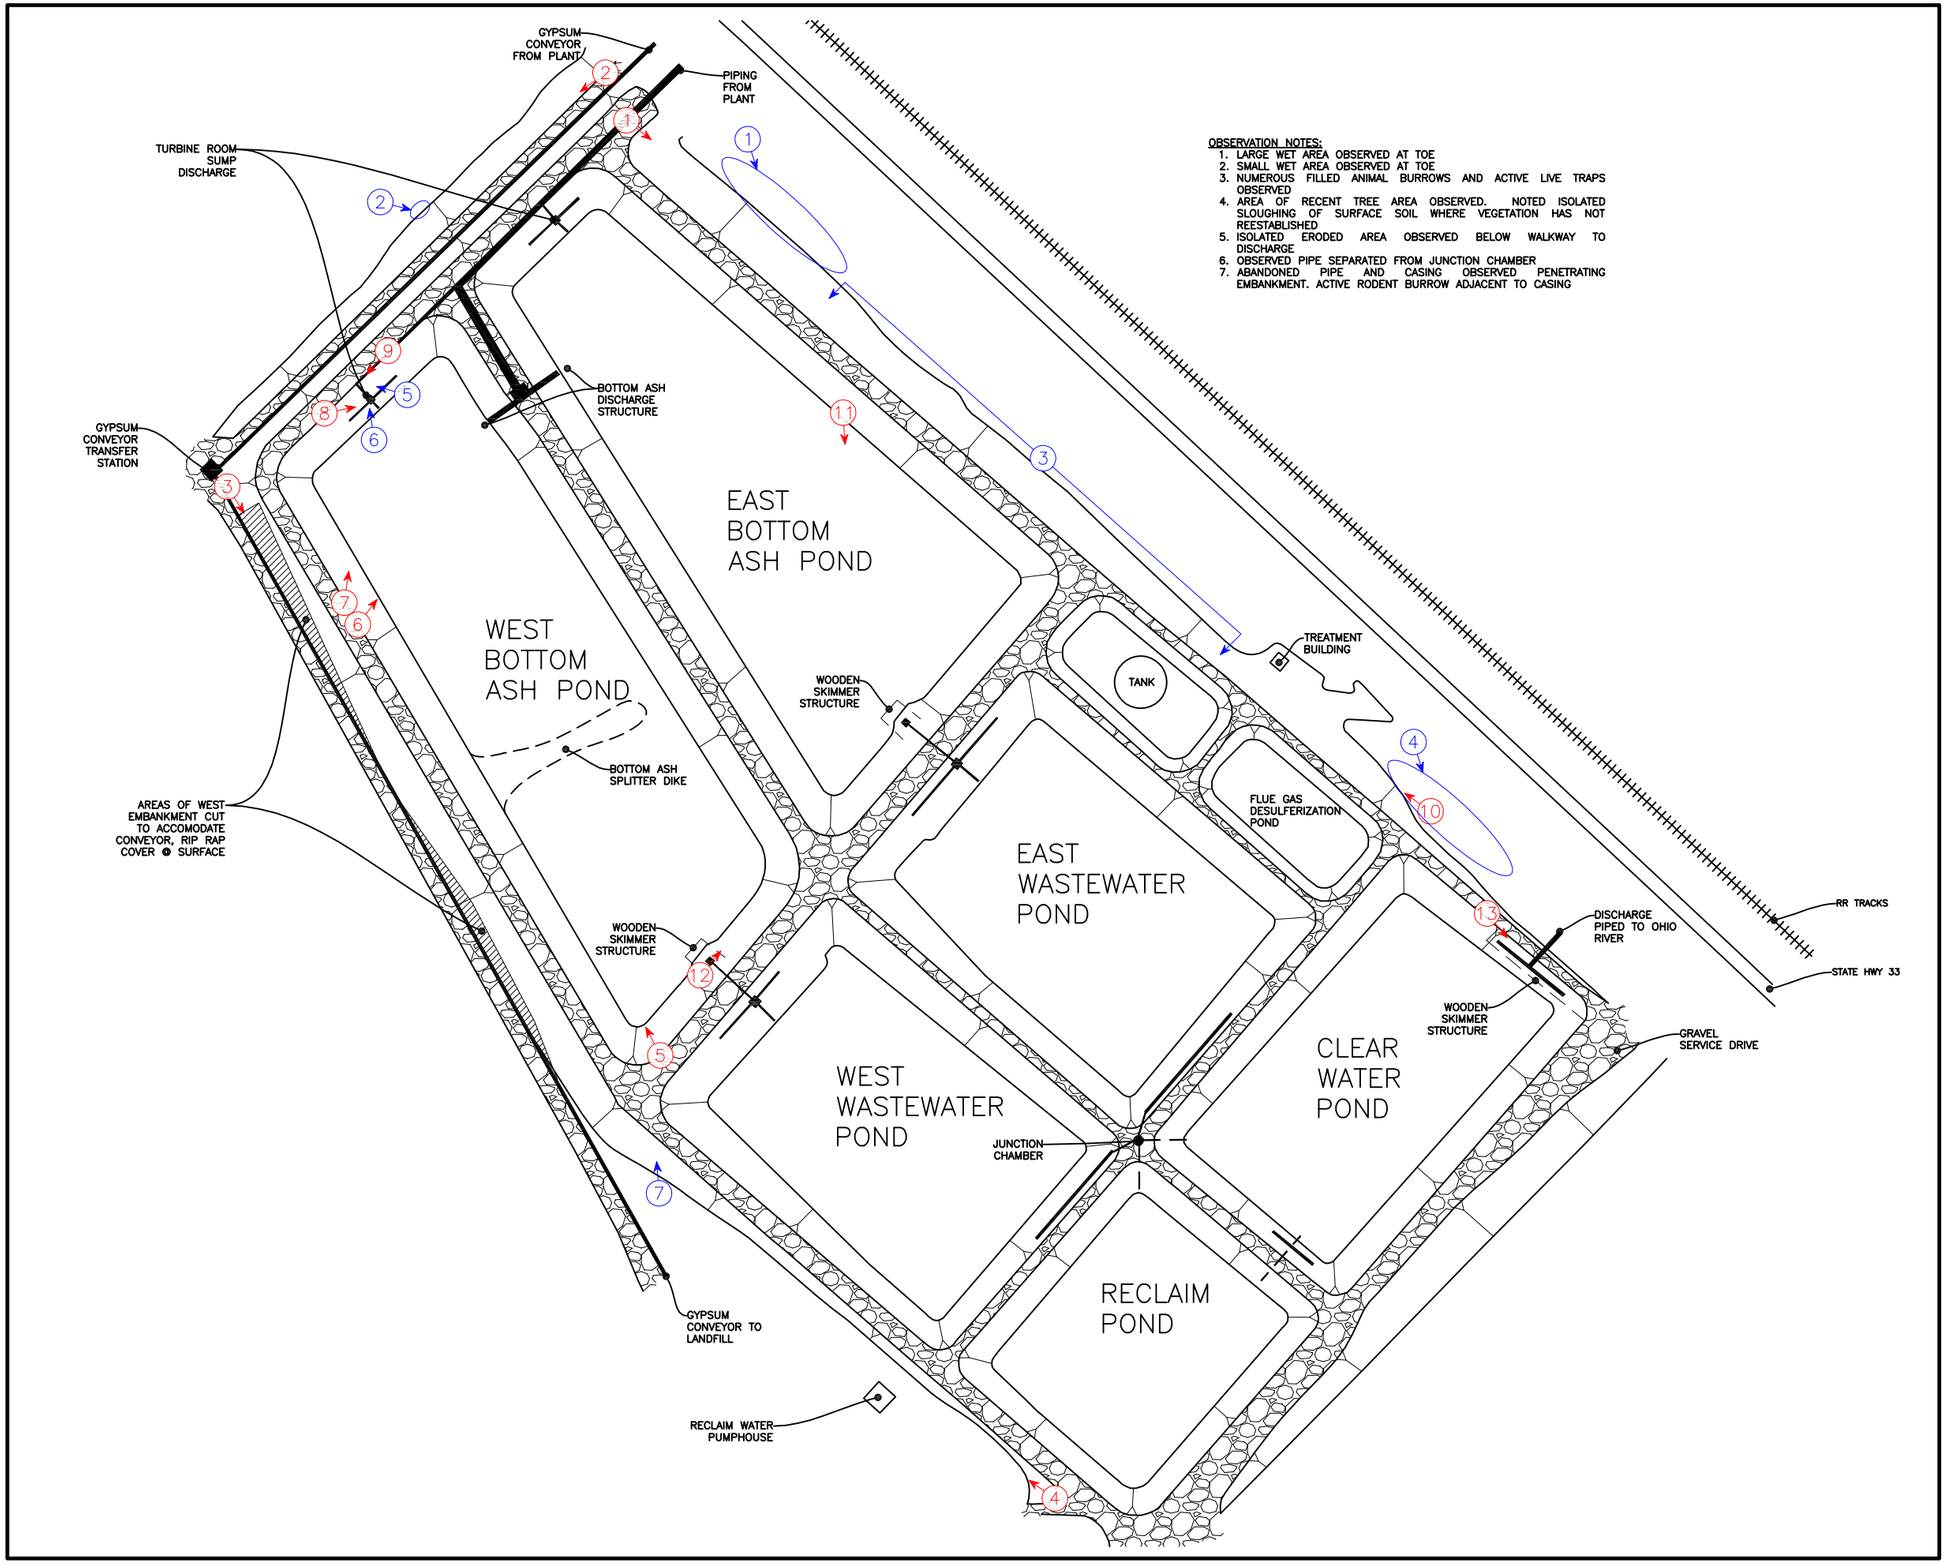
FIGURE 3

Photos were taken during the visual inspection. A photo log of relevant items is incorporated as Appendix B and locations of photos are noted within Figure 3.

OBSERVATION NOTES:
1. LARGE WET AREA OBSERVED AT TOE
2. SMALL WET AREA OBSERVED AT TOE
3. NUMEROUS FILLED ANIMAL BURROWS AND ACTIVE LIVE TRAPS OBSERVED
4. AREA OF RECENT TREE AREA OBSERVED. NOTED ISOLATED SLOUGHING OF SURFACE SOIL WHERE VEGETATION HAS NOT REESTABLISHED
5. ISOLATED ERODED AREA OBSERVED BELOW WALKWAY TO DISCHARGE
6. OBSERVED PIPE SEPARATED FROM JUNCTION CHAMBER
7. ABANDONED PIPE AND CASING OBSERVED PENETRATING EMBANKMENT. ACTIVE RODENT BURROW ADJACENT TO CASING

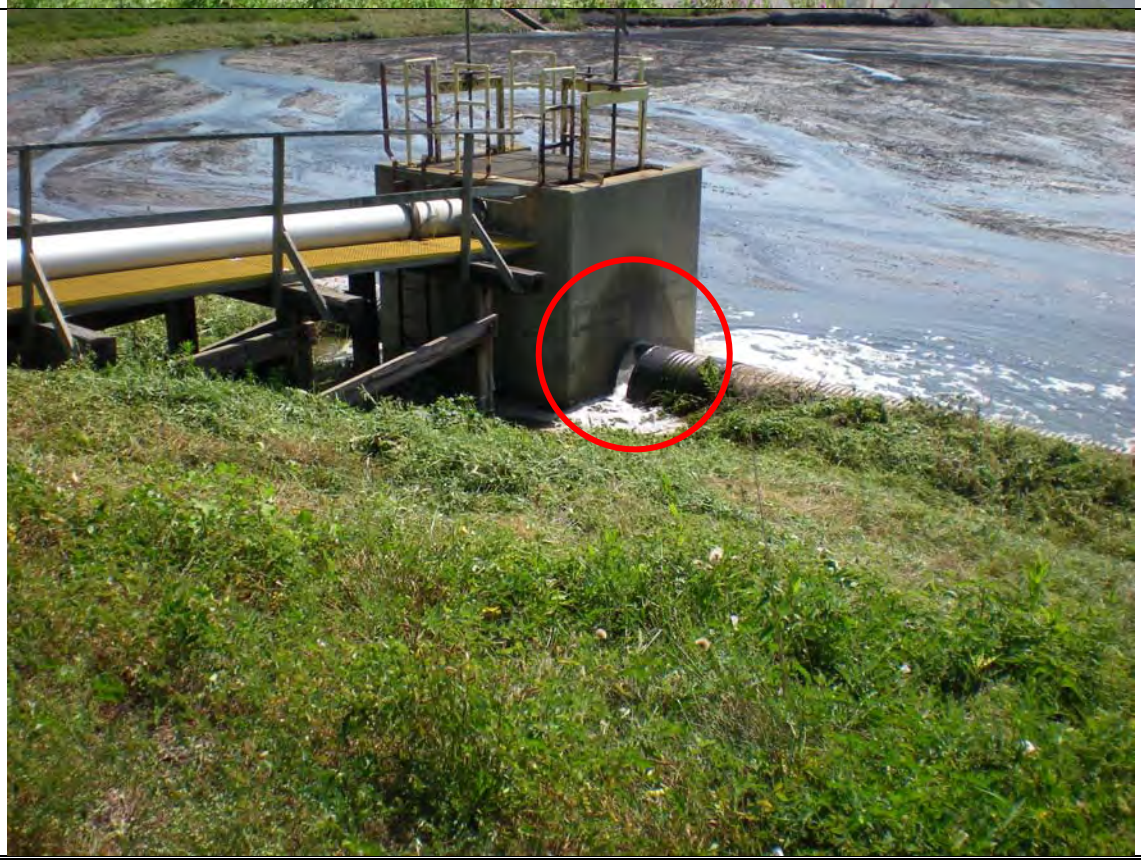
Photo Number: 8

- The Turbine Room Sump Discharge chamber in the West Bottom Ash Pond was observed to have separated from the west manifold pipe. The discharging water was roughly surging out of the separation and beginning to erode the soil behind the chamber, connecting with the erosion described above (Appendix B – Photo 8).

Erosion of the dike embankment crest and slope at the Turbine Room Sump Discharge into the West Bottom Ash Pond should be repaired, including measures to prevent runoff from accumulating on the crest and being channeled to this location. The connection of the Turbine Room Sump discharge header to the junction chamber should also be restored to prevent pond slope and bottom erosion around the junction chamber.

For repair of the erosion and Turbine Room Sump Discharge chamber in the West Bottom Ash Pond, the West Bottom Ash Pond could be allowed to finish its annual service cycle. The repair should be completed prior to reinstating the West Bottom Ash Pond into service for its next annual cycle. Should the condition of this area be observed to significantly worsen prior to the end of the annual service cycle, the area should be repaired immediately.
