Specific Site Assessment for Coal Combustion Waste Impoundments at Reid Gardner Generating Station

NV Energy

Moapa, Nevada

April 2011
Project 092885

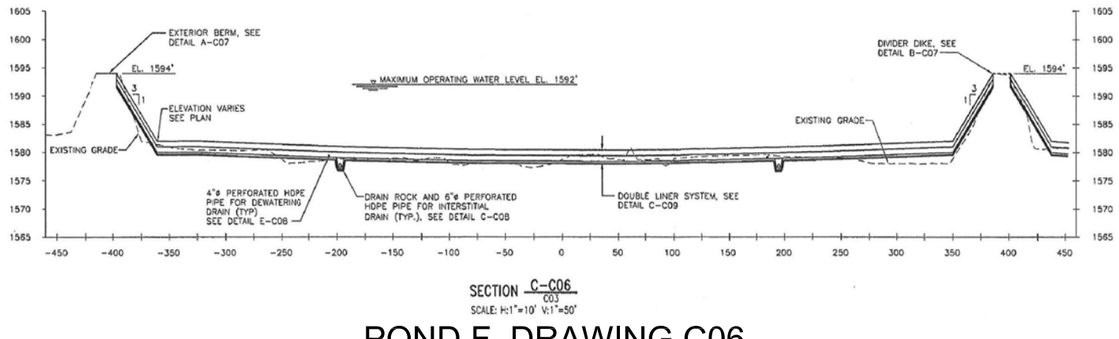
POND F, DRAWING C06

The slope stability analyses completed by Stanley Consultants in 2005 for the design of Pond F show the steady seepage condition is not met when appropriate effective stress, cohesion equal to zero, strength parameters are used.
