Assessment of Dam Safety
Coal Combustion Surface Impoundments (Task 3)
Final Report

PacifiCorp

Naughton Power Station

Kemmerer, Wyoming

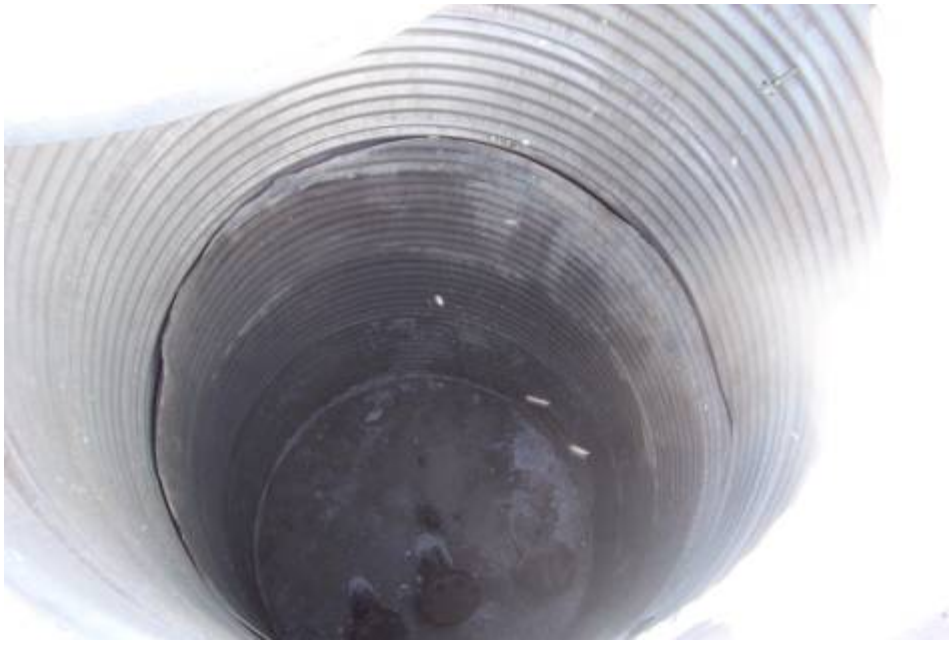
23

Valves in vault at toe of southeast dike about 13 feet deep (cleanouts to sluice line to FGD #2 Pond).
