Coal Combustion Residue Impoundment
Round 9 - Dam Assessment Report

H.F. Lee Steam Electric Plant

Ash Pond
Progress Energy
Wayne County, North Carolina

Dewberry & Davis, LLC
Fairfax, Virginia

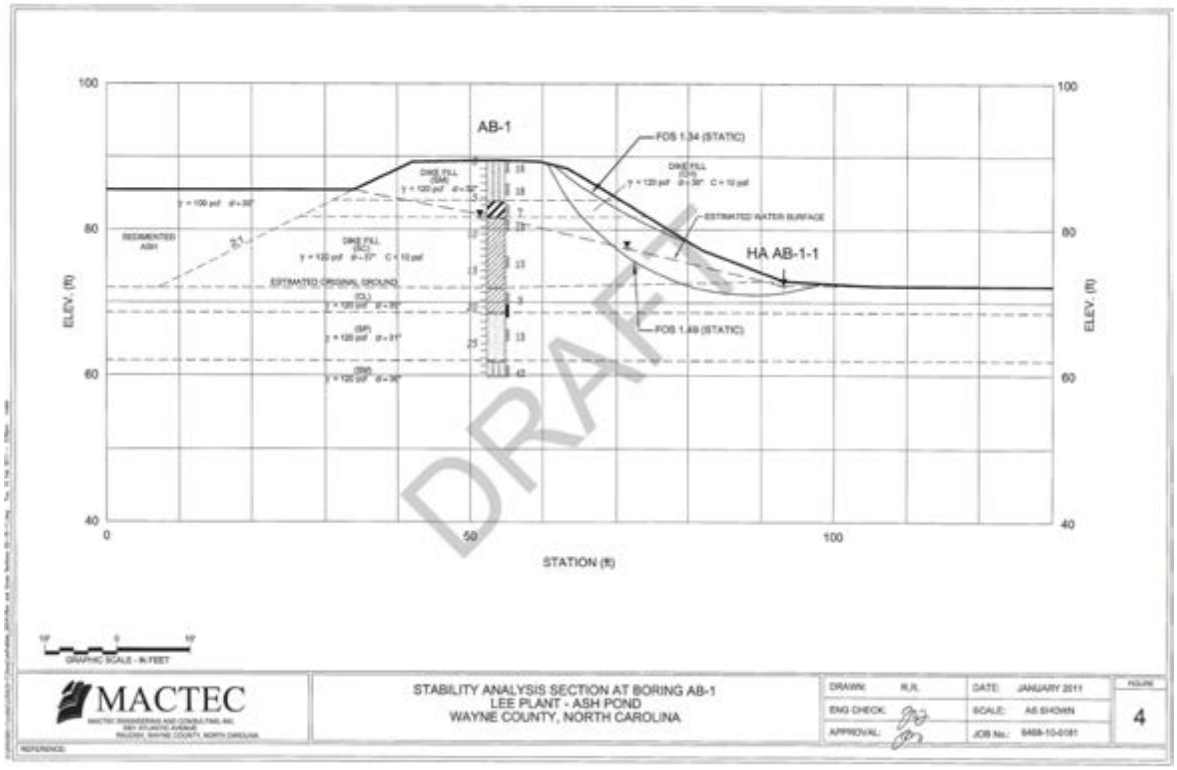
Figure 7.1.2a: Stability Analysis Section (AB-1)

The slope stability analysis provided inadequate results for factors of safety for steady state (normal) loading conditions. All additional technical documentation appeared to be adequate. Engineering documentation reviewed is referenced in Appendix A.

- Perform an analysis for potential of liquefaction
- Develop an action plan to increase the factors of safety for the ash pond embankments at all locations to meet or exceed the minimum requirements for factors of safety for steady state (normal) and seismic loading conditions.

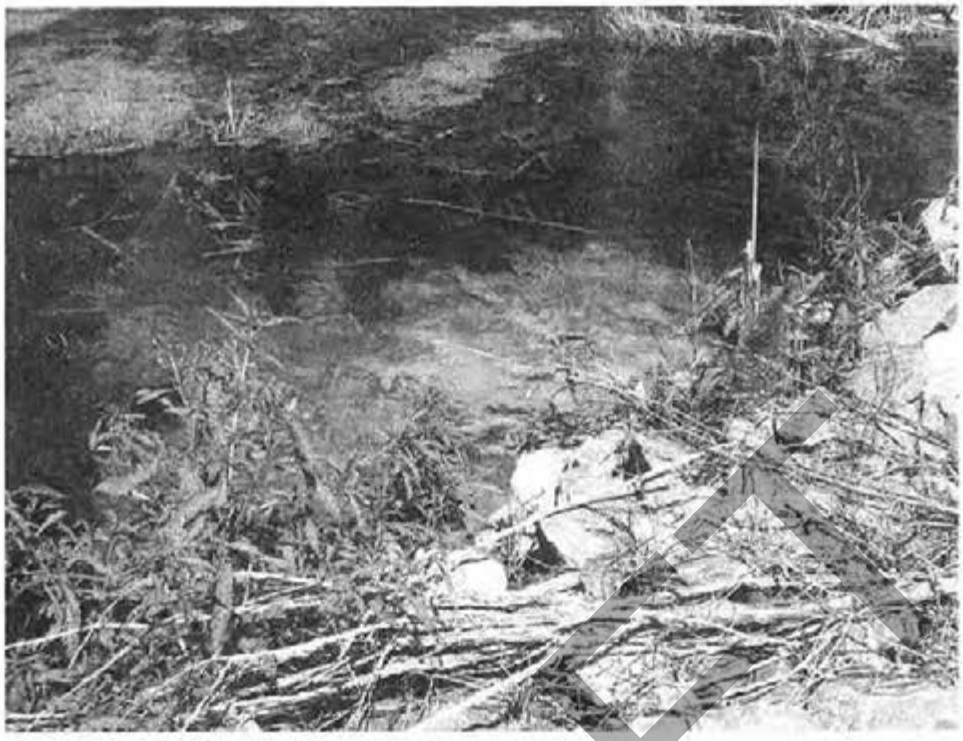
The water exit point is at the outer edge of the previously placed weighted filter and is approximately 50 feet west of piezometer P-6. Water was emerging from the underside of the filter. Water was also emerging from a small diameter boil located a few inches north of the filter edge. The boil had a slight roiling appearance and traces of silt or fine sand were observed in the flow. A small delta of fine sand was present at the boil. Photograph 1 shows the area. Photograph 2 shows the boil. Probing of the boil found an approximate 1-inch diameter opening 4 to 6 inches deep. The exit flow was estimated at less than 1gallon per minute.

Photograph 1. Area of sediment deposit around small boil.

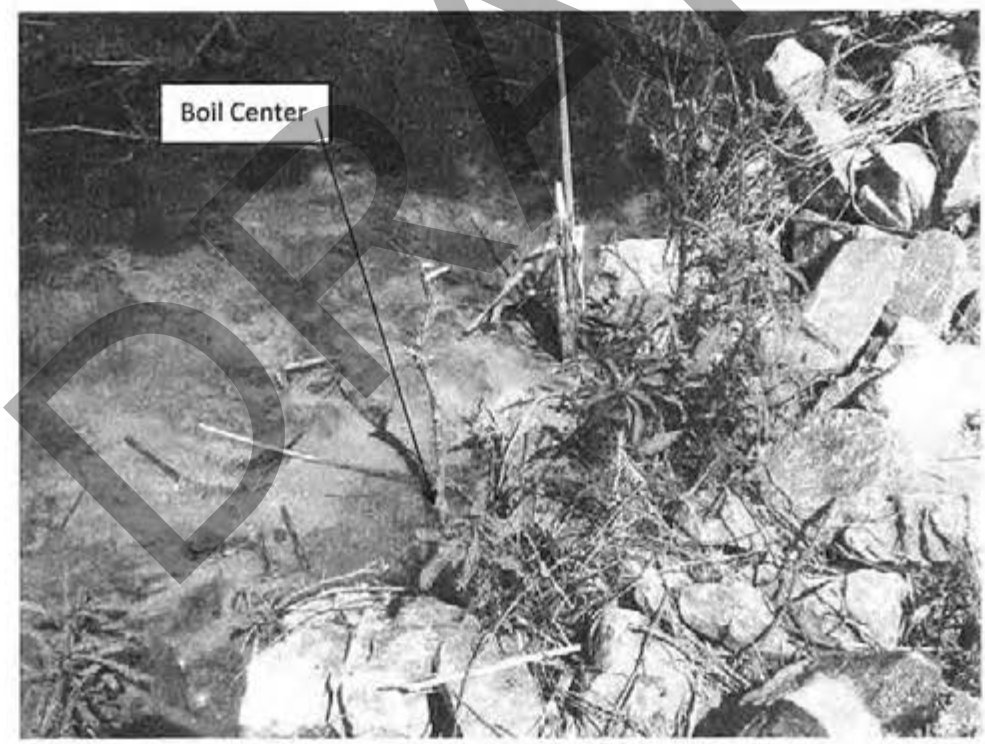
Photograph 2. Boil area (stick is in boil).
