Coal Combustion Residue Impoundment

Round 9 - Dam Assessment Report

Weatherspoon Steam Electric Plant

Ash Pond Embankment
Progress Energy Carolinas, Inc.
Robeson County, North Carolina

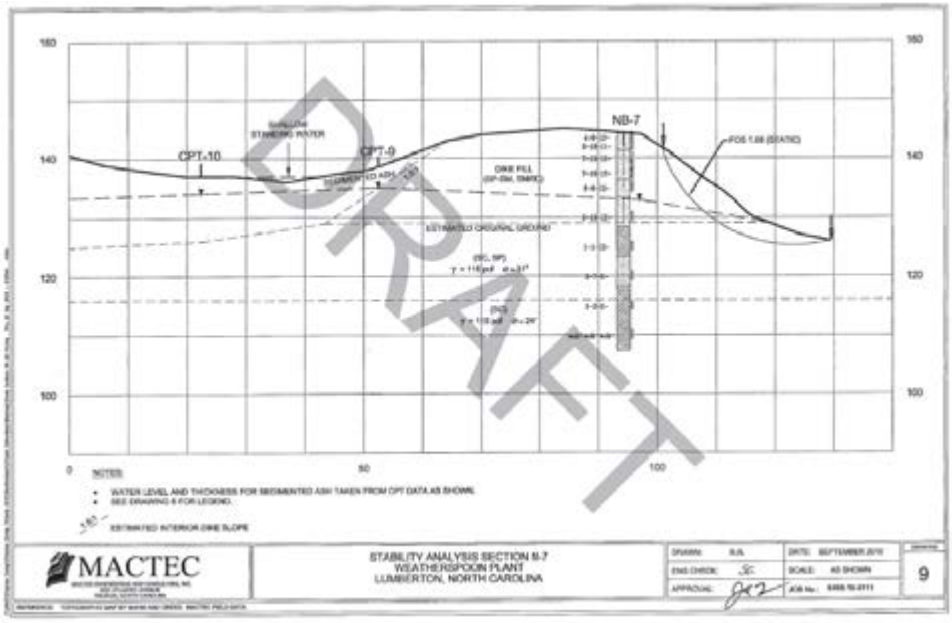
Figure 7.1.2a: Stability Analysis (Section NB-7)

Test results showing the strength parameters of the embankments are presented below. There are multiple sections analyzed in the report and only a portion of those analyzed are shown below. The ones shown below are sections that did not meet the minimum factors of safety.

Stability analysis of the northern ash area has shown in a few locations factors of safety below the 1.5 NCDENR and United States of America Corp of Engineers (USACOE) thresholds. The MACTEC 2010 report concludes that the factors of safety below the threshold are acceptable because the dikes have been in place for 40 to 50 years, no failures have been noted, currently the dikes do not have water impounded against them, and exploration found water levels within the dikes at low levels.

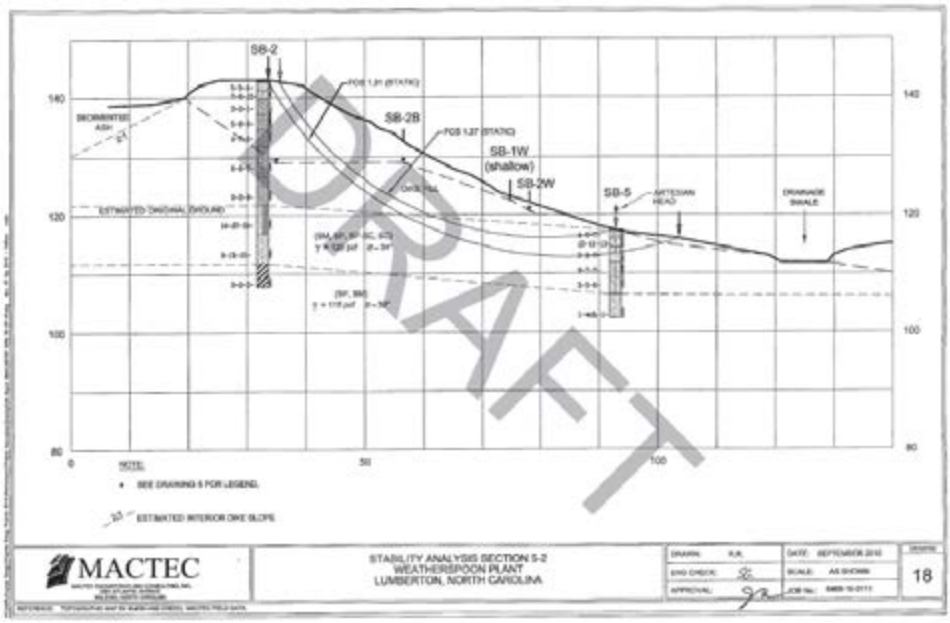
Figure 7.1.2b: Stability Analysis (Section SB-7)

Stability analysis of the southern ash area also showed a factor of safety in one area below the threshold. There was seepage occurring in this area, so it was recommended to place a “riprap blanket on the slope and toe berm/road.” (Appendix A: Doc 03 – Seepage and Stability Analysis)
