Coal Combustion Residue Impoundment

Round 9 - Dam Assessment Report

Canadys Steam Power Station

Ash Pond Embankments
South Carolina Electric & Gas
Canadys, South Carolina

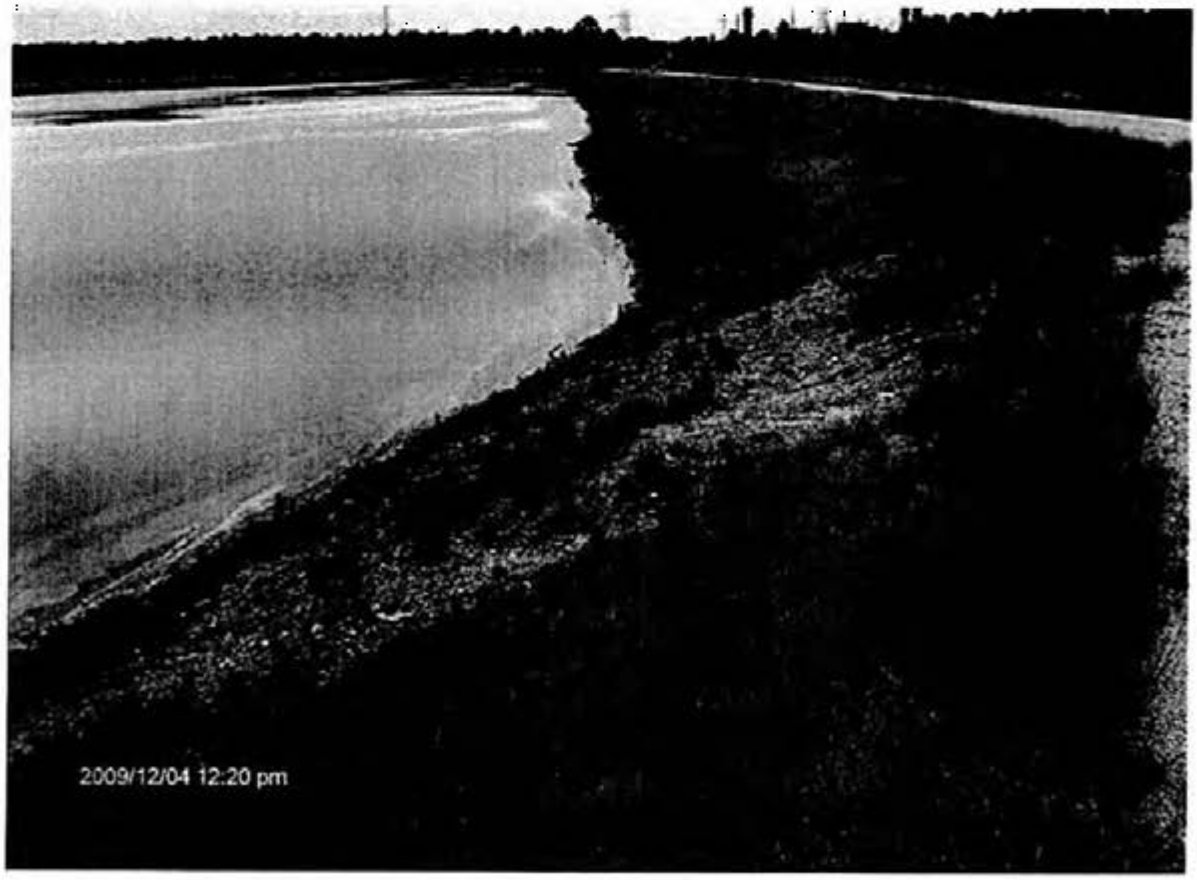
Figure 6: Erosion Damage and Lack of Vegetation Interior of Active Pond

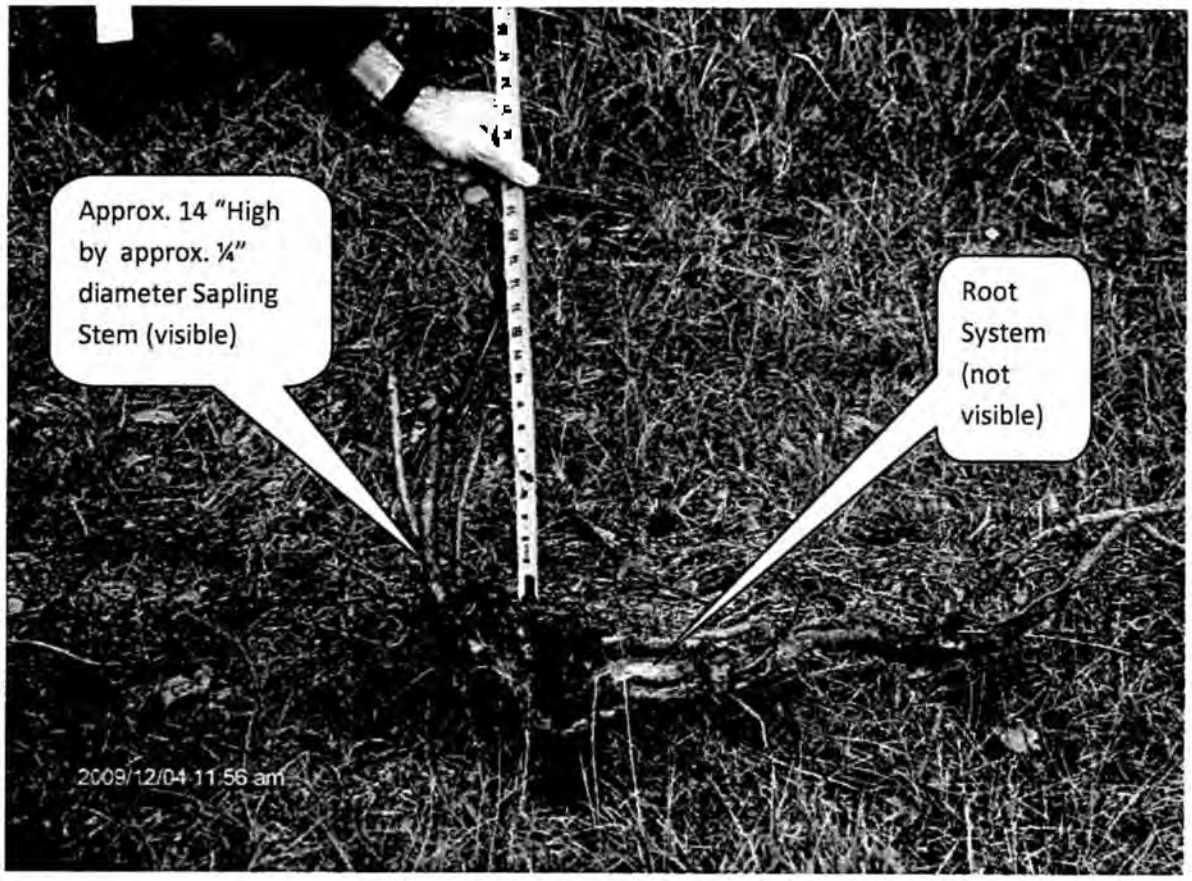
Figure 11: Example of Woody Vegetation Growing on Downstream Side of Berm

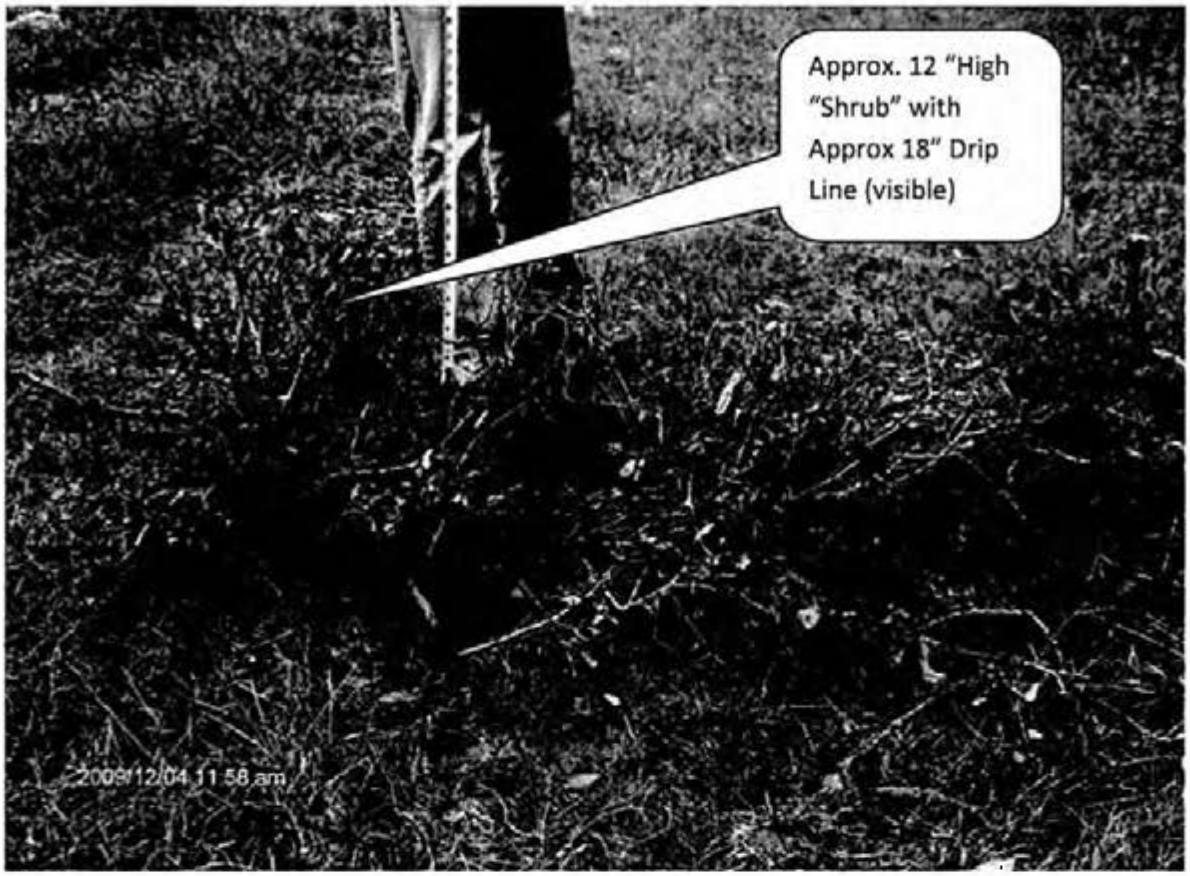
Figure 13: Cut Sapling That Began Growing Shrub-like After Cutting.
NOTE: This is the Same Plant Depicted in Figure 12
