Coal Combustion Residue Impoundment

Round 9 - Dam Assessment Report

Canadys Steam Power Station

Ash Pond Embankments
South Carolina Electric & Gas
Canadys, South Carolina

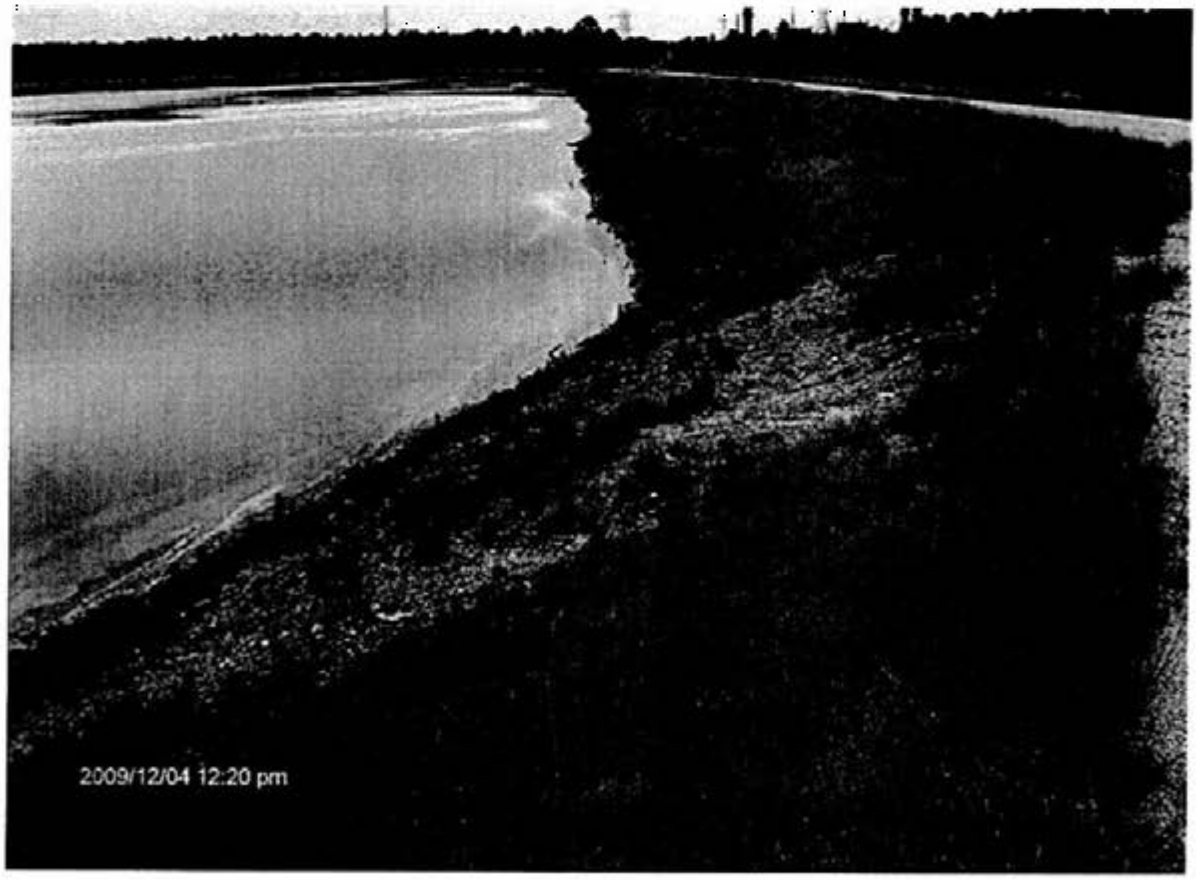
Figure 6: Erosion Damage and Lack of Vegetation Interior of Active Pond

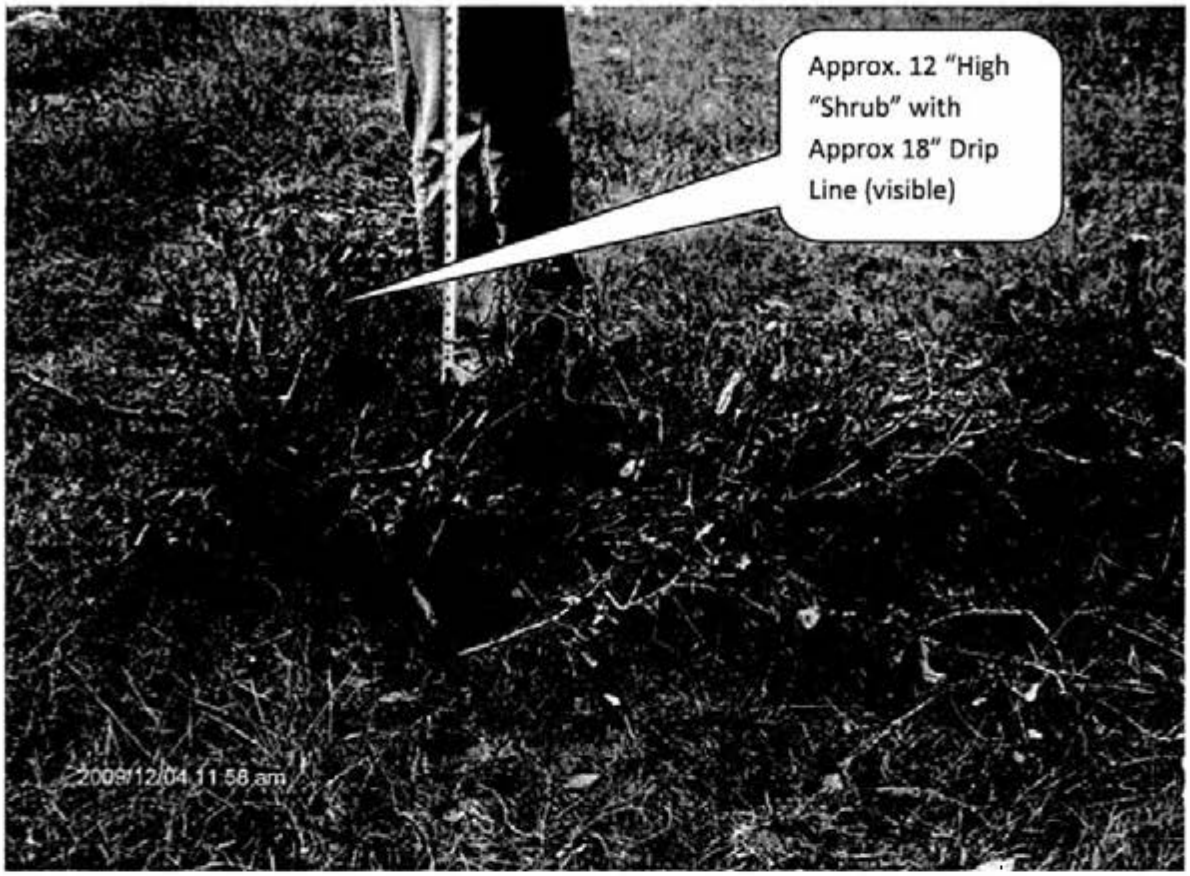
Figure 13: Cut Sapling That Began Growing Shrub-like After Cutting.
NOTE: This is the Same Plant Depicted in Figure 12
