Tanner's Creek Fly Ash Pond Assessment Report

Lockheed Martin
Contractor for the USEPA

September 2009

O'BRIEN & GERE

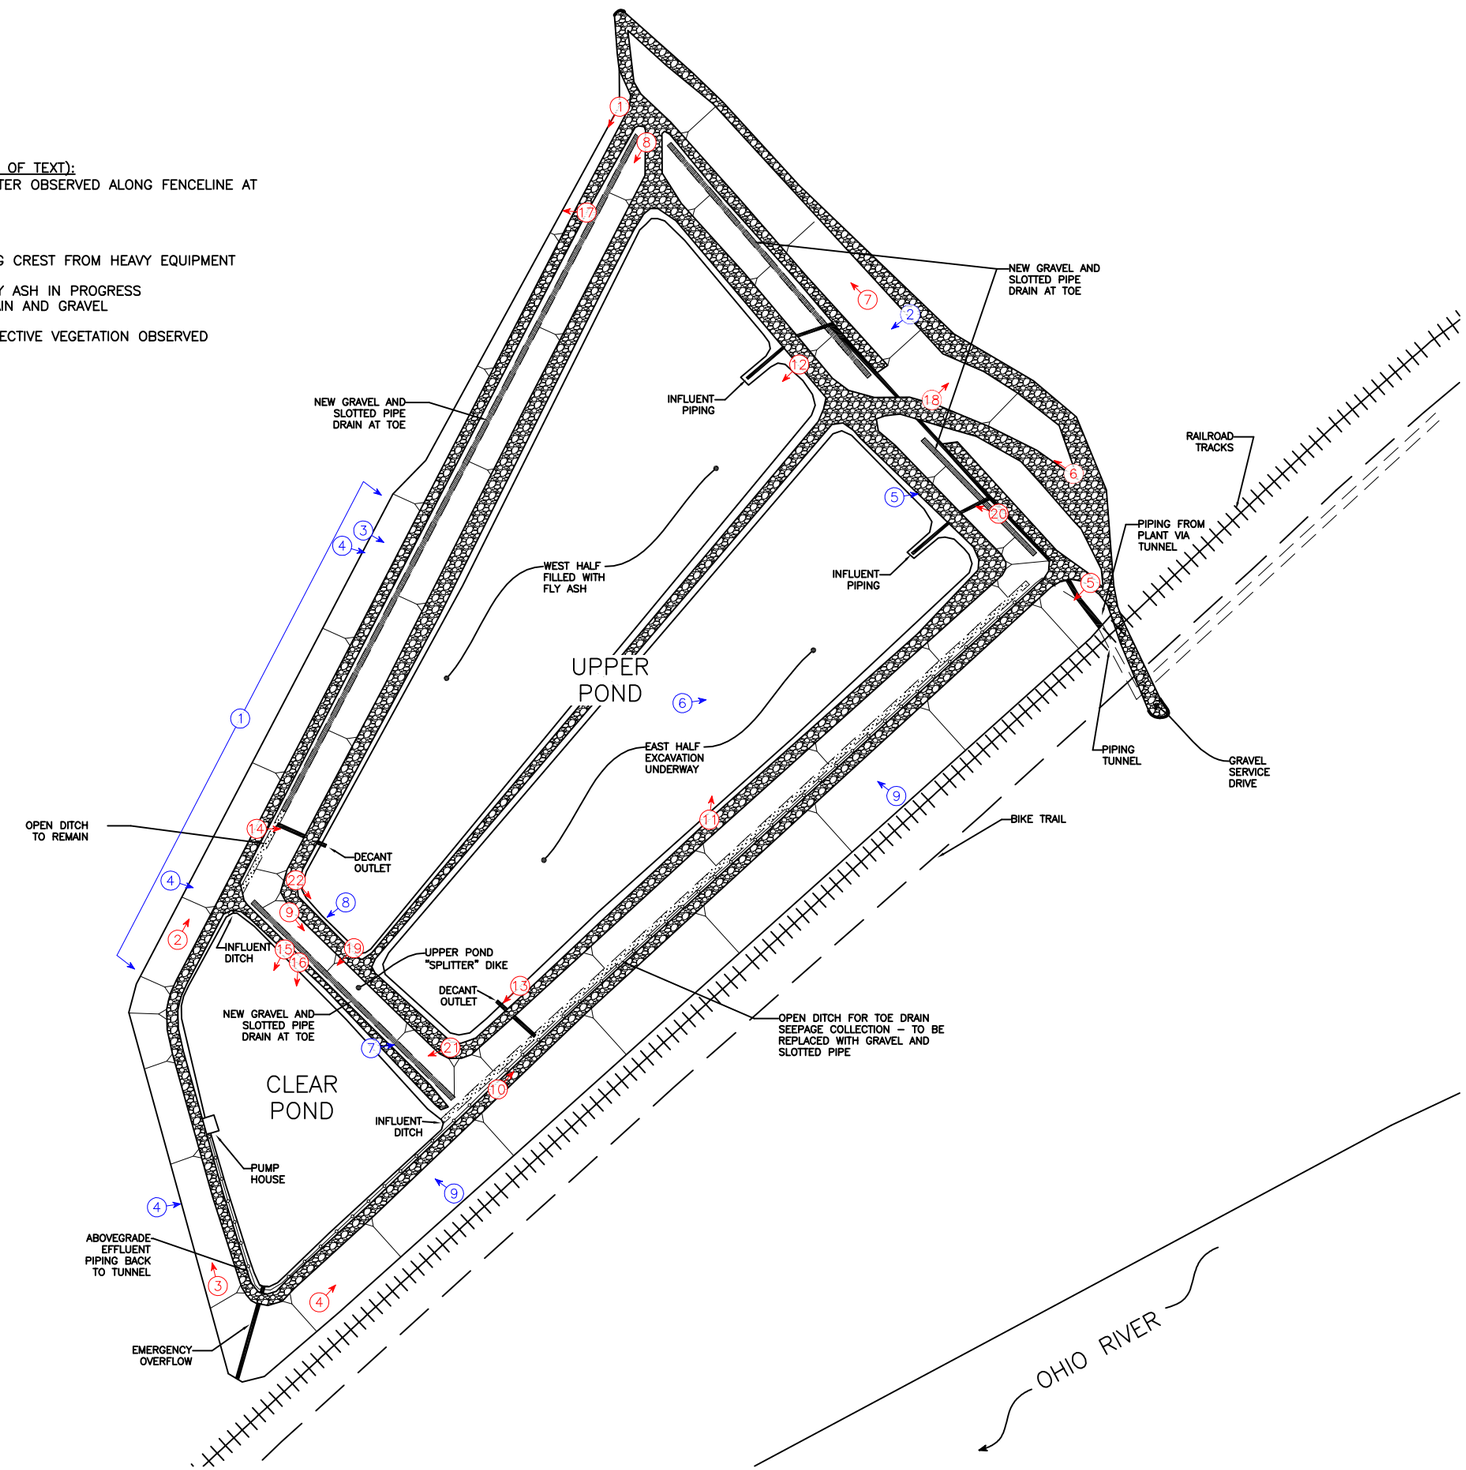
OBSERVATION NOTES (ALSO SEE SECTION 4.2 OF TEXT):

1. SHRUBBERY AND TREES UP TO 4" DIAMETER OBSERVED ALONG FENCELINE AT TOE OF WEST EMBANKMENT
2. ISOLATED SEEP
3. MULTIPLE ANIMAL BURROWS
4. ANIMAL BURROW UNDER FENCE
5. ELEVATION DIFFERENCES OBSERVED ALONG CREST FROM HEAVY EQUIPMENT TRAFFIC
6. OBSERVED EXCAVATION OF DEPOSITED FLY ASH IN PROGRESS
7. OBSERVED INSTALLATION OF SLOTTED DRAIN AND GRAVEL
8. MINOR SCARPS OBSERVED
9. EQUIPMENT RUTS AND REMOVAL OF PROTECTIVE VEGETATION OBSERVED

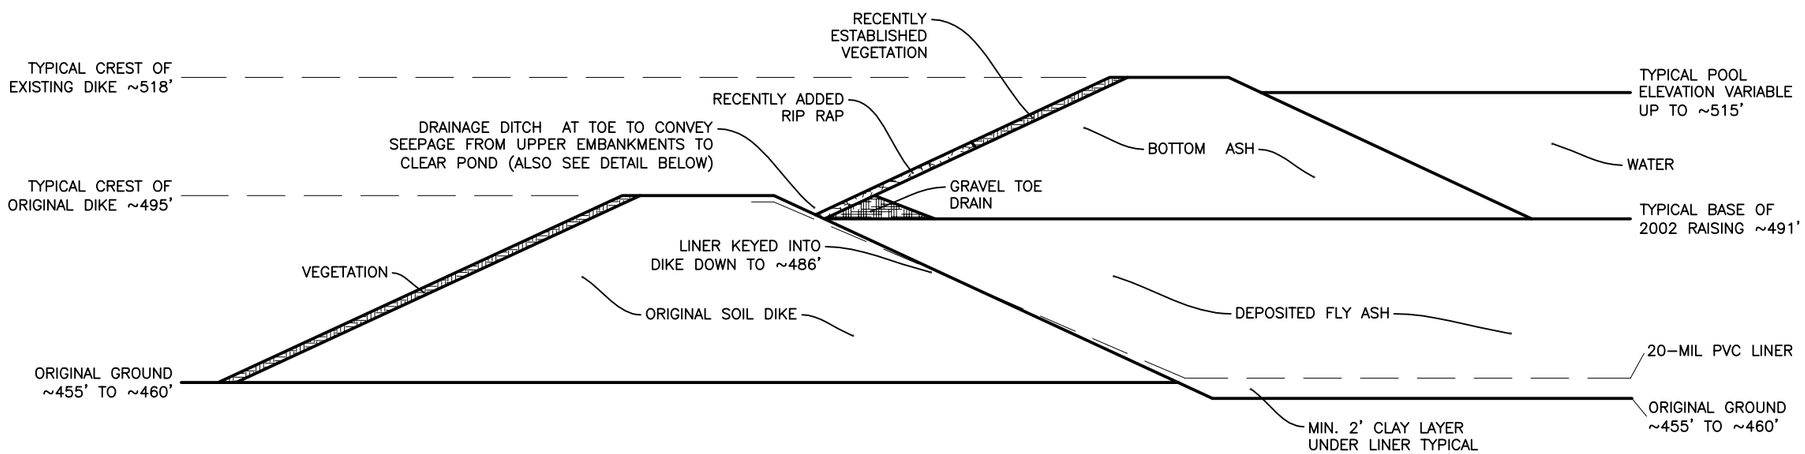
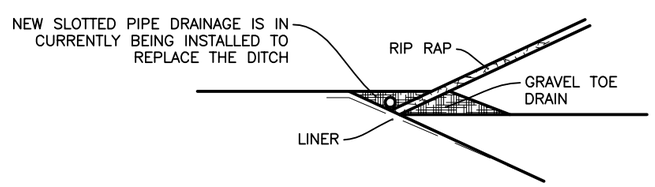
FIGURE 4

NEW CONSTRUCTION DETAIL

(INSTALLATION COMPLETE AROUND 65% OF UPPER EMBANKMENT PERIMETER)

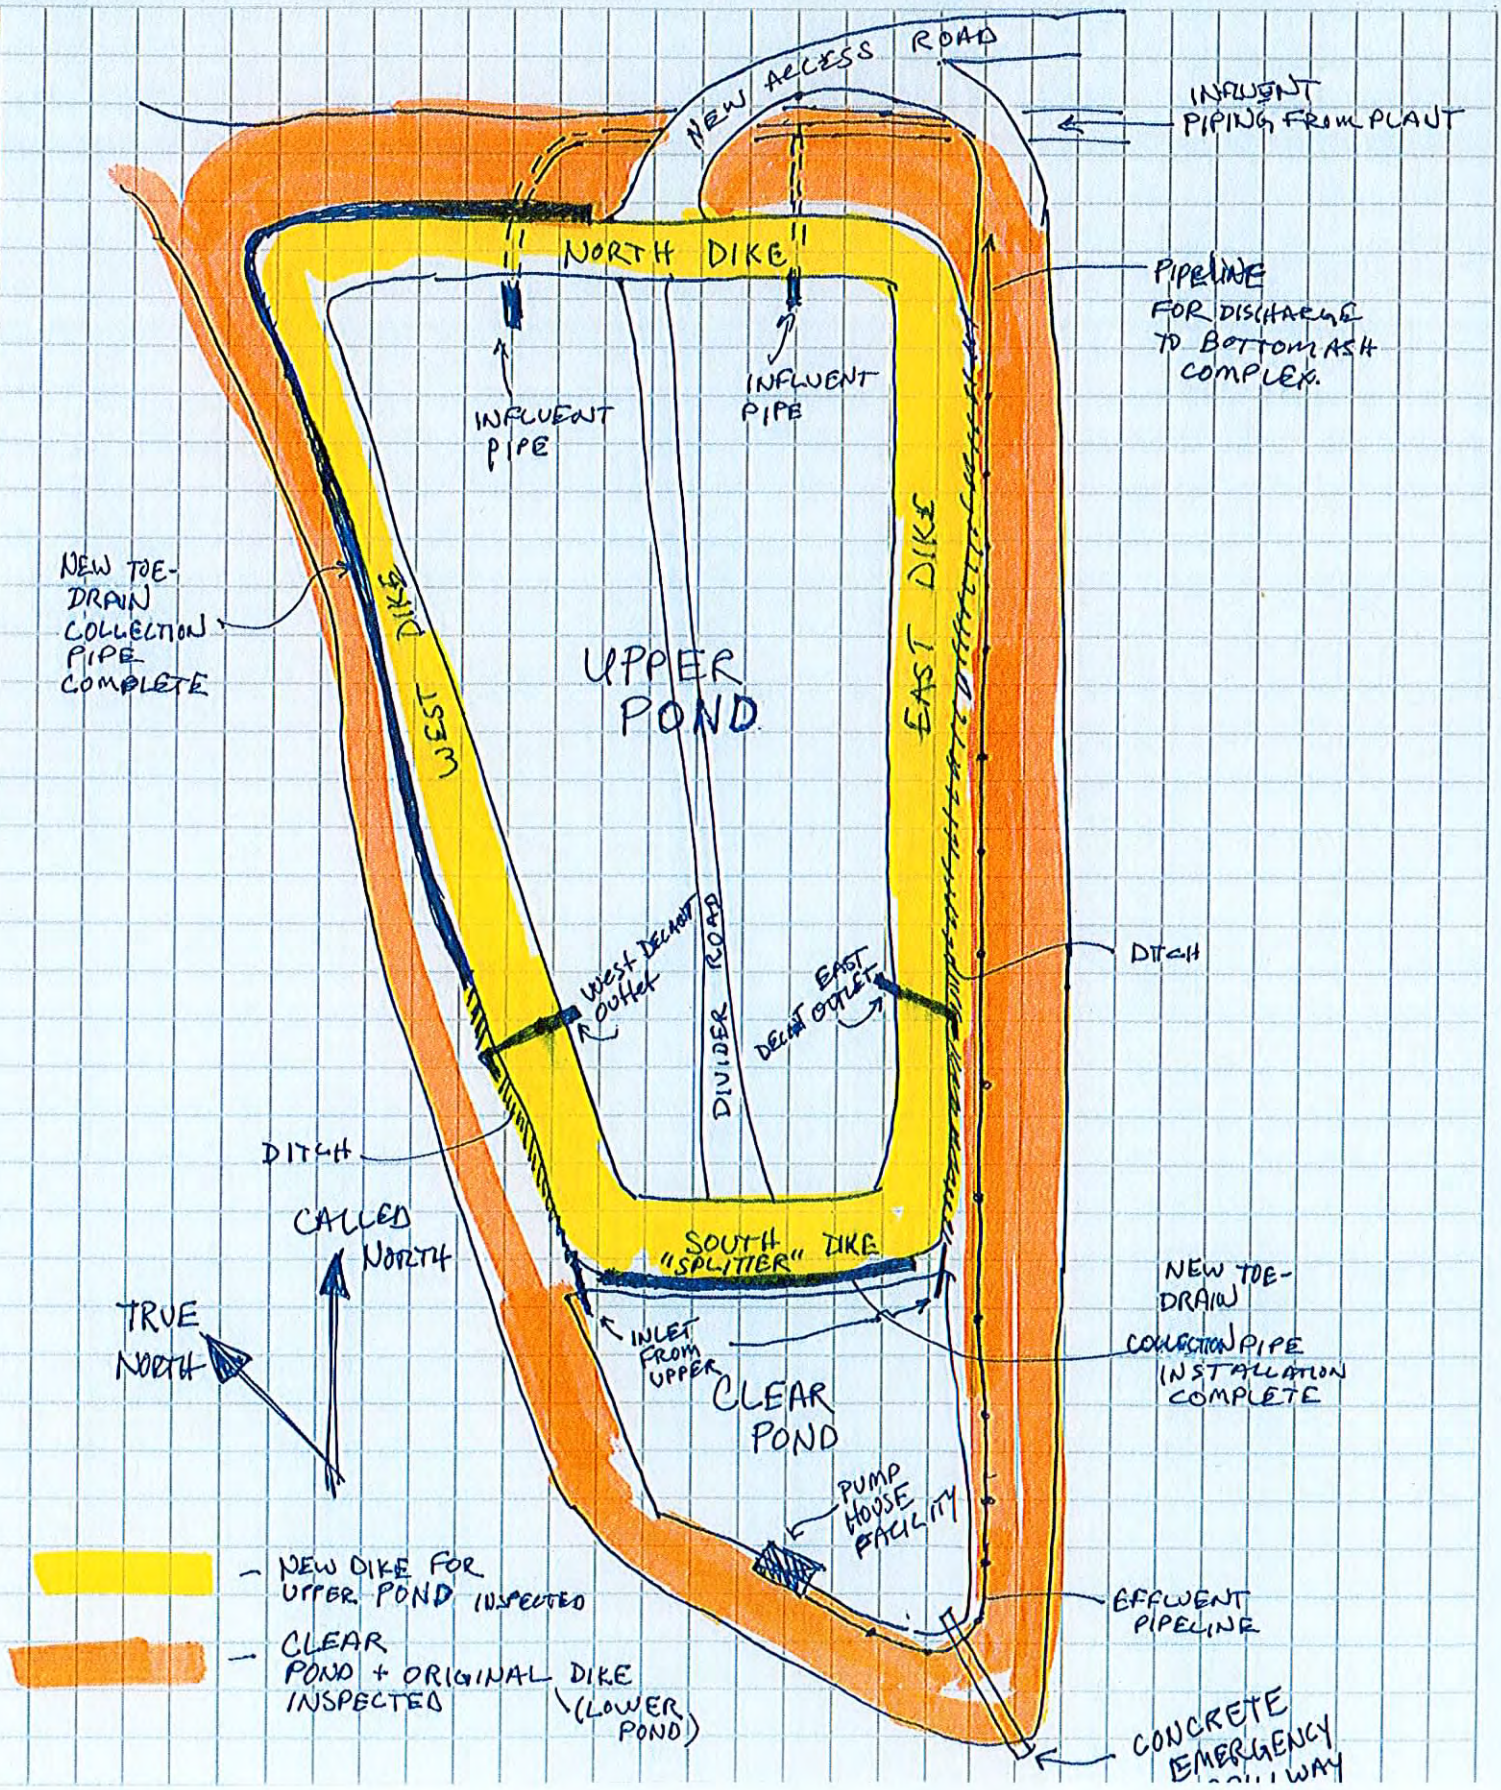
SUBJECT	SHEET	BY	DATE	JOB NO.
PLAN SKETCH - FLY ASH POND	1	JPH	6/3/09	44642

17	Numerous minor scarps were observed along the top of the upstream side of the 'east' and 'south' embankment slopes. Scarps are typically 3' in height and are made more prominent by the addition of roadway aggregate on the embankment crest.
20	Fly Ash Pond not in operation at time of inspection
21	The base of the dike is constructed with a porous gravel toe drain that is designed to collect embankment seepage. A slotted drainpipe is currently being installed at downstream toe around perimeter of dike to replace the existing ditch which conveys the embankment seepage to the outlet.
23	During inspection, the upper pond was filled to capacity with fly ash and fully drained of free surface water. However, when receiving new fly ash, or in an extreme precipitation event, the level of the clear pond (lower pool) may be elevated and this water may rest against the toe of the 'south' (splitter) dike.

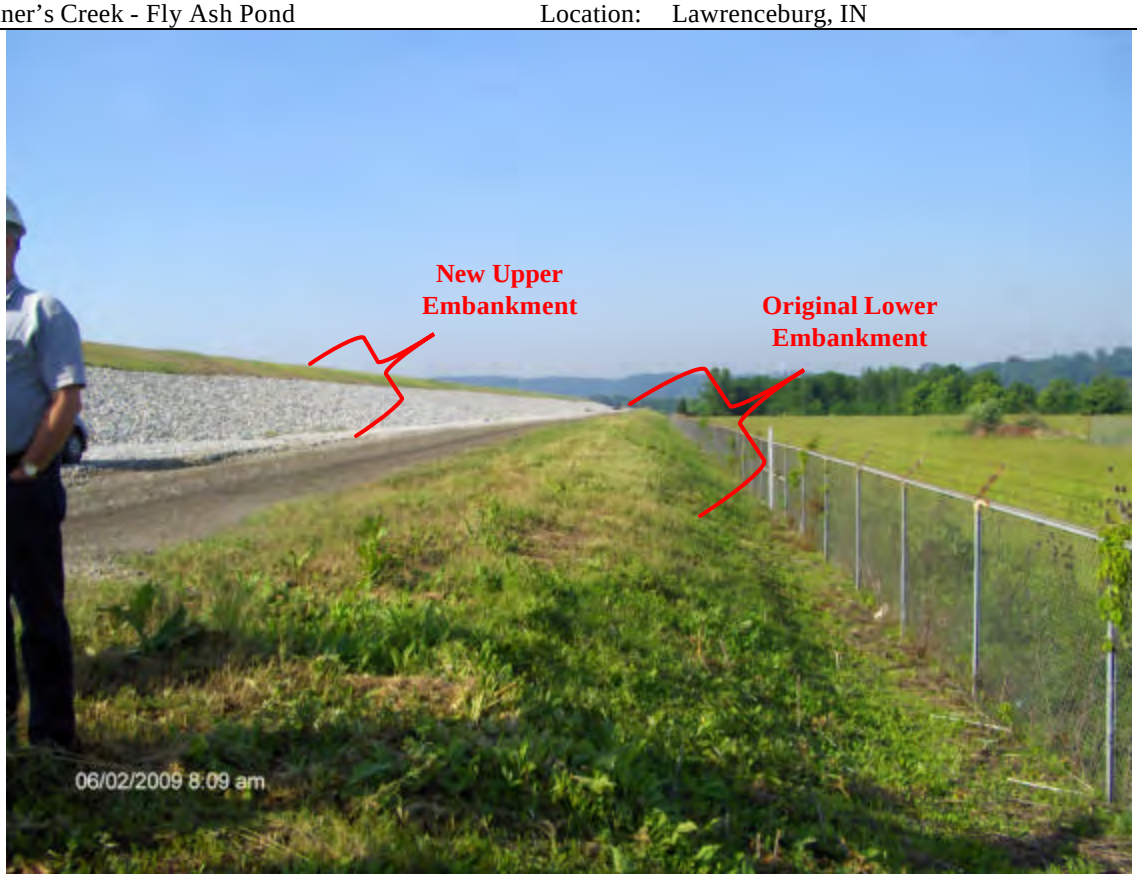
Photo Number: 1

Description: View along west embankment. Note original lower embankment and new upper embankment.

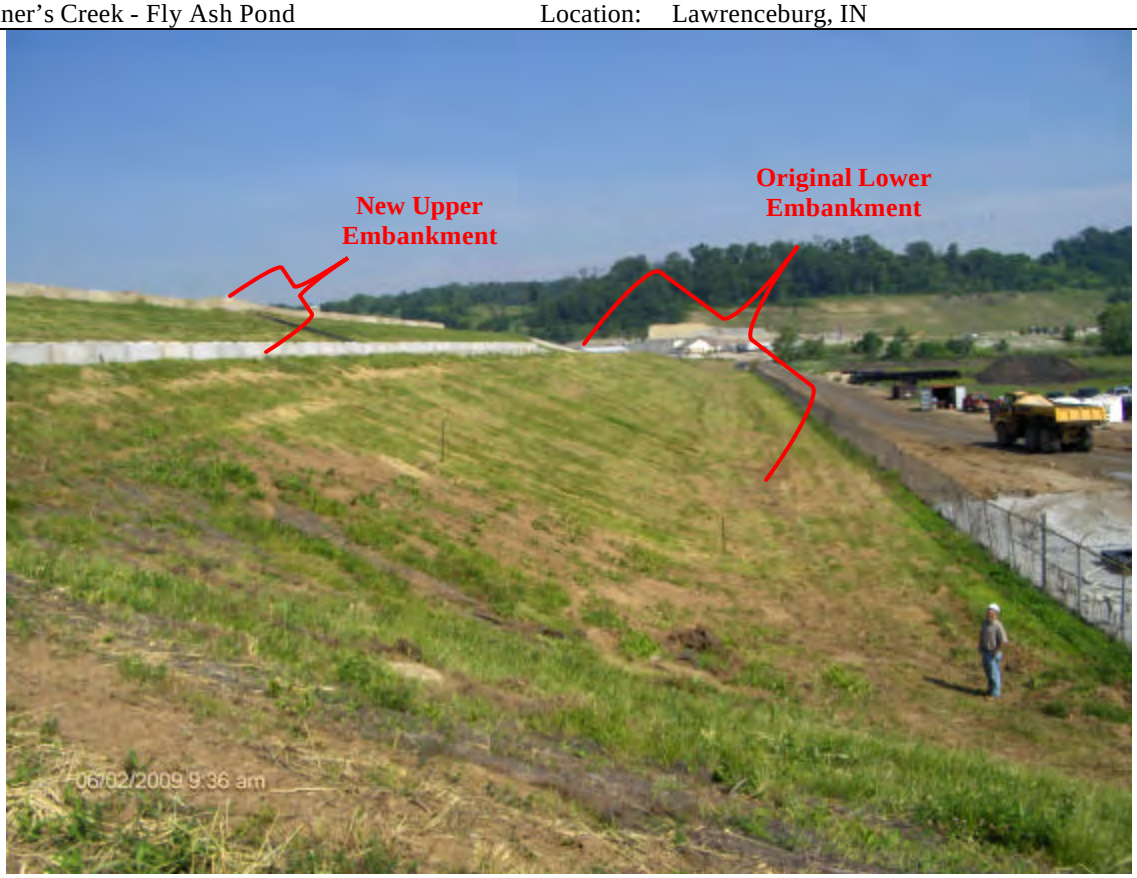
Photo Number: 7

Description: View along west embankment of Upper Pond. Note roadway at left leads up to crest of new upper embankment.

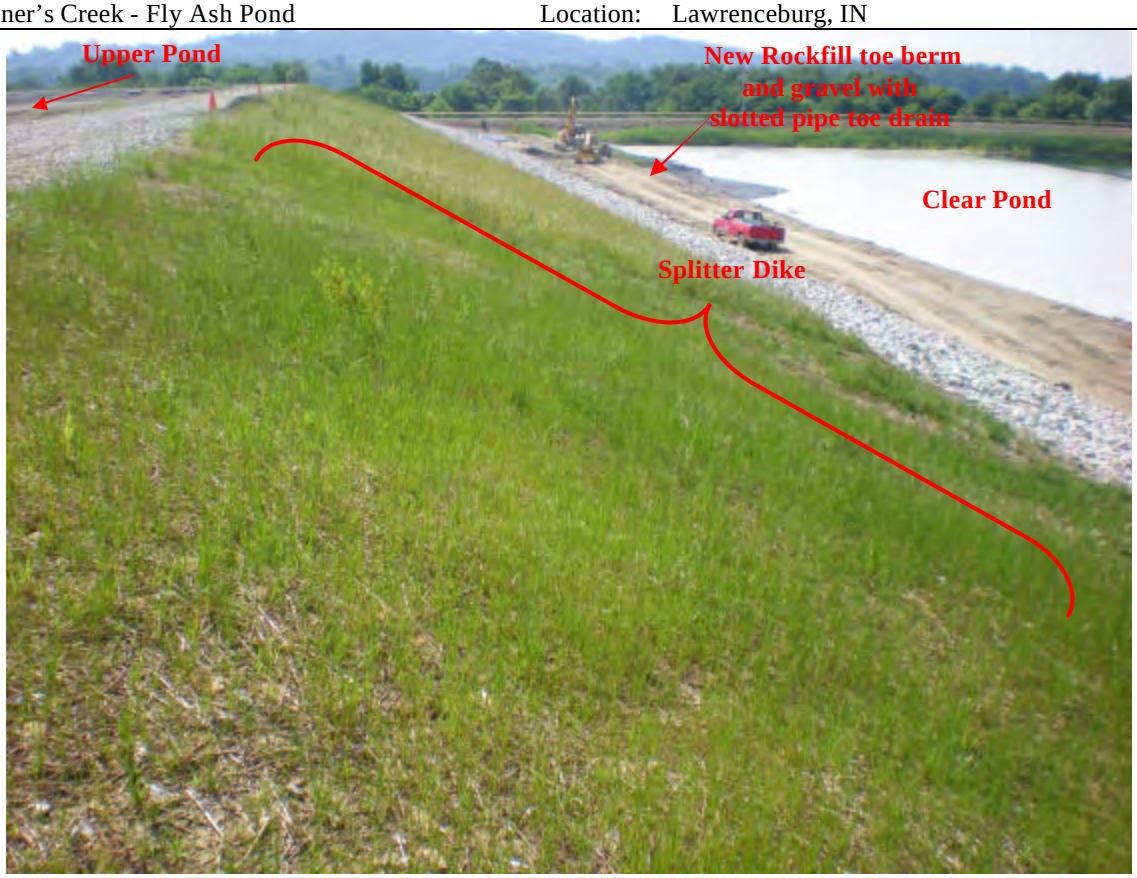
Photo Number: 9

Description: View along east embankment of Upper Pond. Discharge piping from Clear Pond shown in foreground.

A slotted pipe toe drain system is currently being installed to replace the drainage ditch which currently collects seepage from the Upper Pond. The owner should continue as planned with this modification to improve the conveyance of water away from the toe.
