Lower Ash Pond Dam – A.B. Brown Station Assessment Report

Lockheed Martin
Contractor for the USEPA

September 2009

O'BRIEN & GERE

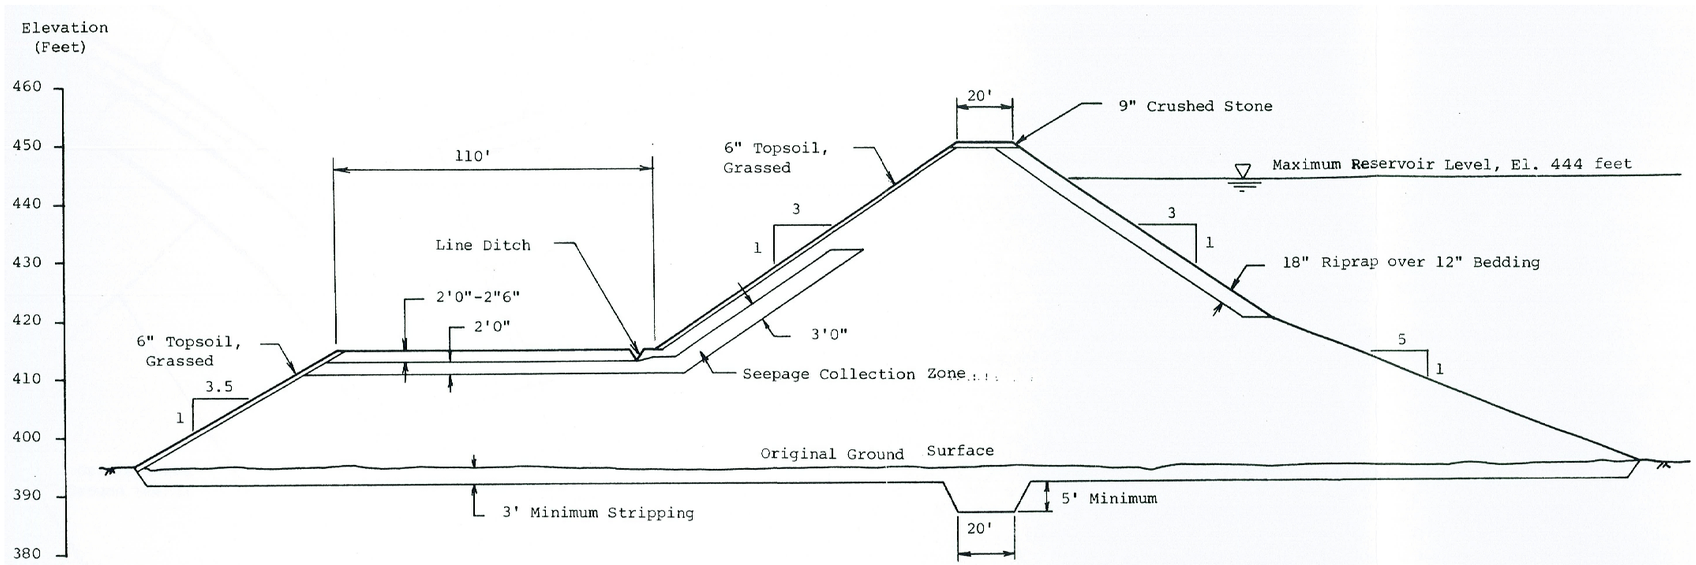
FIGURE 3

Reference: Mid-Valley, Inc., Drawing No. G-1452-1, Dam Sections and Details, January 24, 1975.
