Coal Combustion Waste Impoundment
Round 7- Dike Assessment Report

Lawrence Energy Center

Ash Impoundment Dike
Westar Energy
Lawrence, Kansas

Dewberry & Davis, LLC
Fairfax, Virginia

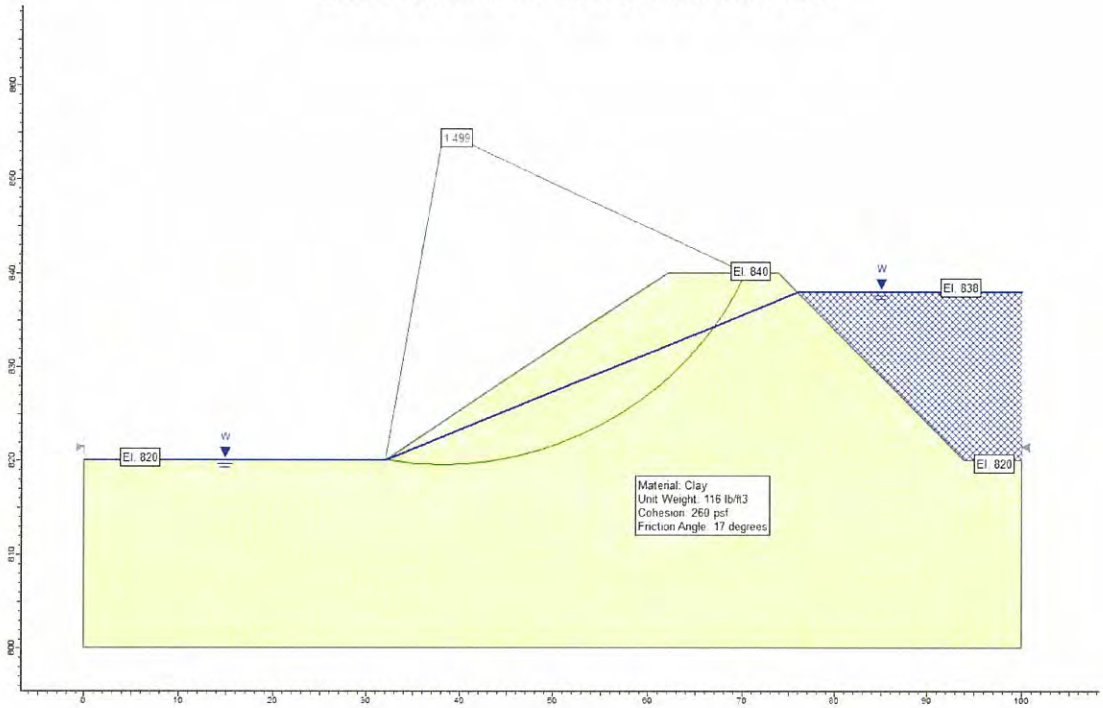
FIGURE 8

Golder performed short-term[4] and long-term[5] stability analyses for each temporary cross section, beginning with a 1H to 1V slope and a 12-foot-wide crest. For cross sections that did not exhibit acceptable factors of safety under this configuration, Golder adjusted the slope angle and/or crest width incrementally until slope stability analyses indicated an acceptable factor of safety under short-term and long-term conditions. A factor of safety of 1.3 is generally considered the minimum acceptable value for temporary earthen structures. The factors of safety resulting from the slope stability analyses are summarized in Tables 3 to 13, with the recommended embankment configurations shown in bold text. The results of slope stability analyses for the recommended embankment configurations are shown graphically in Figures 6 to 16.

STABILITY ANALYSES RESULTS CROSS SECTION 1C

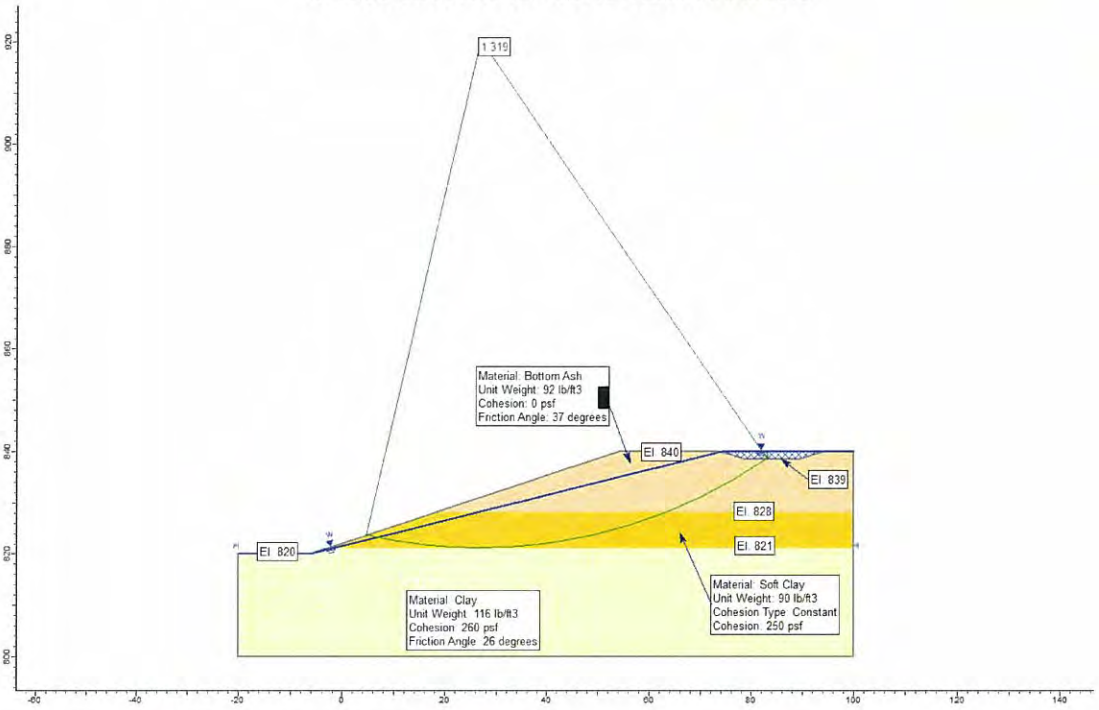
FIGURE 9

STABILITY ANALYSES RESULTS CROSS SECTION 1D

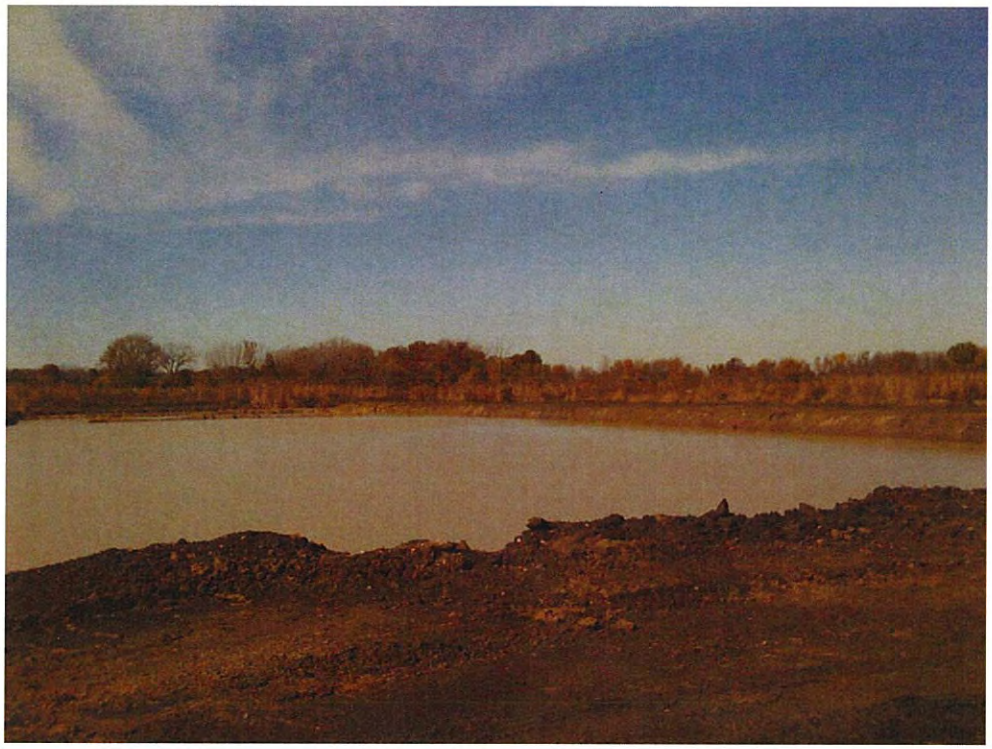
Photograph 1 – CCP storage facility (looking northwest)
