Report of Dam Safety Assessment of Coal Combustion Surface Impoundments
Westar Energy
Tecumseh Energy Center, Clinton, IA

AMEC Project No. 3-2106-0183.0001

Westar Energy's Tecumseh Energy Center's Area 1 and Area 2 (ash ponds) were assessed on October 26, 2010.

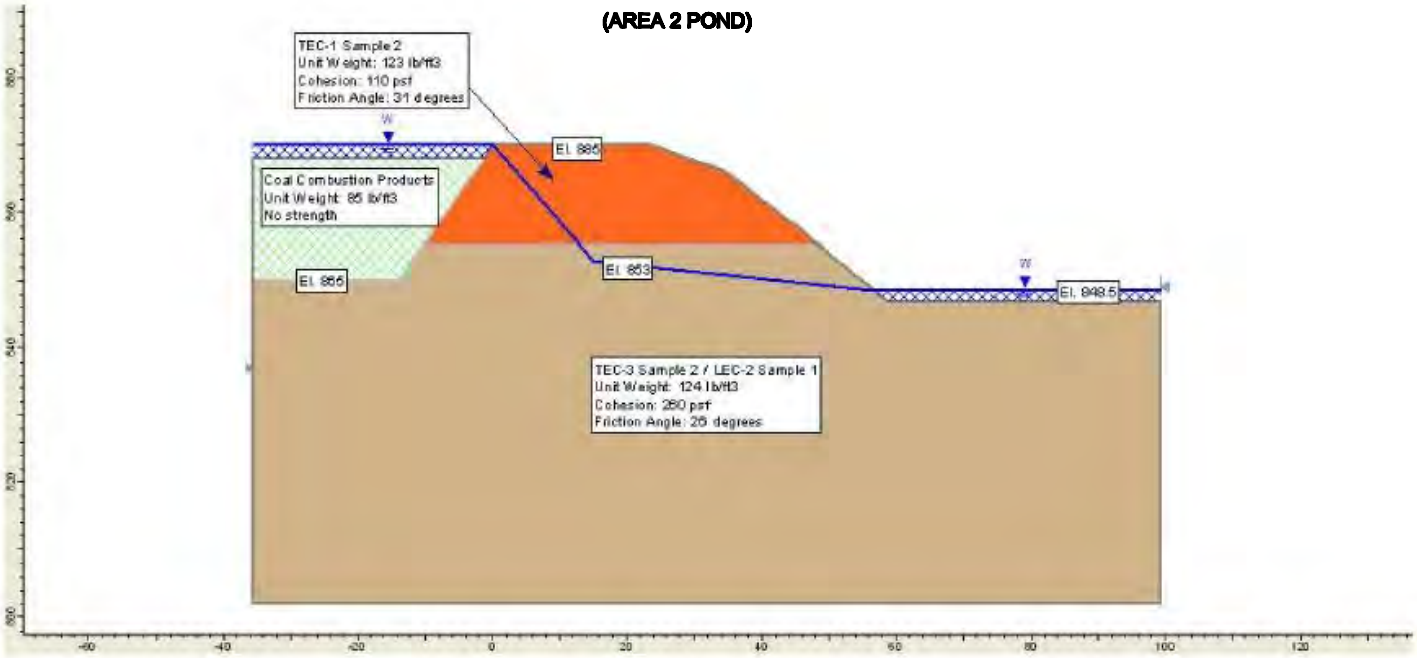
Golder addressed phreatic surfaces for Section 1 by determining the groundwater elevation in the piezometers, P-1 and P-2, five months following installation. The observed elevation was noted as 859 feet above mean sea level. It was noted in the report that Golder assumed the phreatic surface would consist of two surfaces;

Golder noted that the groundwater level in a test hole, which was excavated near Section 1 in September 2010, was at elevation 851 feet above mean sea level. This level was noted as "in agreement with the assumed phreatic surface." The phreatic surface for Section 2 was determined following a similar approach.

Cross Section and Analysis Condition	Computed Factor of Safety	Minimum Factor of Safety*
Section 1 - Static	1.5	1.5
Section 1 - Seismic	1.3	1.1
Section 2 - Static**	1.5	1.5
Section 2 - Seismic**	1.4	1.1

Golder noted that the results indicate that the Area 1 and Area 2 Ponds should "remain stable under maximum anticipated loading conditions."
