Re: Five-Year Review Report — Brantley Landfill NPL Site; Island, McLean County, Kentucky

Superfund Five-Year Review Report
Brantley Landfill
Island, McLean County, KY
EPA ID: KYD980501019

AUGUST 2002

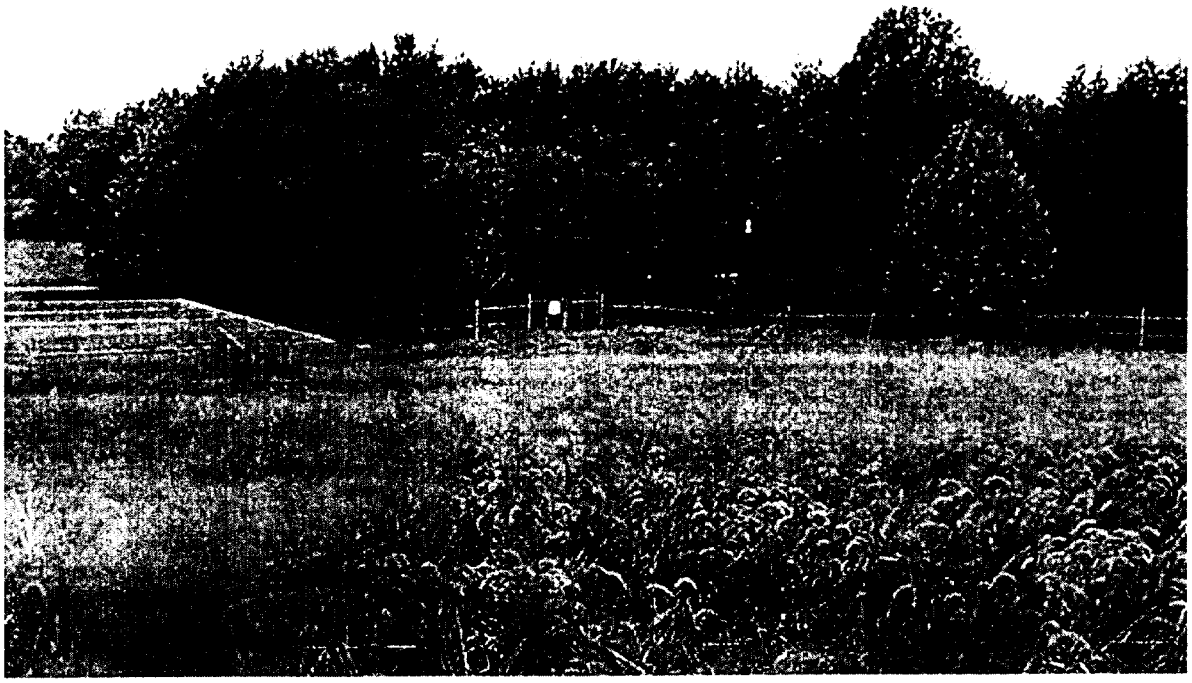
Photograph 10 — Southwestern construction gate and site fence.

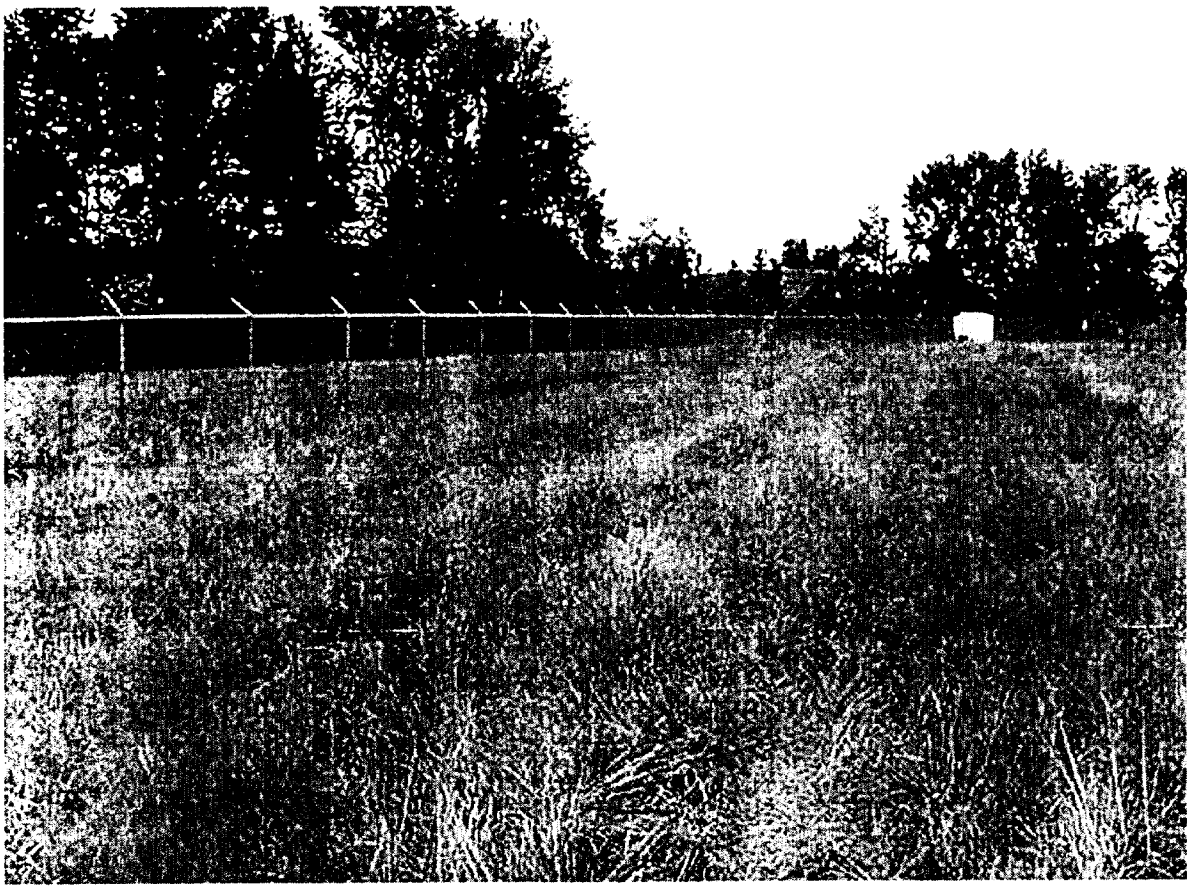
Photograph 12 — Western perimeter fencing at site facing North.
