Inactivation of *Cryptosporidium parvum* oocysts in Drinking Water

Calgon Carbon Corporation's Sentinel™ Ultraviolet Reactor

Office of Research and Development
U.S. Environmental Protection Agency
Washington, DC

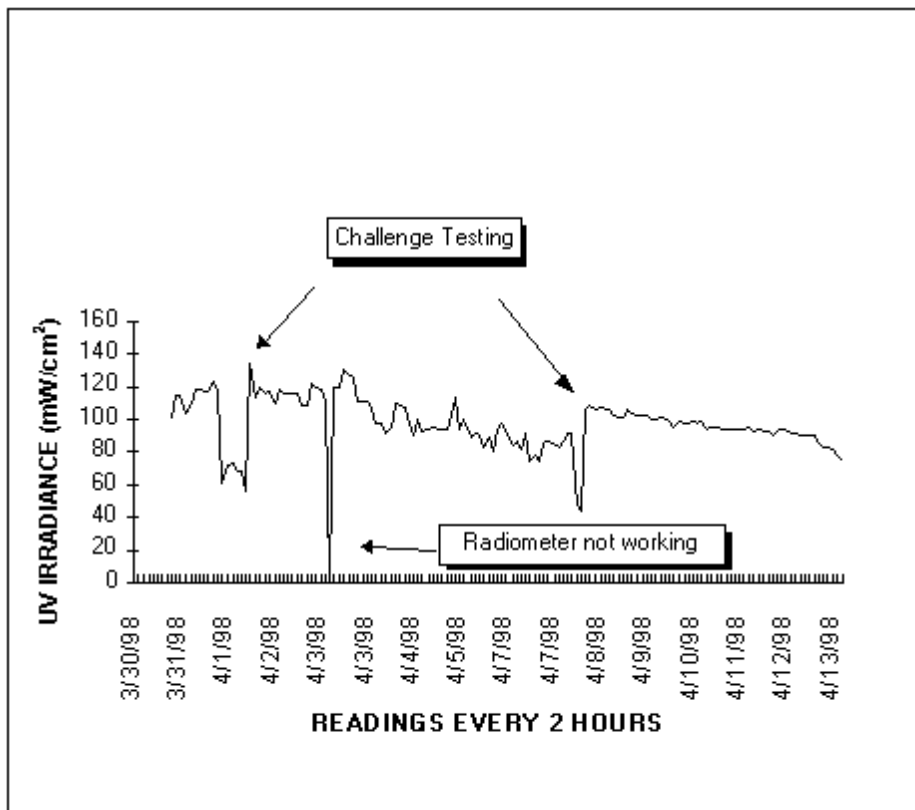
Figure 4-1. Average of UV Irradiance Over Time

At the time it was thought that the diminution might be due to either increased turbidity or to a reduction in lamp irradiance caused by aging or some other problem. When the treatment plant stabilized and the turbidity levels dropped, the irradiance levels rose slightly, suggesting that the water quality was in part a cause of the reduction. The quartz tubes were not noticeably fouled, and absorption coefficients were not appreciably different. The attenuation tubes had bleached out (from UV light) and that, along with a slow degradation in the irradiance due to lamp aging and a change in water quality and absorbance, may have contributed to the loss.

The average irradiance, as shown in Figure 4-1, shows a decline over time.

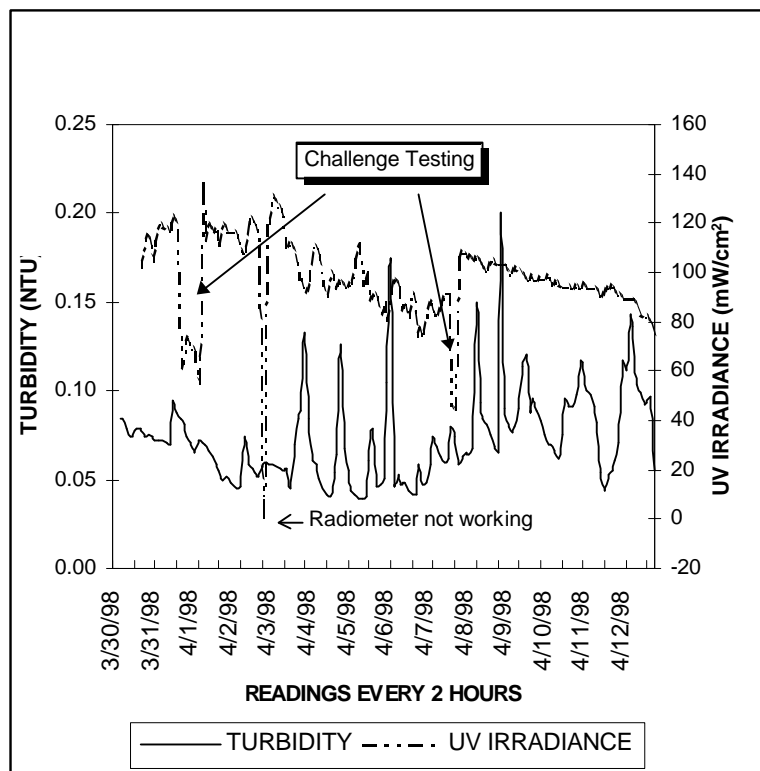
Figure 4-2. Turbidity vs. UV Irradiance

Turbidity alone does not correlate well with irradiance. Turbidity spikes appear to be related to filter backwash periods. The overall turbidity of the plant increased following the change in pretreatment chemistry on April 7 and following that change the filters were backwashed several times a day during the restoration period.

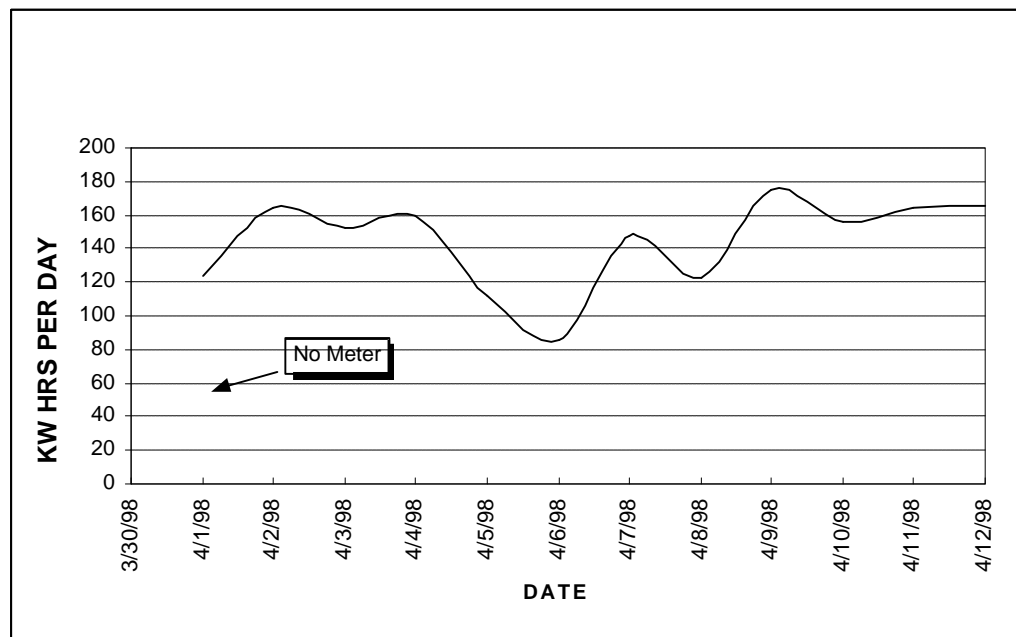
Figure 4-5. Power Used During Testing

Figure 4-5 below shows power consumption during the testing period. Because during the challenge period only at most two lamps were on, power consumption is not constant over time. During the maintenance period the power consumption was approximately 1.046 ± 0.046 kW per lamp. Assuming daily operation of six lamps at full power, the power demand is estimated at 150.6 kW per day.

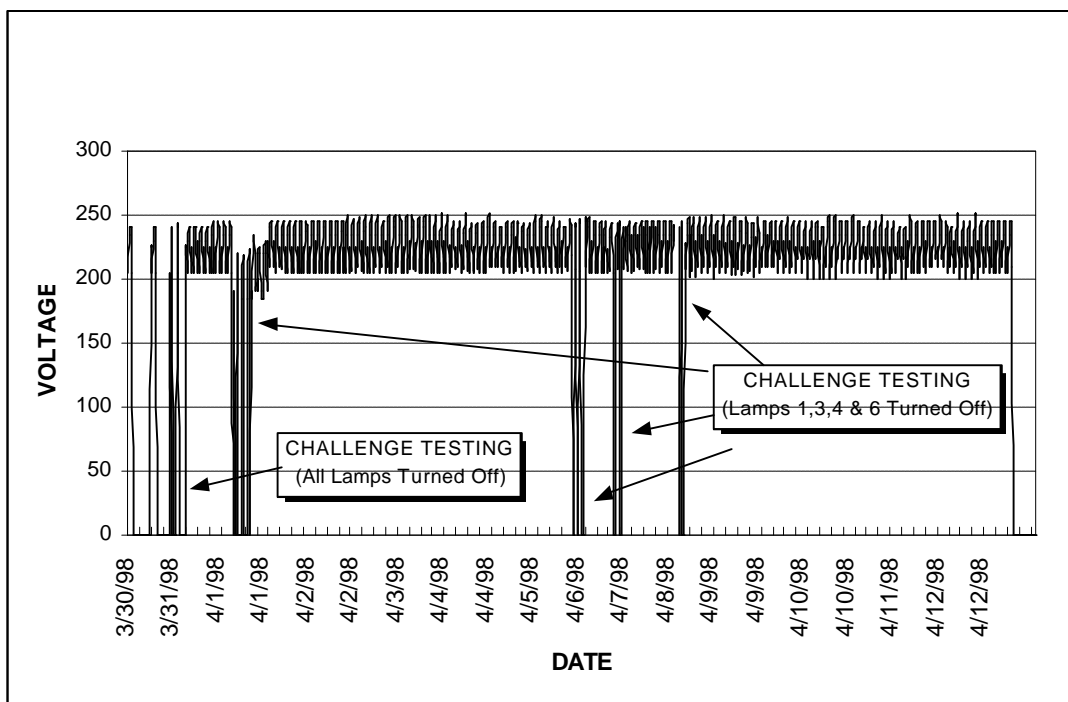
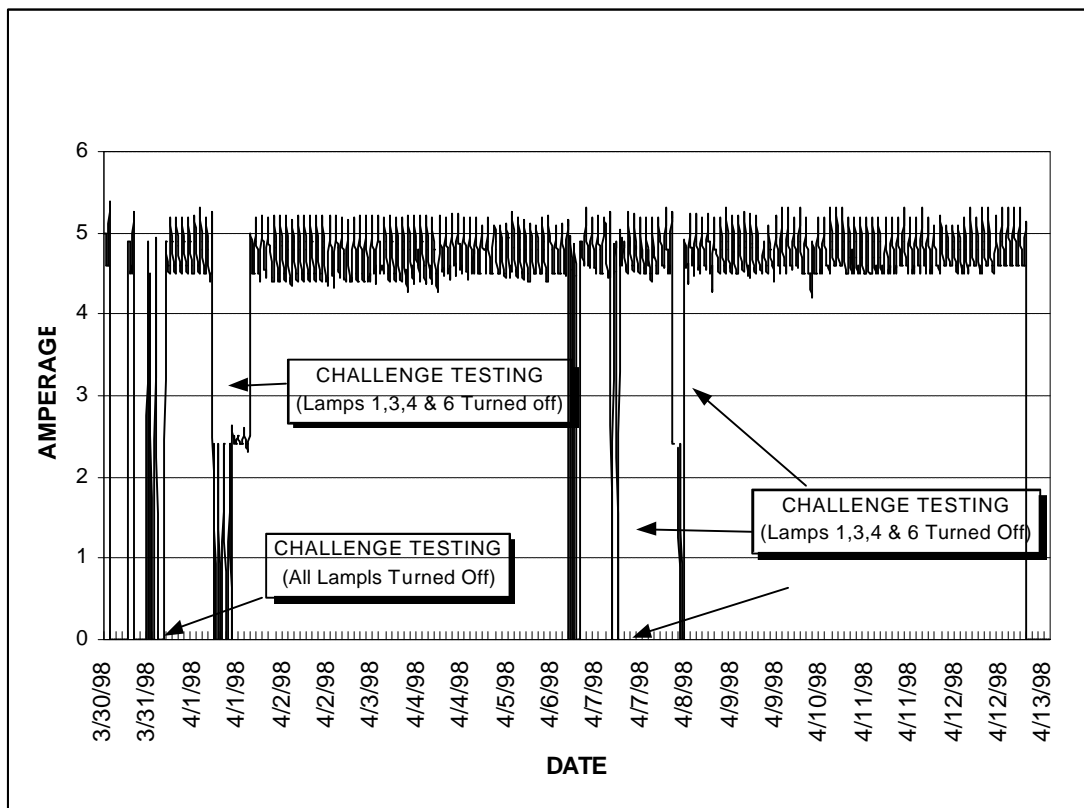
Voltage and amperage readings, except during lamp off times, were stable throughout the period (Figures 4-6 and 4-7). Increased power demand following a reduced power period suggests that initial illumination requires a higher level of power.
